**Aviation Safety Investigation Report
200304074**

**Robinson Helicopter Co
R22**

28 September 2003

Examination of a Fractured Clutch Shaft

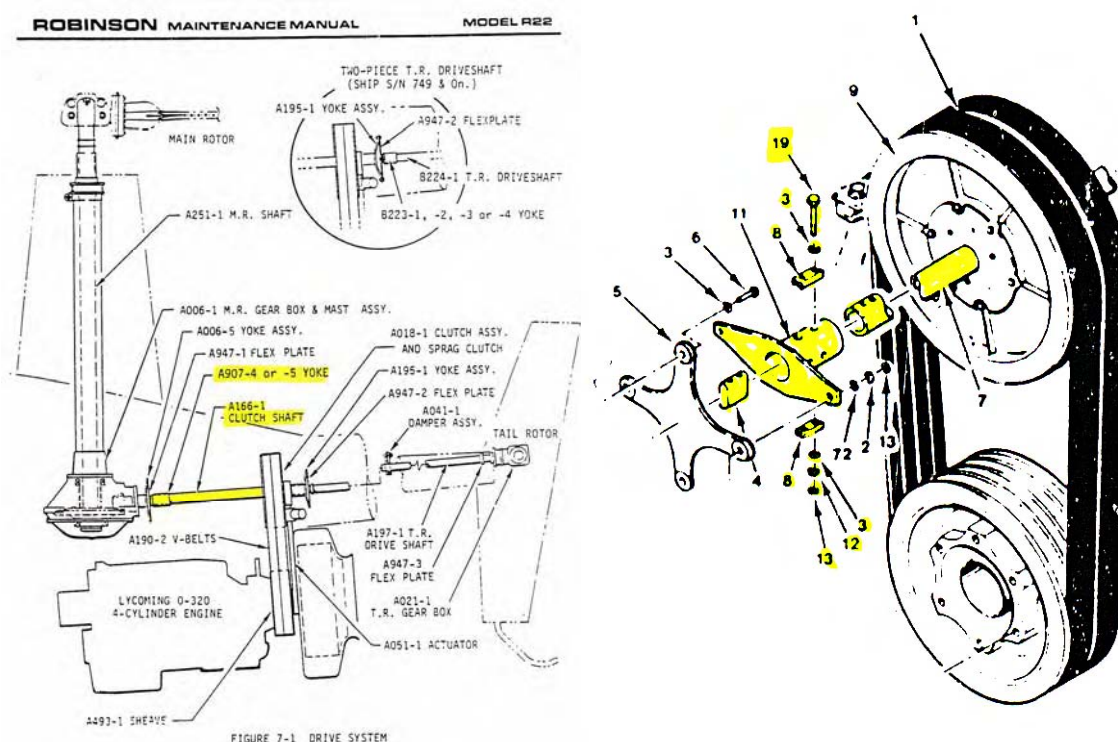
Figure 1. Illustrations of the clutch shaft and yoke components as part of the helicopter's main rotor drive system.

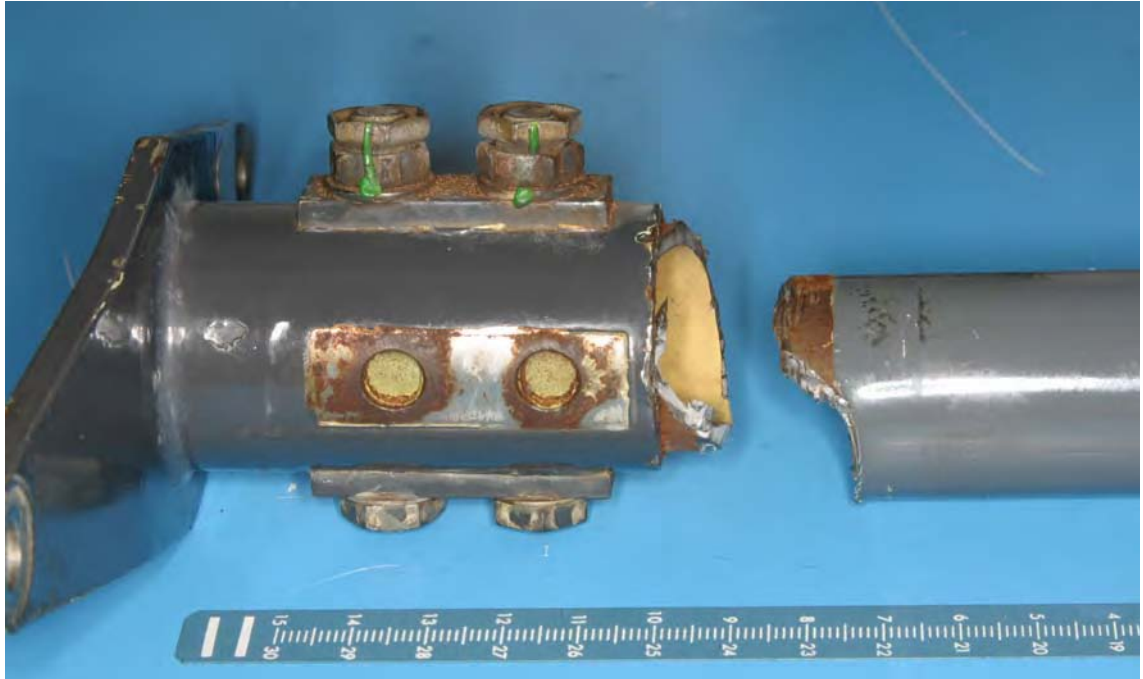
The clutch shaft had fractured at the point of connection to the main rotor gearbox flex-plate yoke (see figure 2 of Appendix A – Technical Analysis Report). The fracture surface indicated pre-existing torsional fatigue cracking, which followed a spiral path from within the yoke connection, and extended around the shaft for approximately 340 degrees over an axial length of about 25 mm. Those crack propagation features were consistent with the initiation and progressive growth of the crack during multiple shaft load cycles prior to the accident flight.

The clutch shaft had fractured at the point of connection to the main rotor gearbox flex-plate yoke (Figure 2). The fracture displayed clear evidence of torsional fatigue cracking, following a spiral path from within the yoke connection that extended around

Figure 2. Clutch shaft, fractured at the point of connection with the flex-plate yoke.

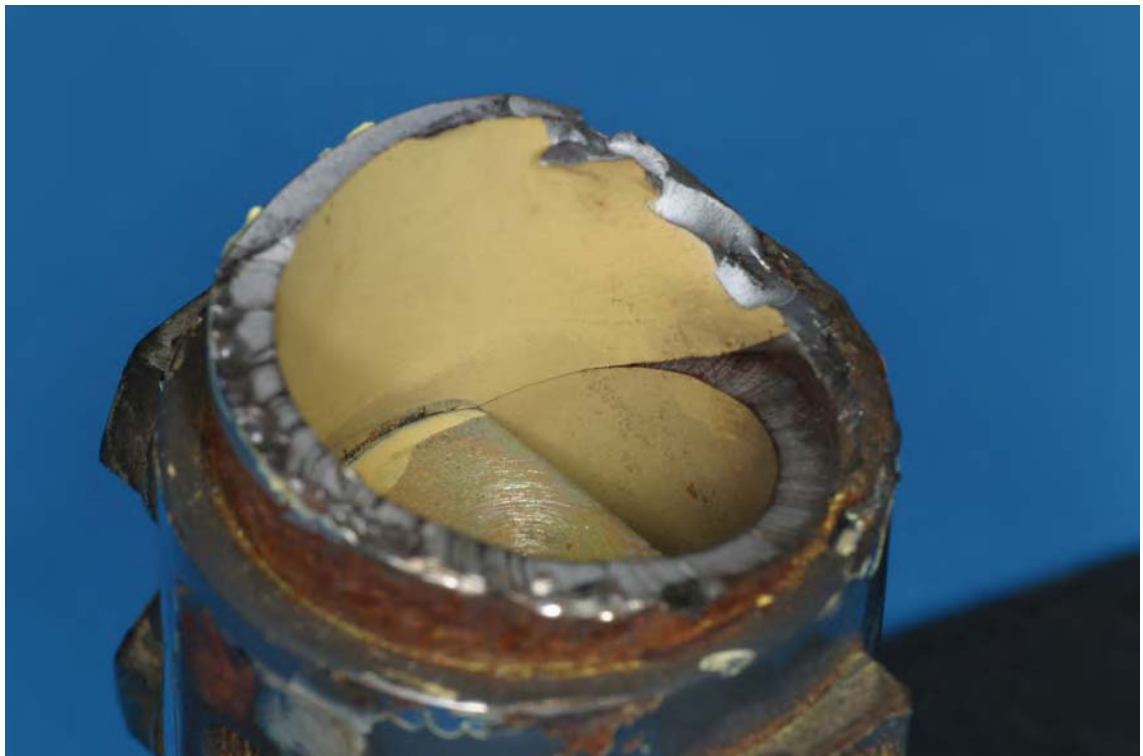
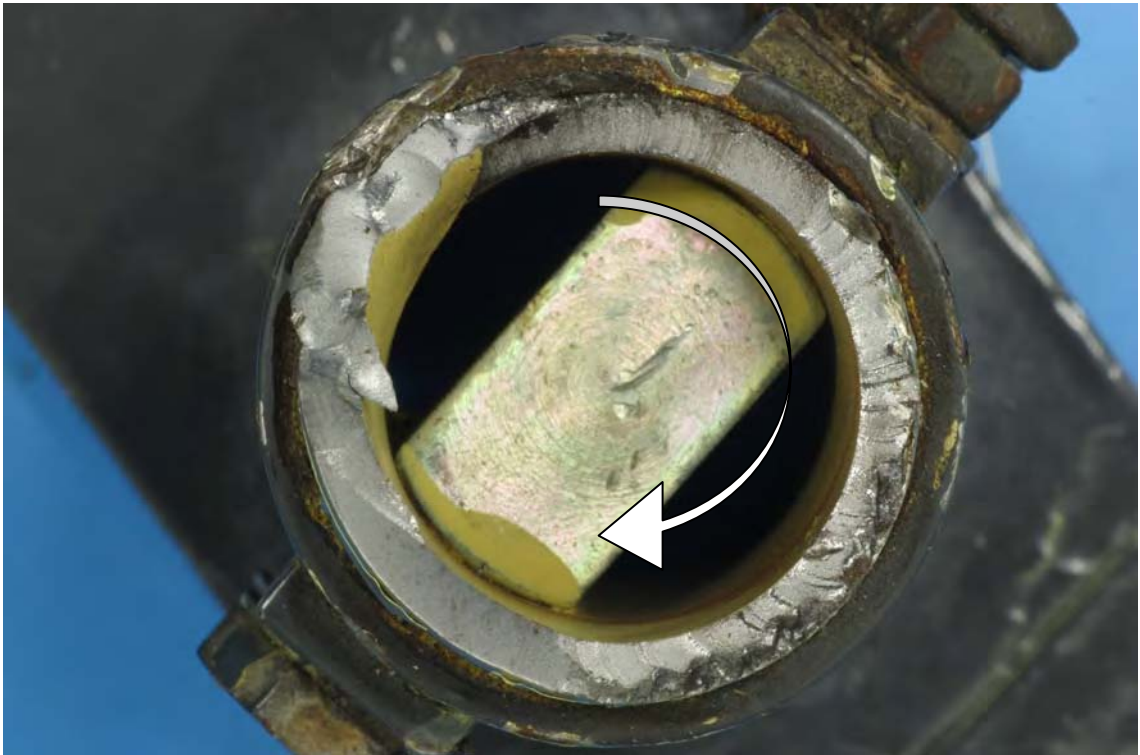
the shaft for approximately 340 degrees over an axial length of around 25 millimetres (Figures 3 & 4). The area of final overload failure represented approximately thirty percent of the overall shaft cross-section and showed mostly ductile shear features.

Figure 3. Shaft fracture surface showing the spiral form typical of torsionally induced failures.

Figure 4. Identifiable crack progression markings (beach marks) on the fracture face indicated the direction of fatigue crack growth (arrow).

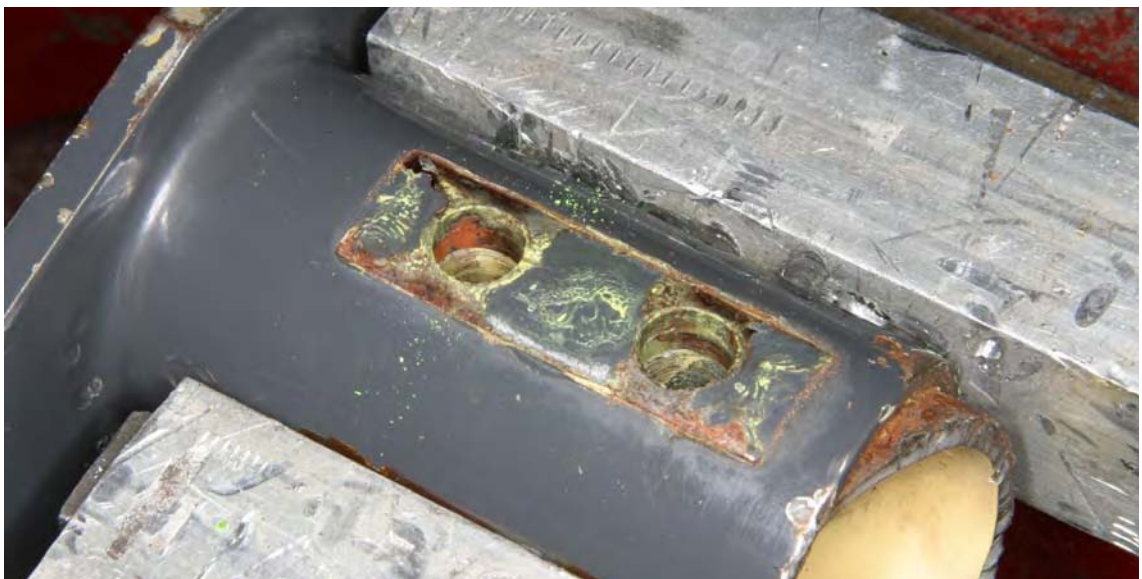
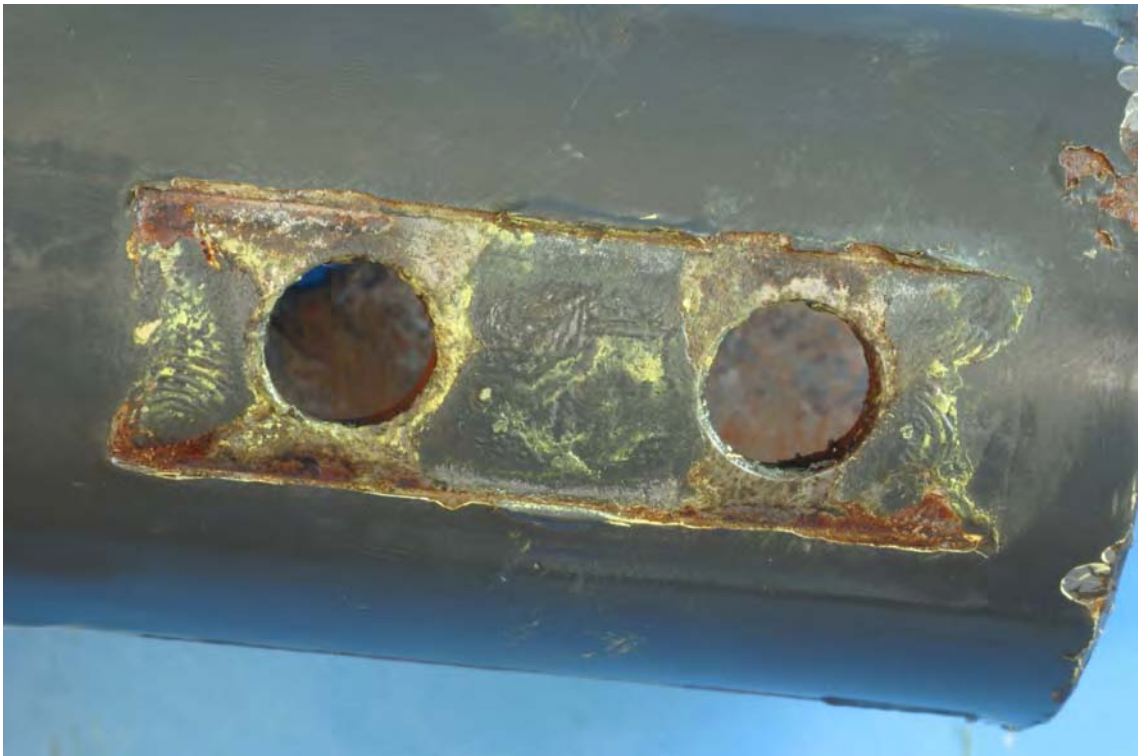
Examination found that when the clutch shaft was assembled to the flex-plate yoke, paint was left on the surface beneath the bearing blocks. That resulted in the applied bolt tension reducing over time. The examination also found that an unapproved jointing compound had been used when the shaft and yoke were last assembled.

Figure 5. Removal of the bolt blocks revealed the assembly of the joint over the painted yoke surfaces.

Figure 6. As shown in figure 5, the surfaces of the yoke had not been cleaned of paint before assembly of the clutch shaft connection.

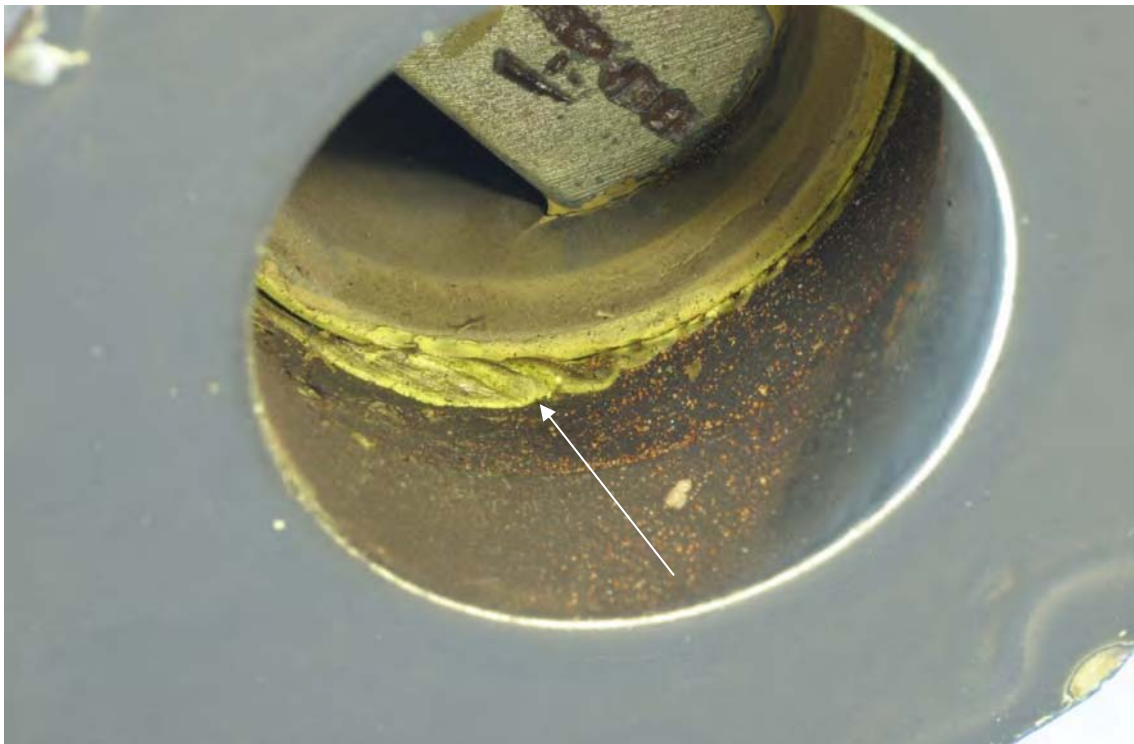
Disassembly of the shaft-yoke connection revealed low levels of break-out torque required for both assembly bolts. The inner and outer bolts loosened at torque values of 7 and 4 foot-pounds respectively; markedly below the 20 foot pounds (240 in-lbs) tightening torque that the aircraft maintenance manual specified for the connection.^[1] Removal of the bolts and bearing blocks subsequently revealed that the blocks had been installed directly over the painted yoke surface (Figures 5 & 6). Inspections found no indications of any attempt to remove the paint from the block seating locations. Evidence a soft, yellow coloured product between the shaft and yoke (Figure 7) suggested the use of a jointing compound or similar material during the last assembly of the connection.

Figure 7. Arrow shows an accumulation of a soft jointing compound within the connection.

The assembly of the yoke-shaft connection with the use of a jointing or similar compound in lieu of the specified primer/s was also held as a factor contributing to the looseness of the connection. The oily, anti-friction properties shown by the compound would have acted to reduce the surface friction within the connection – thus increasing the loads transmitted through the bolts and bolt holes. The non-drying properties of the compound also prevented the effective ‘lock-up’ of the connection when assembled, allowing the surface movement, fretting and bolt interference.

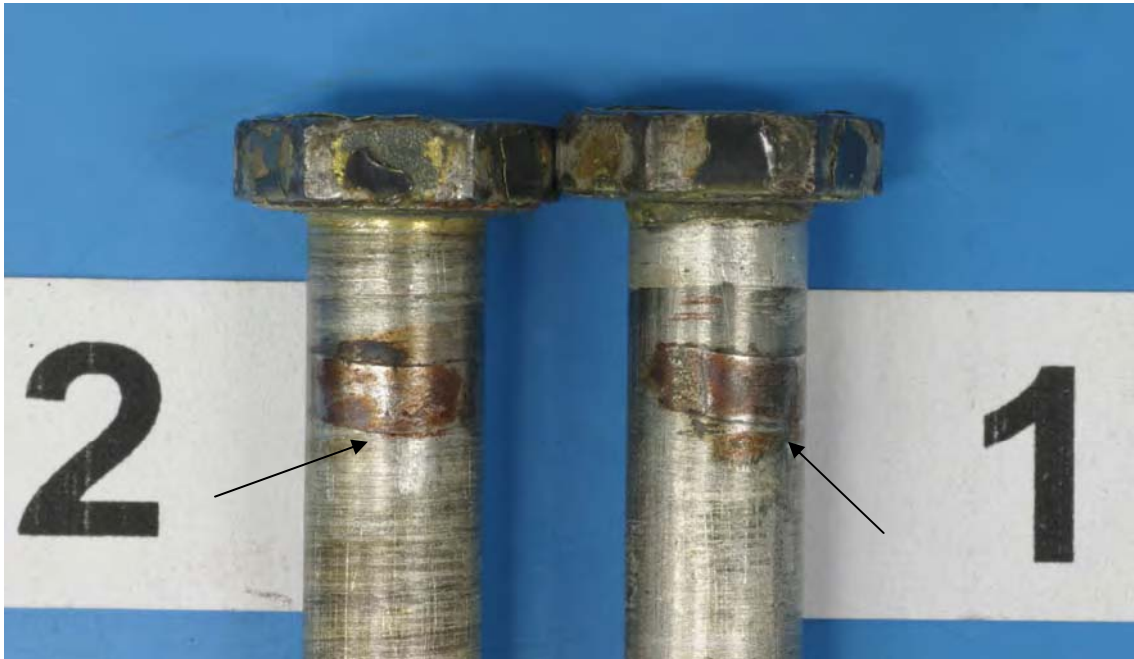
Both connection bolt shanks showed fretting and other prominent evidence of loaded contact against the yoke and shaft hole sides (Figure 8). The orientation of the bolt damage indicated that the looseness of the connection had allowed the transmission of shaft torque loads via shear loading of the bolts. Extensive fretting and corrosion of the mating shaft and yoke surfaces found after removing the fractured stub (Figures 9 & 10) provided further evidence of looseness and movement within the connection. Both mating surfaces showed no evidence of the primer coating (Figure 11) specified by the maintenance manual.^[2,3]

Figure 8. Fretting and wear damage to the bolt shanks, indicating interference with the clutch shaft holes.

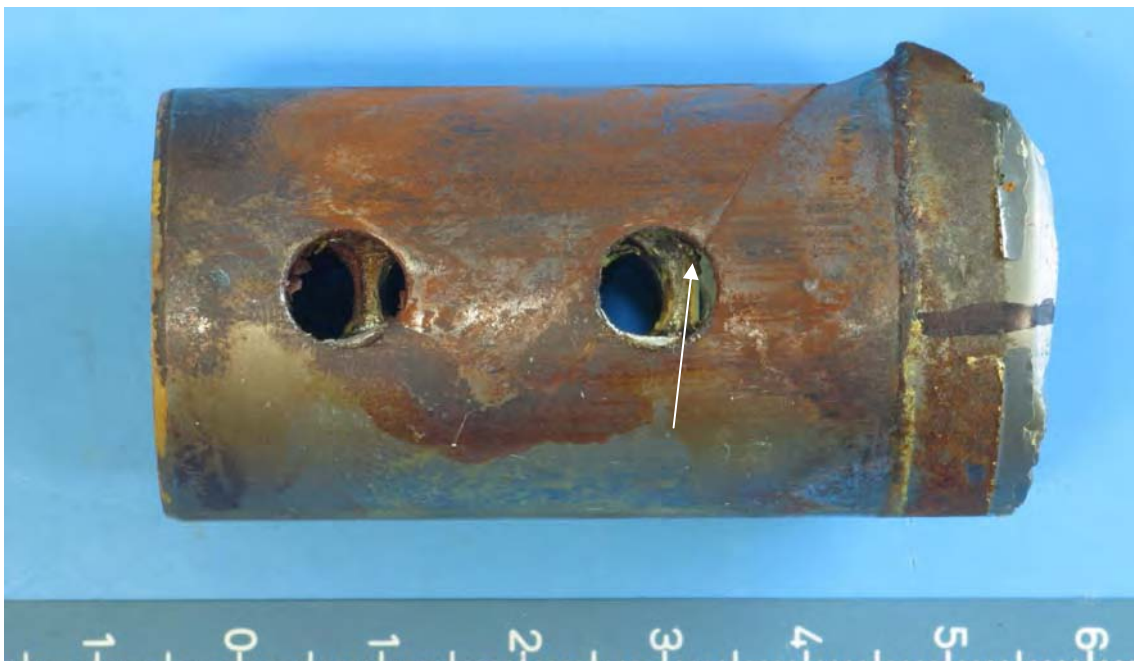
Figure 9. Stub of the clutch shaft removed from the yoke. Crack initiation point shown at the outer bolt hole. Also note the extent of fretting corrosion and damage from the joint movement.

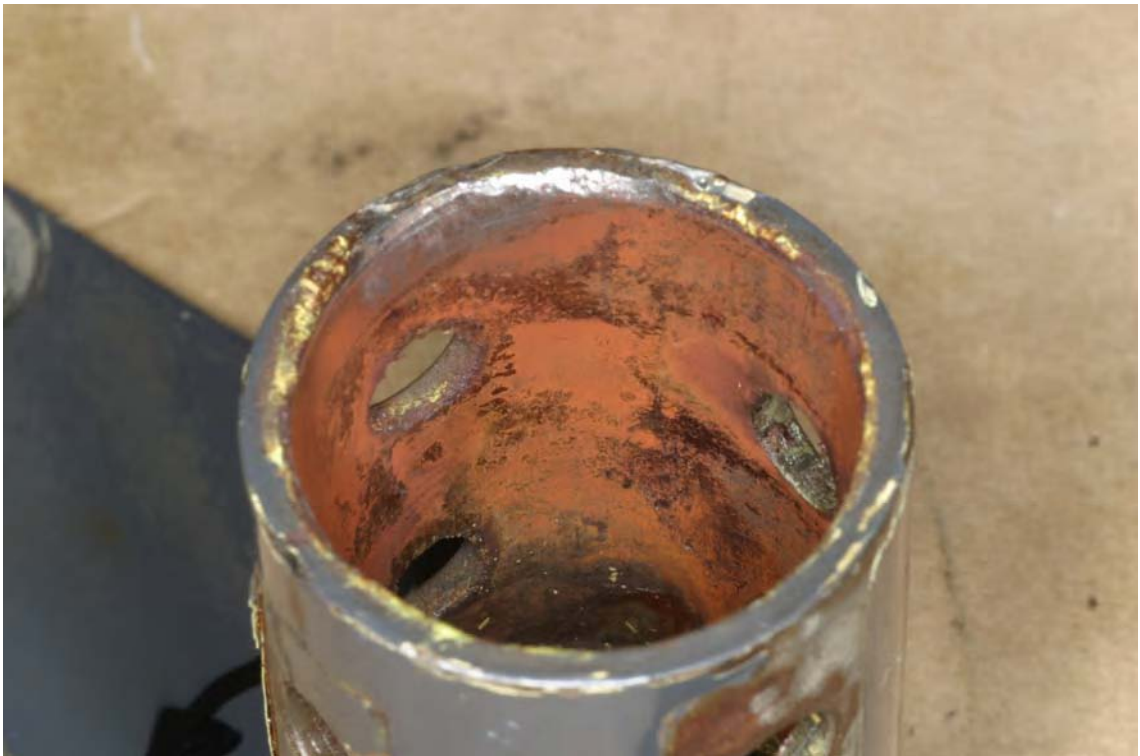
Figure 10. The inside surfaces of the yoke also showed extensive fretting corrosion.

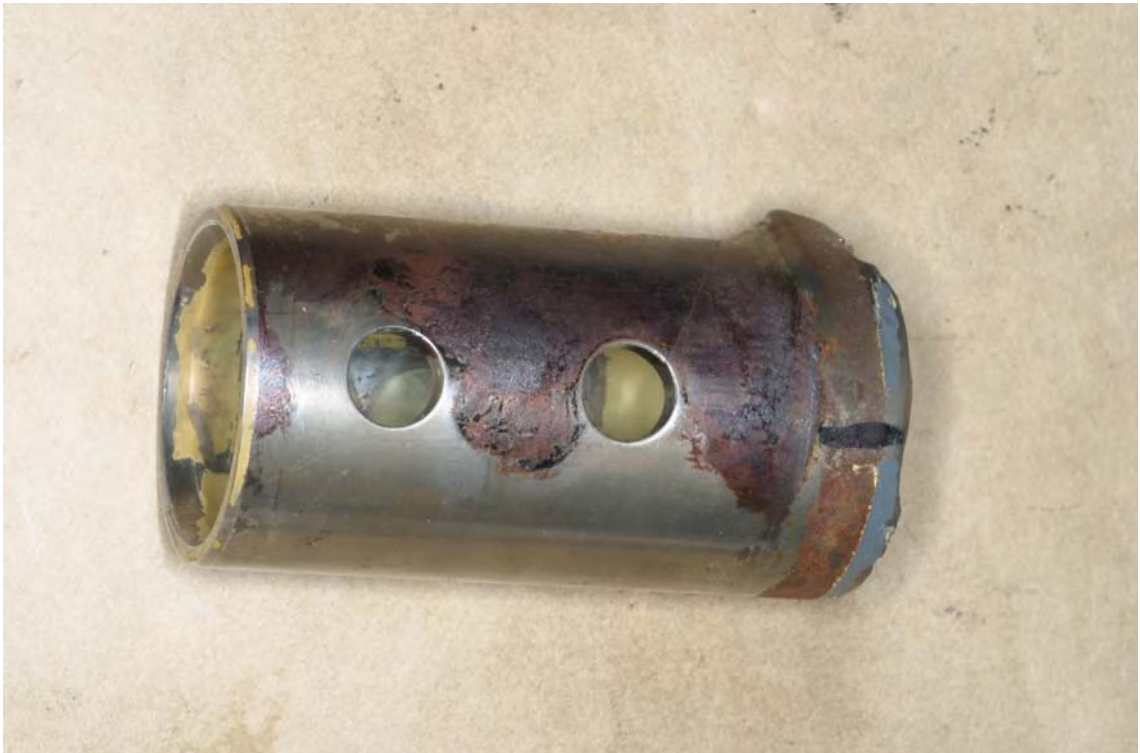
Figure 11. Removing the loose fretting corrosion product revealed the extent of the damage and the absence of any traces of zinc chromate or epoxy primer.

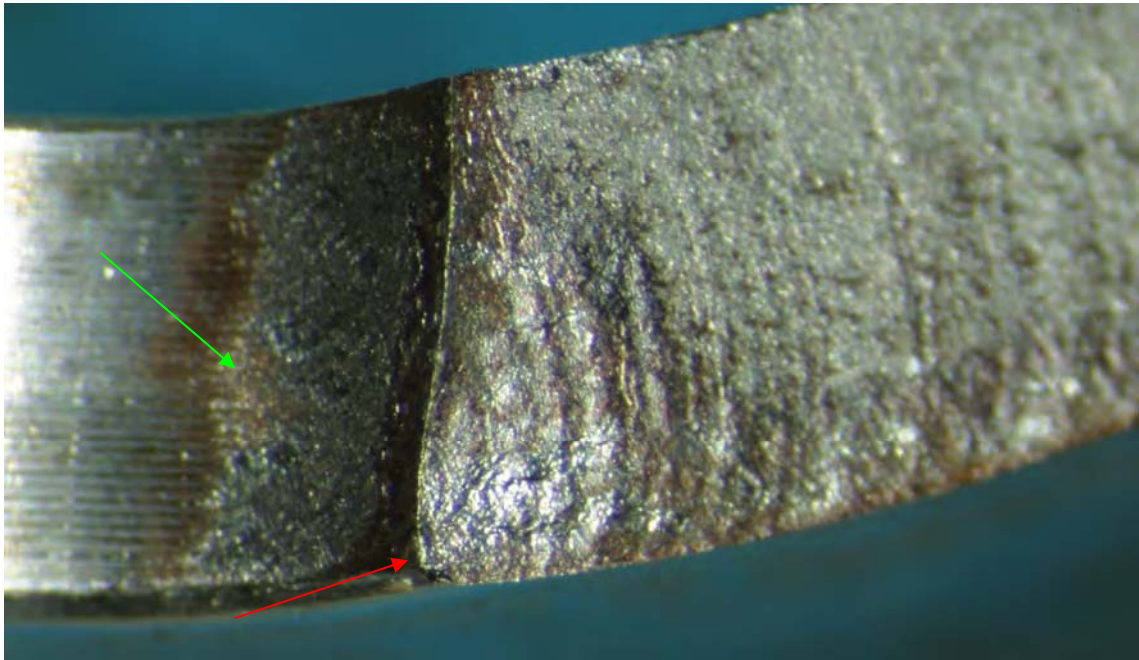
Initiation of the torsional fatigue cracking had occurred from the bore of the inner shaft bolt hole, at an area of fretting damage similar to the damage on the bolt shank surfaces (Figures 12 & 13). The fretting damage was confined to one side of the hole, and similar damage was also found within the other shaft bolt holes (Figure 14) and the aligning yoke holes.

Figure 12. Low-power microscopic view of the fatigue crack origin (red arrow). Note the associated fretting damage on the bore surfaces of the bolt hole (green arrow).

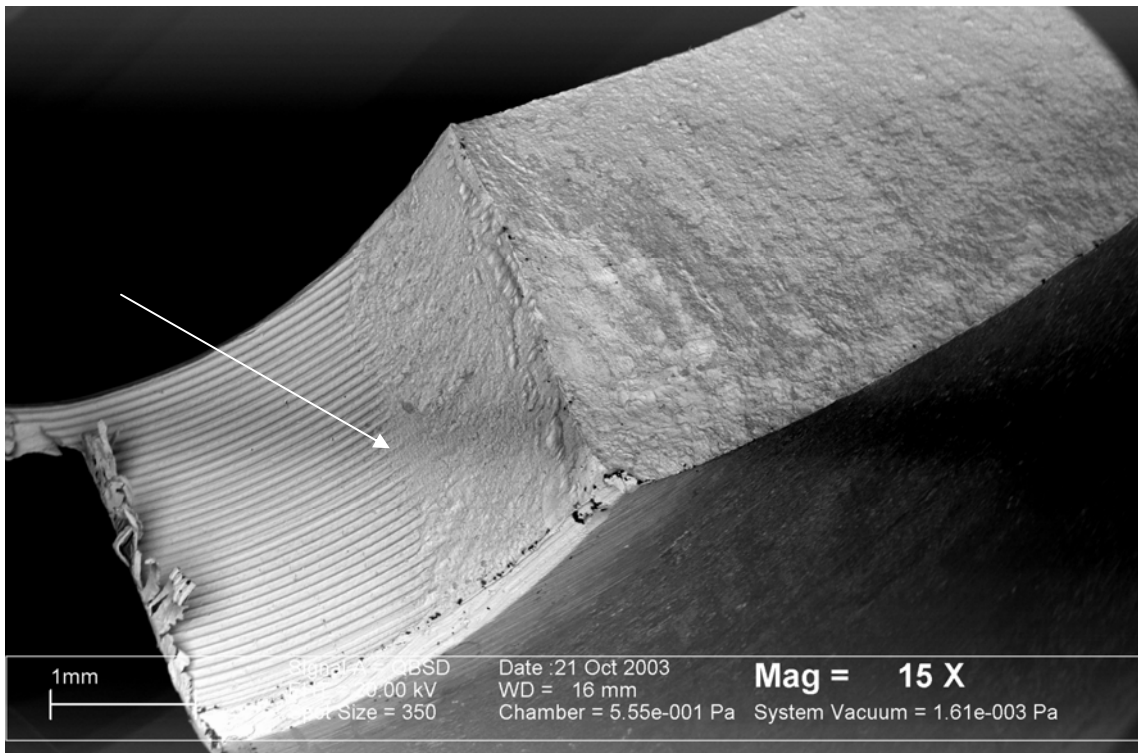
Figure 13. A scanning electron microscope view of the area shown in figure 12. Note how the machining of the bolt hole was disrupted by the fretting damage (arrowed).

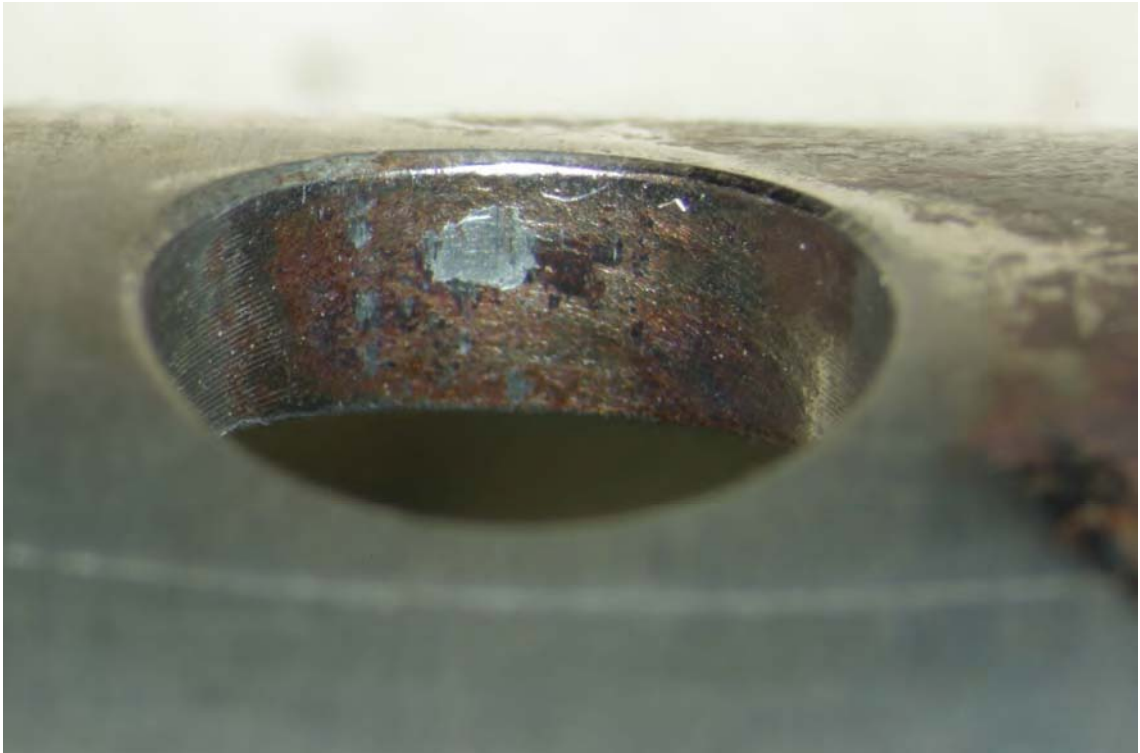
Figure 14. Fretting damage was also found inside the other clutch shaft bolt holes.

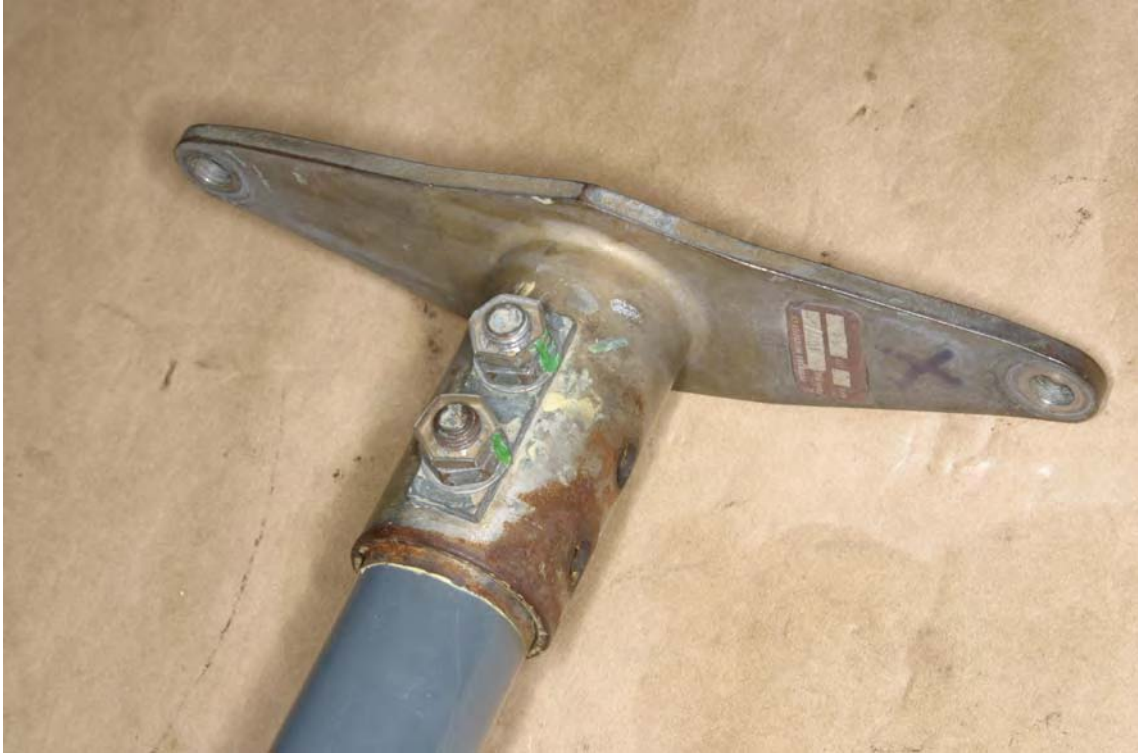
A comparable clutch shaft & yoke unit (Figure 15) was obtained from the same aircraft operator and disassembled in the ATSB laboratories. While the yoke surfaces in that case were unpainted and hence the bolt tensions remained higher (evidenced by higher break-out torques), the connection had still been unstable and showed appreciable fretting of the mating surfaces and on the bolt shanks (Figures 16 & 17). The similar, non-hardening jointing compound had been used within the connection in lieu of the prescribed primer coating (Figure 18). Cracking was not found within any of the shaft bolt holes.

Figure 15. A comparable clutch shaft assembly received for comparison with the failed unit.

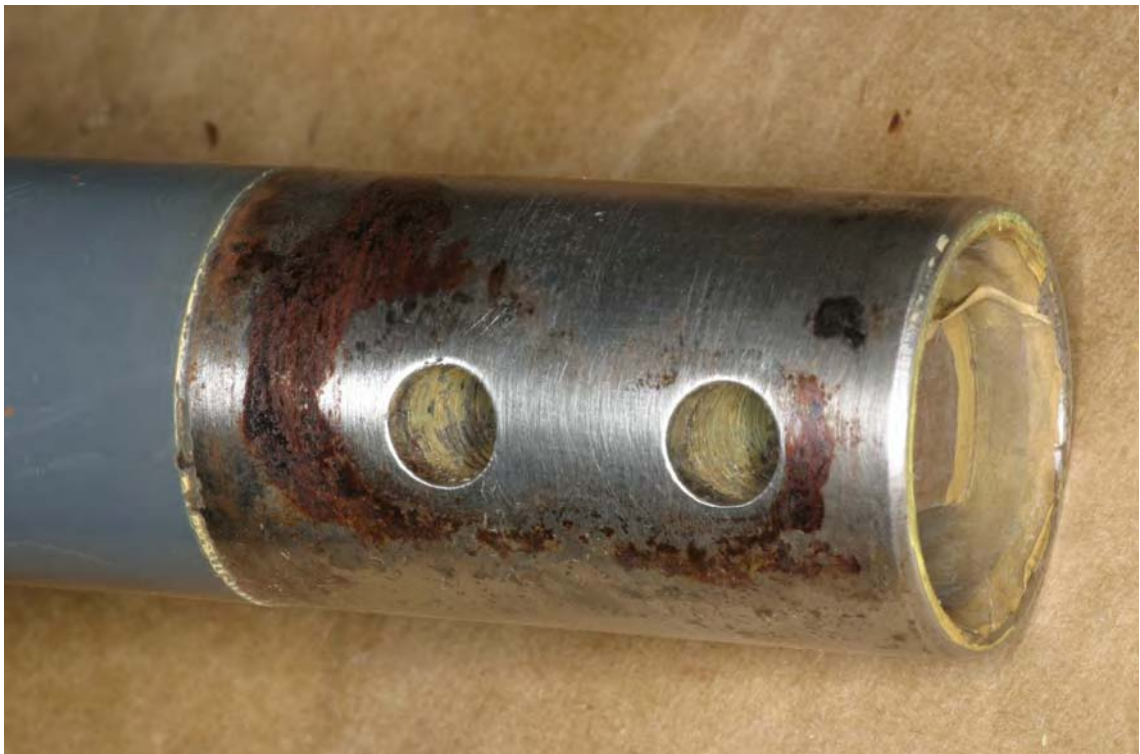
Figure 16. The surfaces of the clutch shaft from the assembly shown in figure 15. Fretting damage was also clearly evident.

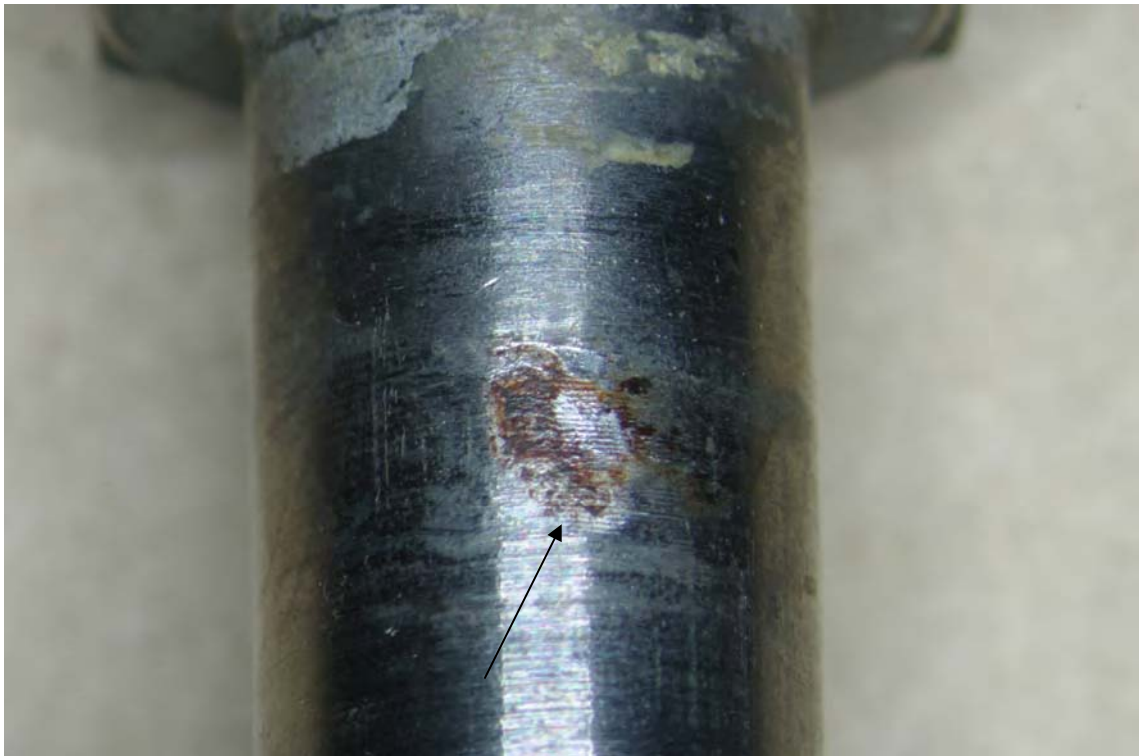
Figure 17. Bolt shanks from the comparison assembly also showed fretting damage and imprints from the hole machining.

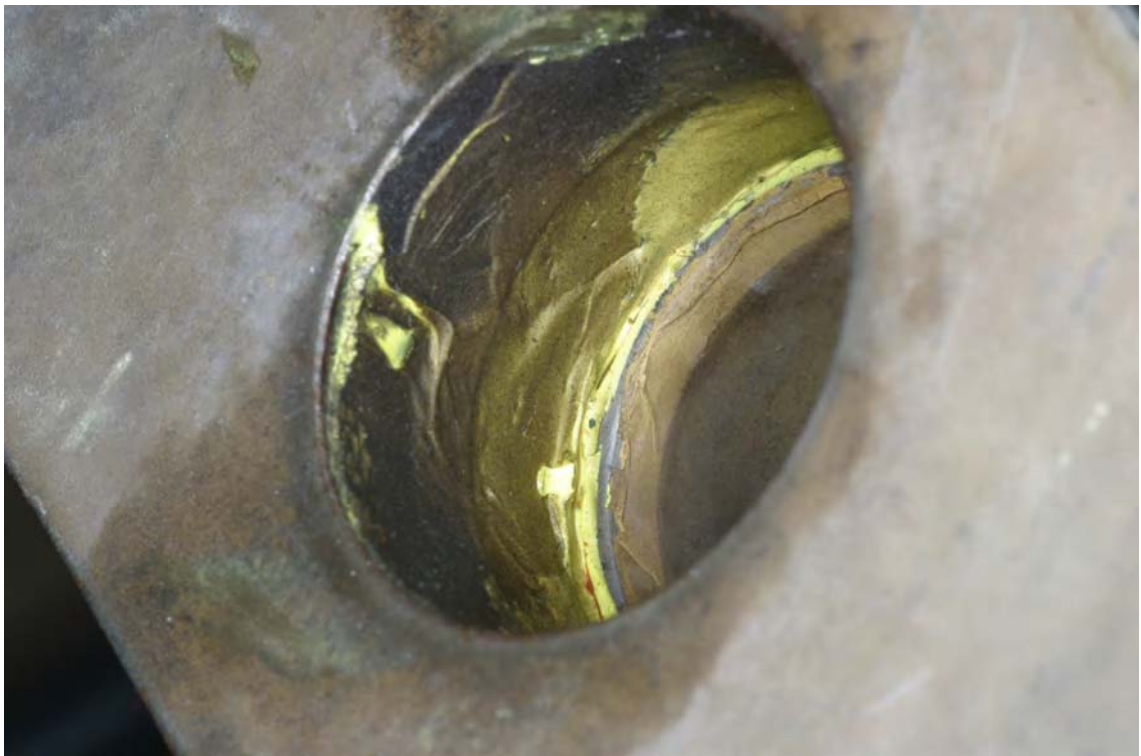
Figure 18. A soft jointing compound similar to that found on the failed shaft was observed within the comparison assembly.

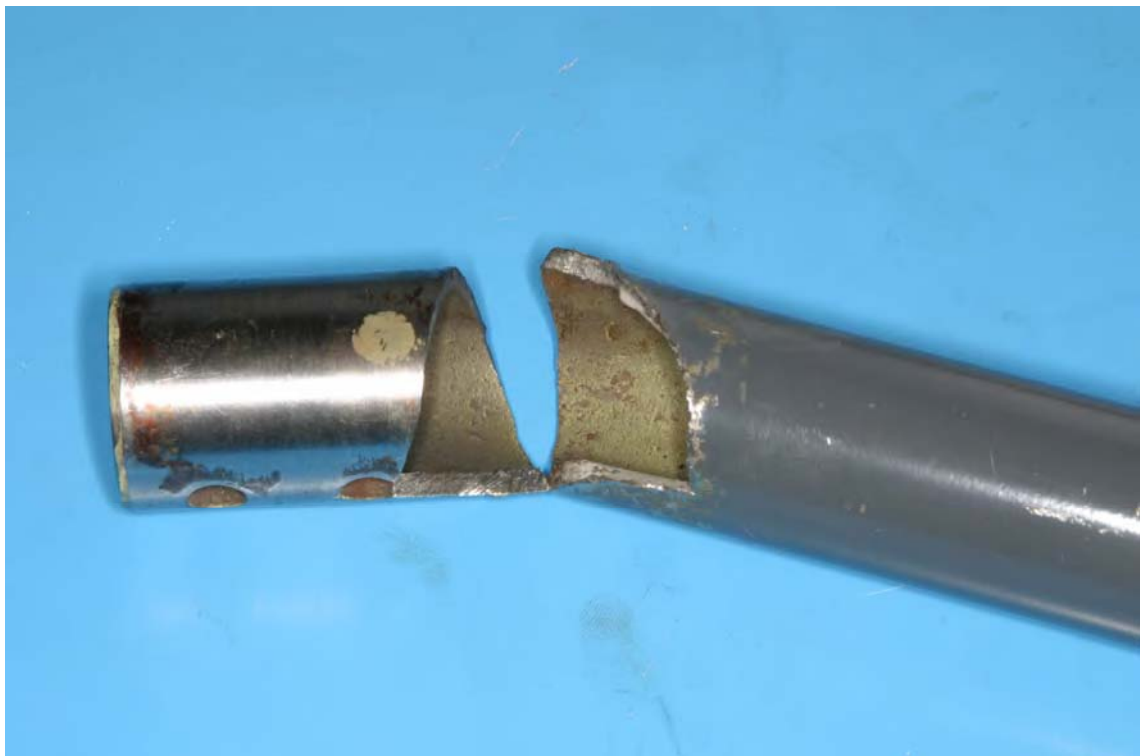
In 1992, another R22 helicopter sustained a torsional fatigue failure of the A166 clutch shaft, with the aspects of the failure appearing very similar to the case in question.^[5] A review of the documentation provided by the Civil Aviation Safety Authority (CASA) concerning that failure^[6] confirmed the prior instability and looseness of the shaft-yoke connection as being a factor contributing to the failure. Similar fretting was found over the mating surfaces of the shaft and within the bolt holes. The torsional fatigue cracking had initiated from the same location and propagated to a comparable extent before failure.

Figure 19. Fractured shaft sections from a previous (1992) failure. Note the similarity of the crack origin and propagation path.

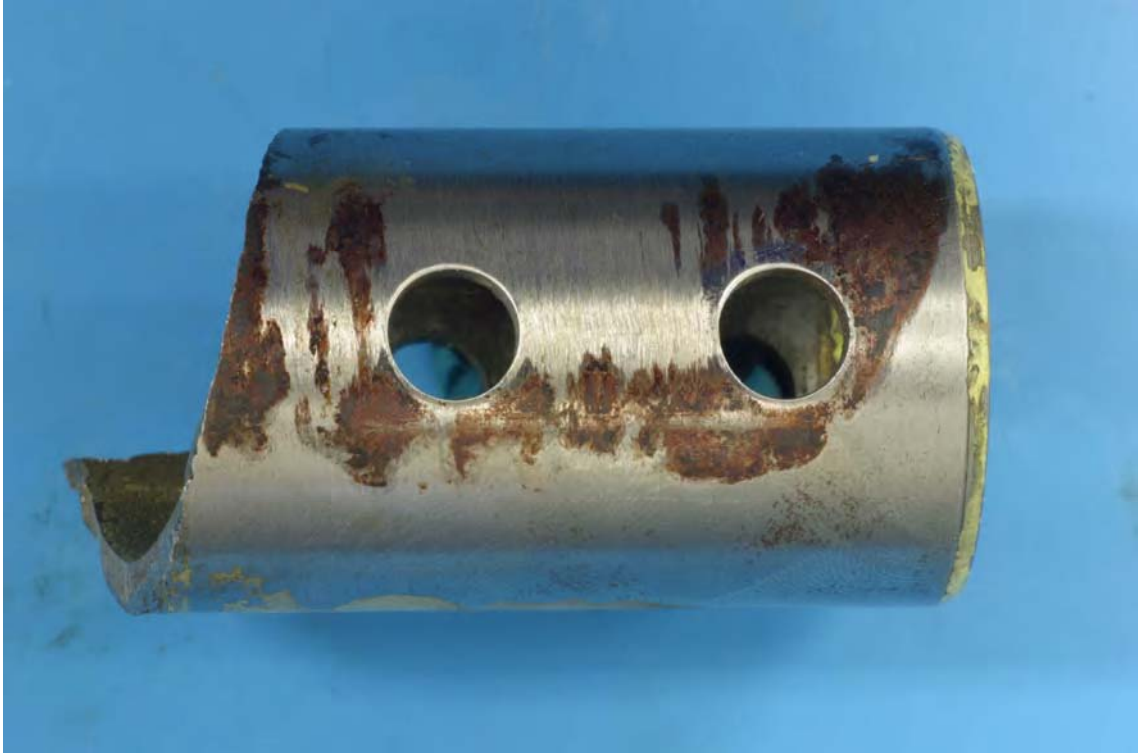
A subsequent inspection of the shaft which had been retained for exemplar purposes (Figure 19) also found no evidence of the use of a primer or similar coating over the shaft connection (Figure 20).

Figure 20. Extensive fretting damage was also evident on the interfacial surfaces of the previous clutch shaft failure.
