AVIATION SAFETY INVESTIGATION  
200304282

**Bell 407  
VH-HTD  
Cape Hillsborough, Qld**

17 October 2003

March 2005

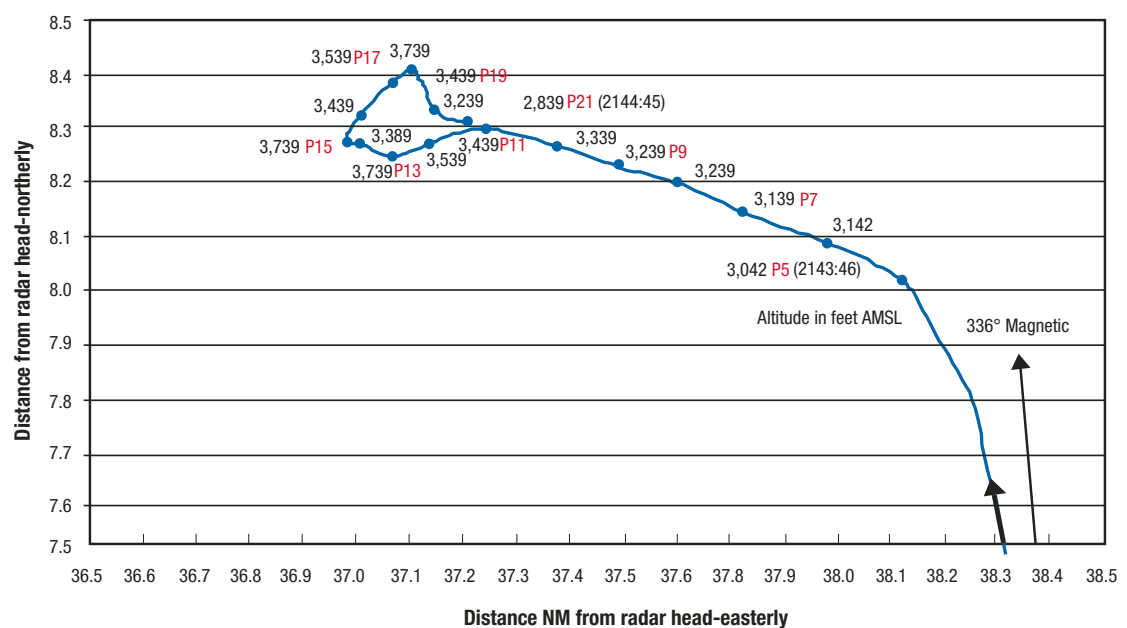
**FIGURE 3: HTD radar track last 75 seconds<sup>6</sup>**

HTD then remained on track, varying in altitude from 2,800 to 3,100 ft until at 2143:46 (refer to Figure 3), position P5, it commenced a left turn at a rate of approximately 5 degrees magnetic per second until the heading had changed through approximately 60 degrees magnetic. A track of approximately 299 degrees magnetic was then maintained for 25 seconds, with the altitude varying from 3,000 ft to 3,400 ft. At 2144:08, position P11, HTD climbed to approximately 3,439 ft and banked left towards the mainland, on to a heading of about 260 degrees magnetic. HTD then continued to climb through 3,500 ft until 2144:16, position P13, when it turned right to a heading of about 290 degrees magnetic. Following a climb to 3,839 ft, HTD turned right to

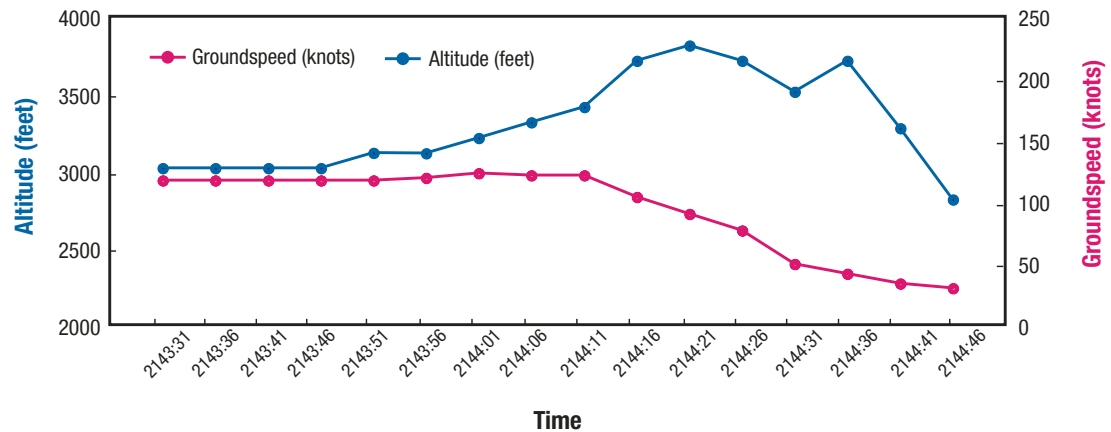
**FIGURE 4: HTD altitude and groundspeed profile**

040 degrees magnetic, position P15, and flew a heading of about 040 degrees magnetic for 12 seconds. At 2144:34, position P18, HTD turned right to a heading of 164 degrees magnetic and, over the next 16 seconds descended to 2,800 ft. At 2144:45, position P21, radar contact with HTD was lost. HTD was descending at the time radar contact was lost. The location of the last radar contact was at co-ordinates 20°56'556 S, 149°06'183 E (refer to Figure 4). Appendix A contains further details on the helicopter's radar track. Figure 4 displays the helicopter's altitude and groundspeed for the same timeframe.

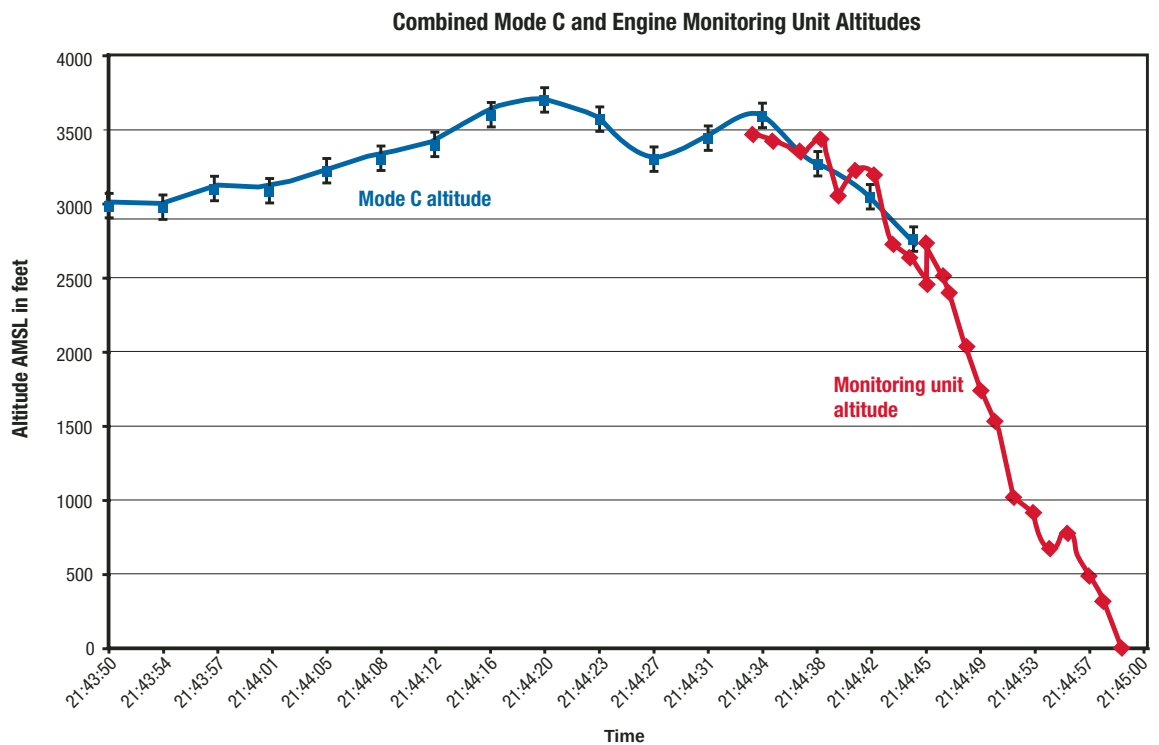
FIGURE 5: Chart of mode C altimeter and engine monitoring unit data overlay

Once recorded radar confirmation ceased at time stamp 2144:46, using the interpreted data from the engine monitoring unit and the radar overlay, it was determined that the helicopter initiated an extreme rate of decent culminating in impact with the water. For further information on the engine monitoring unit refer to section 1.19.

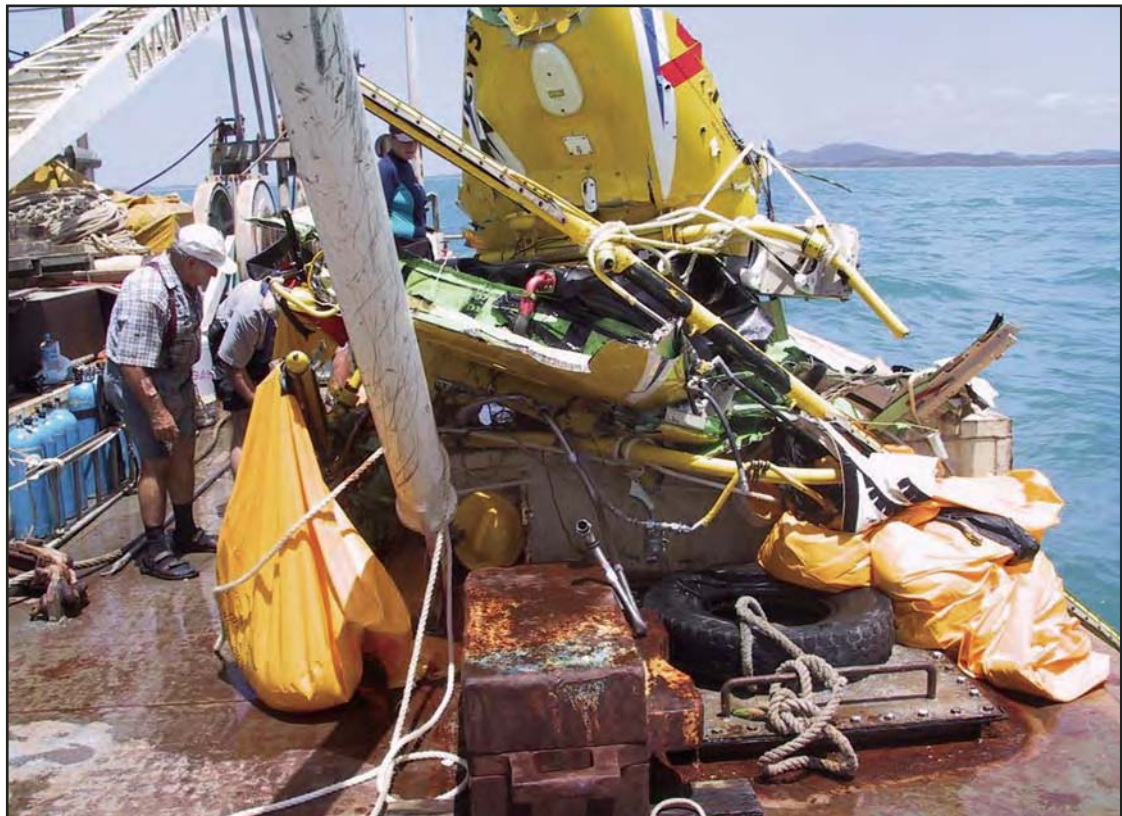
**FIGURE 6: Recovery of wreckage**

High speed impact damage destroyed the helicopter's cockpit and cabin structure. The tail boom, main rotor assembly and main transmission assembly separated during the impact sequence. Figure 6 displays portions of the wreckage recovered to the salvage vessel.

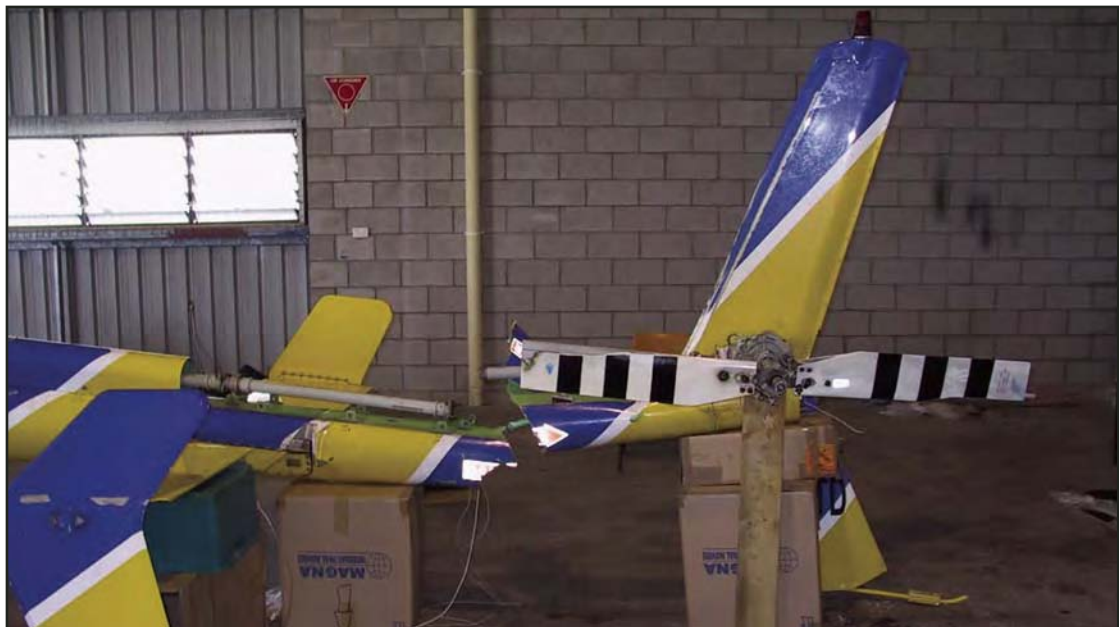
**FIGURE 10: Tail rotor and separated tail section**

Examination of the tail boom structure indicated that a section of the tail boom containing the intact tail rotor, tail rotor blades, tail rotor gearbox, horizontal and vertical stabilisers had displaced forward and upward and separated from the remaining fuselage/tail boom<sup>43</sup>. Figure 10 displays the separation point of the tail section.

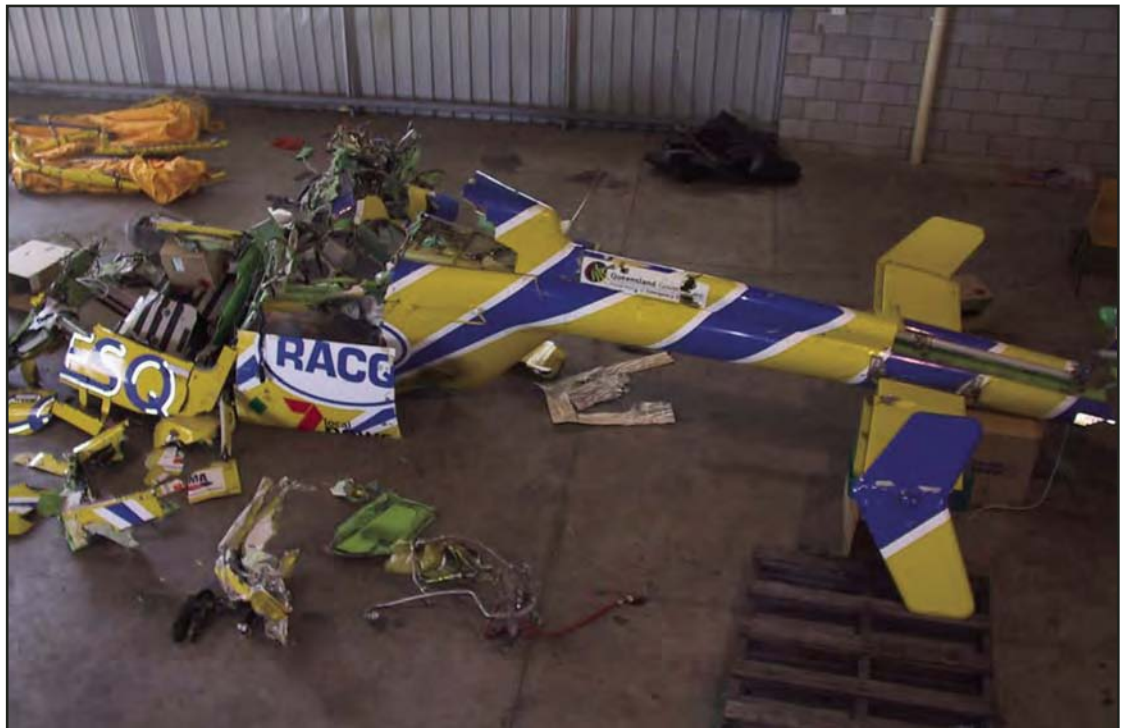
**FIGURE 11: Reconstruction of the wreckage**

Additionally, continuity of the tail rotor controls was confirmed from the tail rotor assembly forward to the tail rotor hydraulic actuator, but disruption of the structure prohibited further validation of the cockpit controls. Continuity of the tail rotor drive shaft was also confirmed. Because of structural damage, continuity of the engine controls could not be confirmed. Figure 11 displays the reconstruction of the available helicopter wreckage.

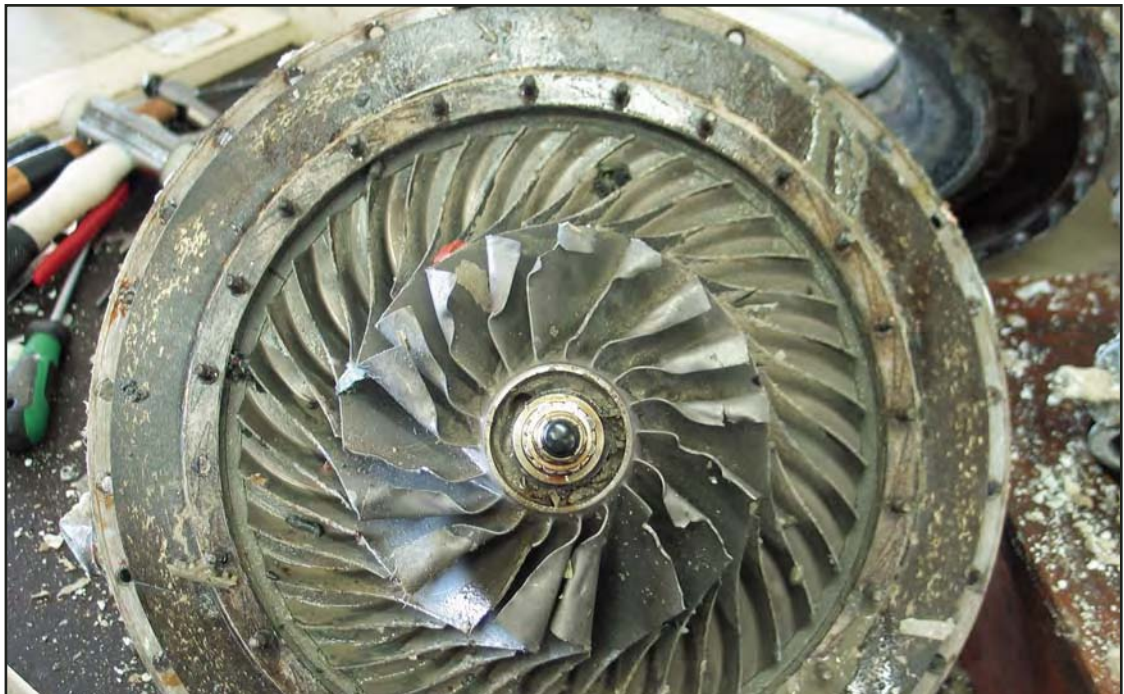
**FIGURE 12: Engine compressor during disassembly**

The engine was recovered and sent to an approved facility for disassembly and inspection under the supervision of the ATSB, with the assistance of the engine manufacturer's representative. Examination of the engine found indications of normal operation at impact. There was no evidence of pre-impact failure of any kind. The engine compressor displayed evidence of high speed rotation at the time of impact. The fuel control unit was severely damaged from impact forces and could not be tested. Further evidence of normal engine operation prior to impact with the water, is documented in section 1.19. Figure 12 displays the engine compressor section with indications of rotation at impact.

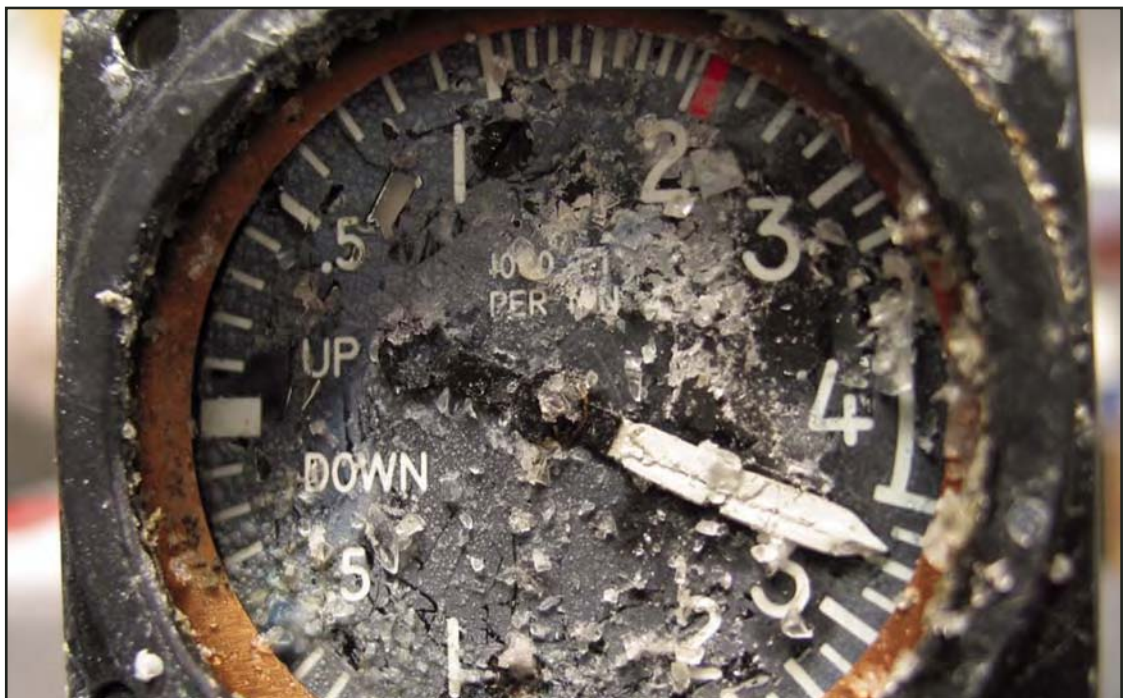
**FIGURE 13: Vertical speed indicator**

The vertical speed indicator was recovered and examined at the ATSB laboratories. The face of the instrument included a witness mark indicating a vertical descent rate of approximately 3,600 ft per minute downward. Figure 13 displays the indicator position as found.

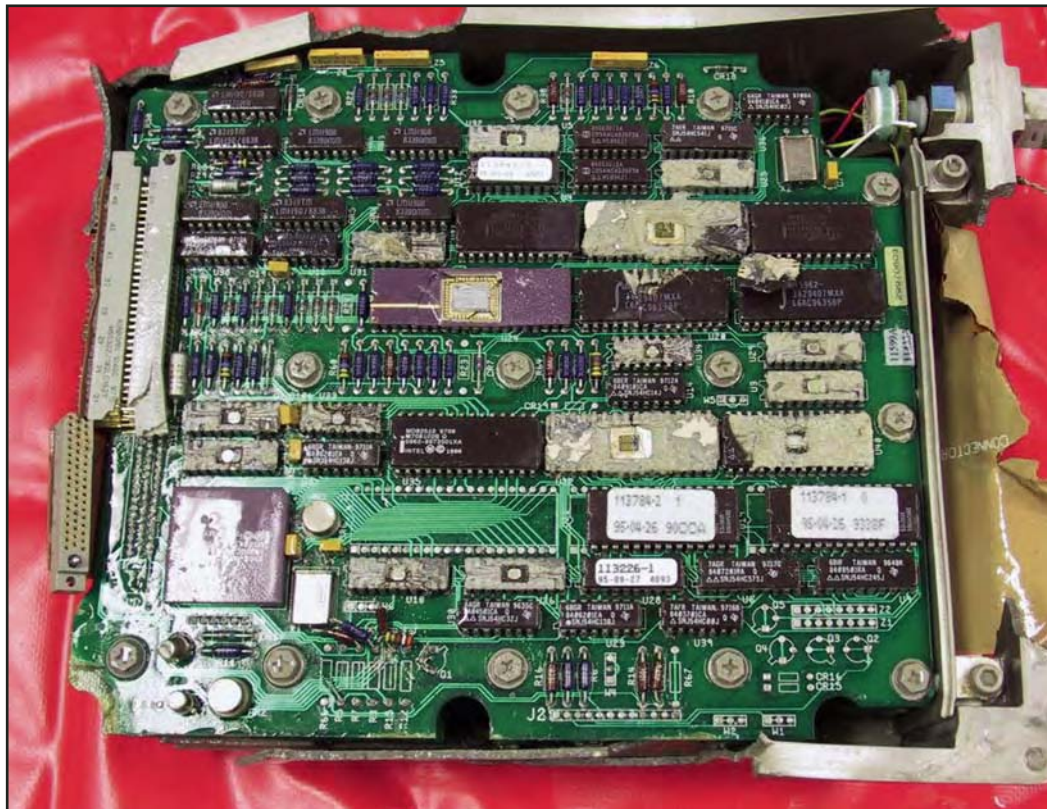
**FIGURE 18: Recovered ECU**

The ECU was successfully recovered, preserved and shipped to the engine manufacturer, where it was placed into quarantine. Data from the EEPROM was successfully downloaded under the supervision of the NTSB. Figure 18 displays the condition of the ECU after recovery.

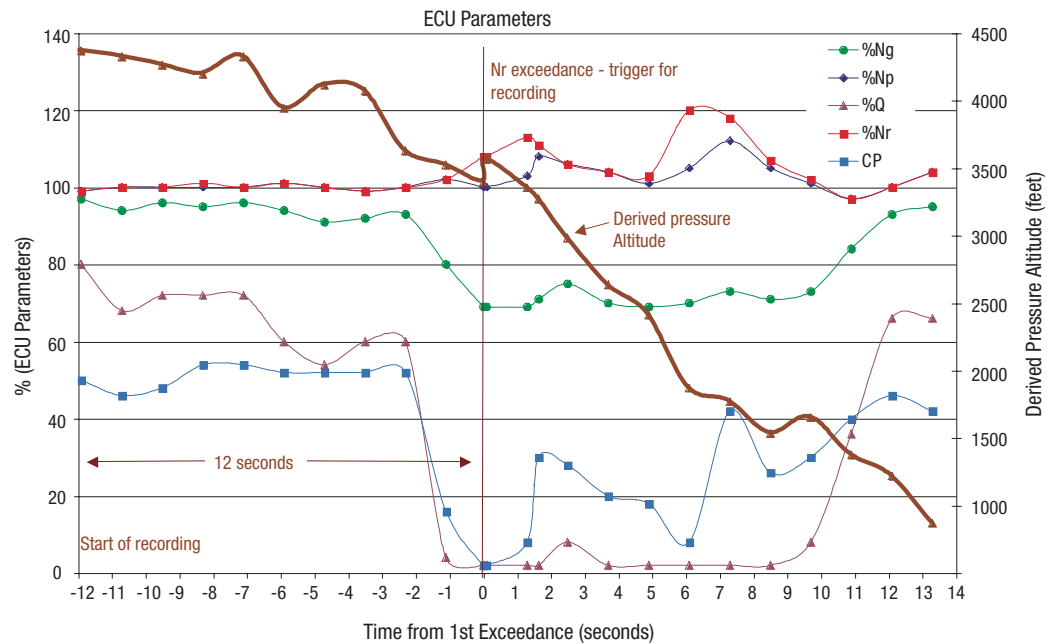
**FIGURE 19: ECU parameters**

The recovered data included approximately 25 seconds of recorded parameters initiated by a main rotor (Nr) excursion event to 120 per cent<sup>94</sup>. The EEPROM captured approximately 12 seconds of data prior to the Nr excursion, and ended approximately 13 seconds later when electrical power to the unit was interrupted. The ECU did not have its own power source, and the interruption of the electrical power supply was most likely the result of impact forces. The chart shows that the collective transducer position sensor (CP) was varying during the duration of the recorded data, indicating that the collective control was being manipulated. The position of the cyclic control was not recorded by the ECU. Figure 19 displays the information recovered from the ECU.

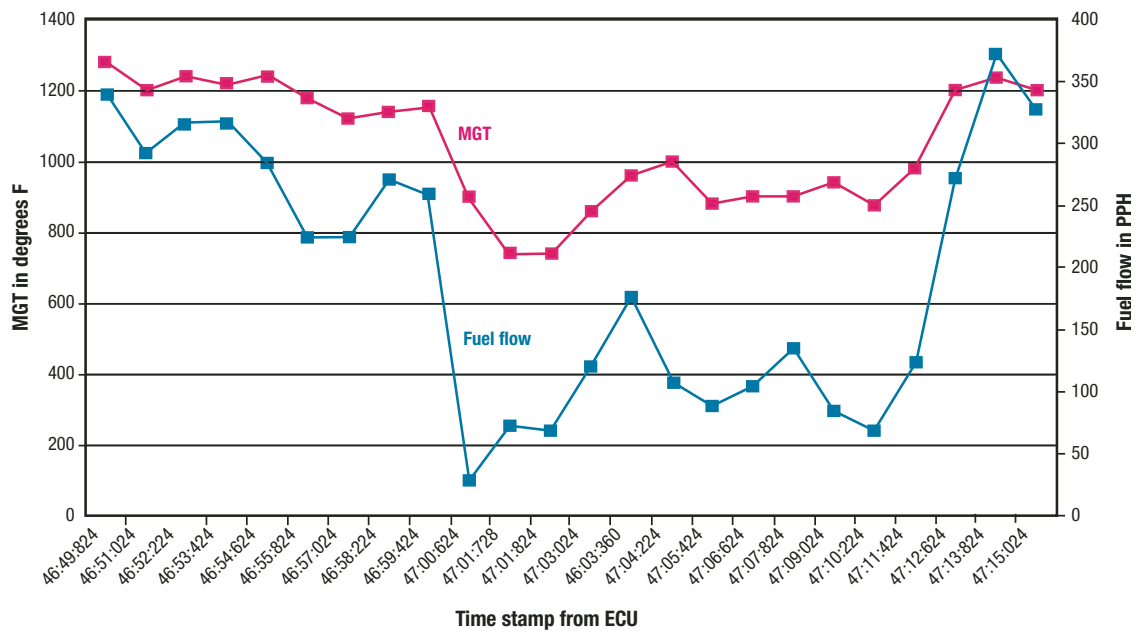
**FIGURE 20: Chart of fuel flow and MGT from ECU data**

A review of the data indicated no recorded anomalies of the engine, and that the engine was performing as designed. Figure 20 shows normal engine response to power requirements, including decreases and increases in both fuel flow and MGT during the 25 seconds recorded.
