Australian Transport Safety Bureau

Piper Aircraft Corp PA-34-200, VH-CTT

Bankstown Airport, NSW

INVESTIGATION REPORT

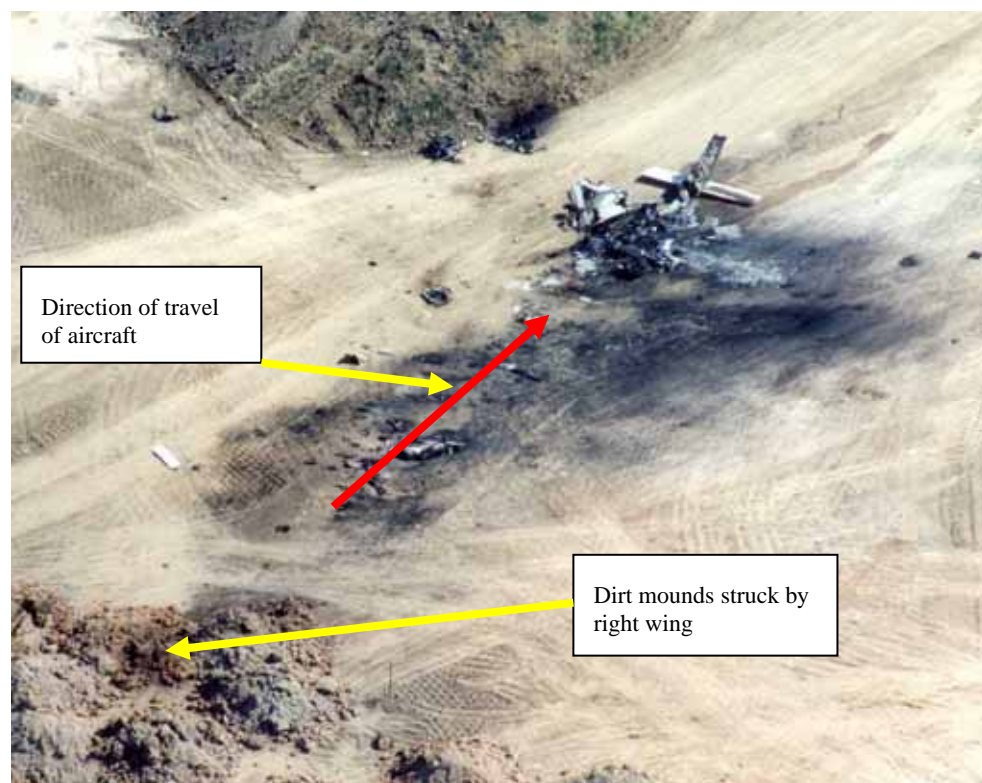
The right wingtip hit a mound of dirt, before the right propeller and engine struck the ground, followed shortly after by the nose, left propeller and engine. The right engine separated from the aircraft. The remaining cabin and empennage fell to the ground and slid backwards for approximately 20 m before coming to rest in a level area.

Figure 2: Accident site and aircraft wreckage

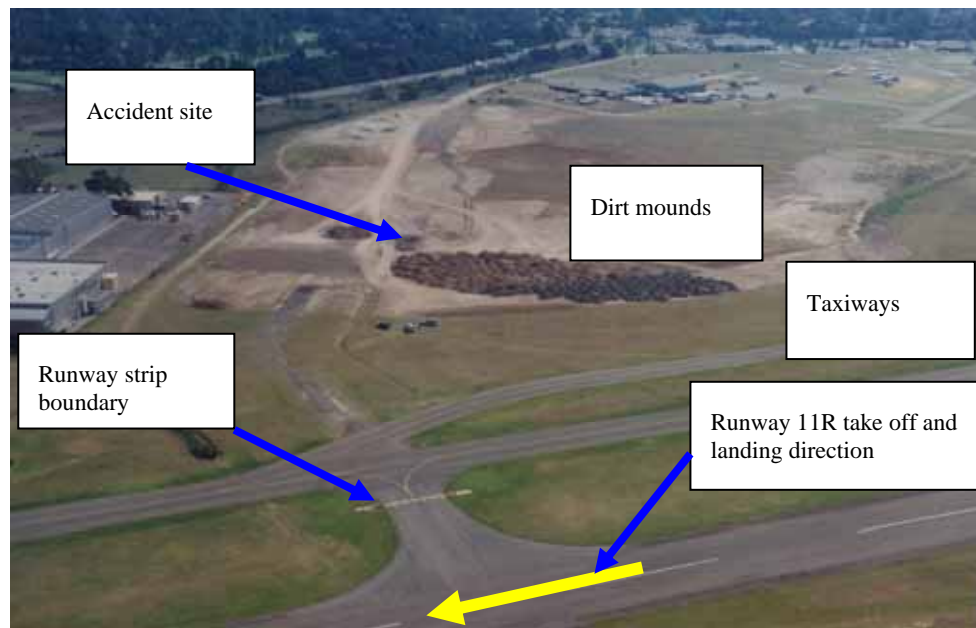
Figure 4: Location of wreckage and dirt mounds on the aerodrome

Ground marks indicated that the aircraft's right wing tip had struck one of the dirt mounds. The outer third of the right wing, including the outboard fuel tank and wing tip fairing was torn from the aircraft during the initial impact with the mound. That impact breached the fuel tank. The investigation estimated that, at impact, the fuselage was approximately 45 degrees nose down, with 60 to 90 degrees of right bank. Soot deposits were found on dirt mounds south of the mound impacted by the right wing tip.

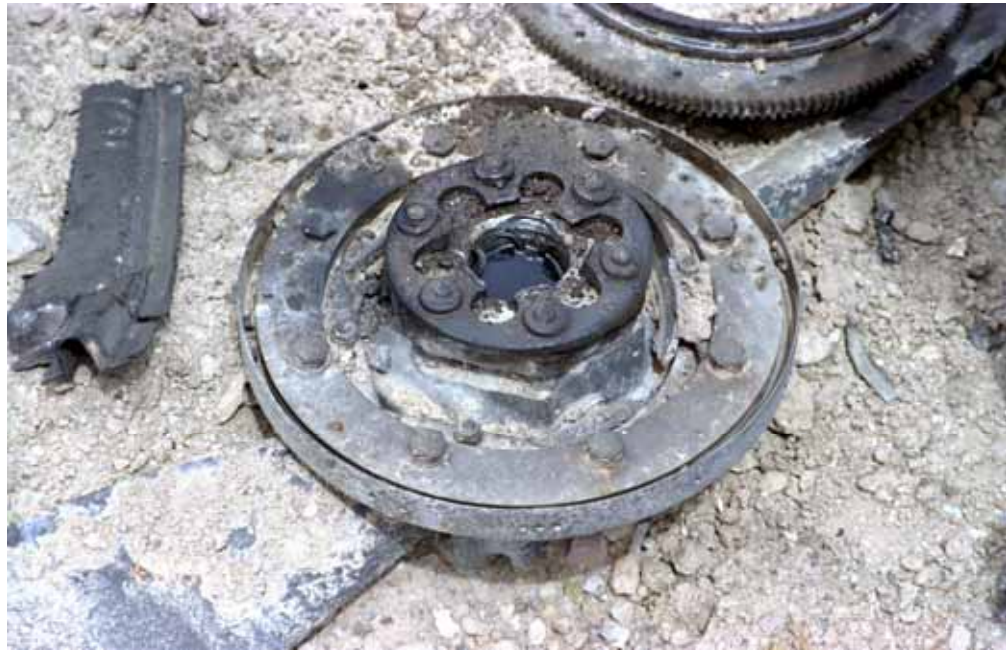
engine separated from the wing during the impact and came to rest east of the main wreckage. The left propeller impacted the ground then separated from the engine leaving the propeller dome buried vertically in the ground. The left crankshaft propeller attachment flange had fractured in bending overload and remained attached to the propeller hub. The ground contact marks from both propellers and the angle of the impression made by the domes indicated that they impacted in a near vertical attitude.

Figure 5: Left propeller as found at the accident site

The damage to the propellers indicated that the engines were delivering comparable and substantial levels of power at impact, with chord-wise blade bending and rotation marks on the blade faces and domes.

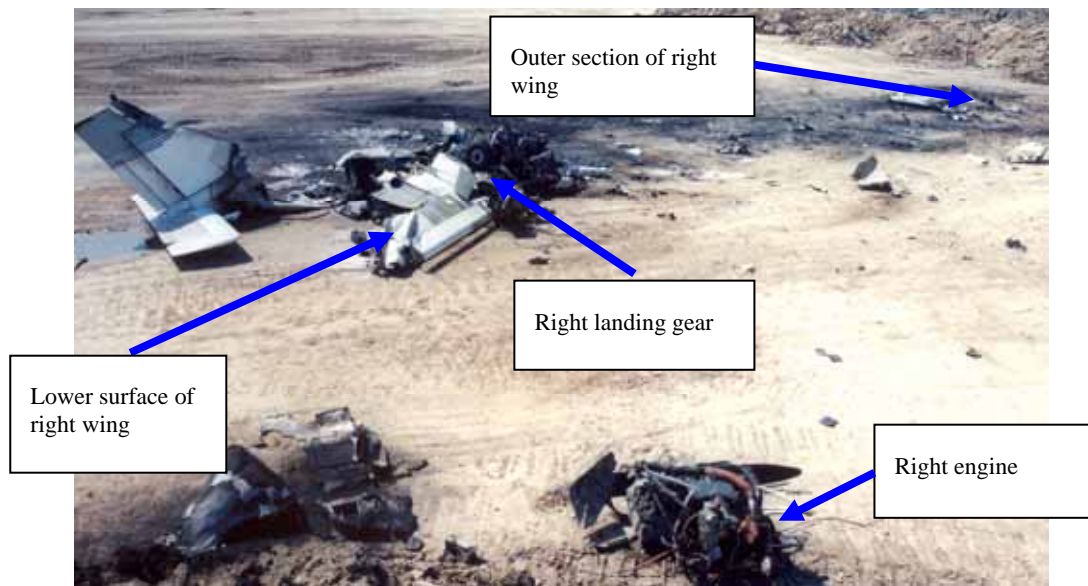
The right main landing gear leg was extended, the left main landing gear had partially melted in the fire and the nose landing gear had been extensively damaged during the impact. The position of the landing gear, at the time of impact, could not be confirmed.

Figure 6: Aircraft wreckage components that were upwind of the fire

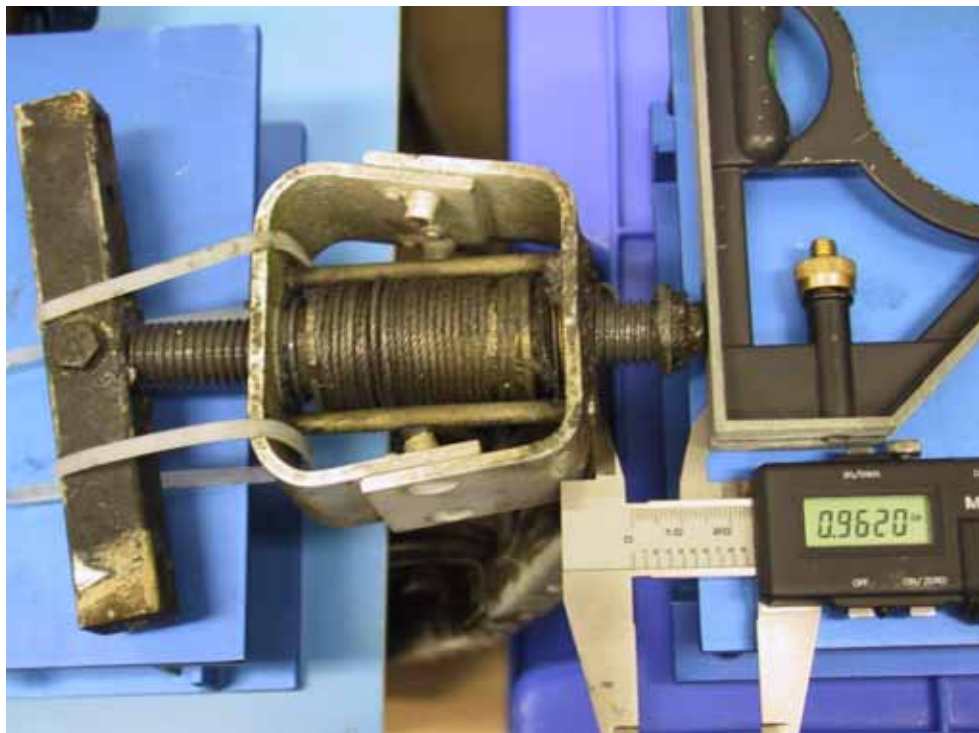
The position of the rudder trim jack assembly screw was measured as 0.853 inches. The rudder's full right trim deflection equated to a screw position of 0.4 inches and the neutral trim position 1.0 inch. It suggested that the pilot may have set the trim to about one-quarter of the available right trim tab deflection. That position was consistent with the observed position of the rudder trim tab following impact. The rudder may have been trimmed to counteract right yaw. Right yaw can be due to an increase in drag on the right of an aircraft or from a difference in thrust from the propellers.¹²

Figure 7: Measurement of stabilator trim screw jack position

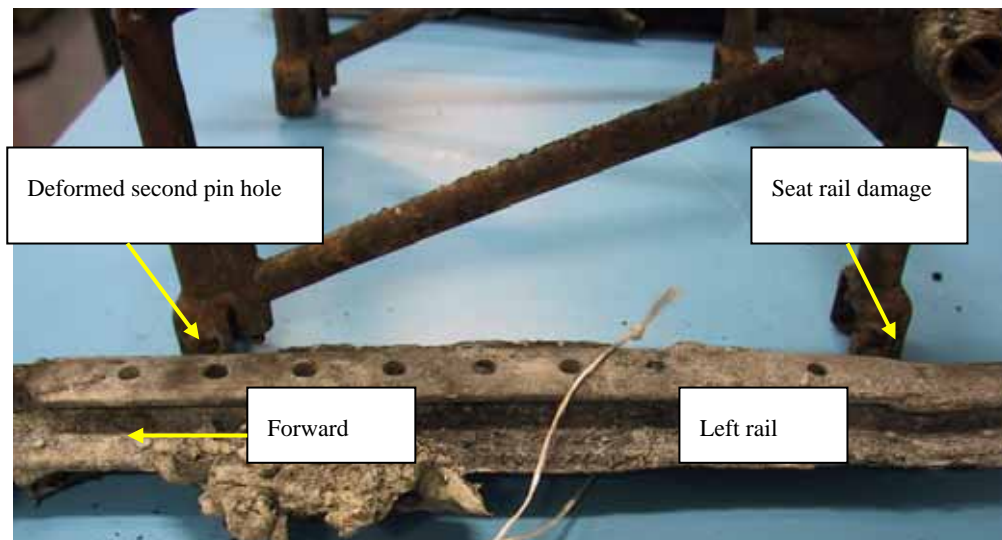
The left pilot's seat was separated from both seat rails and was inclined to the rear. Examination of the seat and rails revealed that three of the four seat runners were splayed. The left front runner was the only one not deformed. The second rearward hole of the left rail was deformed and there was damage at the rear attachment point. The deformation of the seat rail fittings and the damage near the rear attachment point was consistent with the seat being positioned at the second hole from the front. The seat locking pins were in-situ. The right rail seat stop was undamaged. The left rail seat stop was destroyed by fire.

Figure 8: Left front seat left rail

The investigation determined that the damage to the left pilot seat and its fittings was consistent with impact forces and fire.

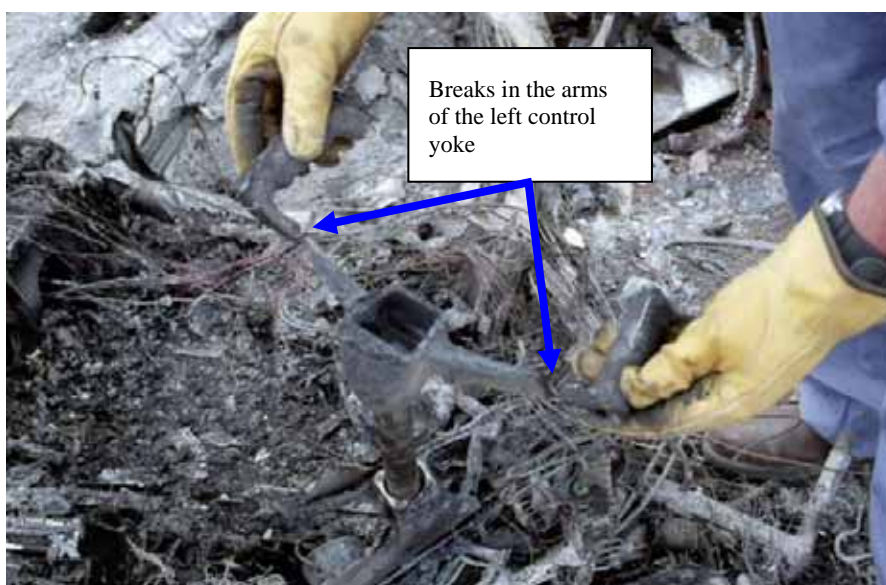
The left and right pilot control yokes were damaged by impact forces and fire. Both the vertical arms on the left pilot's control yoke were broken. The right pilot's yoke was intact.

Figure 9: Broken left pilot's control yoke

The instructor, after leaving the aircraft, indicated that the pilot was flying the aircraft during the loss of control sequence. Although the vertical arms of the left control yoke were broken, suggesting that the pilot may have been holding the yoke at impact, his injuries did not include typical damage to the hands. Consequently, it was not possible to confirm which pilot was flying the aircraft at the time of impact.

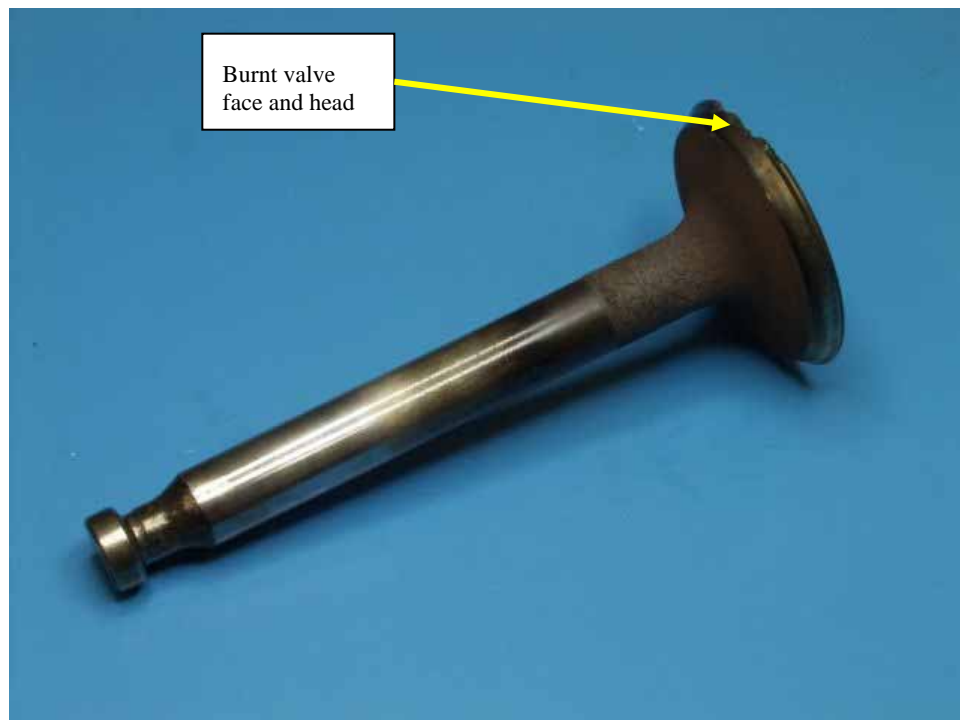
Examination of the left engine revealed damage to the number-2 cylinder exhaust valve and valve actuation train. The two retaining keys for the valve spring on the number-2 cylinder exhaust valve were found to be broken into several small pieces. Despite the damage to the keys, the valve had remained in place. A hardness test of the pieces of the key found that the metal complied with the manufacturer's specifications. The valve head had evidence of radial cracking, and had burnt through the part of the outside circumference that created a seal with the valve seat. The valve's sealing surface and the matching surface on the valve seat were abnormally worn.

Figure 10: Burnt and worn left engine number-2 cylinder exhaust valve

The valve rotator cap and the face of the tappet body evidenced uneven wear, indicating that neither item had been rotating, as intended, during engine operation. The operation of the exhaust valve hydraulic lifter could not be determined. The engine manufacturer advised that the damage to the valve and valve keys was consistent with an improperly operating hydraulic lifter.

The investigation assessed that the valve damage would have resulted in some degradation of power from the left engine, such that it would not have produced rated power. However, the extent of that degradation could not be quantified.
