ATSB TRANSPORT SAFETY INVESTIGATION REPORT

Rail Occurrence Investigation No. 2006/004
Preliminary

Collision between K100E Truck and Freight Train 4AM3 Lismore, Victoria

Lismore Victoria 25 May 2006 Published by: Australian Transport Safety BureauPostal address: PO Box 967, Civic Square ACT 2608

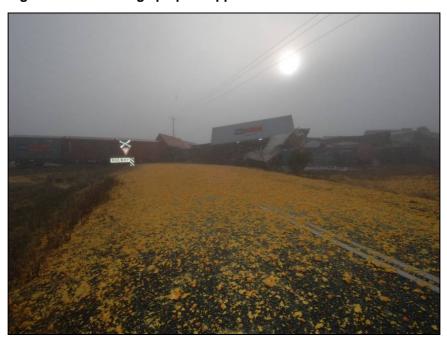
The force of the collision was such that the citrus pulp being carried by the truck was hurled about 60 metres to the opposite side of the level crossing. In addition, part of the truck's 'bull-bar' was imbedded in the side of the second locomotive.

Figure 1: Orange pulp on opposite side of collision

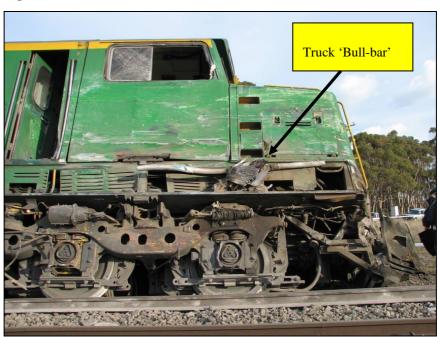
Figure 2: Bull-bar on second locomotive

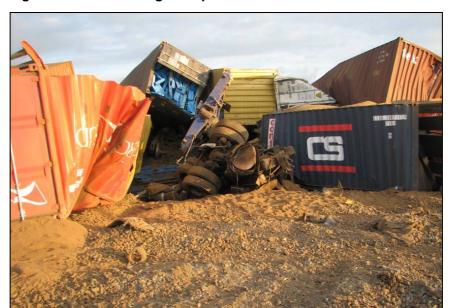
At or shortly after impact, the lead and second locomotive broke away from the third locomotive and the rest of the train. Behind this break in the train, at some time during the derailment sequence the force exerted by the impact of the truck was overtaken by the 'in train' inertial forces which resulted in 41 of the train's 64 wagons being derailed. The derailed locomotive and wagons, normally a length of 844.8 metres, were subsequently compressed into a length of about 170 metres and spread to a width of 55 metres. The lead and second locomotives came to a stop about 70 metres clear of the train wreckage, 14.3 metres from the Lismore to Camperdown Road level

crossing is about 275 metres from the Lismore to Skipton Road level crossing. The infrastructure between the two level crossings was extensively damaged. The truck was broken into various pieces and was buried within the wreckage.

Figure 3: Wreckage and part of truck

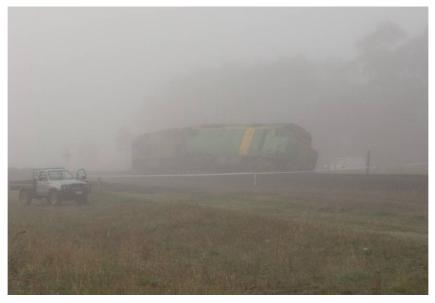
Sunrise at Lismore on 25 May 2006 was at 0728. The minimum and maximum temperatures for the day were about 3 and 12 degrees Celsius respectively. The evidence from witnesses is unanimous in that the area was 'blanketed' in thick fog and visibility was said to be reduced to between 20 and 50 metres. The fog did not clear until much later in the day after the accident.

Figure 4: Fog around two lead locomotives, taken several hours after the collision

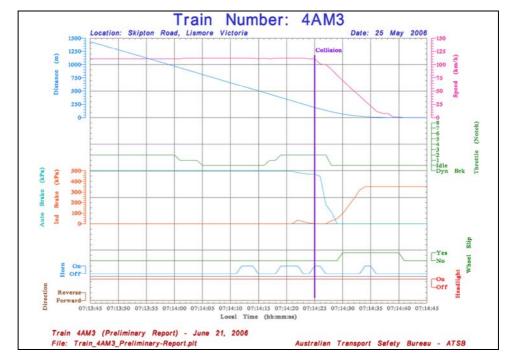
An examination of the leading locomotive data logger reveals that on the approach to the Lismore to Skipton Road level crossing that train 4AM3 was travelling at 111 km/h. The locomotive horn was first sounded for about two seconds from 0714:12 to just after 0714:14. Four seconds later the locomotive horn was sounded a second time for a duration of about three seconds from 0714:19 to 0714:22. While sounding the horn at this time, a brake pipe reduction of 50 kPa² was initiated. Other evidence indicates that this brake application was to slow the train for a 65

km/h temporary speed restriction that was about 2.5 kilometres away. A sudden reduction in speed and brake-pipe pressure was recorded about 3.5 seconds later at 0714:25. It is likely that this was when the collision occurred. At this time (0714:25) the horn again sounded for just over one second. The horn was then sounded, for the fourth time, seconds before the locomotive stopped 14.3 metres short of the Lismore to Camperdown Road level crossing.

The data logger records show that locomotive NR52 travelled a further 189 metres from the point of collision until it stopped. However, during the stopping sequence, the logger also recorded some wheel slip which may have affected the distance it recorded. This would mean that the distance recorded from the collision until stopping (189 metres) may be somewhat shorter than the actual distance travelled.

Figure 5: Locomotive data logger recording, NR 52

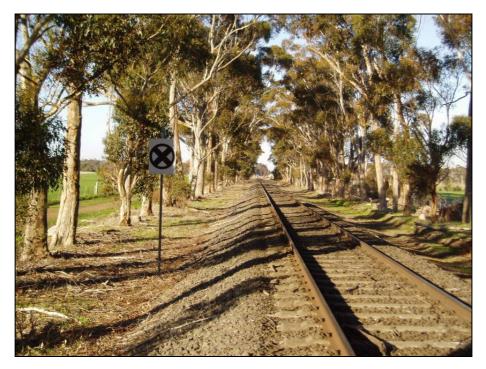
The Lismore to Skipton Road level crossing is passively protected by warning signs on the approach to either side of the crossing. A give way sign and white clearance line painted on the road are located 8.5 metres from the track centre on the level crossing. Although not a factor in this instance, trees line either side of the rail line on the 'western' or Adelaide approach until 175 metres from the level crossing. If a train is travelling at the permitted 115km/h this gives road traffic 5.48 seconds in which an approaching train would be visible, weather conditions permitting.

Figure 7: Trees on the 'western' approach to the Lismore to Skipton Road crossing

The Australian Transport Safety Bureau recommends that the Australian Rail Track Corporation and VicRoads review the level of short term protection provided³ at the Lismore to Skipton Road level crossing, particularly noting the limited visibility of approaching trains to motorists at or approaching this crossing.
