**ATSB TRANSPORT SAFETY REPORT**

Aviation Occurrence Investigation – AO-2007-018

**Total power loss  
Cecil Park, NSW  
5 February 2007  
VH-HYY, Cirrus SR22**

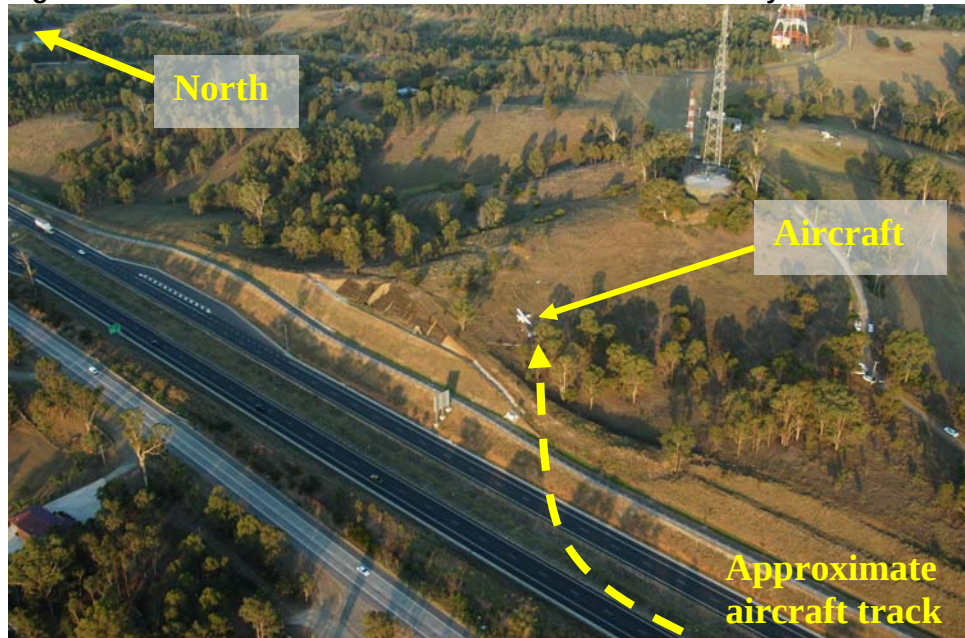
**Figure 1: Aerial view of accident site and the M7 motorway**

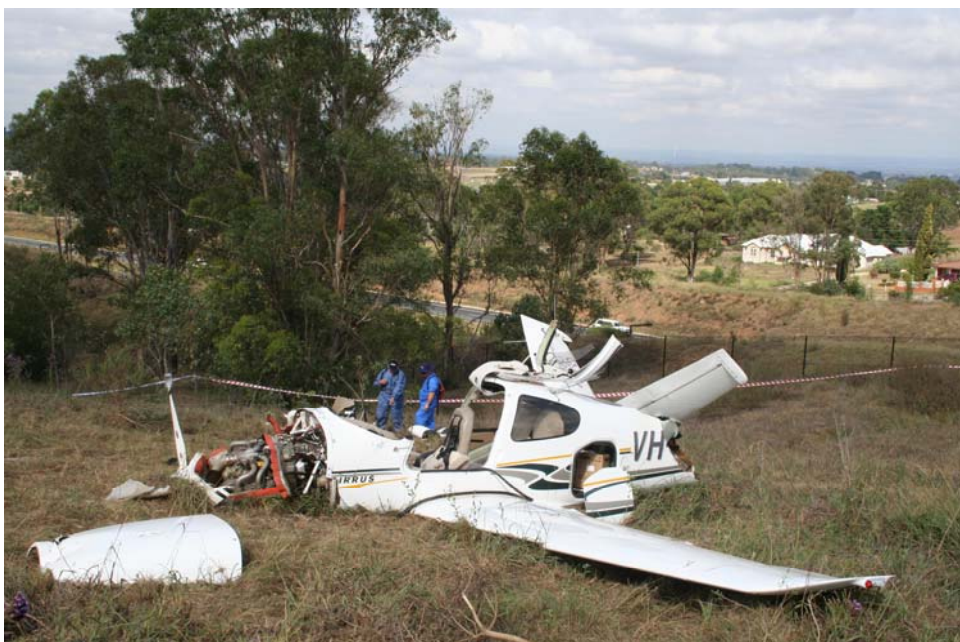
The impact completely detached the right main landing gear assembly and fractured the fibreglass laminate structure of the left main landing gear. Both wings were extensively damaged and both internal wing fuel tanks were breached. The engine mounts were fractured and the engine moved rearward, damaging the engine firewall. The impact partially crushed the foot well areas and rudder pedal assemblies on both sides of the cockpit.

**Figure 2: Aircraft wreckage**

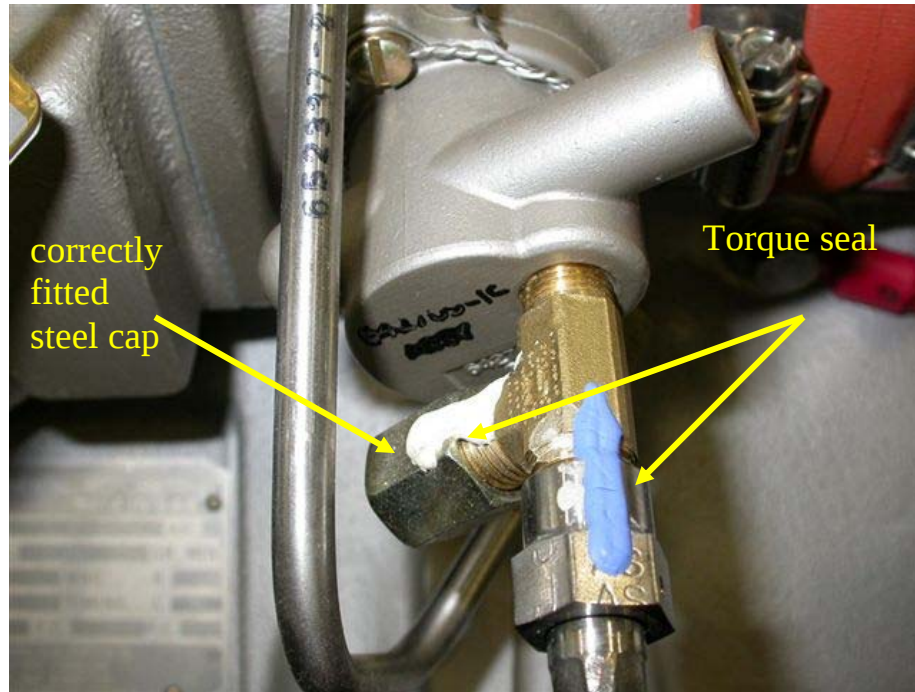
The steel cap was normally tightened over the T-fitting to a specified torque to ensure it remained secure. A mark comprising of inspection lacquer (Torque Seal™) was painted onto the cap and metal. Any breakage of the inspection lacquer mark would indicate the steel cap had moved relative to the metal fitting (Figure 3).

**Figure 3: IO-550-N T-fitting installation**

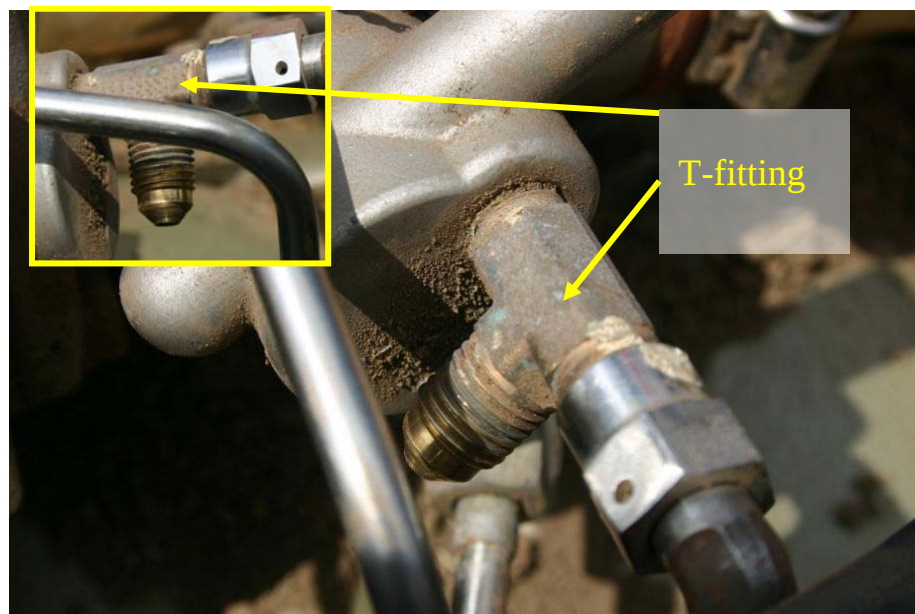
An examination of the engine on HYY noted that the steel cap from the T-fitting on the engine-mounted fuel injection system was missing (Figure 4).

**Figure 4: The T-fitting on HYY without its associated steel cap**

The steel cap intended to seal the test port on the engine's fuel injection system T-fitting was not found at the accident site.

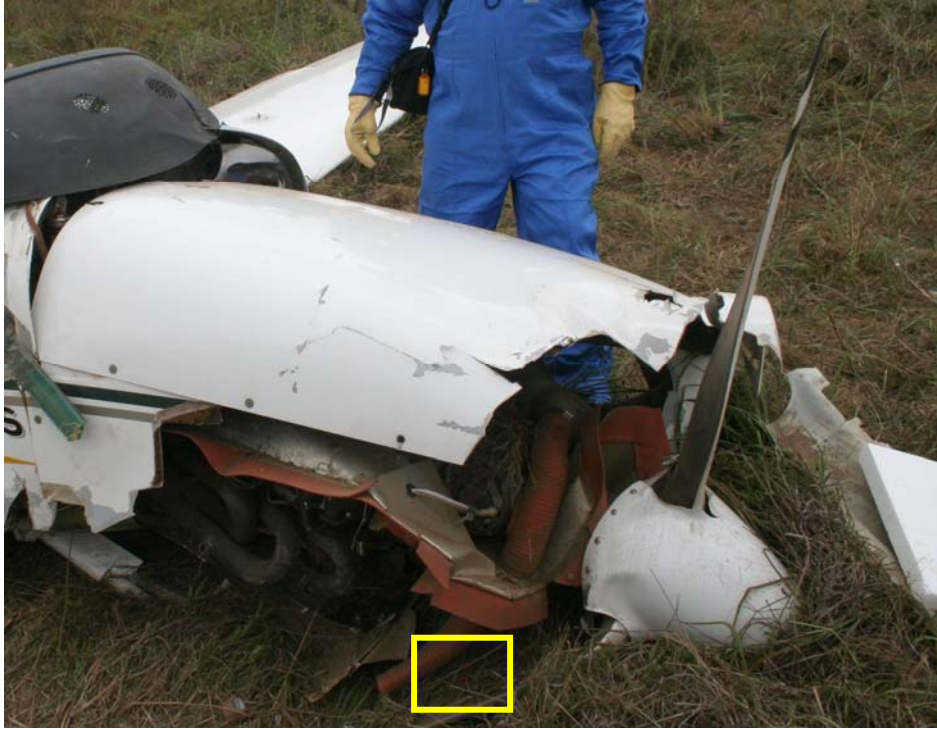
A small red plastic blanking cap, with the same thread type and diameter as the T-fitting, was found beneath the engine on the ground, adjacent to the remains of the fibreglass lower engine cowl (Figures 5 and 6).

**Figure 5: Red plastic blanking cap location**

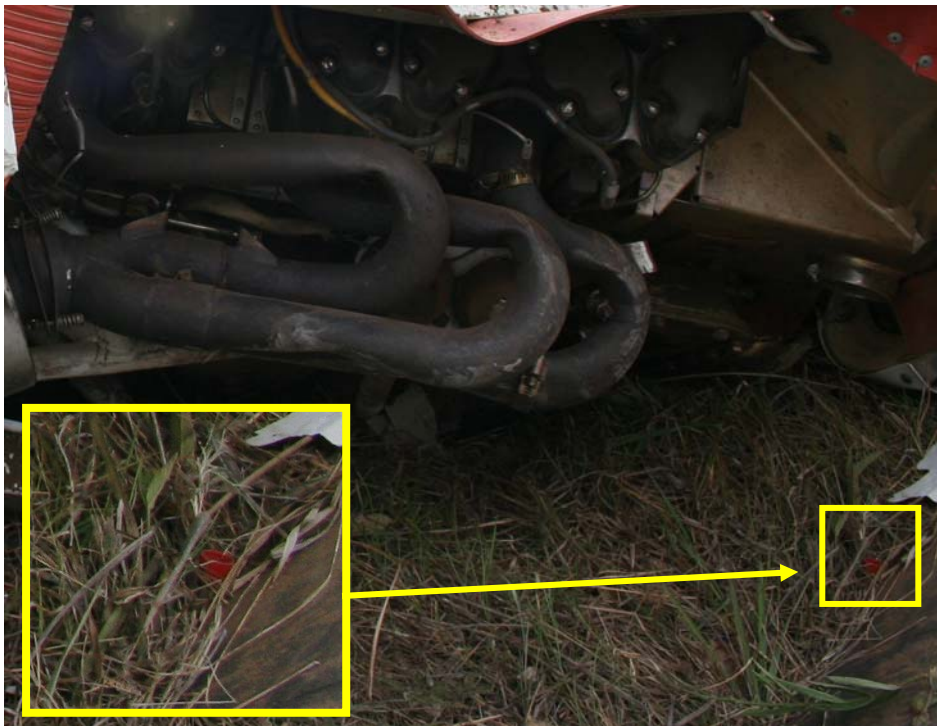
**Figure 6: Detail of red plastic blanking cap location**

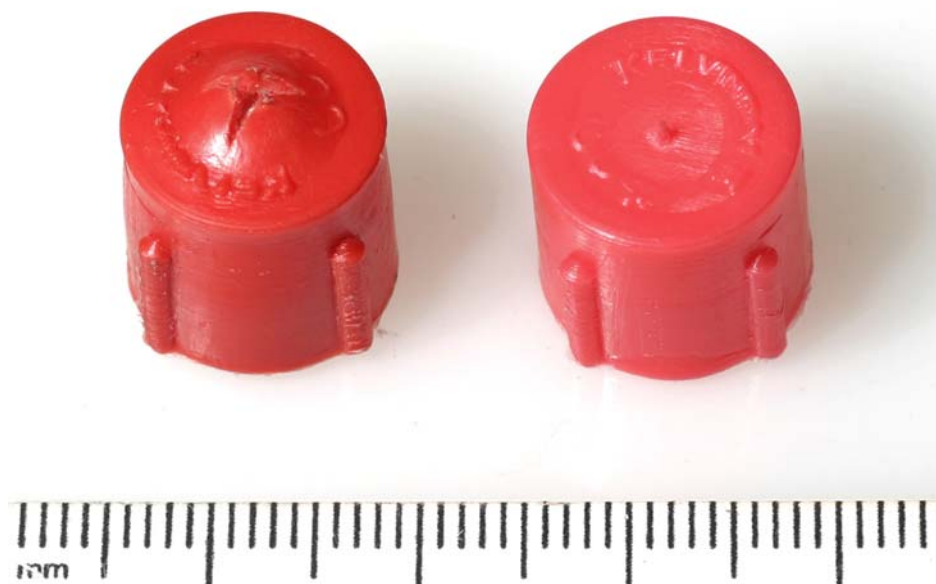
Visual examination of the plastic blanking cap revealed obvious distortion and cracking around the cap head. The central part of the cap had bulged outward. The amount of deformation is apparent by comparing the cap from HYY to an unused plastic cap of the same type (Figure 7).

**Figure 7: Red plastic blanking cap from HYY (left) beside an unused cap**

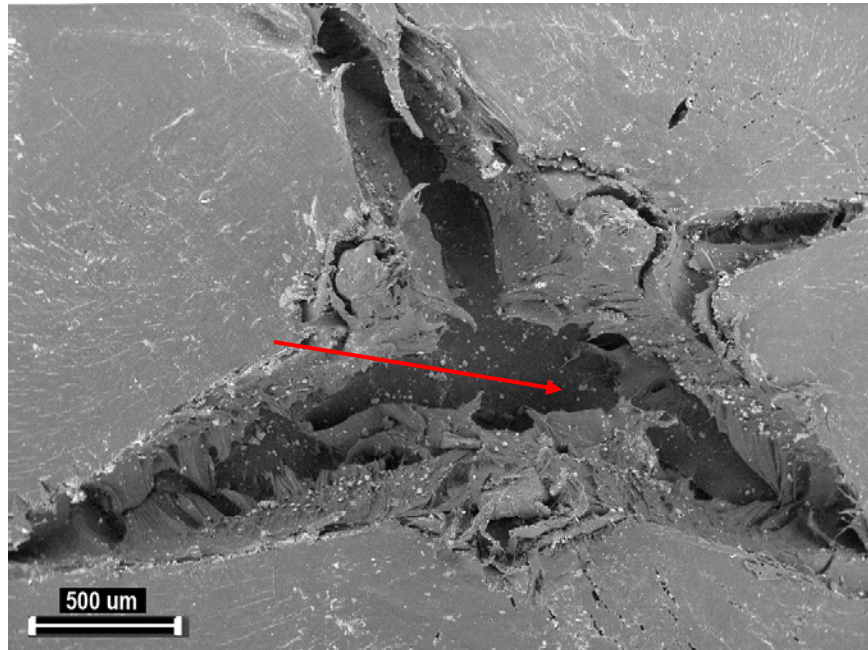
Four principal cracks had propagated radially from the cap centre. Examination of this region by scanning electron microscope revealed regions of pronounced high local plasticity and many voids and micro-cracks in front of the tip of each crack (Figures 8 and 9).

**Figure 8: SEM image of the rupture site at the centre of the bulge.**

Note: Arrow indicates intact membrane at end of cap.

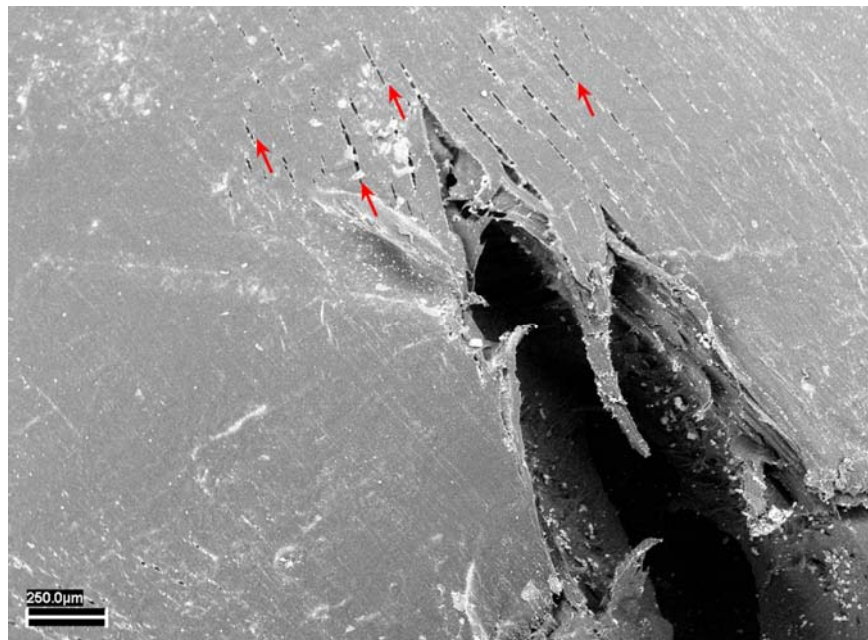
**Figure 9: High magnification SEM image of the rupture site.**

Note: Arrows indicate voids, in front of the tip of a crack, that were produced by internal overpressure of the cap.

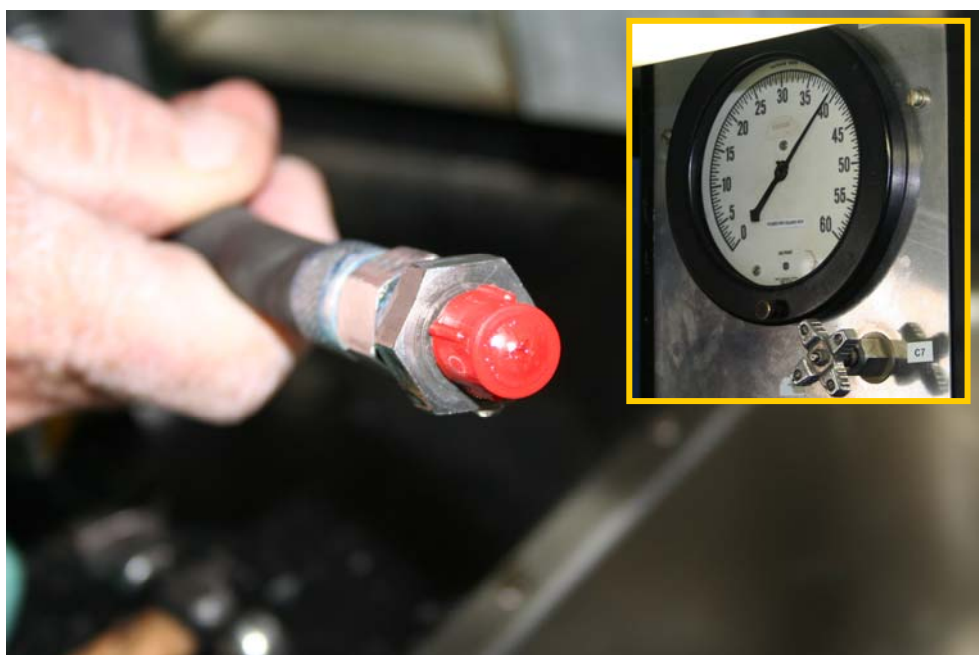
The blanking cap from HYY was found to contain a pressure of up to 40 Psi without leaking (Figure 10). The new plastic cap contained a pressure of 60 Psi.

**Figure 10: Pressure testing of the red plastic blanking cap from the accident site, with the gauge reading inset.**

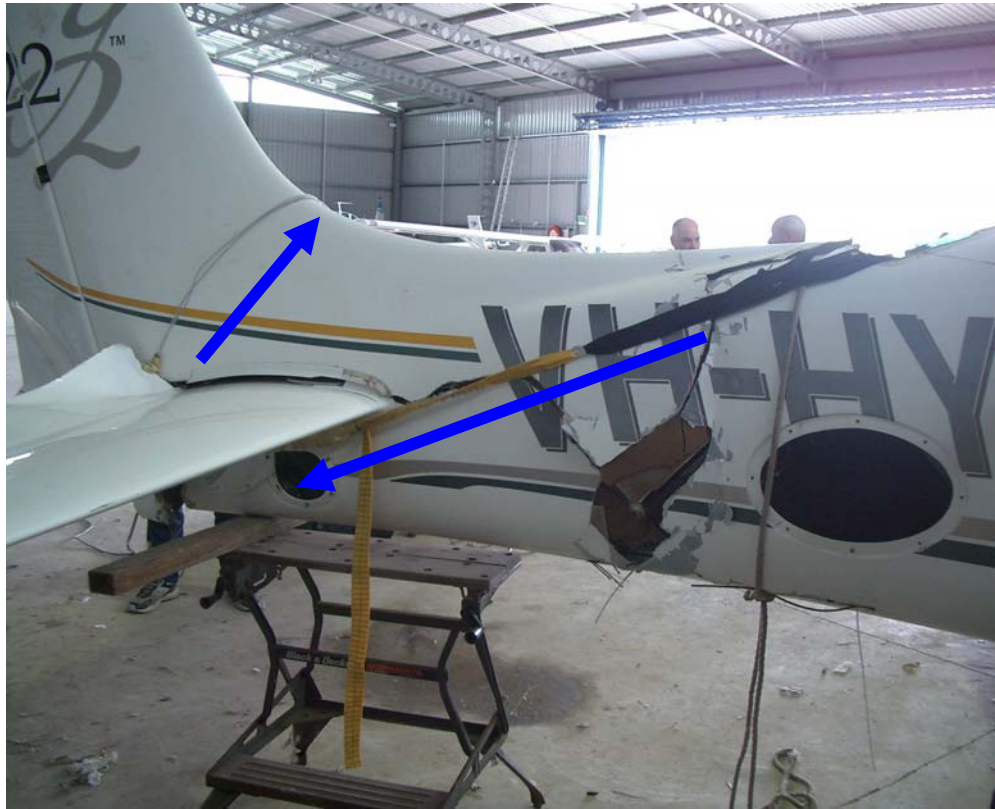
Figure 14: Path travelled by the CAPS rocket and harness

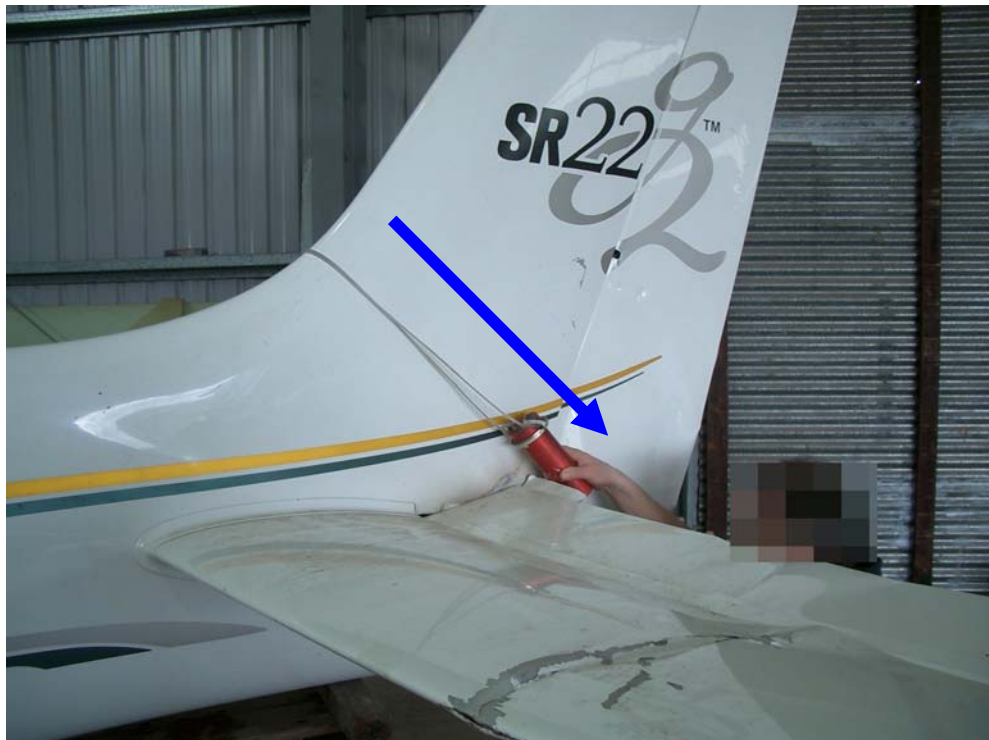
Figure 15: Path travelled by the CAPS rocket and harness

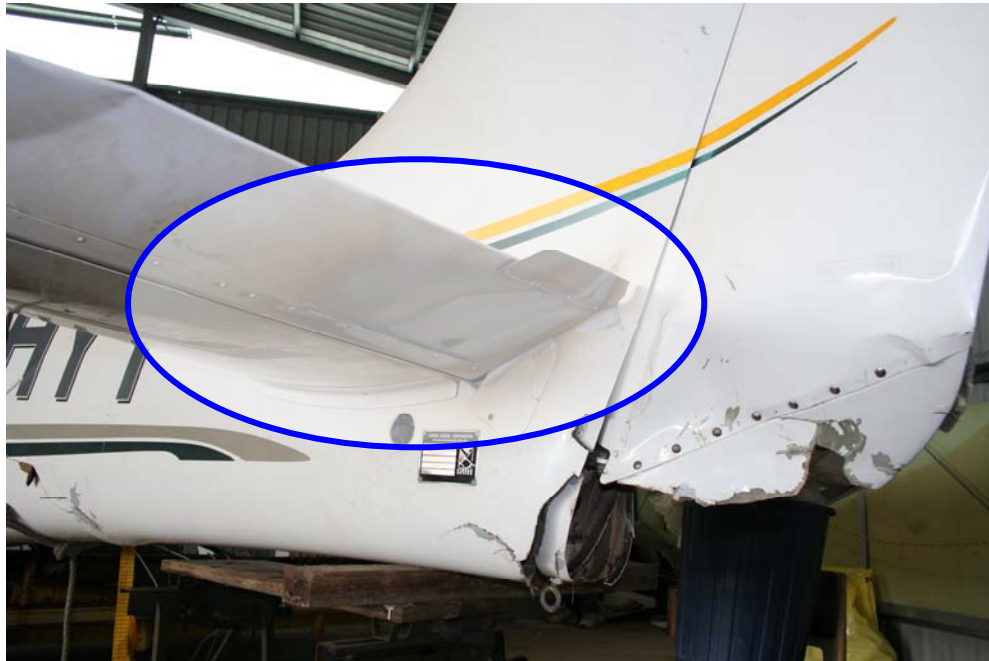
The rocket burnt out beneath the left elevator and left side of the vertical stabiliser. Heat damage marks from the rocket exhaust were evident on the side of the empennage, indicating that the elevators were in the full up position when the marks were made (Figure 16).

**Figure 16: Burnt paint (circled) on lower surface of left elevator**

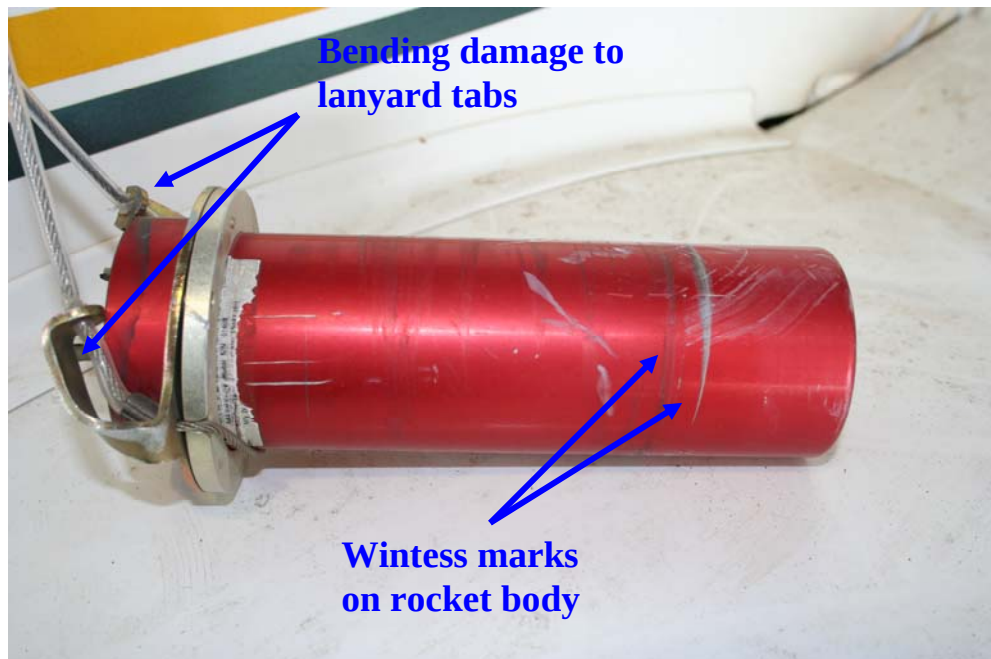
Damage and marks on the rocket body were consistent with the pick-up collar assembly and cable having prevented the rocket from exiting the launch tube cleanly. Bending of the pick-up collar lanyard tabs was consistent with the rocket having pulled unevenly on the parachute lanyard during deployment (Figure 17).

**Figure 17: Rocket and pick-up collar from VH-HYY**

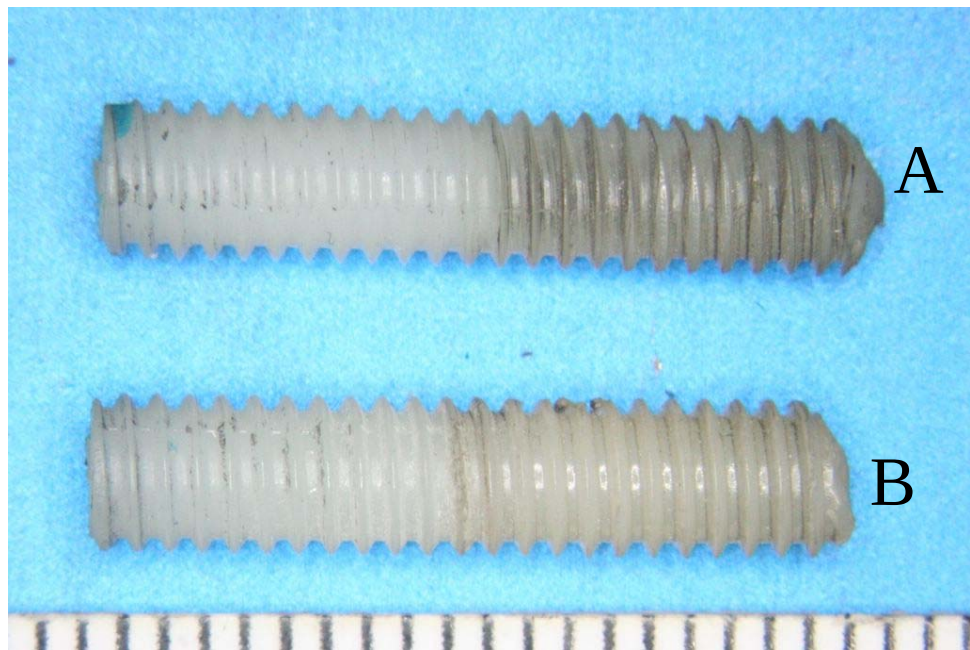
The ATSB examined the two nylon tension screws retaining the pick-up collar assembly onto the rocket launch tube (Figure 18). The fracture surface of one (screw A) was conical in shape, exhibiting multiple interlacing fracture planes arranged in a somewhat spiral fashion (Figure 19). The other (screw B) showed a single dominant fracture plane at a shallow angle across the screw (Figure 20).

Both fractures appeared consistent with the screws having been overloaded. There may have been some torsional overload on the conically fractured screw (screw A).

**Figure 18: Comparison between the two fractured nylon tension screws**

One of the nylon retaining screws which kept the pick-up collar in place on the rocket's launch tube was found to have damage consistent with excess torque having been applied. Such damage could have occurred during assembly or disassembly at some time prior to the accident flight and would have reduced the ability of the screw to maintain the pick-up collar alignment when the CAPS rocket was activated.

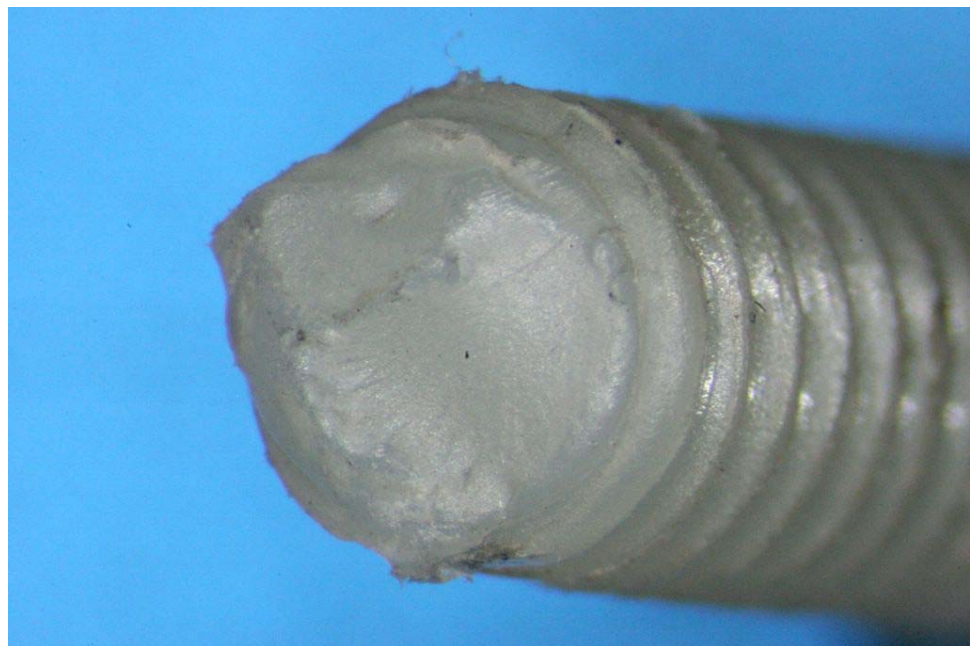
**Figure 19: Conical fracture surface of nylon tension screw A**

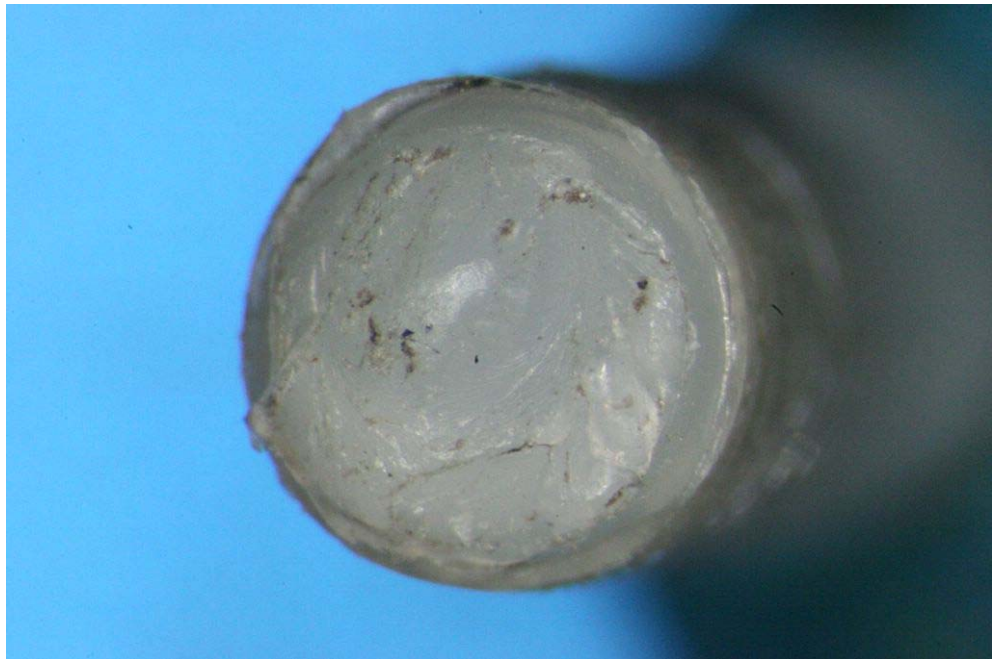
**Figure 20: Fracture surface of nylon tension screw B**

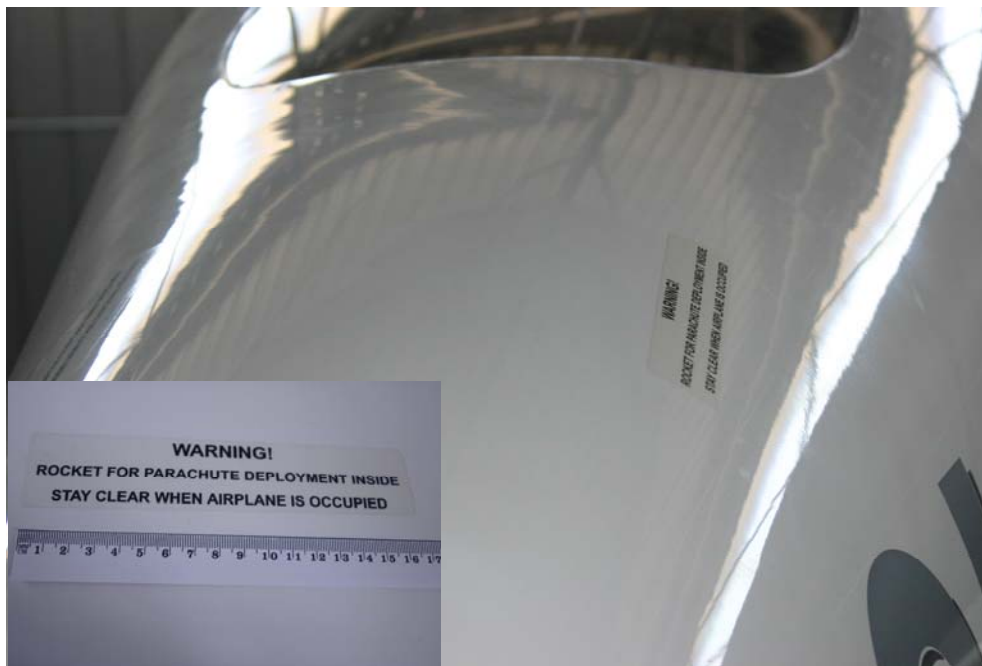
CAPS warning placards on HYY were positioned on each side of the fuselage on top of the fibreglass CAPS cover (Figure 21). No external fuselage CAPS warning placards remained after the cover had been jettisoned during CAPS activation.

**Figure 21: Typical fuselage CAPS warning placards**

Additionally, as a result of the ATSB's investigation, it was noted that the warning placards for the subject airplane were on the parachute enclosure cover. When the CAPS fired; it effectively removed the external placards from the airplane by removal of the enclosure cover during the launch sequence. Keep in mind in this case the danger was removed therefore the need for placards was moot. Despite this, Cirrus Design is taking action to identify planes that may have this configuration and relocate the placards to the fuselage. This way regardless of the location of the parachute enclosure cover the exterior of the airplane will be placarded.

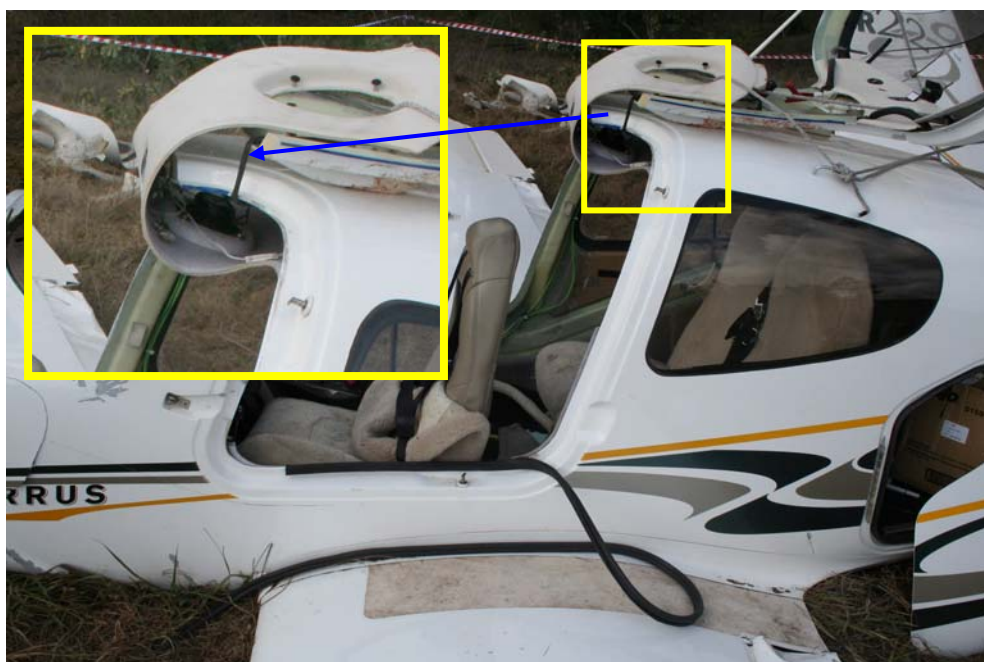
Some of the emergency services personnel who attended the aircraft accident had no prior knowledge of the CAPS and the potential dangers it posed. The ATSB warned the attending police site controller of the existence and potential danger of the CAPS. Following consultation with the ATSB and an aircraft manufacturer's representative, emergency service personnel subsequently cut through the roof of HYY to remove the injured occupants. The CAPS activation cable was stretched tight as a result of cutting through the roof and folding it back onto the rear fuselage (Figure 22).

**Figure 22: CAPS activation cable stretched tight on roof of aircraft.**

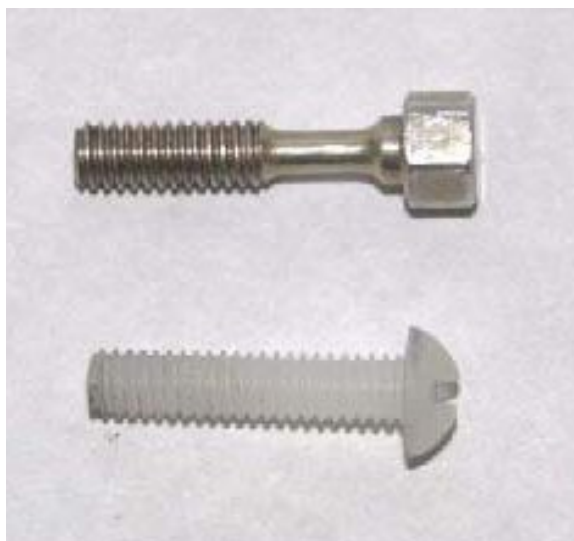
**Figure 23: New design aluminium tension screws (upper) compared to nylon type (lower)**

On 2 April 2007, in response to the failure of the CAPS in VH-HYY, and subsequent testing in the USA, the aircraft manufacturer issued Cirrus Alert Service Bulletin, SB A2X-95-10, ATA 95-00: Special Equipment, CAPS Pick-up Collar Support Replacement (Appendix A). The Service Bulletin introduced a new CAPS pick-up collar support and aluminium tension screws (Figures 23 and 24).

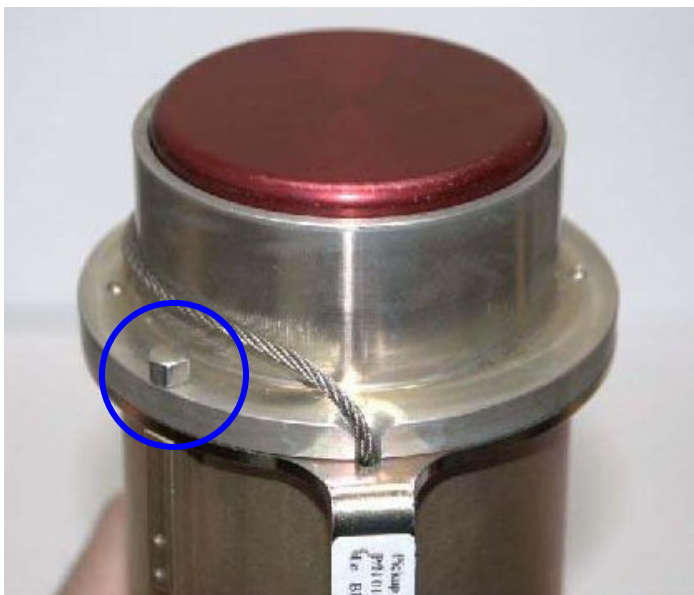
**Figure 24: New design pick-up collar; showing aluminium tension screw (circled)**
