Aviation Occurrence Investigation AO-2007-061

Preliminary

Collision with water
Approx 24 km SE Inverloch, Vic.
17 November 2007
VH-CHU
Cessna Aircraft Company C337G

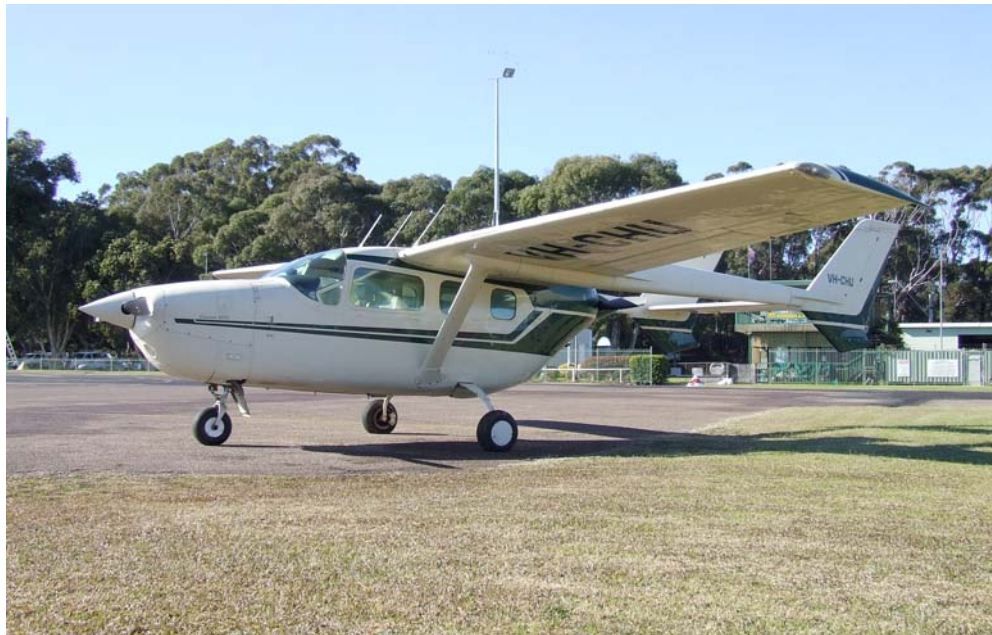
Figure 2: VH-CHU

The aircraft (Figure 2) was manufactured in the United States in 1977 and at the time of the accident had been operated for about 5,810 hours. The pilot purchased the aircraft in September 2007.

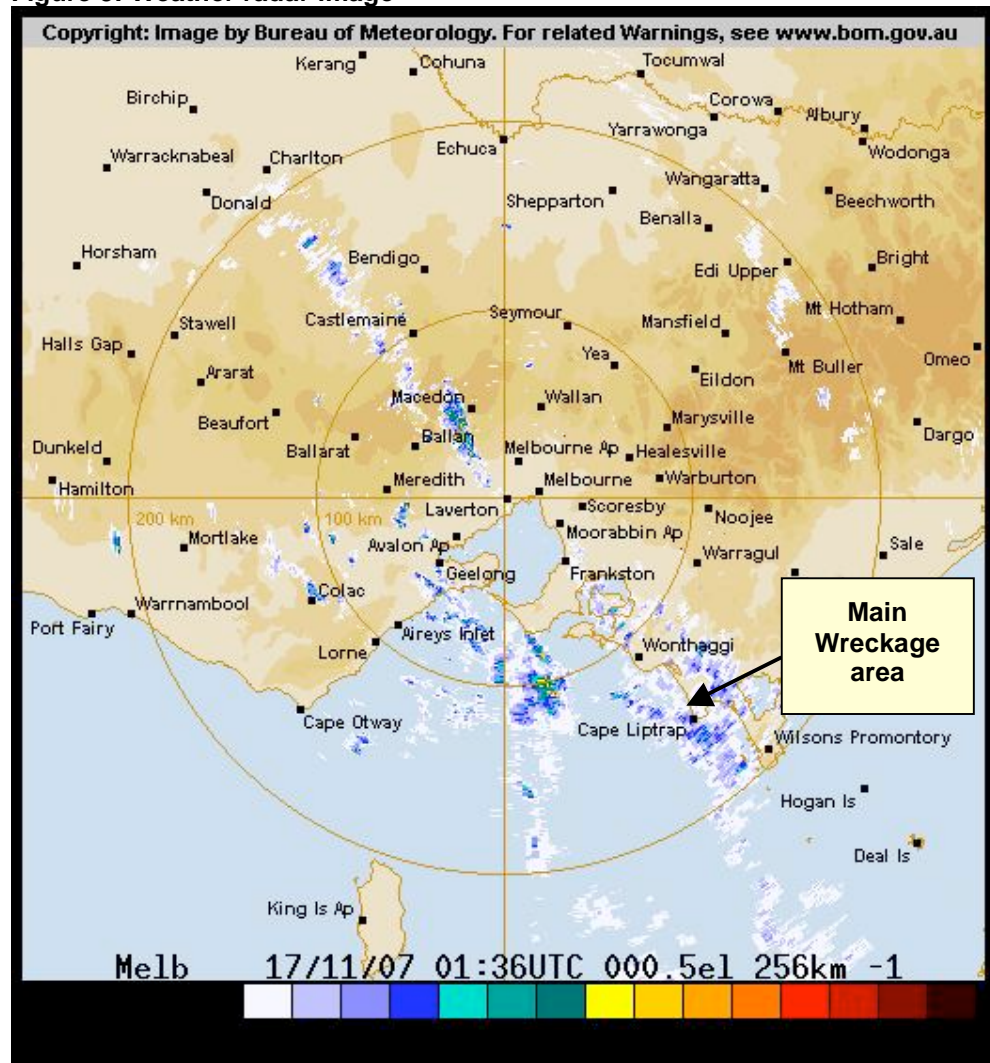
Figure 3: Weather radar image

The Bureau of Meteorology produced a visible satellite picture (taken at approximately 1233) and radar imagery from the Melbourne Airport radar (Figure 3). The images show a band of scattered showers affecting the area between Wonthaggi and Wilson's Promontory between 1200 and 1300.
