ATSB TRANSPORT SAFETY INVESTIGATION REPORT  
Rail Occurrence Investigation 2007/003  
Final

# Derailment of Train 3MR2 near Roopena, South Australia

22 May 2007

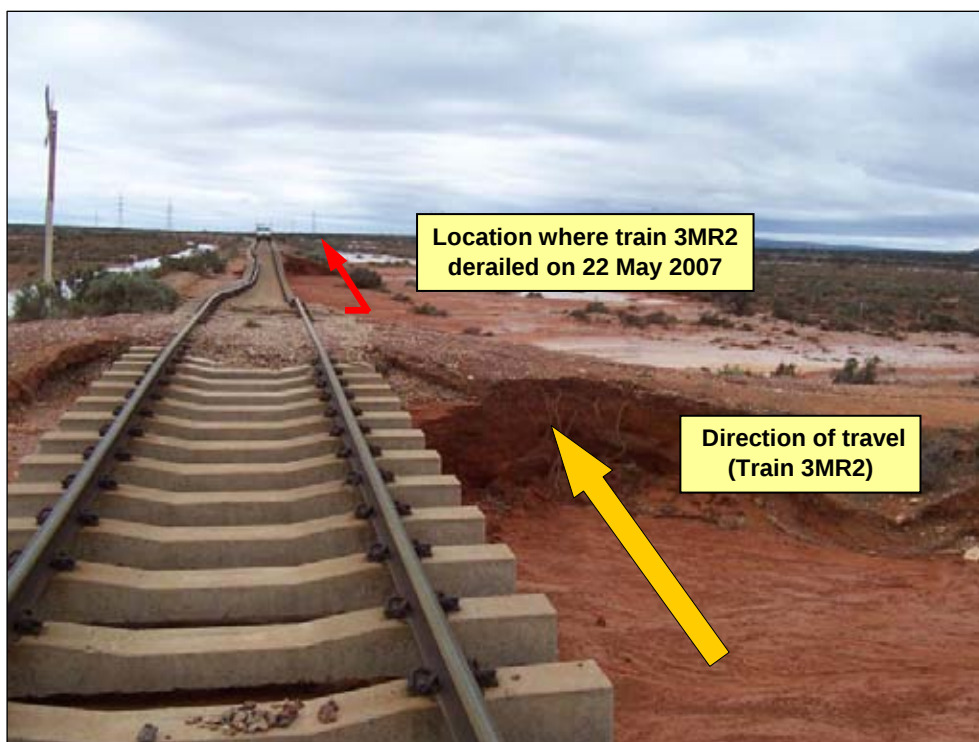
**Figure 3: Track damage due to flooding (photograph, 22 January 2007)**

Train 3MR2 derailed soon after passing over an unsealed level crossing located at the 138.100 track kilometre point<sup>5</sup>. About four months before the derailment, the railway track north of Whyalla had been damaged due to heavy flooding. The flood damage occurred after heavy rains (about 92 mm recorded at Whyalla<sup>6</sup> on the 19th and 20th of January 2007) washed ballast and earth away from under the track resulting in significant track damage over almost 30 track kilometres, including the area either side of the unsealed level crossing (Figure 3).

The flood damaged track was repaired and train services resumed on 27 January subject to a restricted speed limit of 40 km/h. The temporary speed restriction was removed on 9 February and no defects were identified in the area when the track geometry car travelled the Port Augusta/Whyalla line the following day, 10 February.

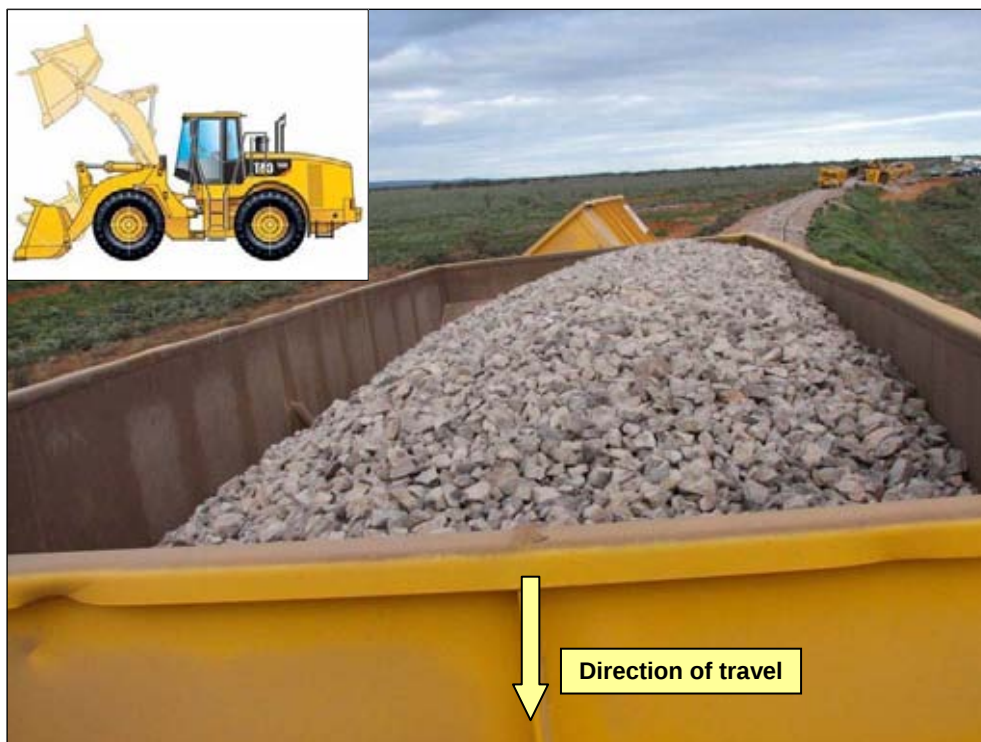
**Figure 4: Wheel loader and uneven loading on AHWX-12**

On site observations found that the loads in each of the ballast wagons on train 3MR2 were not evenly distributed across the entire width of the wagon. Computer simulation showed the wagon to be sensitive to spring compression length such that the body roll would have been sufficient to cause the front left-hand suspension springs to become fully compressed. It is likely that the uneven load distribution on wagon AHWX-12 caused the left-hand suspension springs to compress more than if the load had been evenly distributed.

Note: While the load in wagon AHWX-12 is likely to have been disturbed during the derailment, the load profile illustrated in Figure 4 is generally consistent with the profiles observed in the wagons that did not derail.

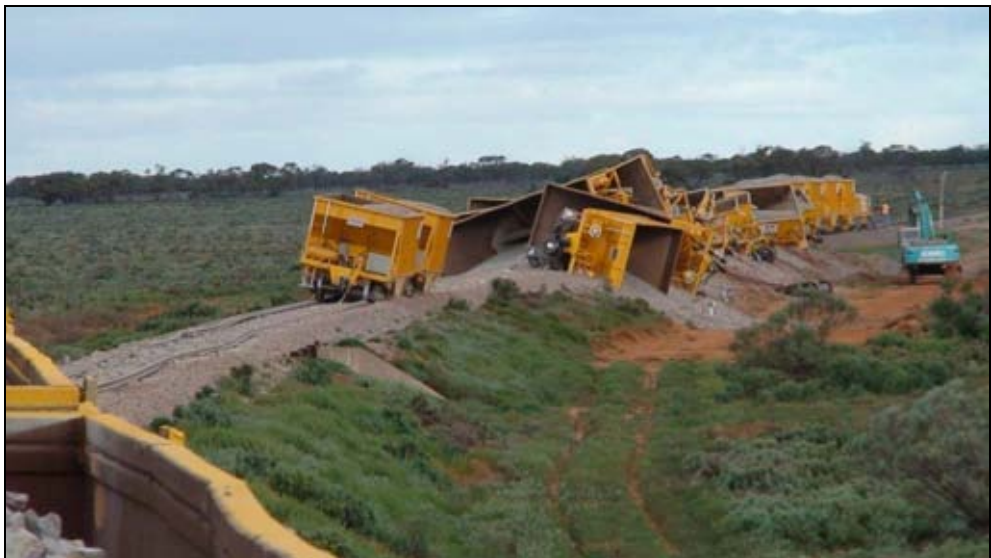
**Figure 5: Derailement site**

The undamaged front and rear portions of the train were hauled to Port Augusta and Whyalla respectively. Excavators were used to remove the ballast from the derailed wagons before the cranes lifted the wagons clear of the track to allow track restoration work to progress. The track was reopened for traffic at about 1700 on Saturday 26 May 2007 and the damaged rollingstock progressively recovered from the track side over the following weeks. A total of twenty seven wagons were damaged along with about 400 metres of track.

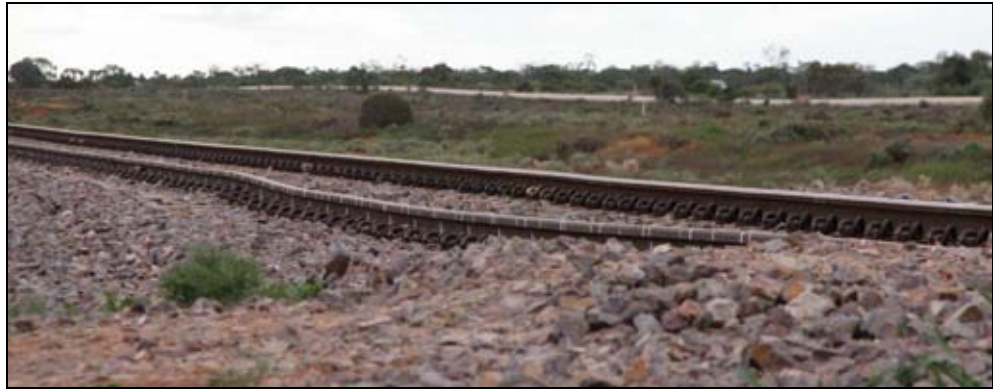
**Figure 6: Track geometry defect (Photograph, 22 May 2007)**

Note: The angle and magnification of the photograph provides an enhanced view of the track geometry defect.

The main feature of the geometry defect was a significant dip in the eastern rail between 18 and 39 metres from the POD. The western rail also showed a dip but of a much smaller size. The dips were followed by a hump in both rails as the track passed over the unsealed level crossing. The point of drop-off was about 15 metres past the centre line of the level crossing. Figure 7 illustrates the dips and humps in terms of the variation in track level from the estimated design level.

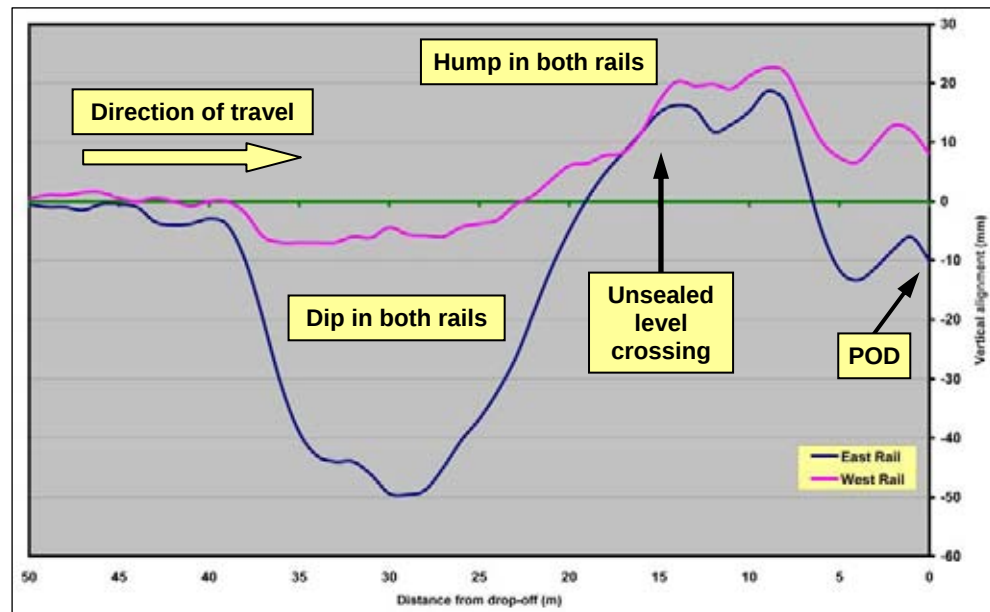
**Figure 7: Vertical Alignment**

The opportunity was taken during the retrieval of non-derailed wagons to measure the track's deflection under load. Since data could only be obtained from a few points, no conclusive assessment could be made as to the extent to which the

vertical alignment parameters would be affected by deflections under load. However, the data did indicate that the effect was likely to be insignificant.

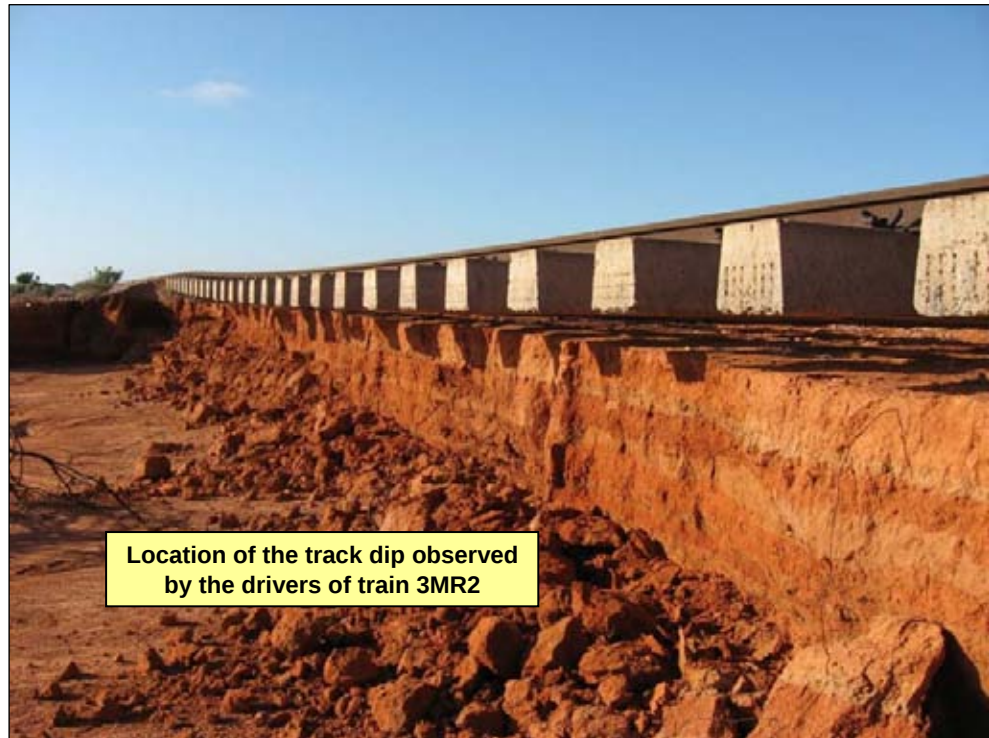
**Figure 8: Track damage due to flooding (photograph, 22 January 2007)**

The flood damage that had occurred in January 2007 had left this section of track completely suspended as the track foundation was washed away from beneath the sleepers (Figure 8). It is possible that the earth below the repaired track formation had compacted and settled thereby allowing the track dip to develop. Further rain during late March may also have contributed to the development of the track defect at this location (50 mm of rain was recorded at Whyalla on 20 March 2007).

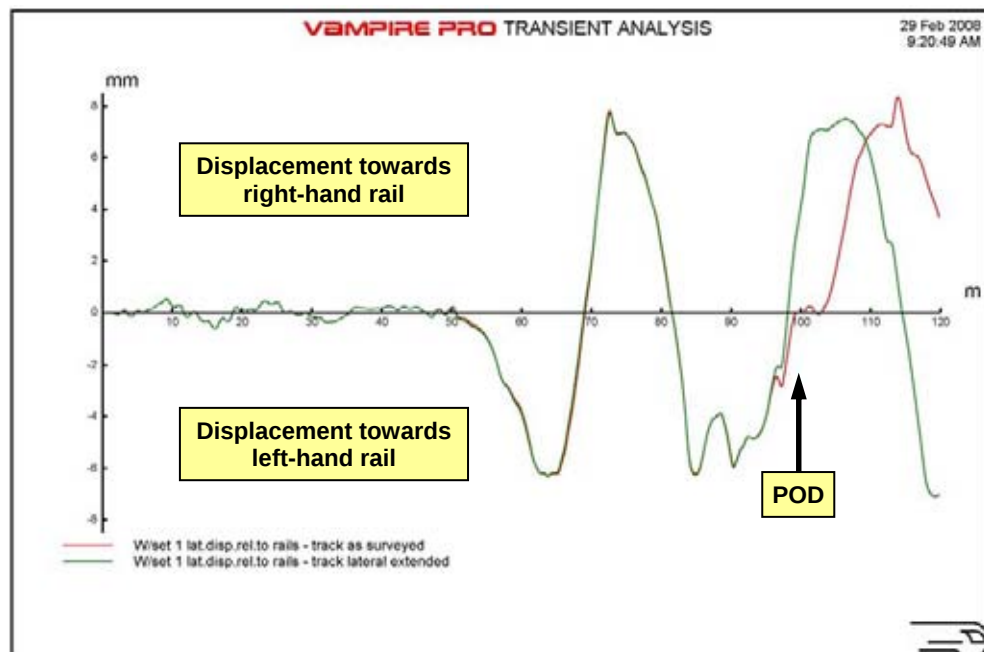
**Figure 9: Wheel-set lateral displacement**

It was found that modifying the lateral track alignment component had a significant effect on the lateral displacement of the wheel-set, placing it in flange contact with the right-hand rail at the POD (Figure 9 – green trace).

As a result, the L/V ratio at the leading right-hand wheel became significant, reaching a peak value of 0.98 at this point. While the simulated L/V ratio remained within the usual limit of 1.20, it still indicated an increased risk of a flange-climb derailment as the leading right-hand wheel passed the POD in this case.

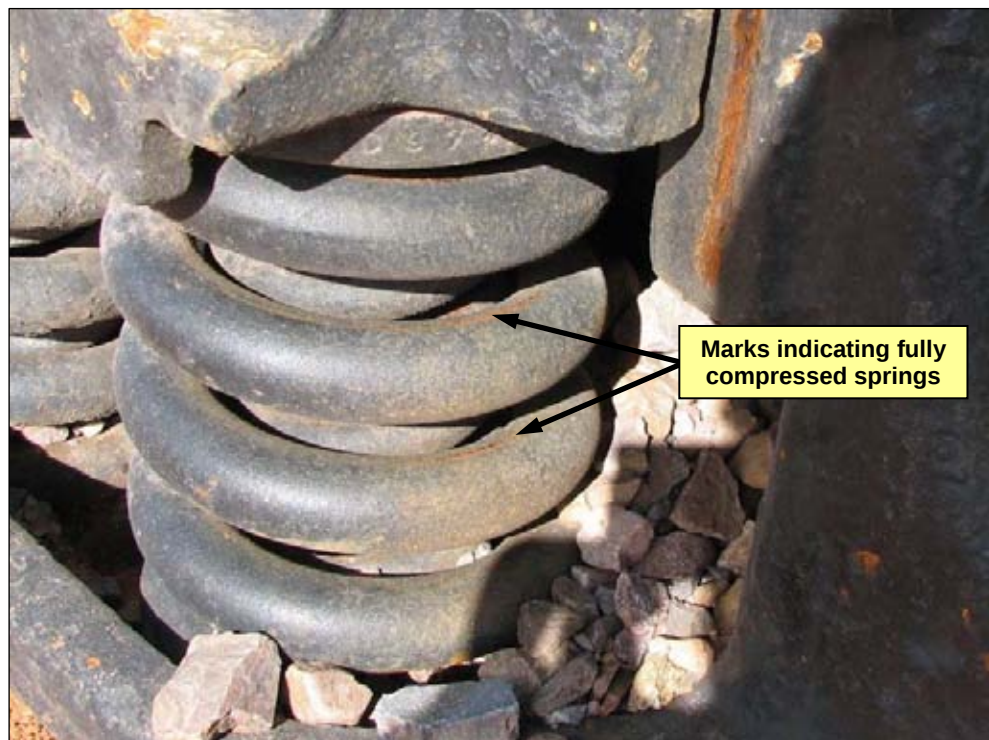
**Figure 10: Front bogie, left-hand spring pack**

Figure 10 shows evidence of the front left-hand coil springs going solid on wagon AHWX-12. However, there is similar evidence on the trailing left and trailing right-

hand springs. In each case, it is evident that the instances of solid running have been minor. While it is likely that these occurred at some point during the derailment, it was not possible to determine if they occurred at the POD. It should also be noted that some coil springs in the undamaged wagons also showed evidence of going solid.

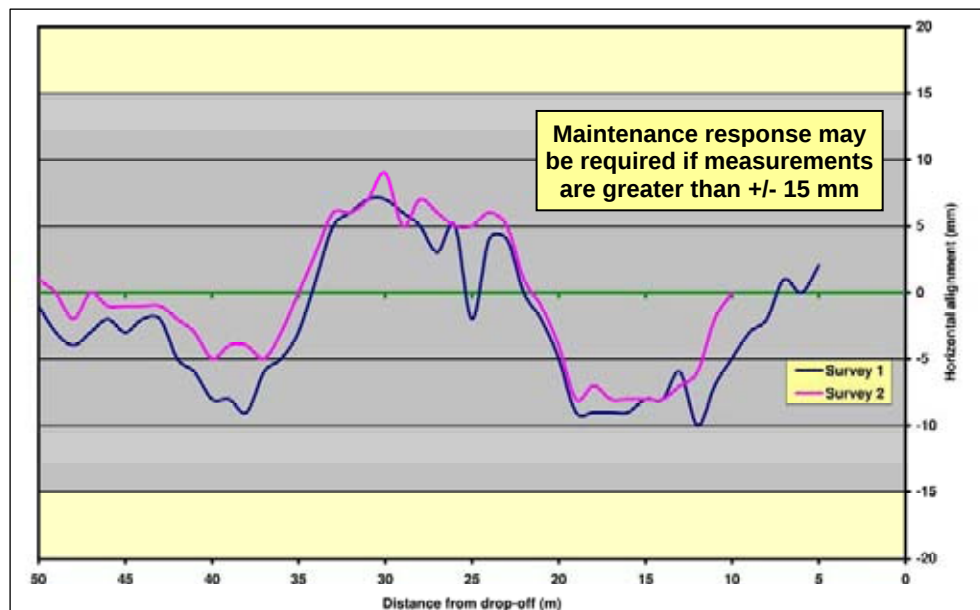
**Figure 11: Horizontal alignment**

When considering the horizontal alignment defect at Roopena, the CoP does not require a response, on track rated at 100 km/h, until the defect exceeds 15 mm. If the speed is reduced to 80 km/h, a response is not required until the defect exceeds 19 mm. Figure 11 illustrates the results from two surveys for measurement of horizontal alignment at Roopena. The horizontal alignment defect does not exceed 10 mm for either survey. Without any guidance to the contrary, it is unlikely that a horizontal alignment defect of this size would be considered critical, even when considered in combination with other track defects.
