**ATSB TRANSPORT SAFETY INVESTIGATION REPORT**

Aviation Occurrence Report – BO200502316

# **In-Flight Failure of a Tailrotor Drive Shaft**

**Fig Tree Pocket, Qld**

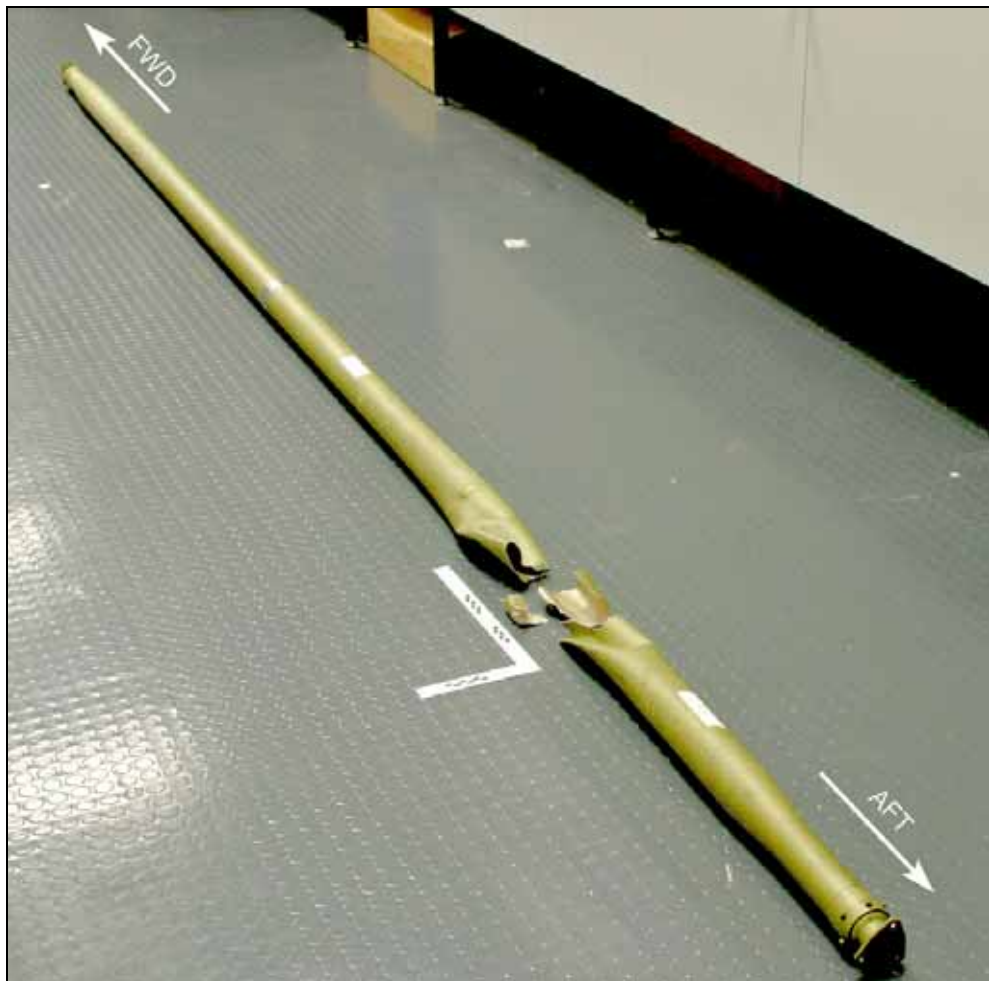
Initial examination of the tailrotor shaft, as-received by the ATSB, revealed that the component had fractured through the rear section approximately 760 mm from the tailrotor gearbox connection. The failure had caused the shaft to separate into four pieces with two of them being main tubular sections and the other two being much smaller fragments, see figure 2.

**Figure 2: Photograph of the broken tailrotor drive shaft (P/N 369D25518-501, S/N 009999-3892) as-received by the ATSB.**

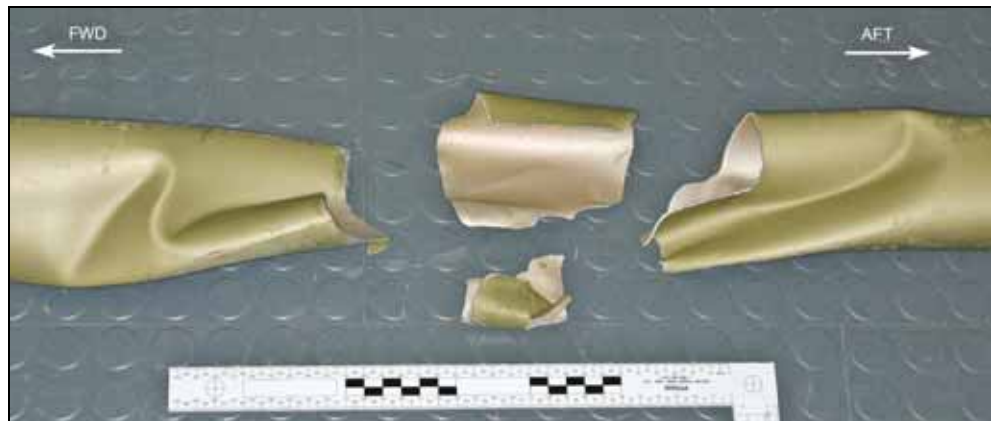
One of the main features observed on both shaft segments was the significant degree of twisting-type distortion. When both shaft segments were aligned to the pre-failure position, as shown in figure 3, the corruption to the component structure became evident. The general shape of the damage indicated that failure had occurred by buckling and was driven by torsional loading. The indicated direction of torsion, as viewed looking aft, was as if the forward portion of the shaft rotated clockwise relative to the aft portion of the shaft, see figure 4.

**Figure 3: View of the failure location.**

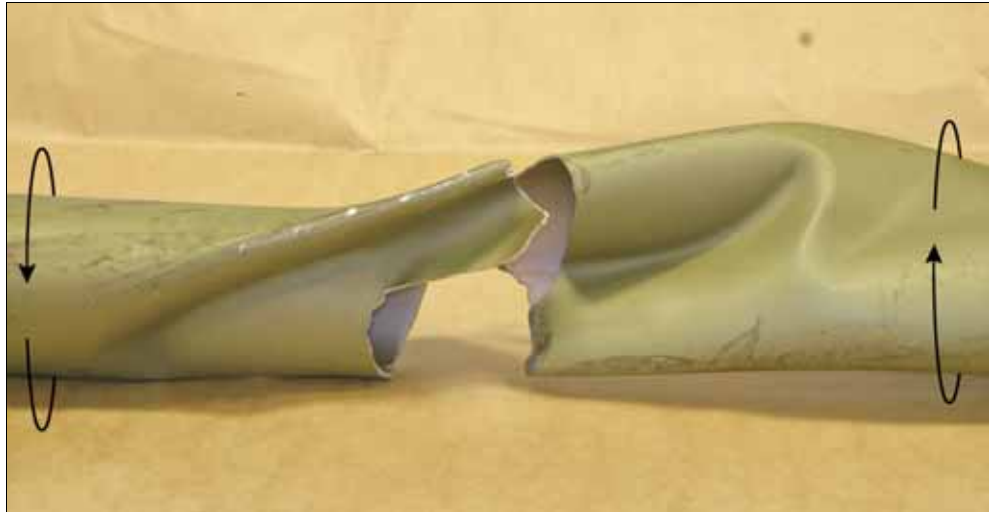
**Figure 4:** Close view of the buckling to the shaft structure. The torque reaction required to produce such deformation is arrowed.

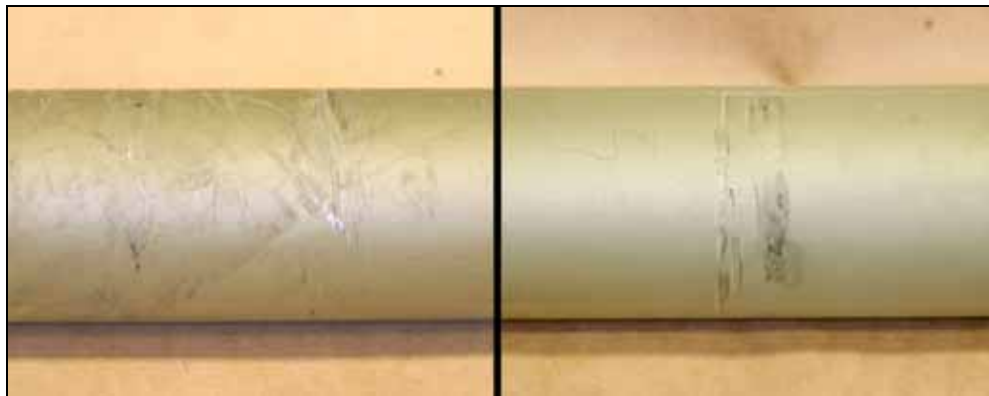
Secondary damage to the shaft included many randomly oriented scratches and scores to the painted surface and underlying substrate, see figure 5. Several deeper circumferential scratches and indentations were noted on the most severely folded sections of each shaft fragment. The general appearance of this damage was consistent with contact with the tailboom inner fairing after the primary shaft failure.

**Figure 5:** Various external secondary surface damage including scratches, rotational scuff marks and indentations were observed along the length of the shaft.

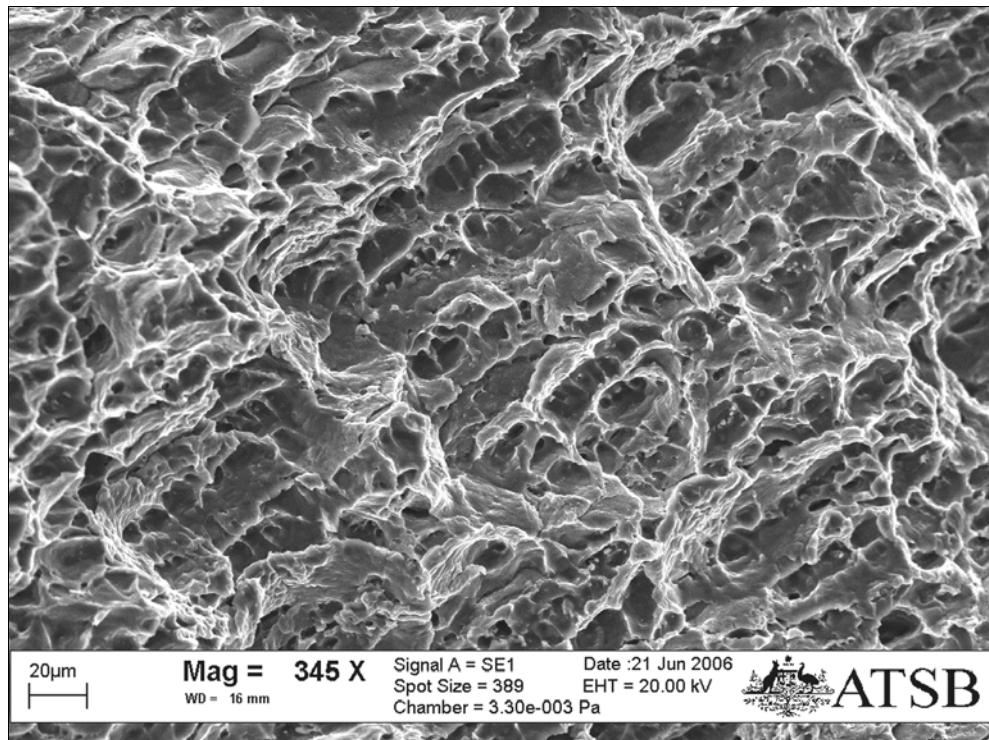
examination revealed only evidence of ductile tearing or shearing from a gross overload event, see figure 6.

**Figure 6: High magnification scanning electron micrograph of the fracture showing a typical region of ductile overload.**

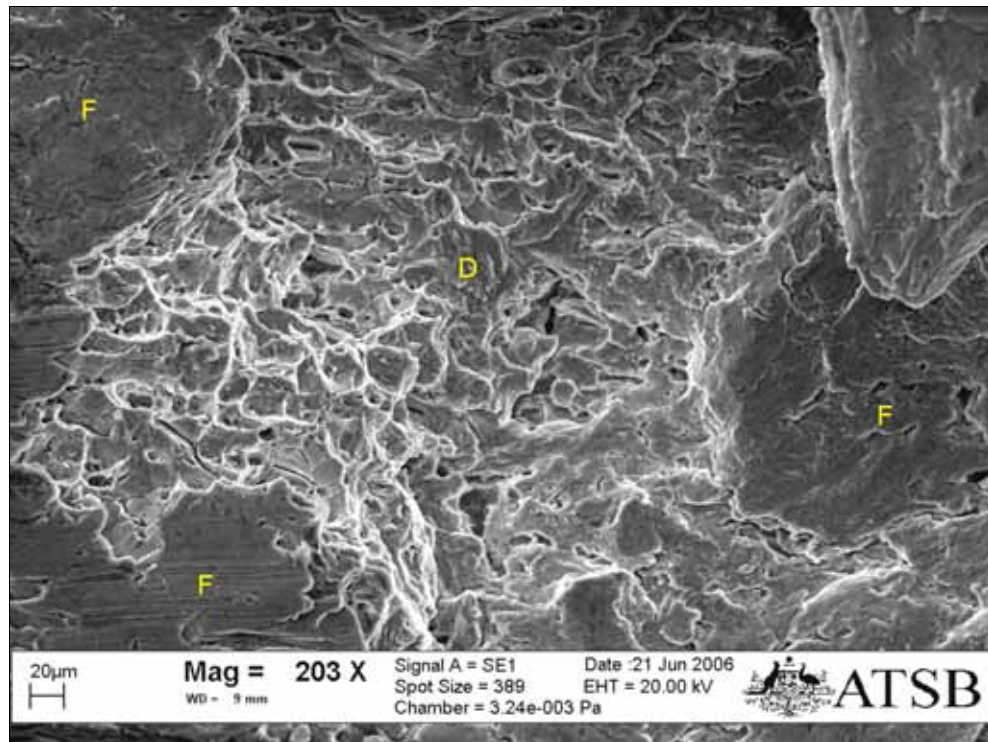
Some of the fracture surfaces had their finer features obscured from ‘metal-to-metal’ contact, see figure 7. The general appearance of the contact marks indicates that the damage had been caused subsequent to the shaft failure.

**Figure 7:** Scanning electron micrograph of the fracture surface showing ductile overload areas, labelled 'D', and some regions of post-failure damage, labelled 'F'.
