**Australian Transport Safety Bureau**

**Robinson R44, VH-YKL**  
**43km NW Kununurra, WA**  
**8 November 2003**

**INVESTIGATION REPORT**

**BO/200304546**

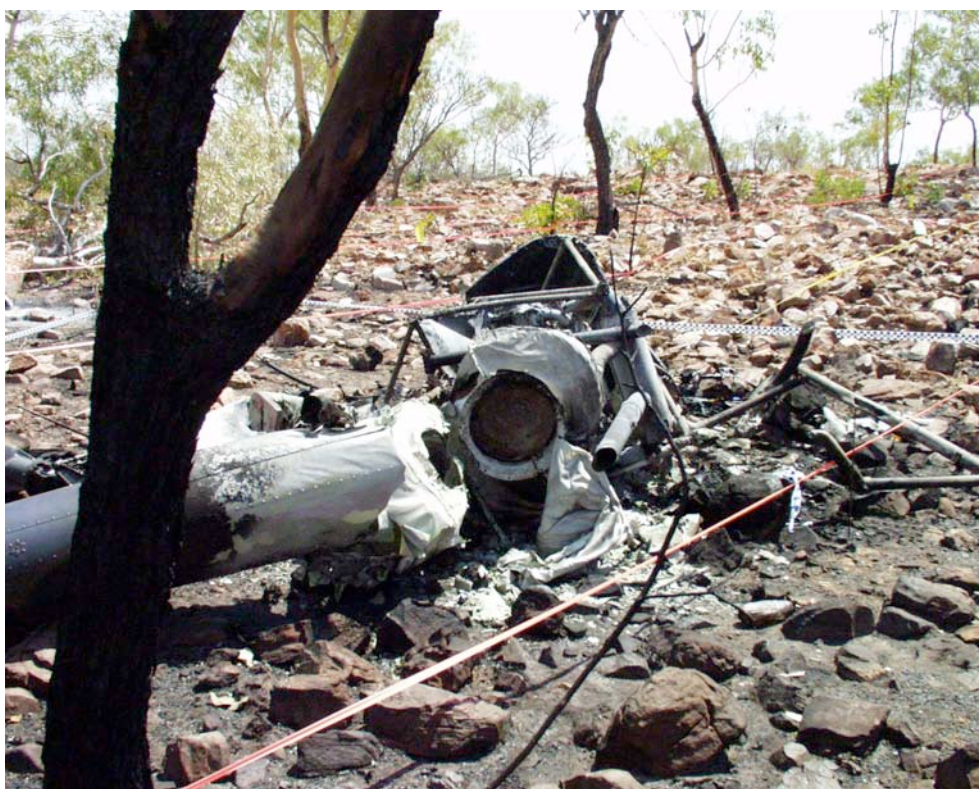
The accident site (Figure 1) was located on the western side of a small hill in remote country 43 km NW of Kununurra. The helicopter initially collided with a tree about 36 ft AGL, just below the crest of a hill with a 12 percent slope, and then impacted with rough boulder-strewn terrain.

**Figure 1: General view of wreckage**

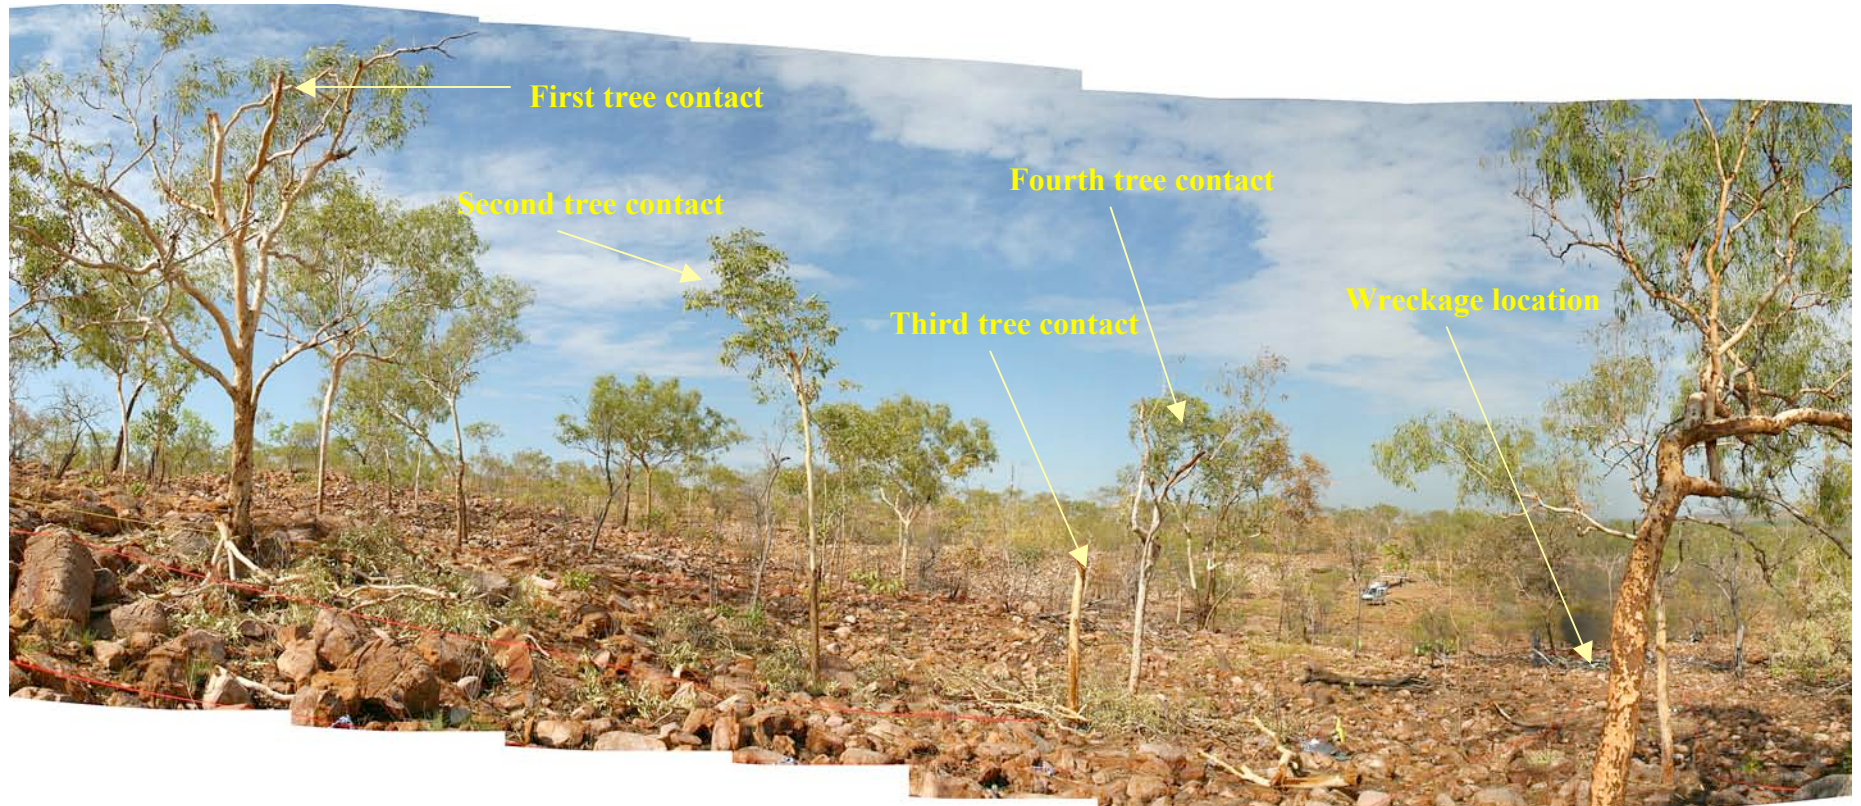
Four trees, close to the line of flight (Figure 2) were observed to exhibit varying degrees of damage from contact with the helicopter. Contact with these trees shattered the main rotor blades into numerous fragments that were scattered in the early portion of the debris path. During this contact, one main rotor blade also contacted the tail boom.

Six metres to the right of the fourth tree, ground strike marks attributed to main rotor blade fragments were observed, with other blade debris scattered between the second and fourth tree. The extensive damage to the main rotor blades was consistent with high energy in the rotor system at the time of impact.

The tail boom contacted the base of the third tree and dislodged the tail rotor gearbox from its mount plate. Witness marks on the tree trunk from the tail rotor gearbox and pitch change mechanism (Figure 3) placed the helicopter in an approximate 37 degree nose-up and near wings-level attitude when the gearbox impacted the tree.

**Figure 2: Panoramic view of accident site with damaged trees**

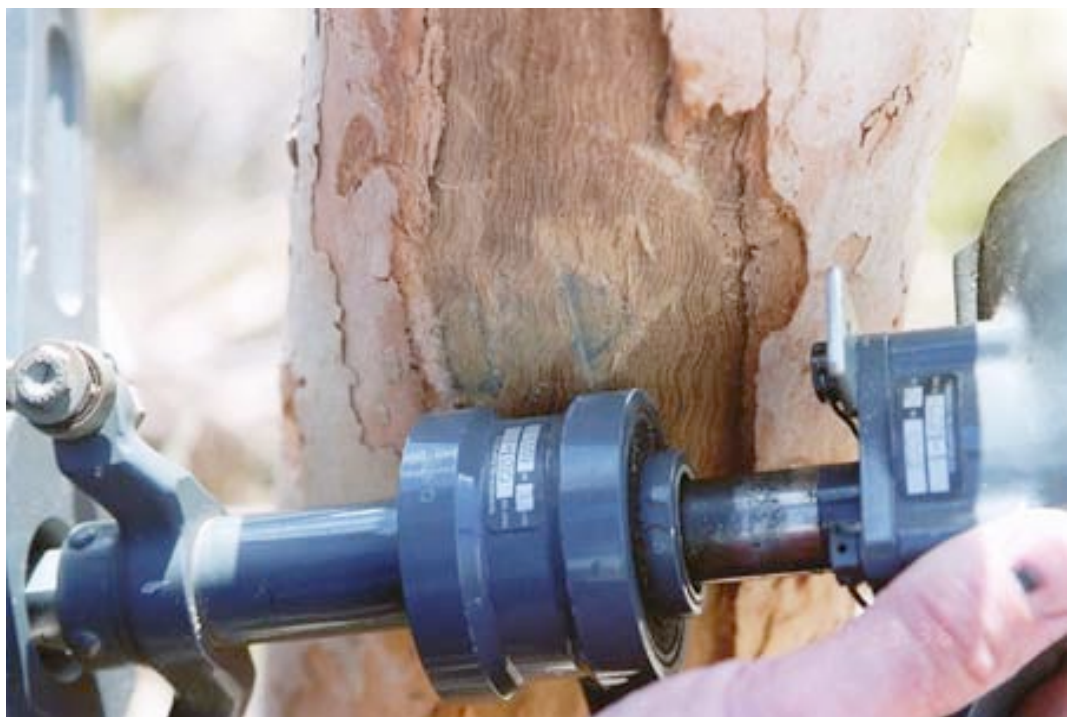
**Figure 3: Tail rotor gearbox assembly tree imprint**

The tail rotor drive shaft was found with a torsional twist in the shaft section immediately aft of the upper pulley sheave. That torque twist was indicative of sudden stoppage of the tail drive section while the drive train forward of that continued to rotate. The damage was consistent with the tree contact described earlier (Figure 3).

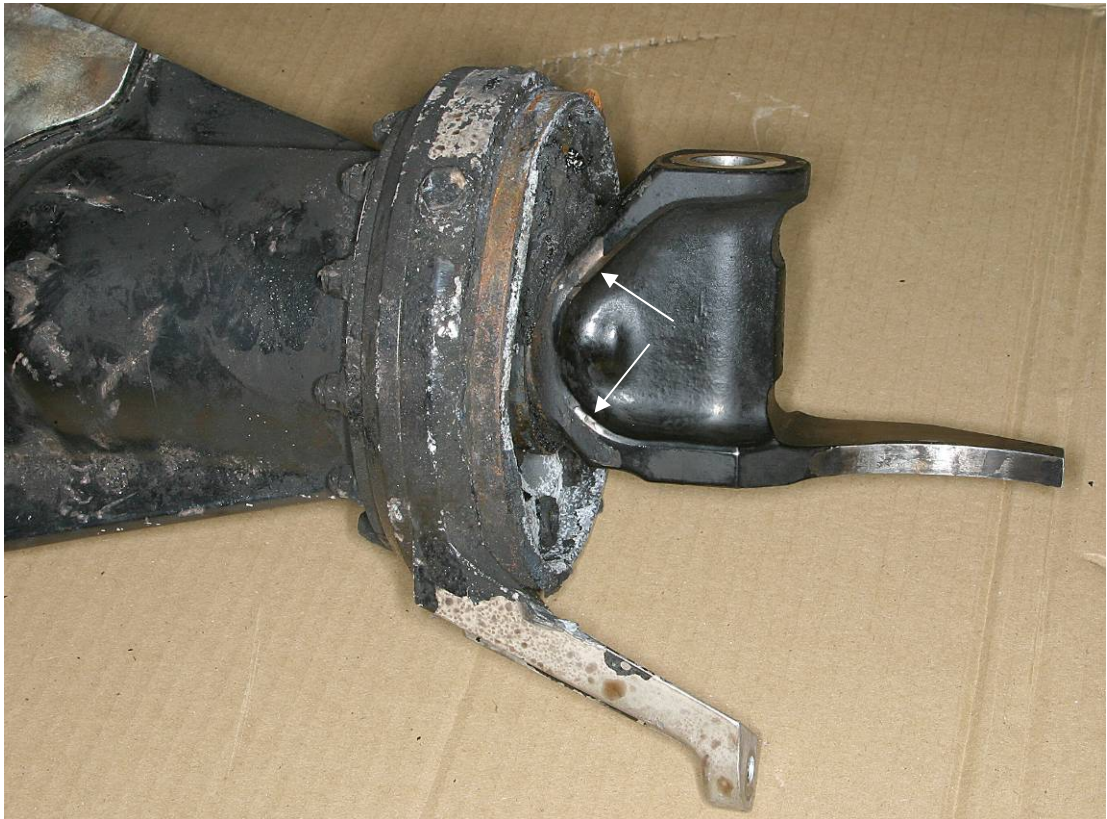
The hub components had been exposed to a ground fire after the accident and had sustained moderate surface charring and discolouration as a result. Despite that damage, the assembly was examinable (figure 1) and showed no evidence of abnormal rotor conditions. The spindle tusk showed no evidence of impact or abnormal loading and the hub teeter stop and up-coning stop contact surfaces showed no unusual markings or damage, other than a band of disrupted paint on the blade spindle that indicated contact with the up-coning stop at some time prior to or during the accident. The pitch-change linkage was not connected to the pitch horn when the blade hub was examined, having been disconnected at the accident site in preparation for transport to the ATSB's laboratories. The bore of the interconnecting pitch link bolt hole showed distortion and scoring damage consistent with exposure to heavy forces through the pitch link and bolt.

**Figure 1: Hub assembly of blade S/N 4186-A showing general sound condition and absence of gross mechanical damage. Contact against the up-coning stops was evident (arrowed).**

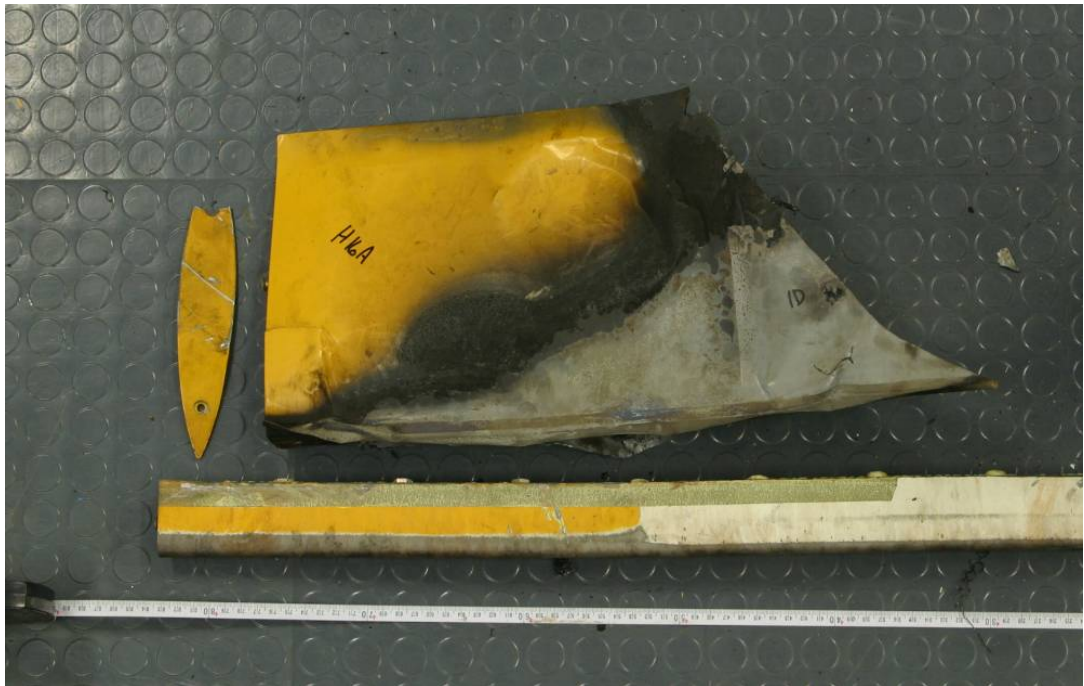
**Figure 2: Area at the tip of blade S/N 4202-A that exhibited backward peeling separation of the skin from the leading edge spar.**

As revealed during the general examination, blade S/N 4202-A showed a 470 mm long area of upper aerofoil skin that had separated from the leading edge spar and rolled backward, suggesting aerodynamic influences. The skin separation had occurred by failure of the adhesive joint between skin and spar, exposing the adhesive material which remained predominantly on the spar surface. To characterise the mechanism of joint failure, a section of the spar containing an area of comparatively undamaged adhesive (figure 4) was removed and compared against a similar area where the adhered skin had been mechanically peeled away in the laboratory (figure 5). Comparison involved optical and electron microscopy of the adhesive base and the skin under-surface (bonded surface).

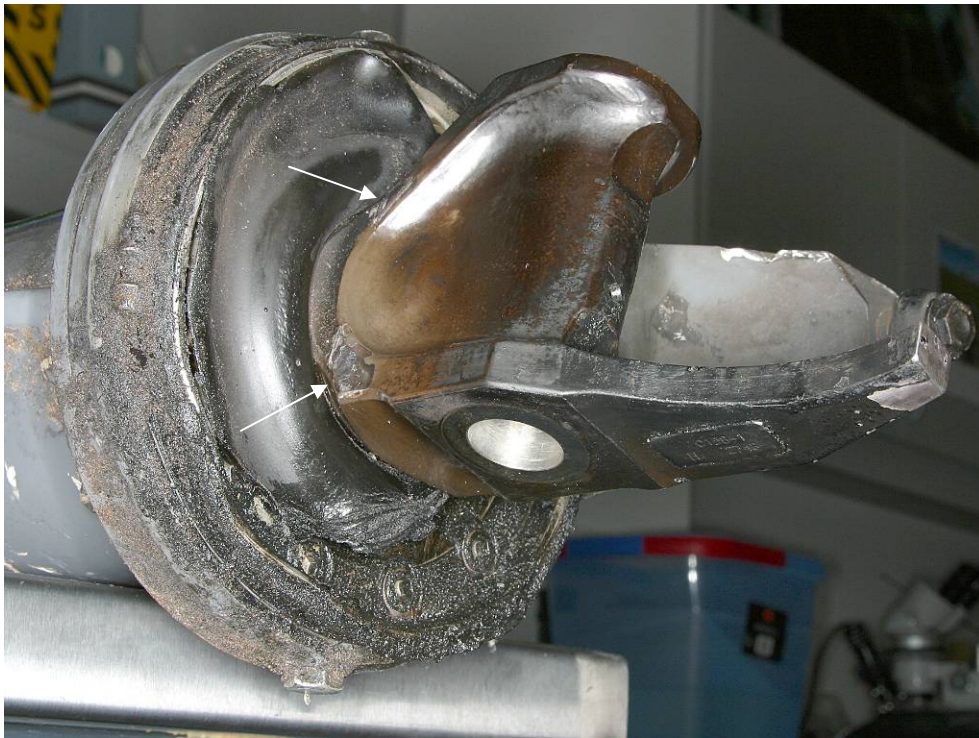
General examination of the hub (after on-site removal from the rotor head) showed little external mechanical damage to the spindle, with the spindle tusk and teeter stop showing no evidence of abnormally heavy contact (figure 3). The upper spindle surfaces showed evidence of contact against the up-coning stop at some stage prior to or during the accident sequence. Tearing and abrasion of the hub sealing boot was typical of accident-induced damage. The pitch change linkage had fractured through the base of the rod-eye at the horn end of the assembly – the fracture showing bending overload features.

**Figure 3: Hub assembly of blade S/N 4202-A – contact against the up-coning stop shown at arrows.**

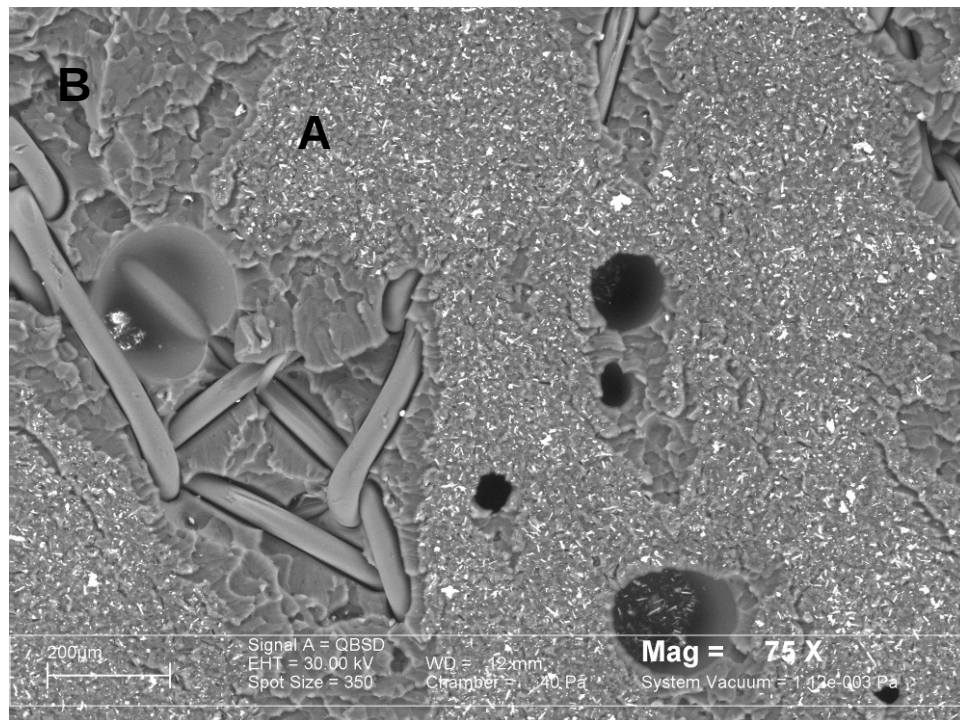
The observations made during examination of the separated skin joints indicated that both were very similar in physical appearance. Both showed a predominantly adhesive failure at the skin interface, with isolated areas of cohesive failure of the bonding agent around small voids that were dispersed throughout the joint. In no area was there any evidence of pre-existing bond failure or indications that the bonding agent was breaking down or failing.

**Figure 4:** This image is a low magnification SEM view of the surface of the adhesive along the leading edge spar to skin joint found separated after the accident. The image shows a mixture of adhesive failure (area A) and cohesive failure (area B).

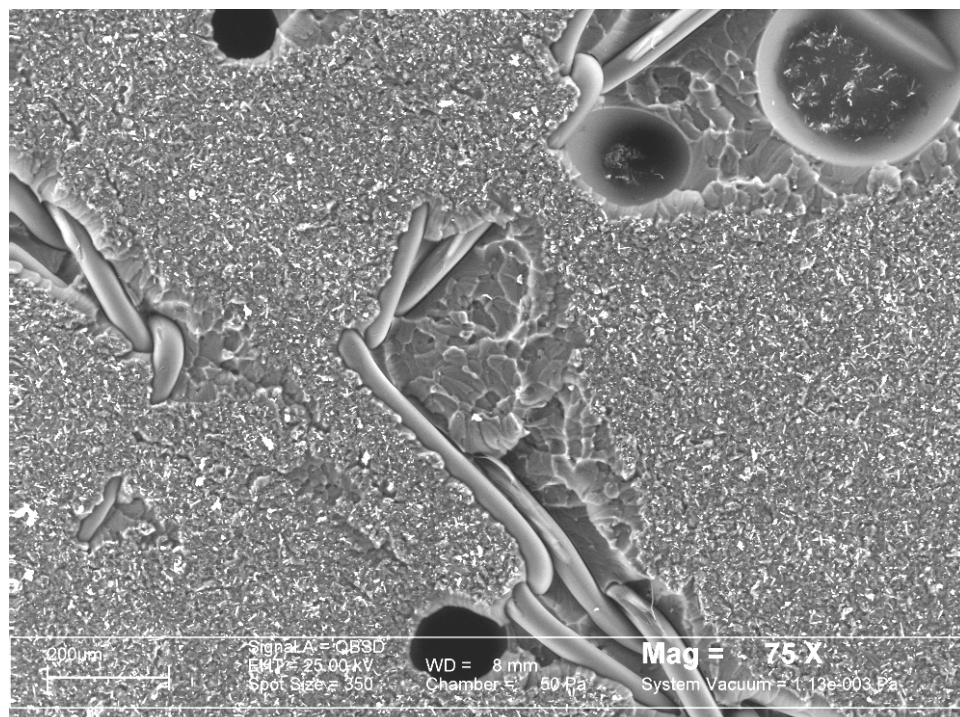
**Figure 5:** This image is a SEM view of the surface of the adhesive along the leading edge spar to skin joint that was separated mechanically in the laboratory. Note the general similarities to figure 4 above.

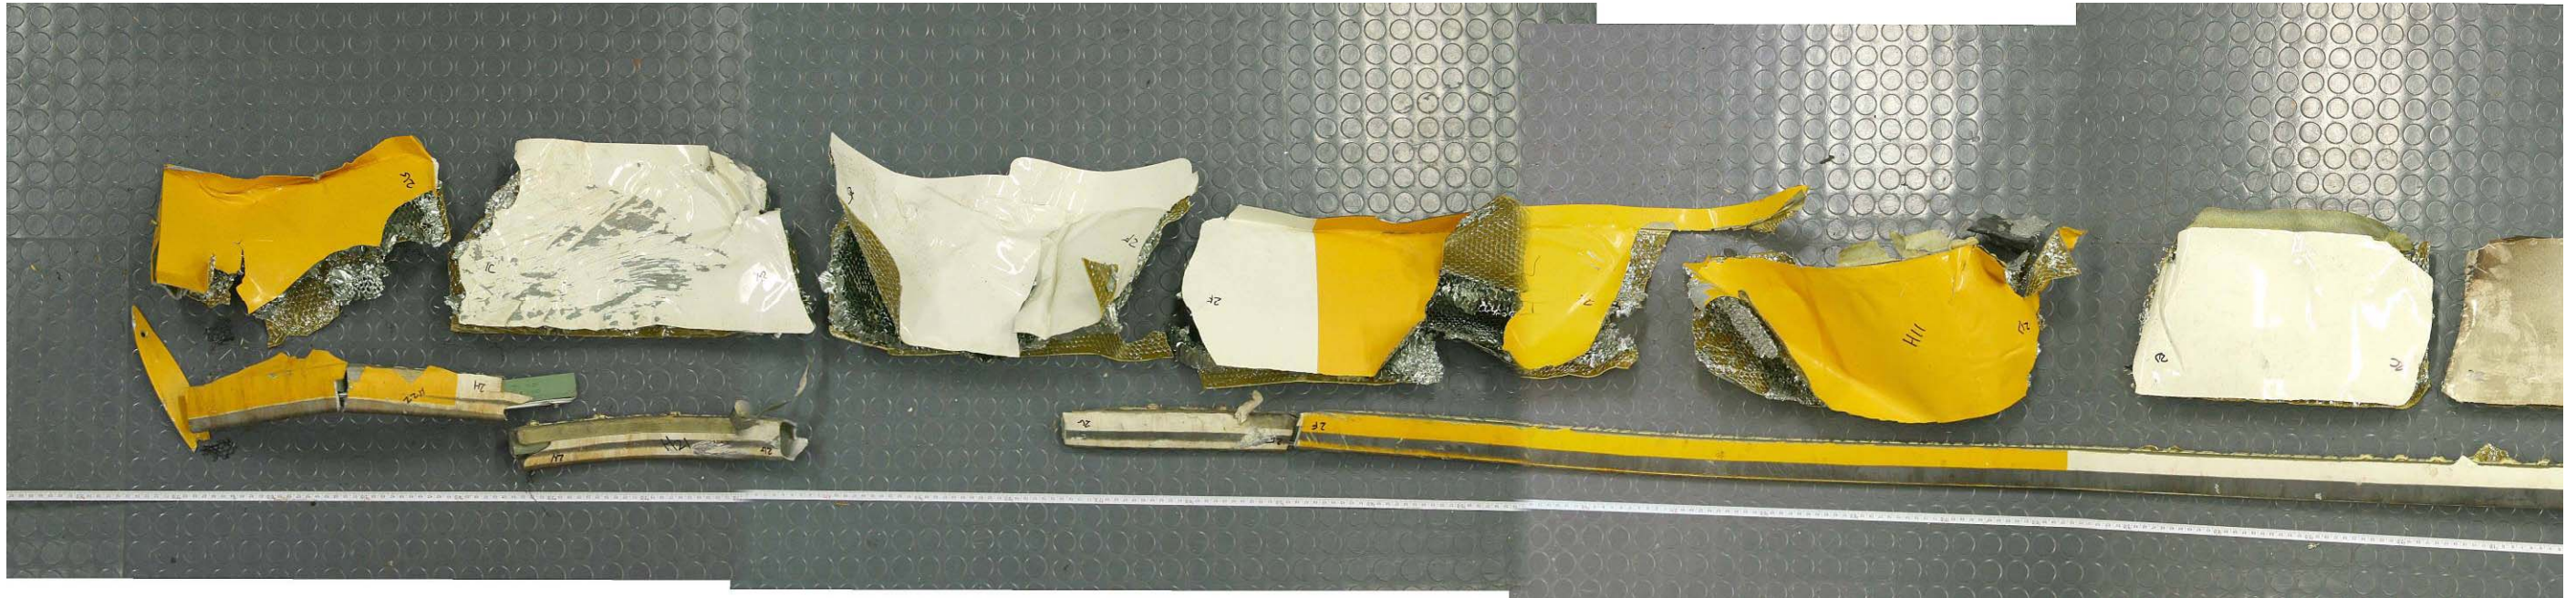
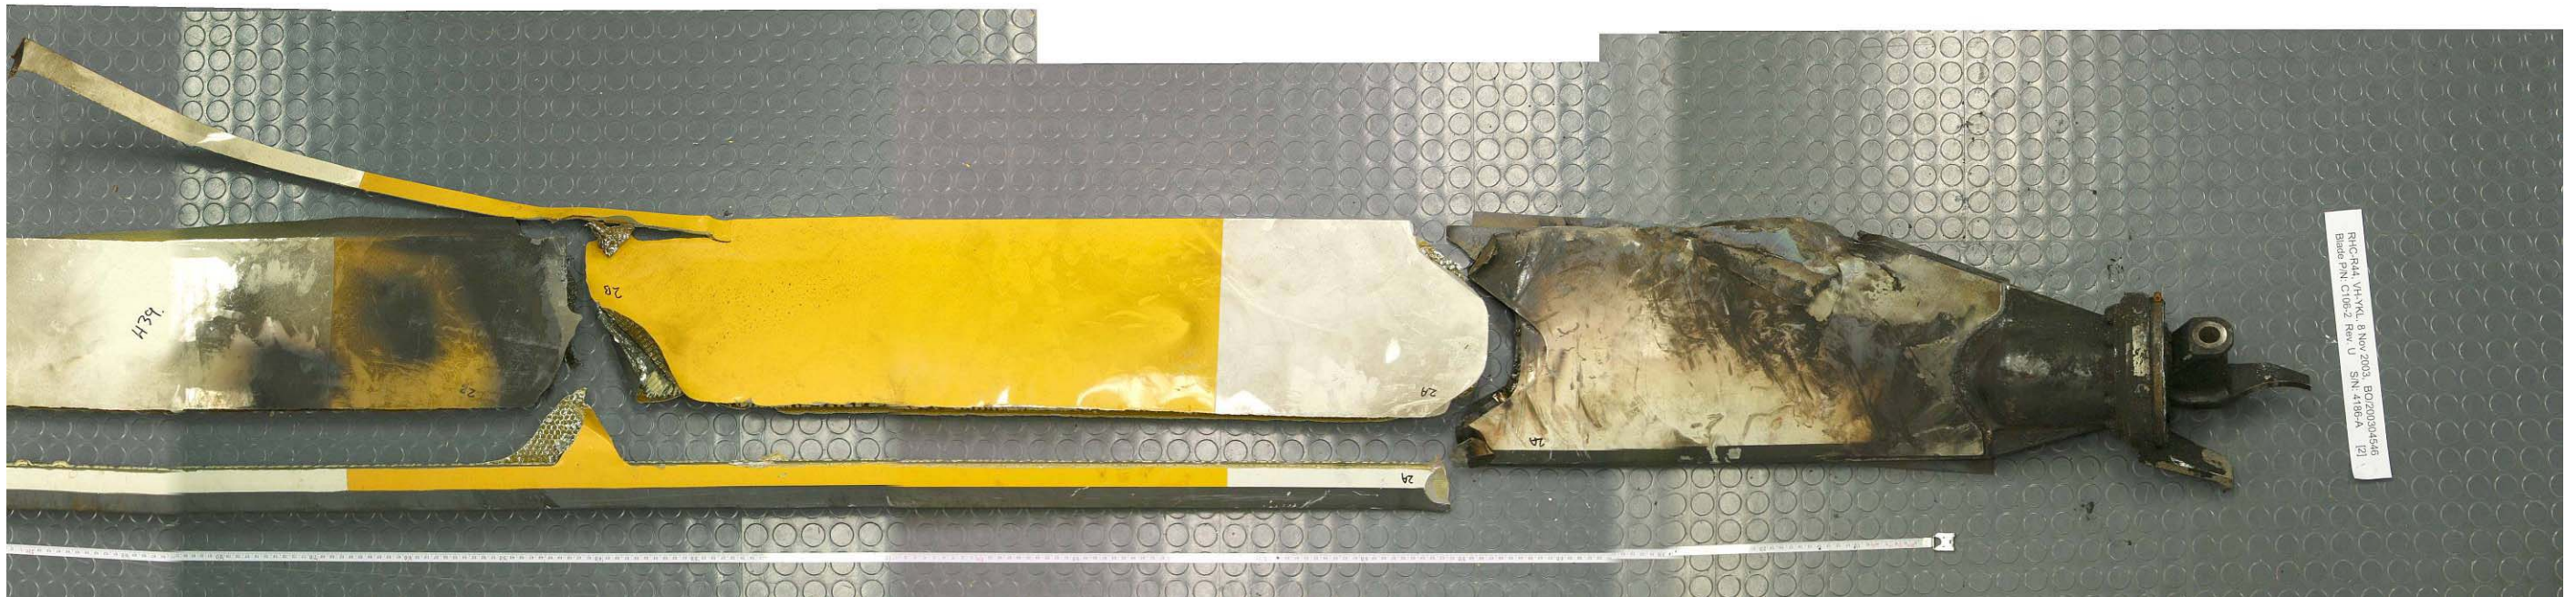
#### 3.1 Blade S/N 4186-A – upper surface montage image

As recovered, the leading edge spar of main rotor blade serial number 4186-A had fractured into five sections, with the bulk of the damage occurring within the outermost 1,500 mm of the blade length (Annexes 3.1 & 3.2). The honeycomb cored aerofoil section behind the spar had fragmented into numerous pieces, ranging in length from 350 mm to nearly 1,000 mm, with a notable transition to smaller fragments along the blade length toward the tip. Separation of the blade skin from the leading edge spar had again occurred in most areas by ductile tearing along the inner edge of the adhesive joint. Some adhesive failure of the joint was noted, where the aerofoil skin had curled and peeled away axially along the blade length.

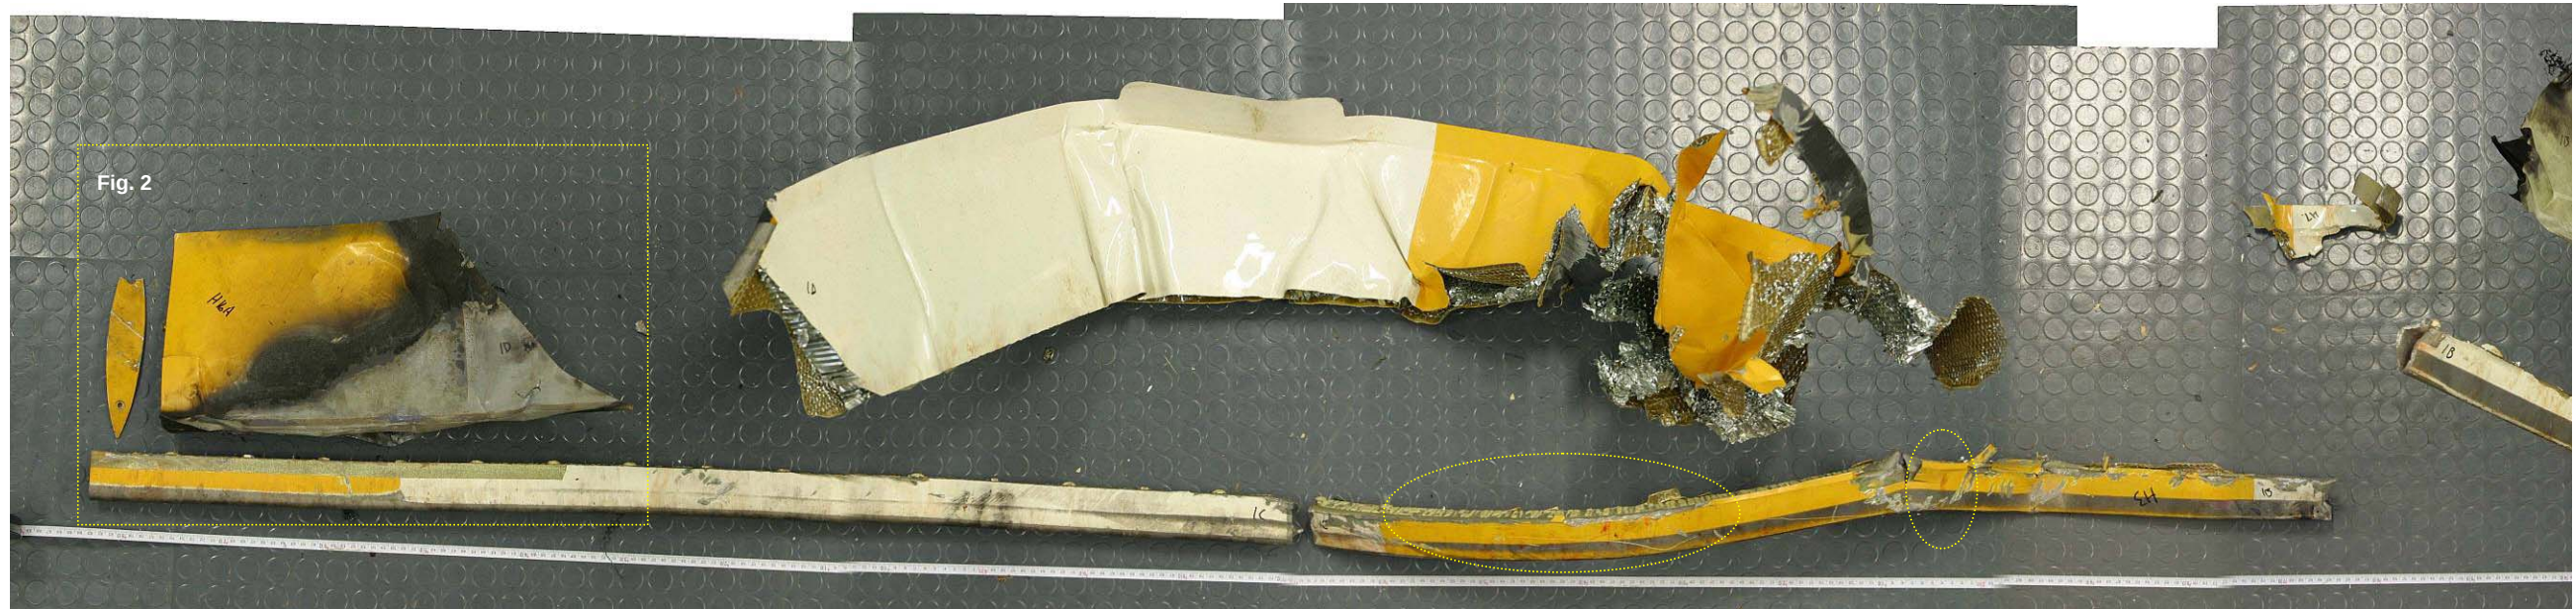
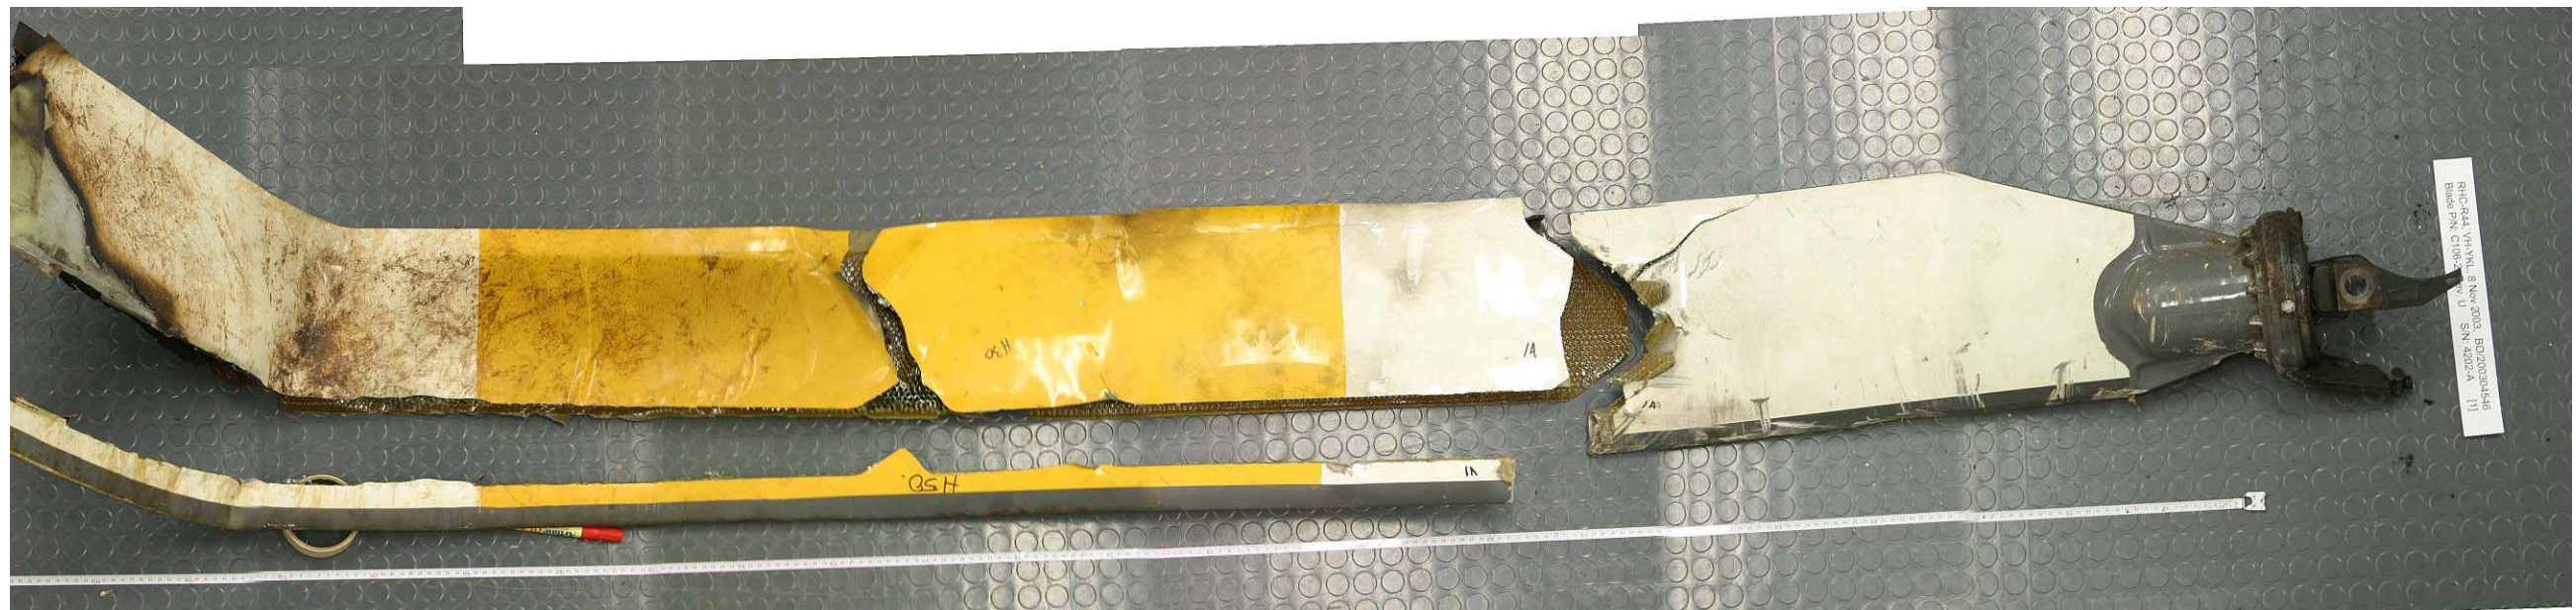
As recovered, the main rotor blade serial number 4202-A had fractured transversely into five main sections, with the leading edge spar in four sections (Annexes 3.3 and 3.4). The leading edge spar had separated from the aerofoil sections for the full length of the blade, with the separation occurring almost entirely by ductile tearing of the surface skin along the rear edge of the spar. A 470 mm length of upper aerofoil skin, extending from the tip of the blade, had separated from the leading edge spar by failure of the adhesive joint. Although fire damaged, the separated skin showed backward folding and curling away from the joint in a manner that suggested aerodynamic effects (figure 2). That area of skin separation, being atypical of the rest of the blade skin damage, was the subject of a more detailed examination as documented in section 1.5 of this report.

3.3 Blade S/N 4202-A - upper surface – montage image (paint transfer marks circled)
