## ACCIDENT INVESTIGATION REPORT

**Piper PA32-300 Aircraft VH-PGC  
near Merimbula, New South Wales,  
on 29 February 1976**

## Special Investigation Report 77-2

September 1977

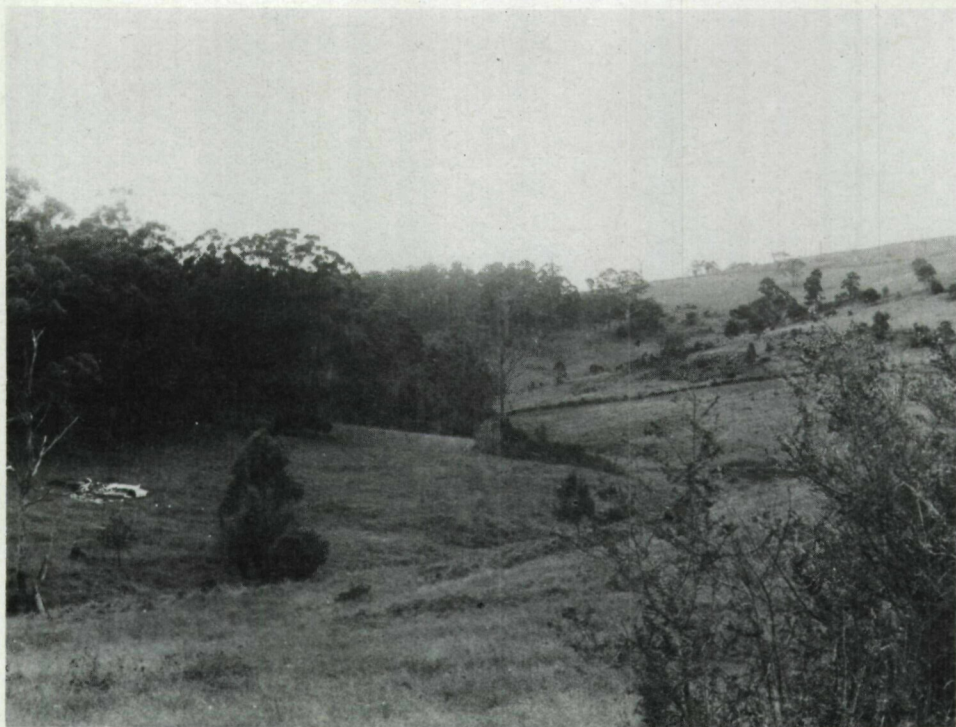
*View to south-west showing approach path of VH-PGC. Main wreckage at left.*

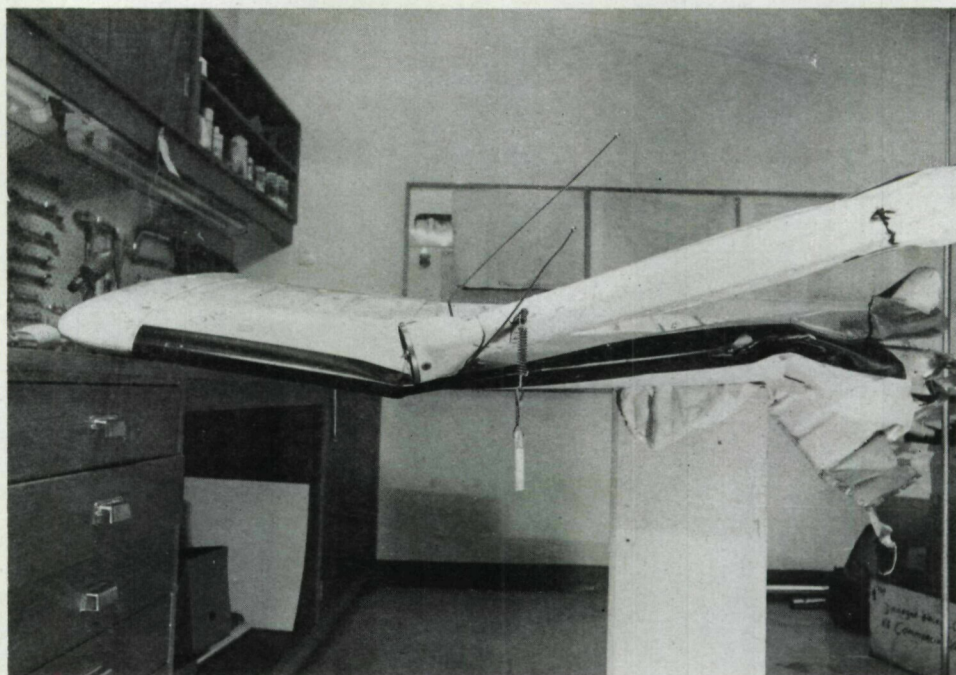
When the fin broke away to the right, the stabilator tab drive mechanism was disrupted by the rudder actuating horn assembly, and the top of the fin struck the leading edge of the right-hand stabilator some 65 centimetres from the stabilator tip. The stabilator had been subjected to a leading-edge-down rotation to the full extent of its normal travel, striking the stabilator stops with sufficient force to distort them, and the right-hand stabilator broke from the aircraft in a downwards and backwards direction.

*Fin collapse to right. Impact with leading edge of right-hand stabilator.*

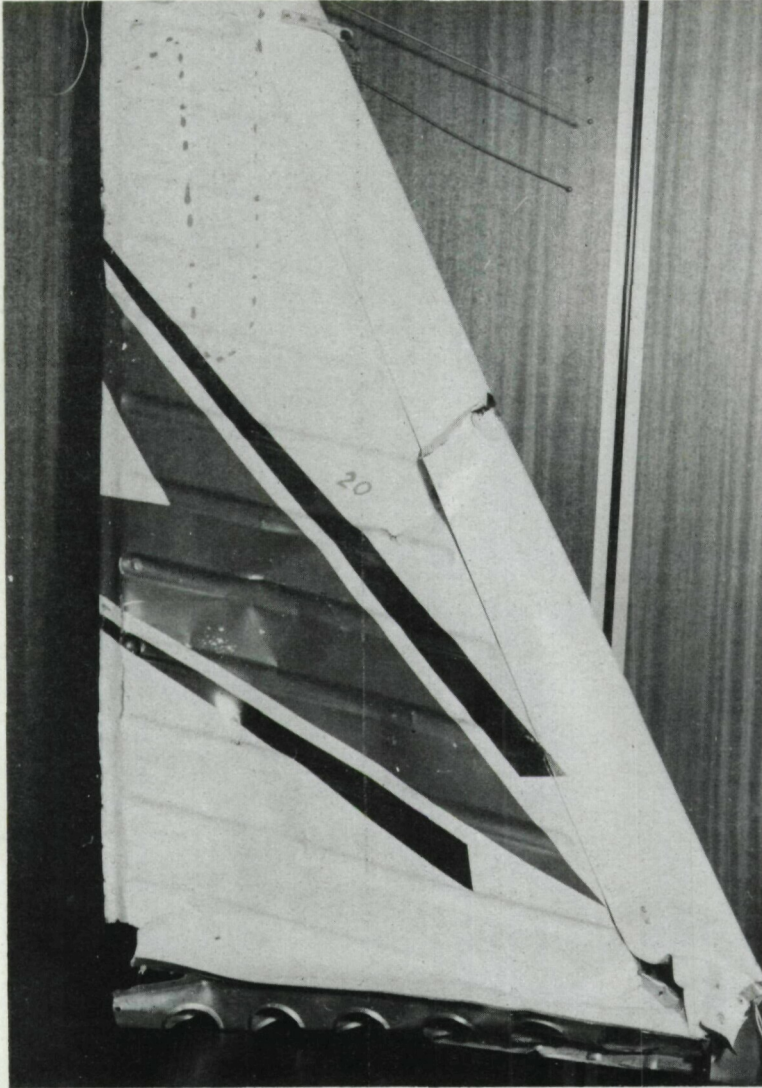
The fin had collapsed to the right following a bending failure of the rear spar just above its fuselage attachment fitting. The forward fin attachment fitting had pulled from the rivets which secured it to the fuselage structure. There was evidence that prior to the final fin collapse the rear spar had partially failed by bending to the left and that there had also been large deflections of the forward attachment to both left and right. In addition the fin structure had sustained bending failures along a line joining the approximate mid-point of the leading edge and the base of the rear spar. These buckling-type failures showed evidence of repeated reversed bending deflections of increasing amplitude.

*Right-hand side of fin. Diagonal wrinkling from mid-leading edge to spar fracture point at bottom left.*
