## ACCIDENT INVESTIGATION REPORT

**Partenavia P68B Aircraft VH-PNW  
near Essendon Airport, Victoria,  
on 10 July 1978**

## Special Investigation Report 79-1

March 1979

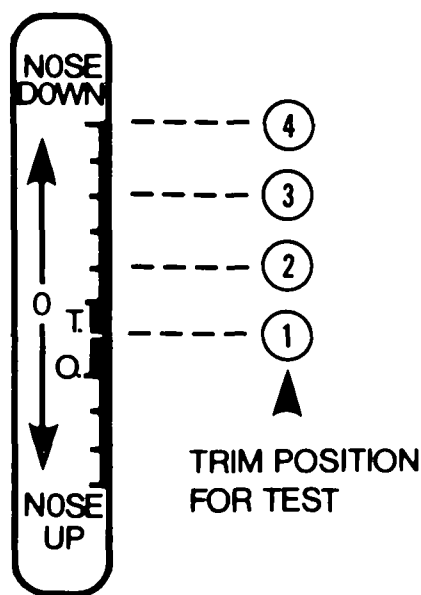
Figure 1 is a representation of the cockpit trim indicator. The thicker shaded area shows the trim range for take-off. The full nose-down trim stop in the test aircraft coincided with indicator position 3.5. Trim settings used in the tests are indicated.

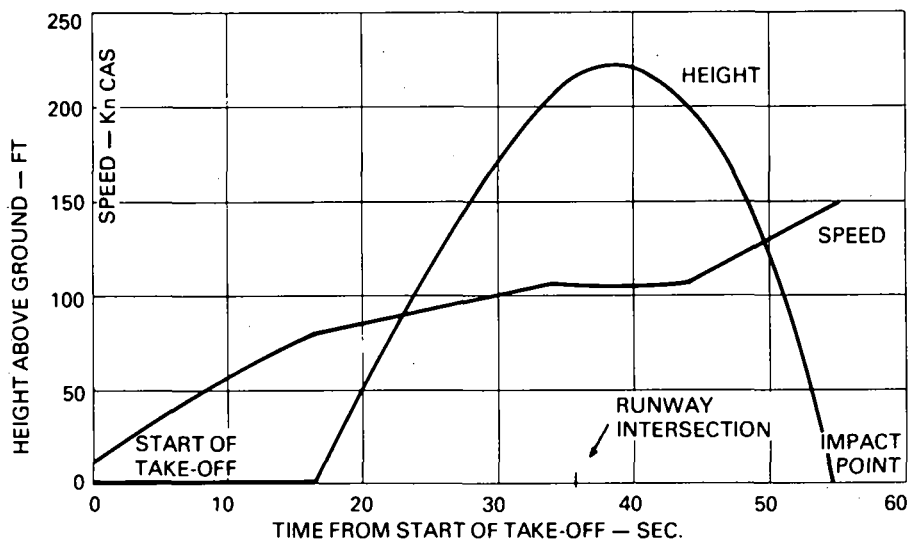
## APPENDIX B

At Appendices B and C two graphical representations of the flight path are shown. These graphs, which are based on time from start of take-off and distance from start of take-off respectively, have been derived from computer integration of known performance of the aircraft, flight test information and the following parameter values applicable to this flight:

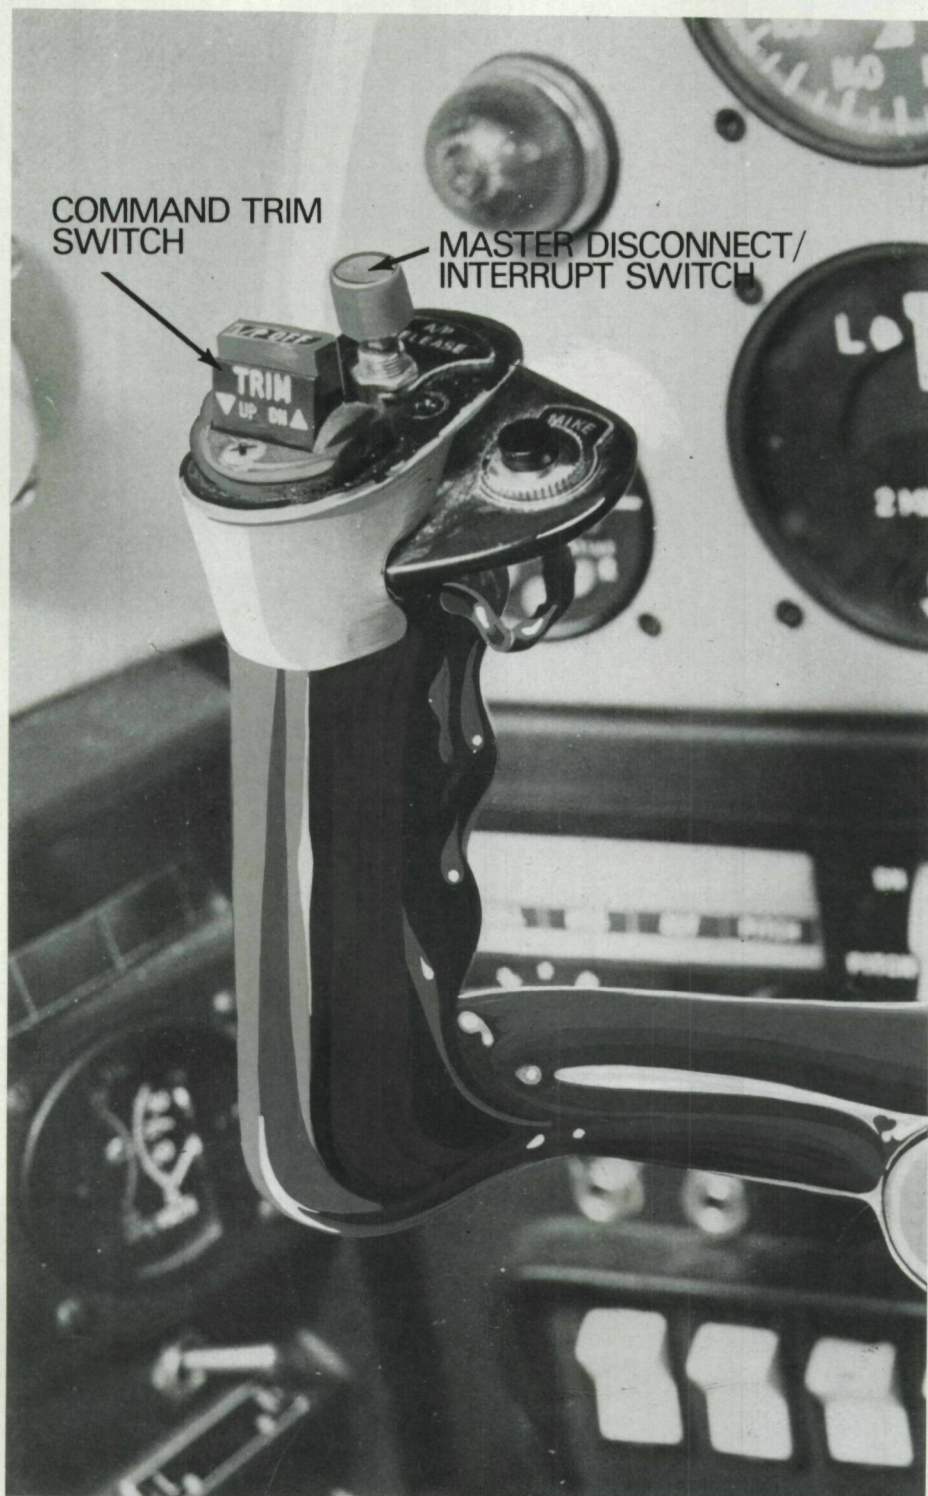
Switches on left control yoke

In addition to the manual system, the aircraft is fitted with an electric pitch trim system and the trim cable described previously passes around the capstan of the pitch trim servo. The system has two operating modes, command trim and auto-trim. The command trim mode operates independently of the autopilot system and provides the pilot with the facility of actuating the stabilator trim system by means of a rocker switch. The auto-trim mode operates when the pitch section of the autopilot is engaged, and provides automatic aircraft longitudinal trim. The system is designed to withstand any type of single malfunction without uncontrolled operation resulting. A detailed pre-flight check procedure is specified to detect any malfunction. When the top bar of the command switch, which is located on the top of the left horn of the left control yoke only, is depressed it disconnects the autopilot, if it should be selected on, and arms the command mode. If the top bar is held depressed and the switch is moved forward, a nose-down trim change will occur. If the top bar is held depressed and the switch is moved rearward, a nose-up trim change will occur. Forward or rearward movement of the switch is not effective unless the top bar is held depressed (see Appendix D).

In addition the system includes a master disconnect/interrupt switch which is also located on the top of the lefthand control yoke, forward of the command switch. When depressed and released it disconnects the auto pilot, if it should be selected on. When

Although the pilot-under-supervision has no recollection of operating the command trim switch on his control yoke, the design of the hand grip and the position of the switch is such that inadvertent operation seems possible. Advice from experts in the fields of psychology and human movement has confirmed that, if the pilot's thumb was positioned in the vicinity of the switch at the time that he became involved with the flap retraction/engine failure sequence, it would be quite possible for him to operate the switch in the nose-down sense, for a period, without being aware of it. The factors which could lead to this situation were all associated with the flap retraction/engine failure sequence and include his pre-occupation with events requiring actions on his righthand side, involving the muscular and nervous systems of the right side of his body, together with the development of tension loads of some 16 kg in his left arm and, initially, a considerable compression load in his left leg.
