Bureau of Air Safety Investigation

Air Safety Report

Mid-Air Collision Between Cessna 172-N VH-HIZ and Piper PA 38-112 VH-MHQ

BASI Report 881/1042

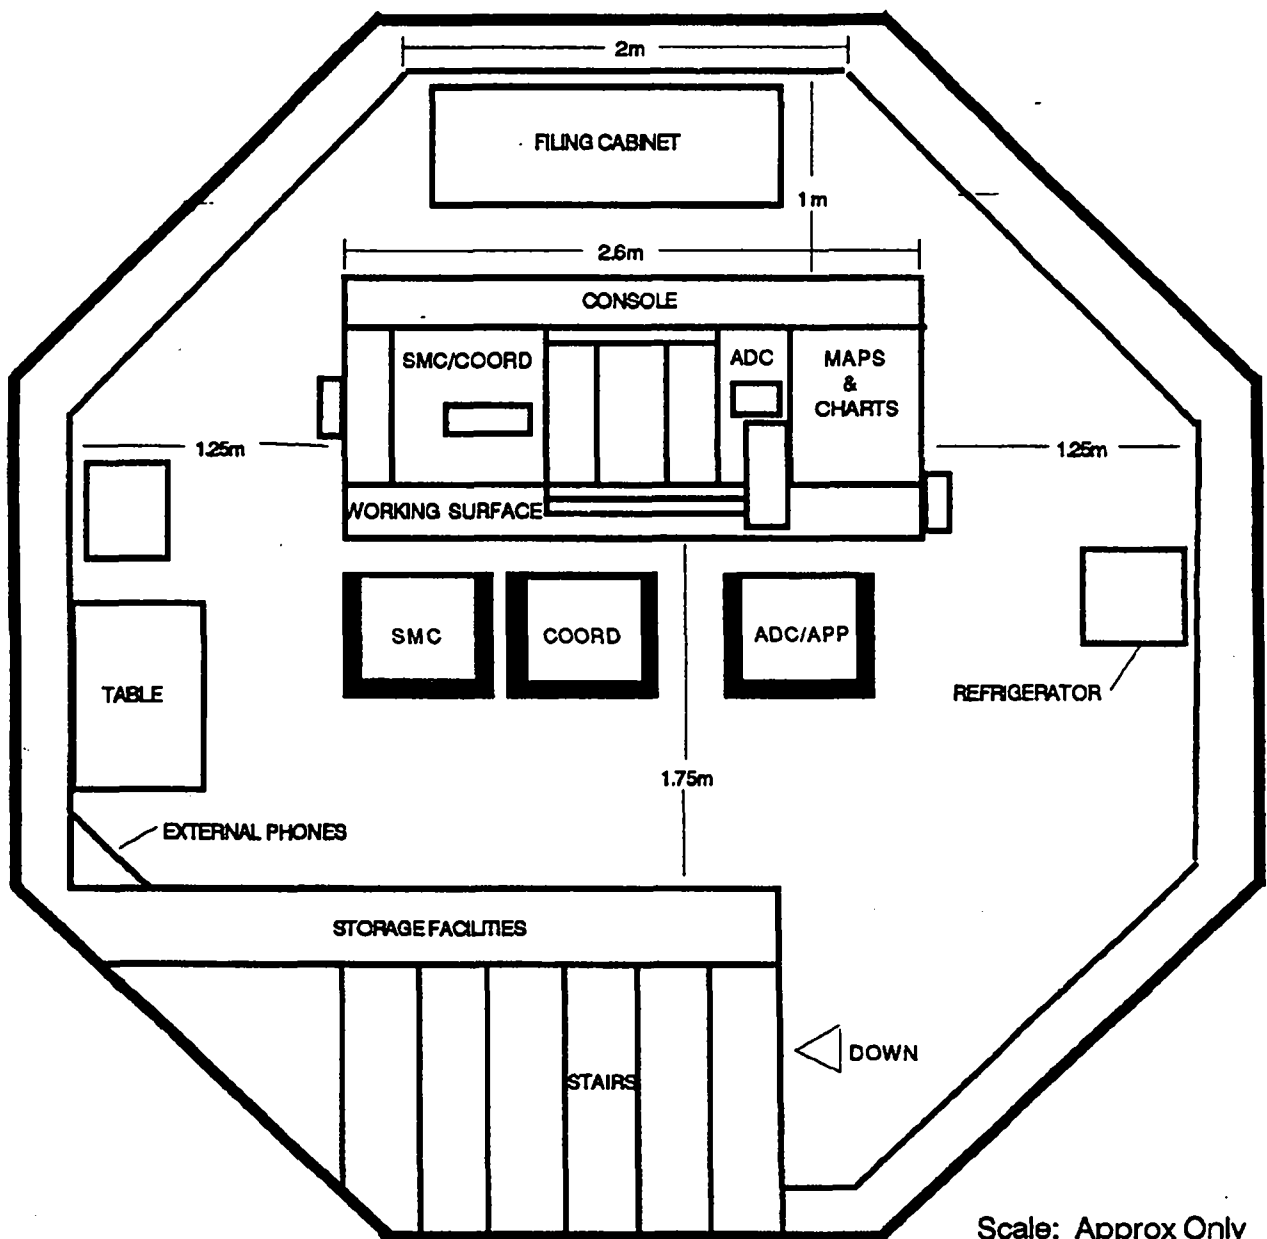
COOLANGATTA CONTROL TOWER CABIN FLOOR LAYOUT

There are obstructions to visibility caused by the eight roof pillars and eight glazing joint strips, on the external panels only, which reduce the all round vision by a total of 14.62%. Any obstructions to vision, created by the tower pillars or glazing joint panels, can be overcome by the controller moving sideways in the required direction.

The external glazing has suffered the ravages of continual exposure to salt air and pitting caused by airborne sand particles which degrades vision under certain ambient light conditions.

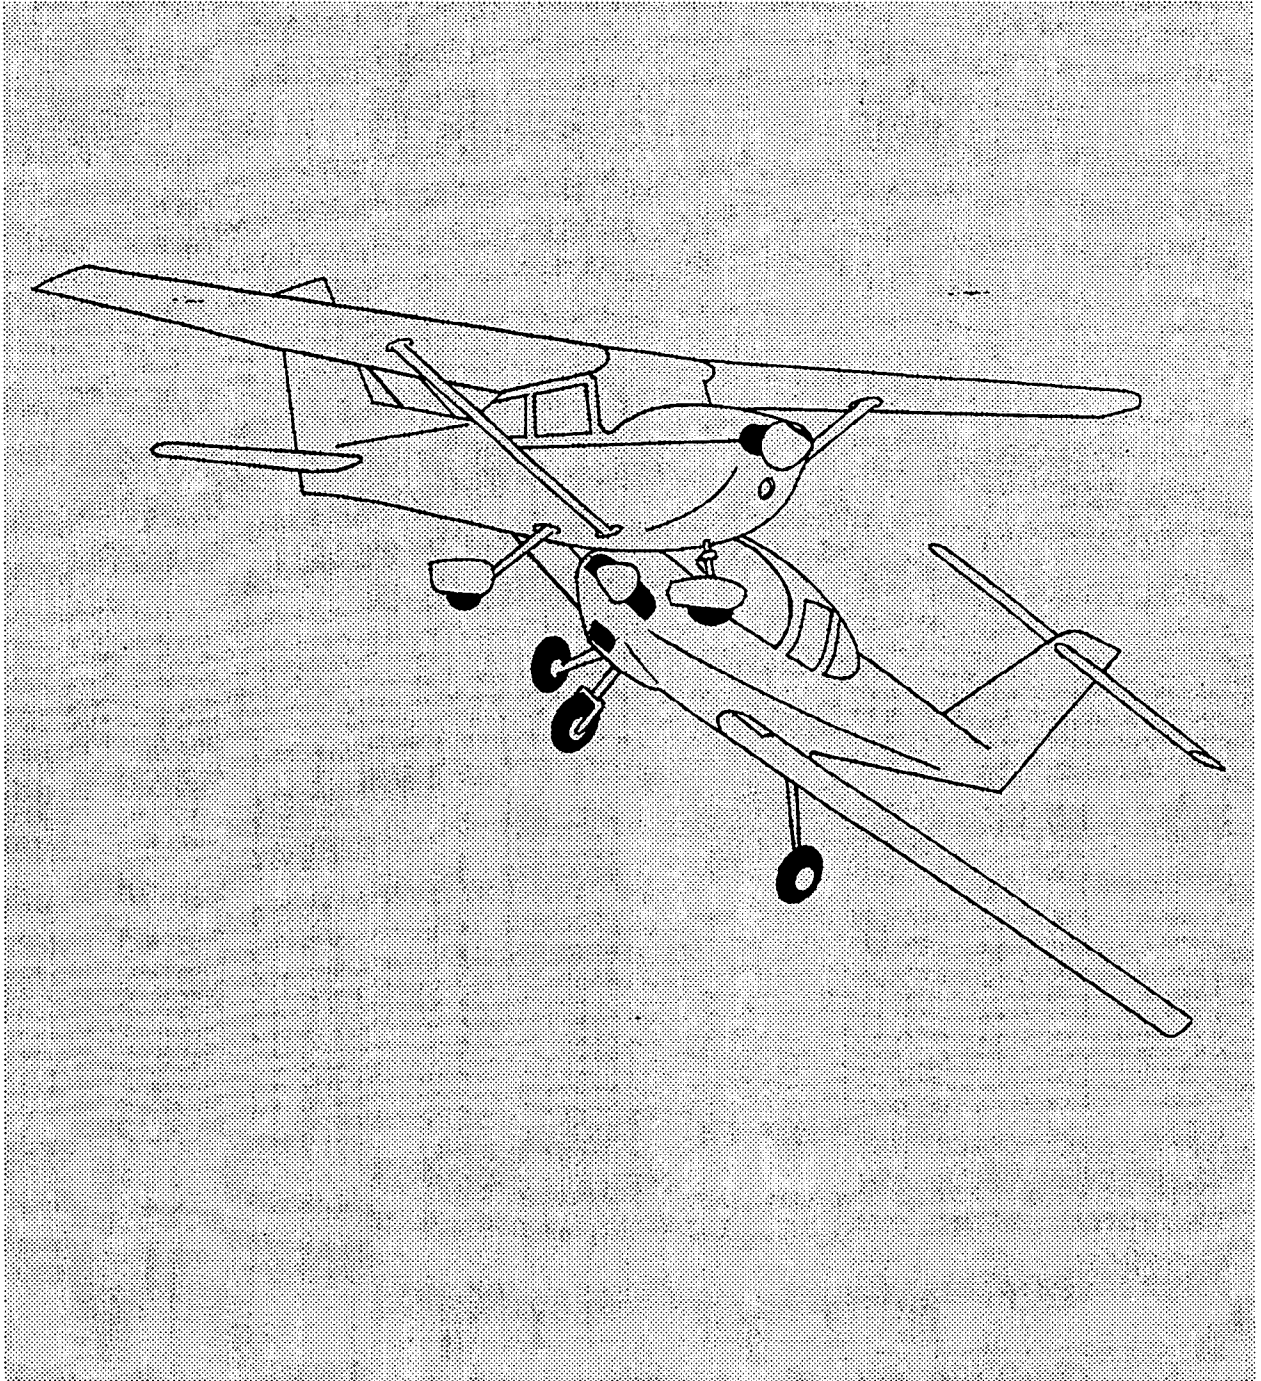
PROBABLE ATTITUDES AT IMPACT

1.12.2 Nature of Collision. The nature of the collision sequence was determined from a detailed examination of impact marks on the wreckage. The initial contact was between the left mainwheel of VH-HIZ and the inboard leading edge of the right wing of VH-MHQ. The wheel then entered the cockpit of VH-MHQ through the right hand cabin door, tearing the cabin roof, doors, and windscreen from that aircraft. At the same instant, the propeller of VH-MHQ entered the left side of the forward fuselage of VH-HIZ at the engine firewall and cut through the cabin floor, leading to major structural failure in this area.

The failure of the cabin floor of VH-HIZ allowed the engine and forward cabin to depart upwards and to the left, and led to the left wing being almost completely severed near the wing strut attachment point. Simultaneously, the entire wing centre section separated from the fuselage and the three sections fell independently to the ground.

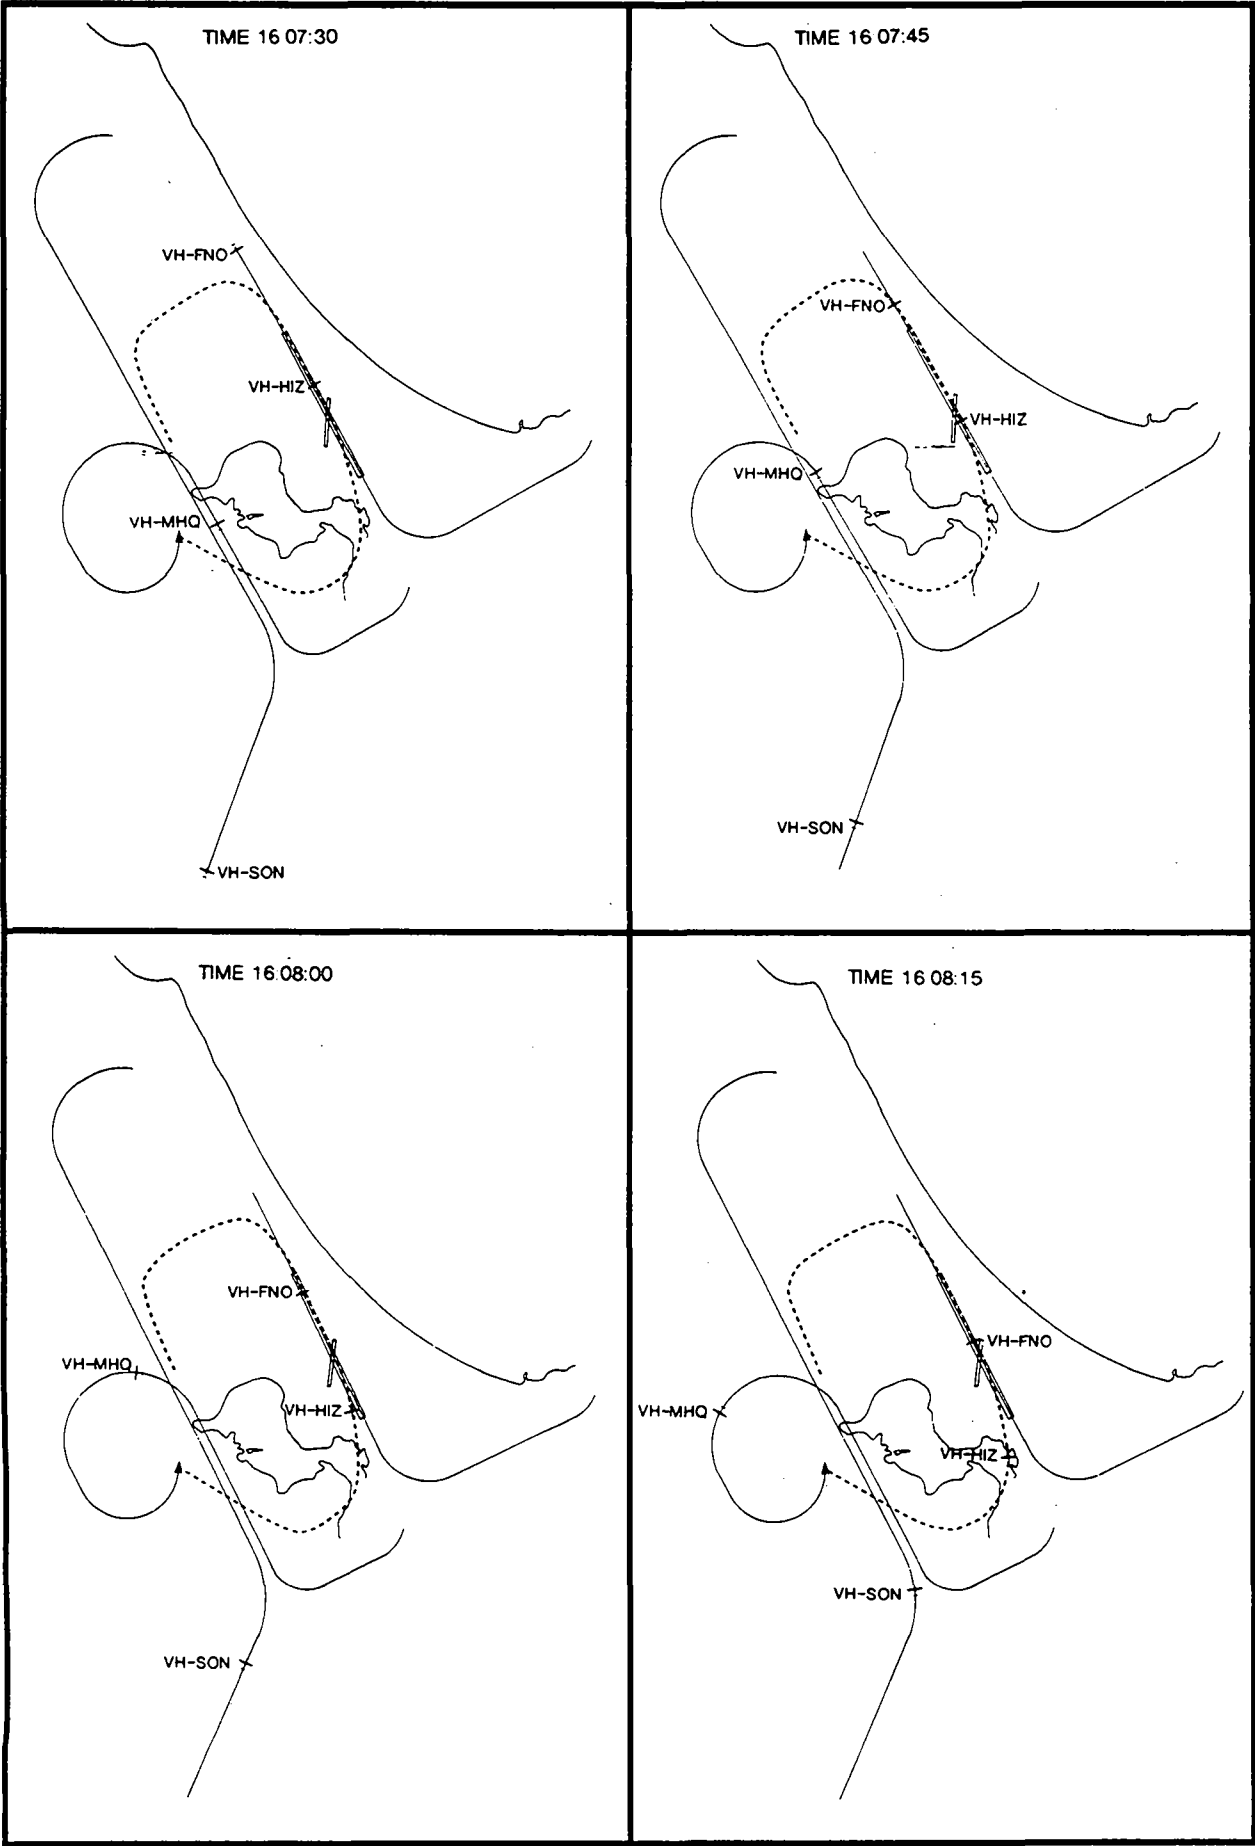
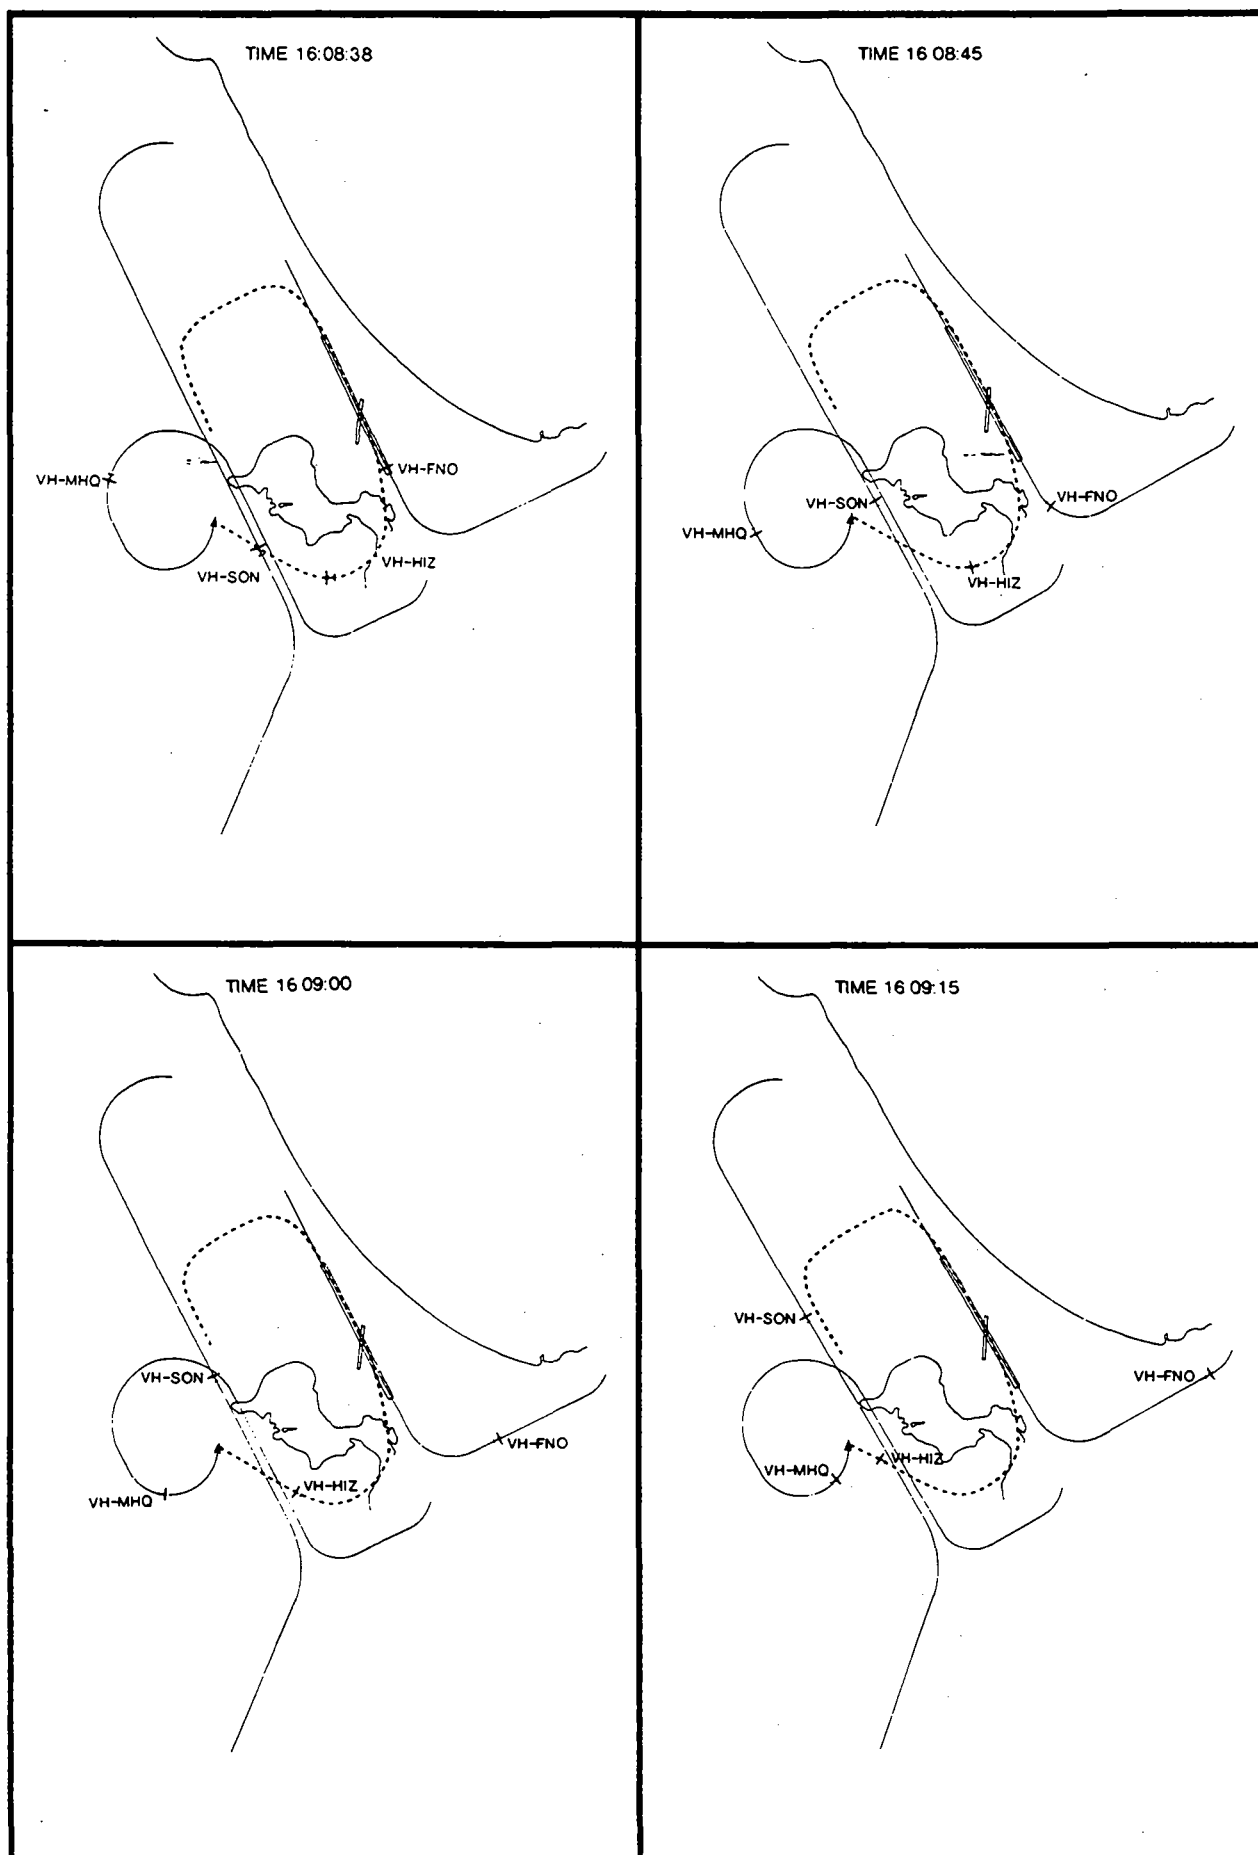
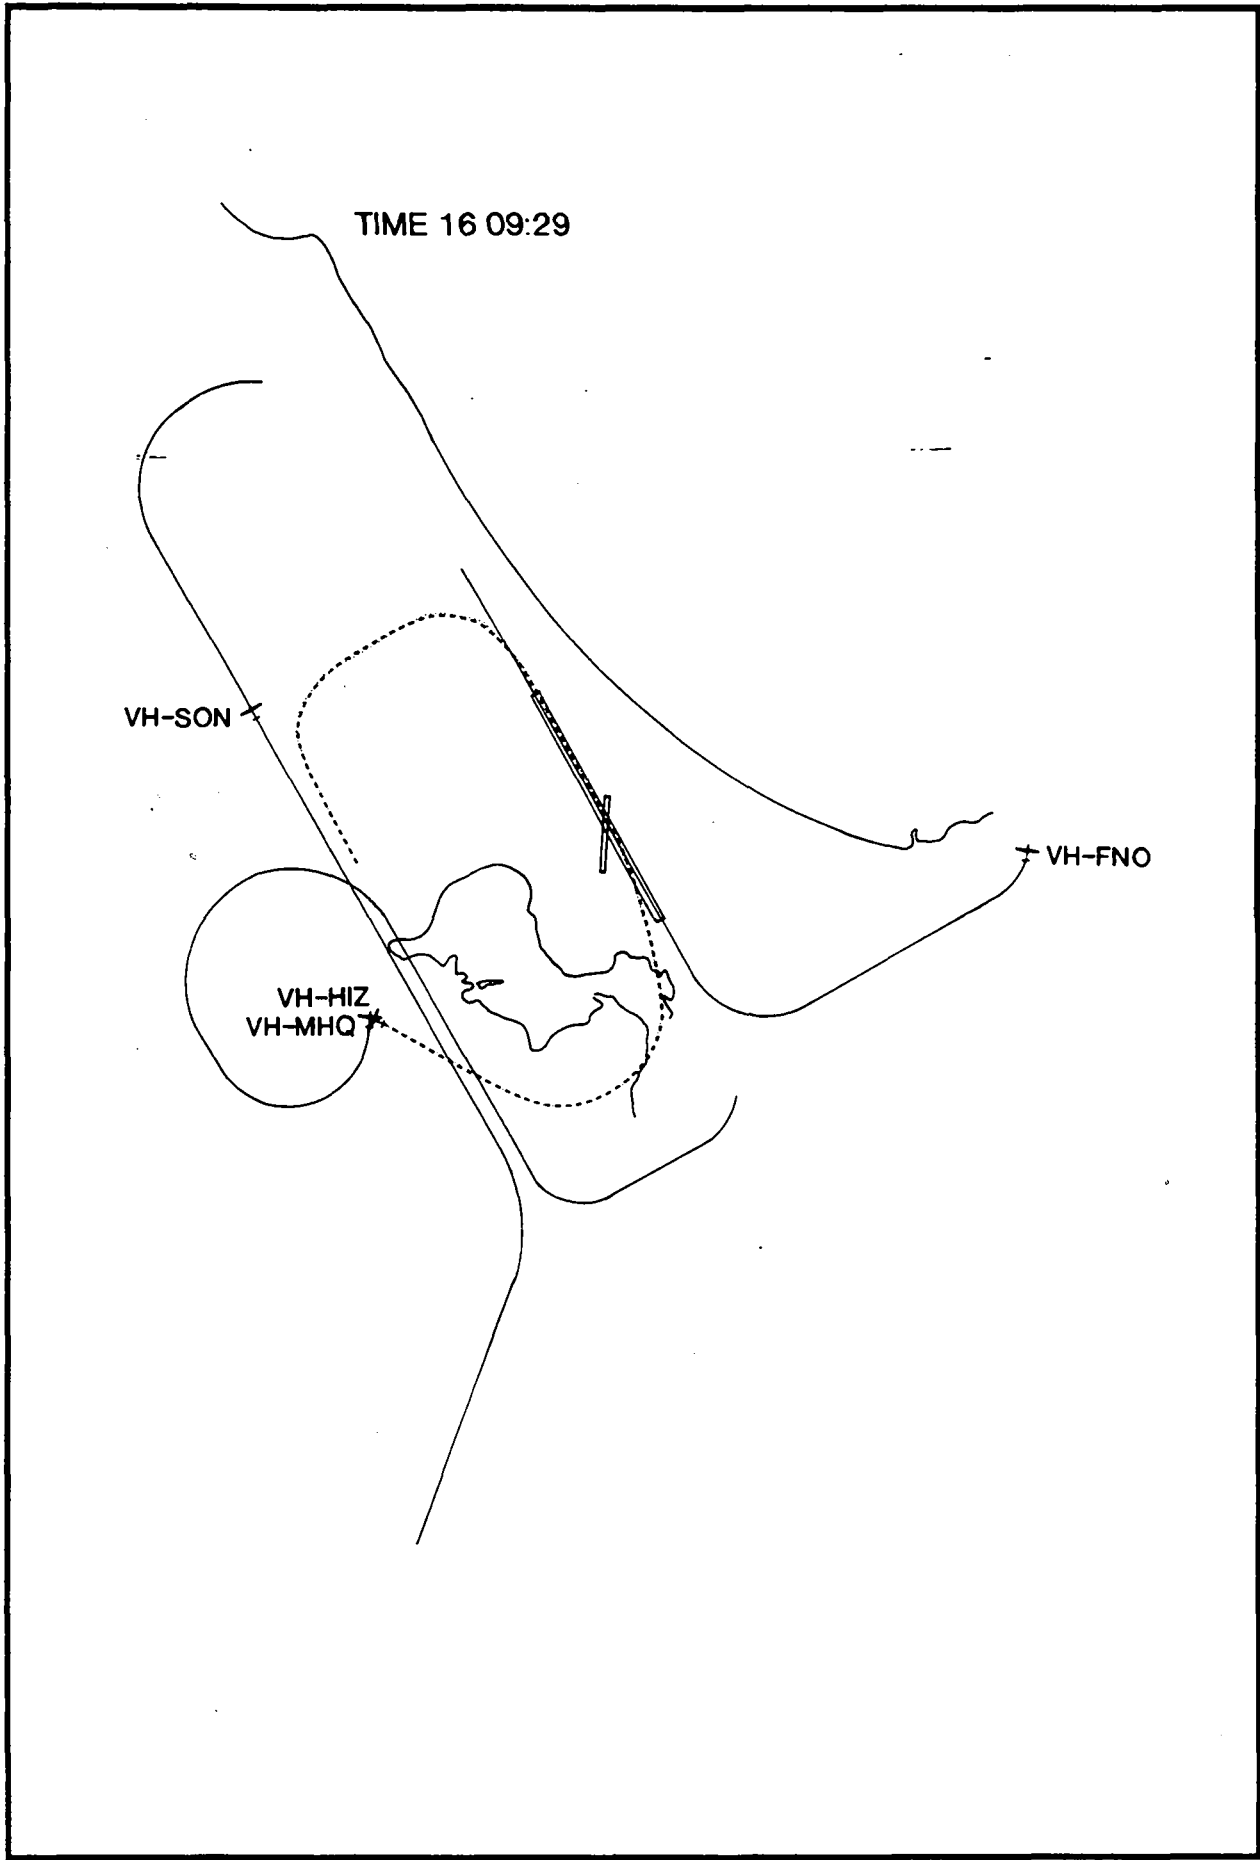
PRESENTATION OF PROBABLE FLIGHT PATHS

The ADC/APP expected that the orbit carried out by VH-MHQ would be symmetrical. Based on witness reports, times, aircraft performance, the position of the accident site and the relative positions of all the aircraft in the circuit area, the computer reconstruction of the most probable flight paths indicated that this was not the case. It was likely that after completing the first half of the orbit, VH-MHQ flew straight and level until VH-SON was observed to be well clear, and then continued the orbit. This resulted in VH-MHQ being further upwind than anticipated by the ADC/APP.

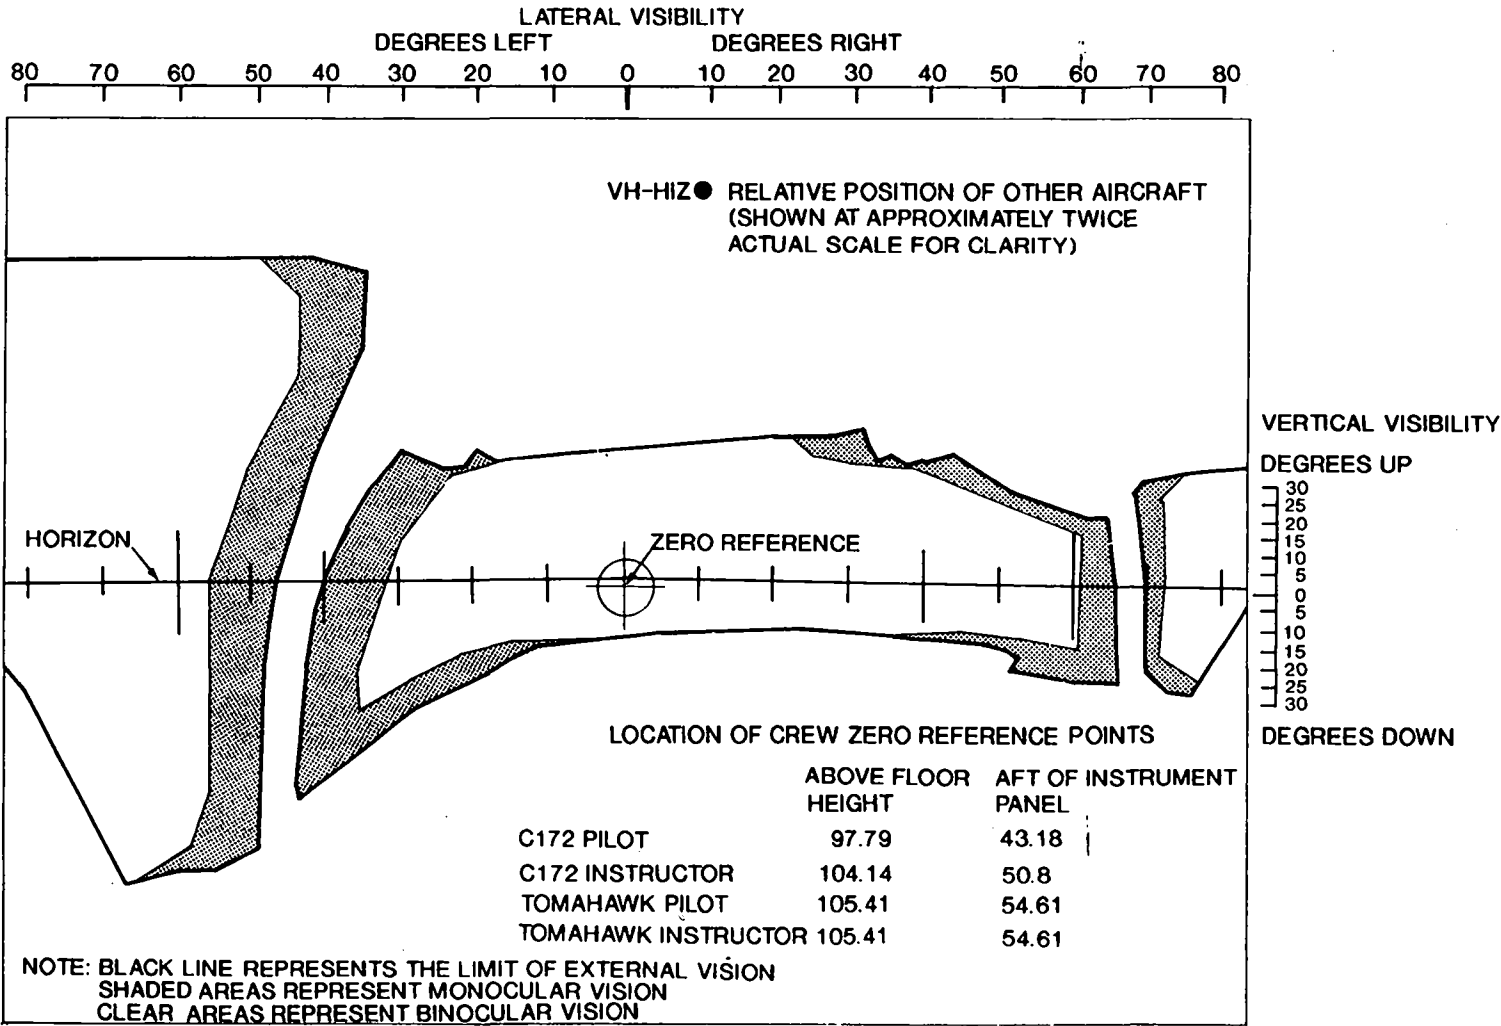
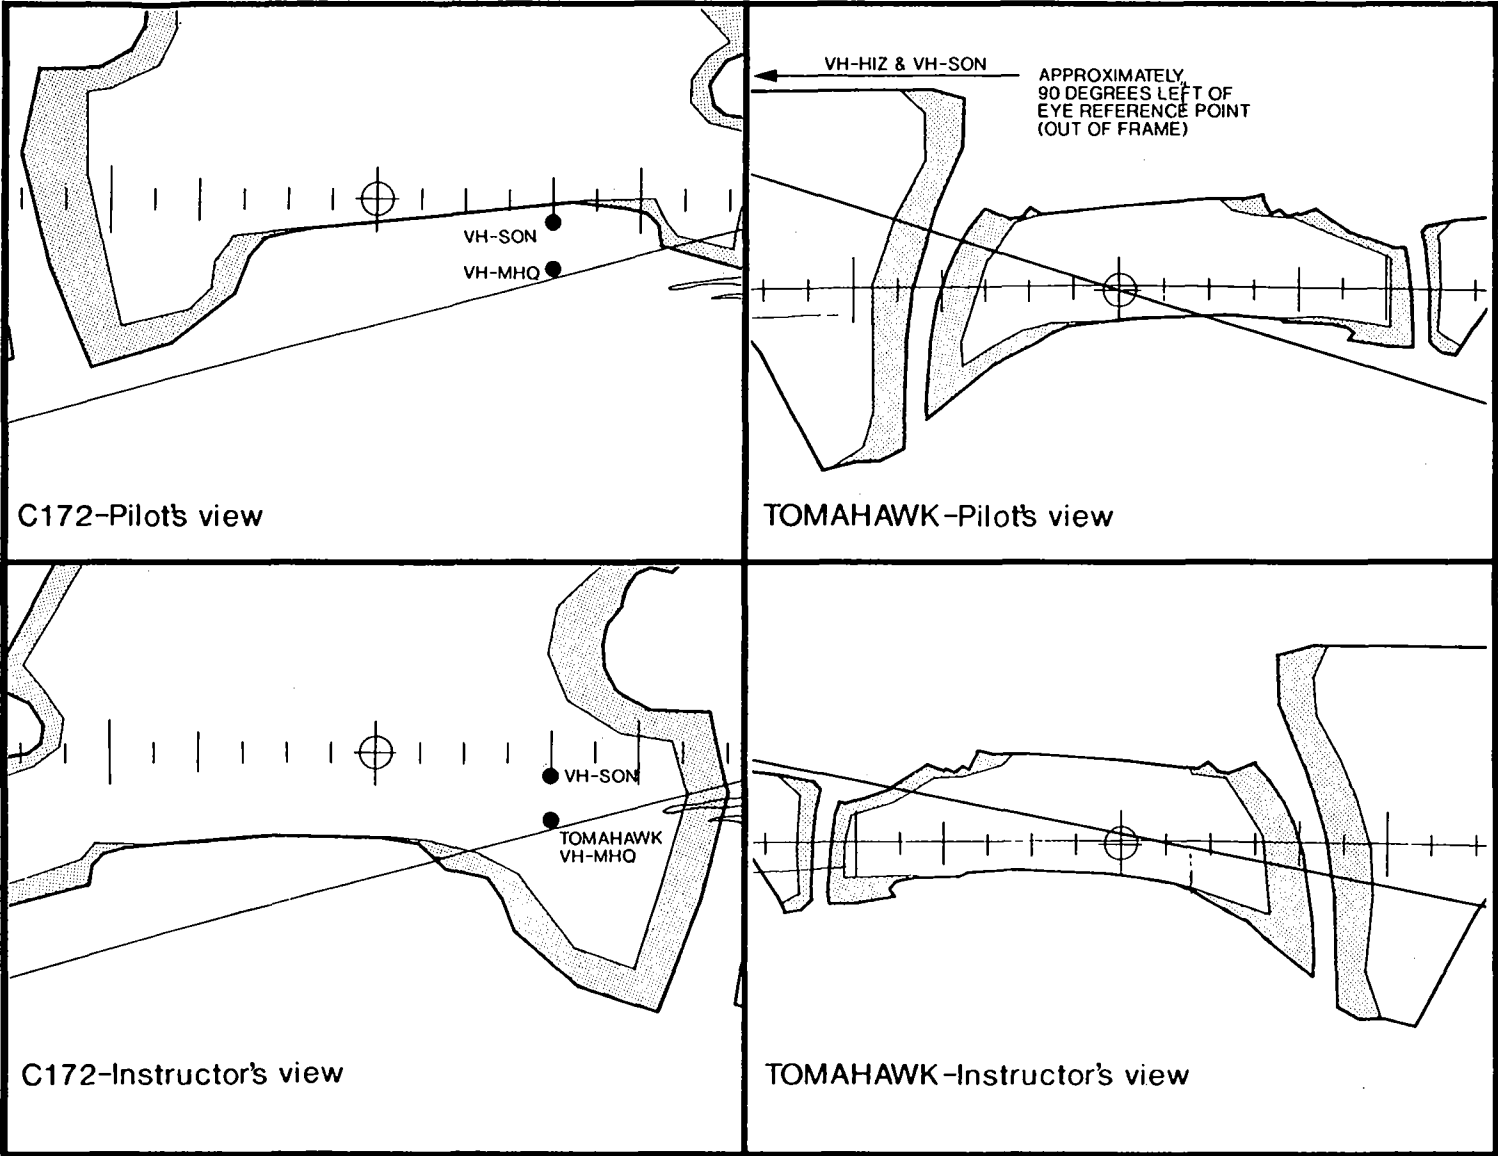
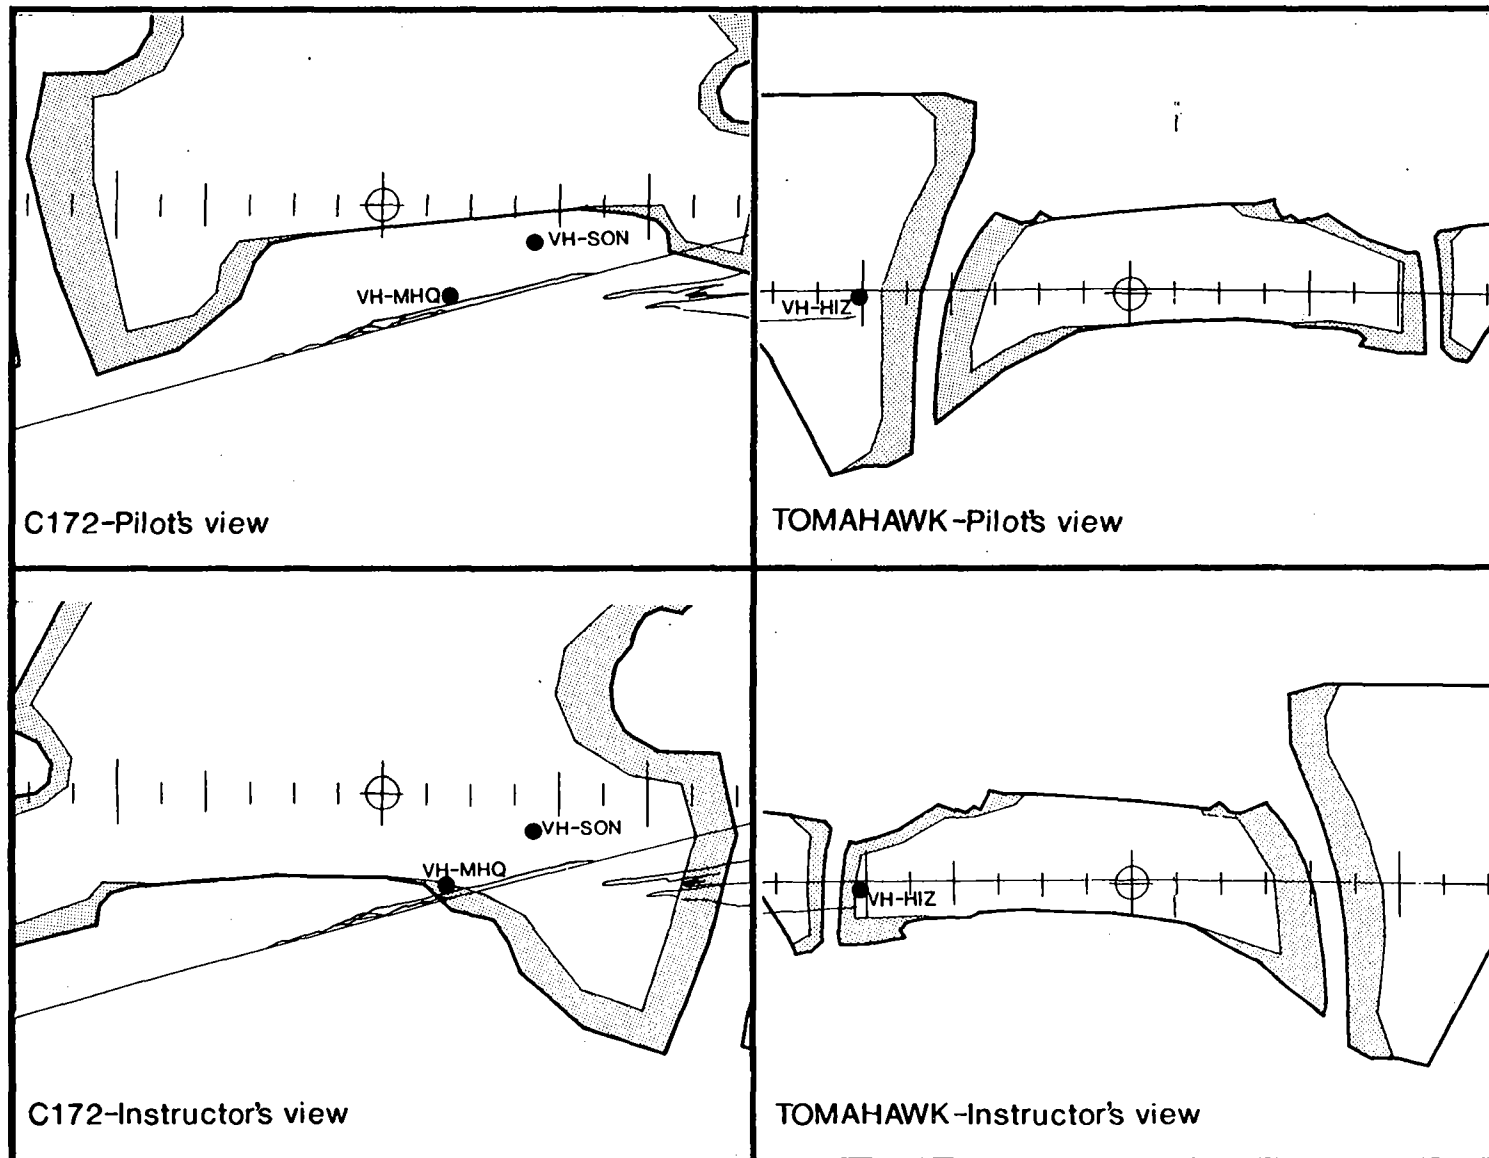
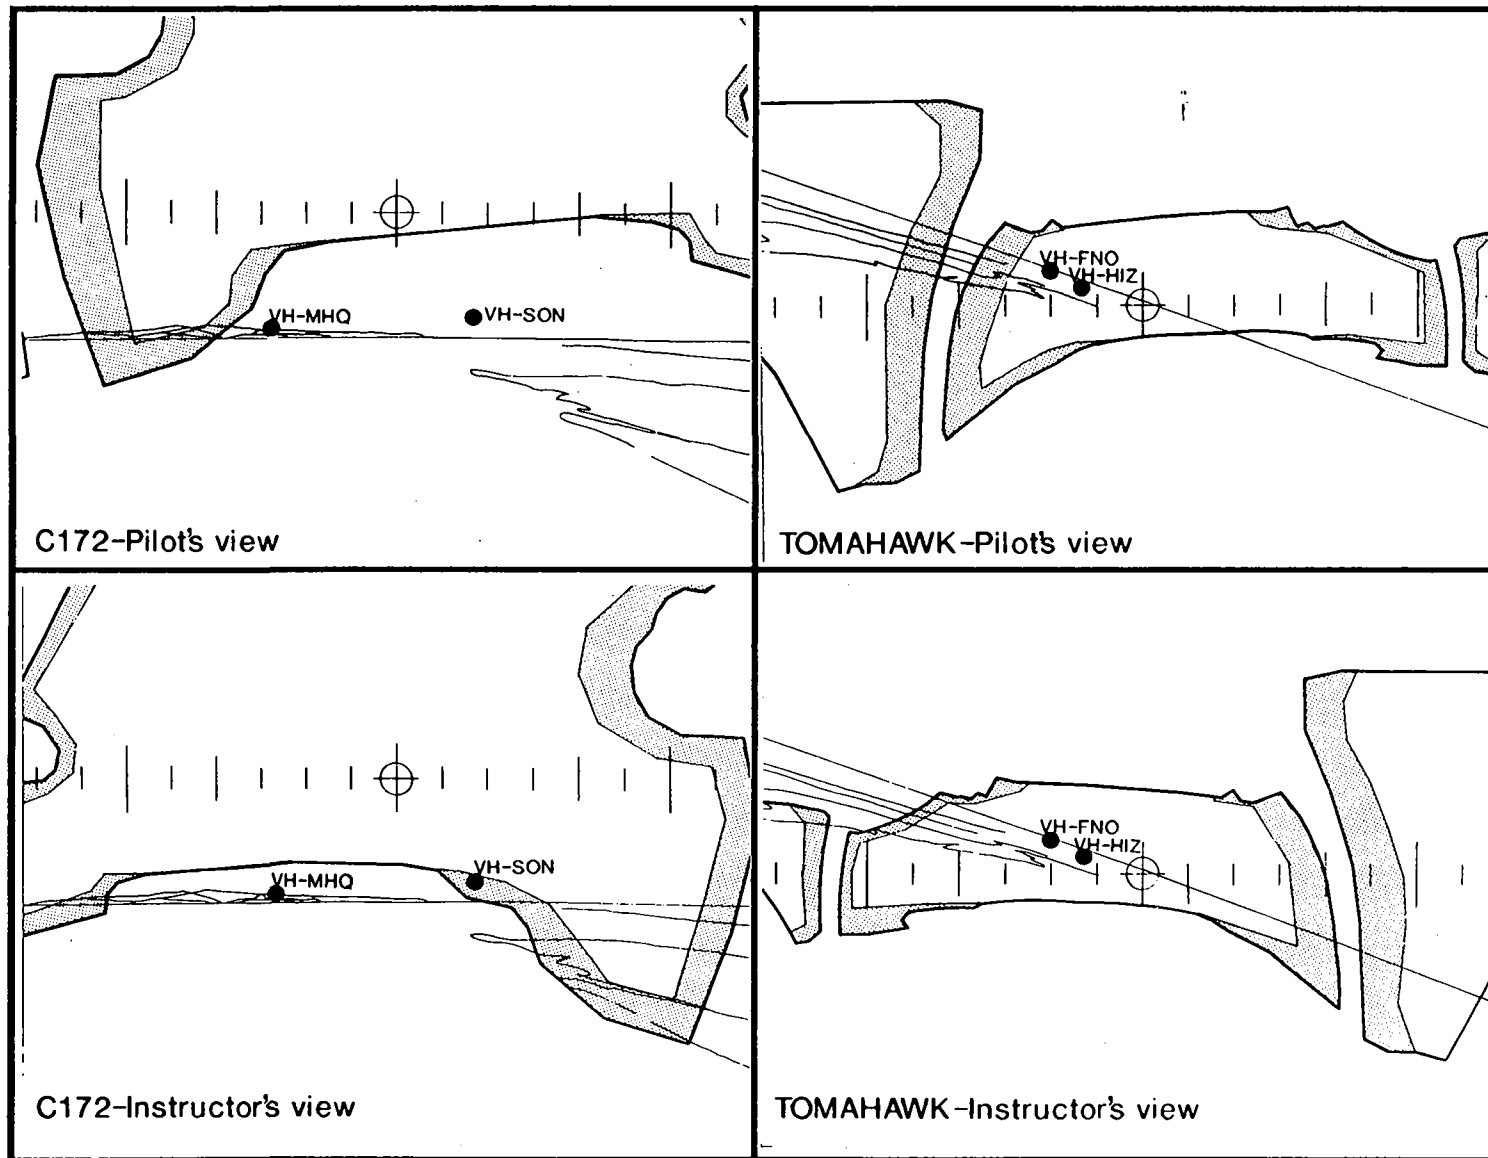
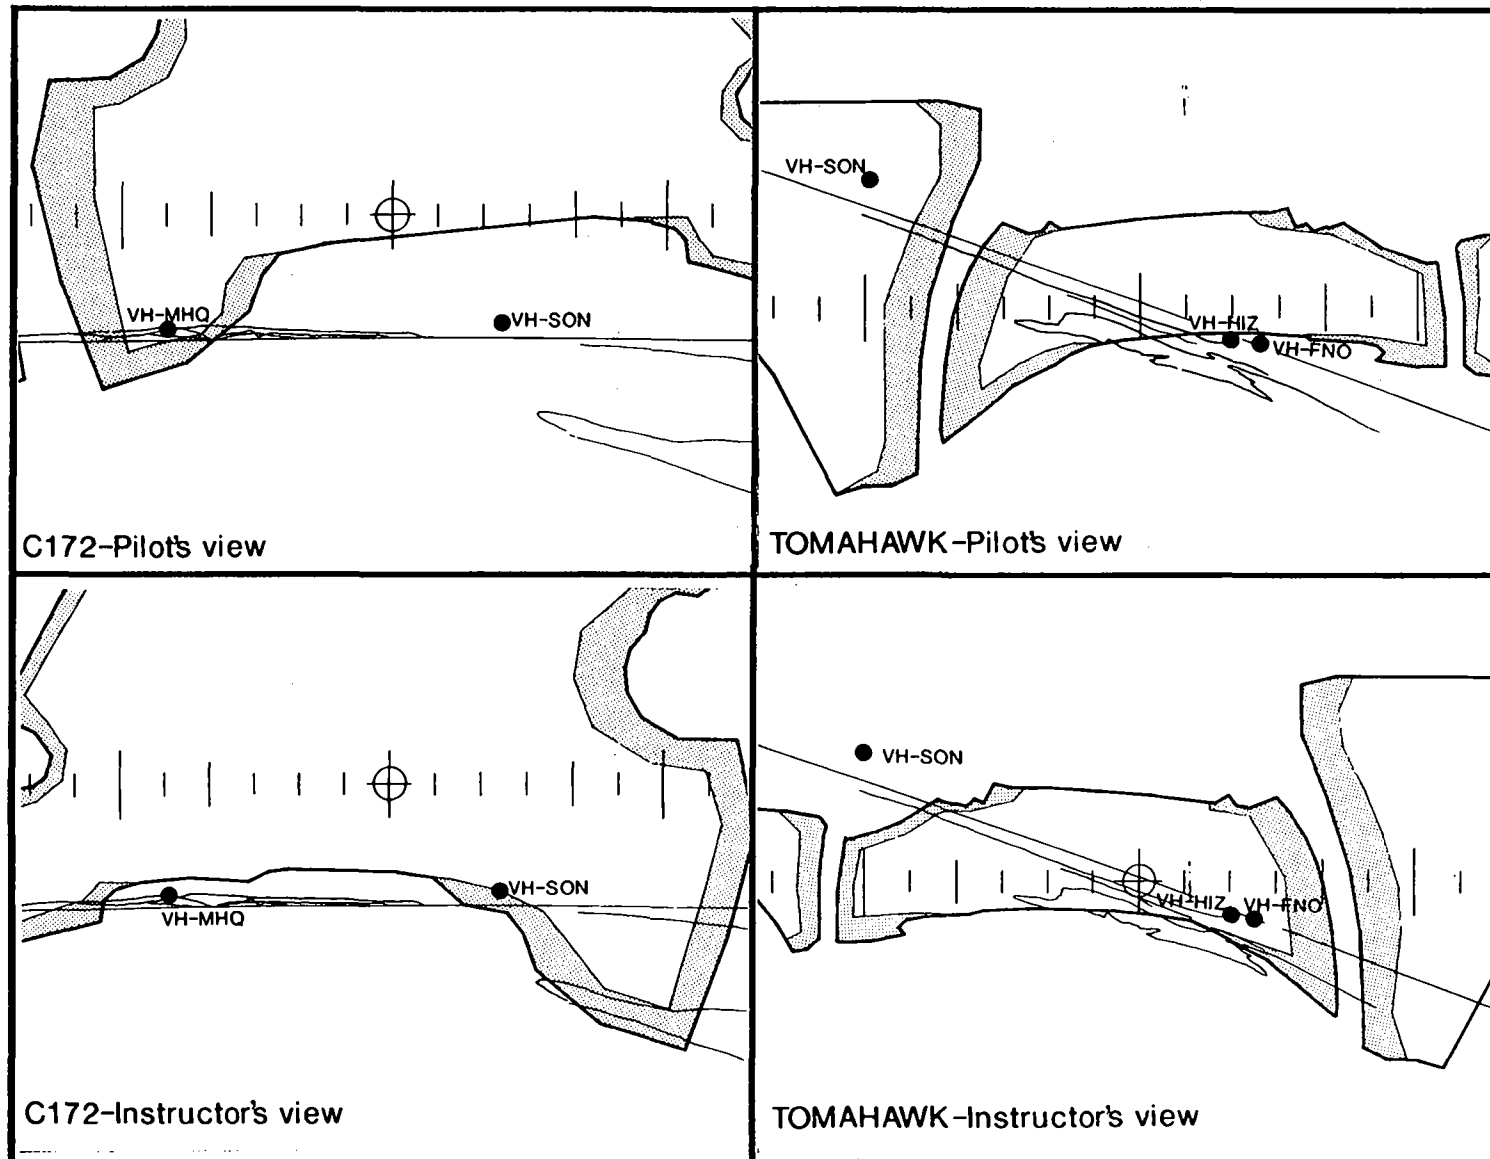
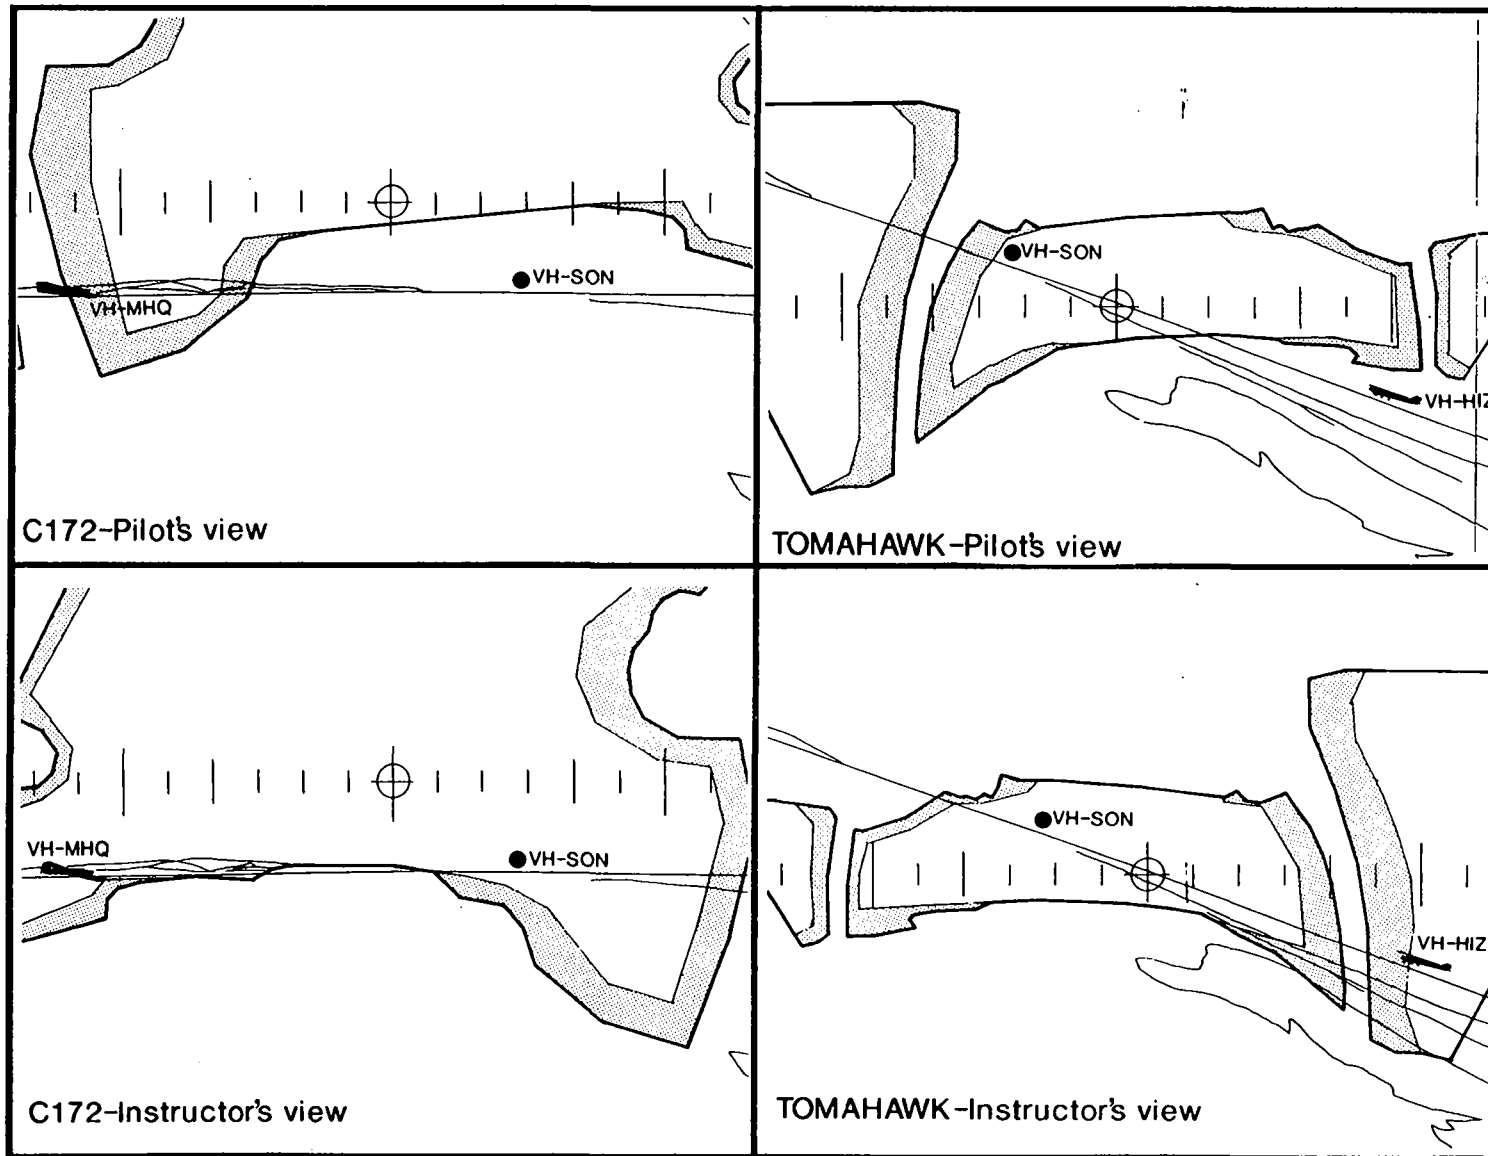
COCKPIT VISIBILITY DIAGRAMS

During flights conducted as part of the investigation, it was determined that the sighting of VH-HIZ as it climbed away from the runway would have been extremely difficult from the relative position of VH-MHQ. It was found that the visual target presented by a small aircraft could not be readily detected against the background of the terrain features and texture of the Coolangatta airport environment. It was therefore unlikely that the pilots of VH-MHQ would have seen VH-HIZ beyond VH-SON even when the aircraft were aligned.

A further factor probably affected the visual detection, and therefore their continuing mental expectation of the relative position of VH-MHQ by the pilots of VH-HIZ. The computer graphics animation showed that the nose up attitude of VH-HIZ during its climb and right turn away from Runway 14 would have caused VH-MHQ to be obscured from the view of the pilots of VH-HIZ for most of the period between that aircraft's final touch-and-go and the collision. Therefore, they would probably not have expected (Refer to Appendix 8, Figures 2 to 5) to see VH-MHQ beyond VH-SON at the time the aircraft were aligned. In addition, VH-MHQ would have been difficult to see because of the small size of the target, its position close to the horizon and the ambient light conditions (Refer to paragraph 1.7). All these factors would have lessened the probability of visual detection of VH-MHQ by the pilots of VH-HIZ.
