SPECIAL INVESTIGATION REPORT

BASI Report B/916/3032

**DC-10 Series 30ER Aircraft HS-TMC
and
A320-211 Aircraft VH-HYC**

**Near collision at
Sydney (Kingsford Smith) Airport
12 August 1991**

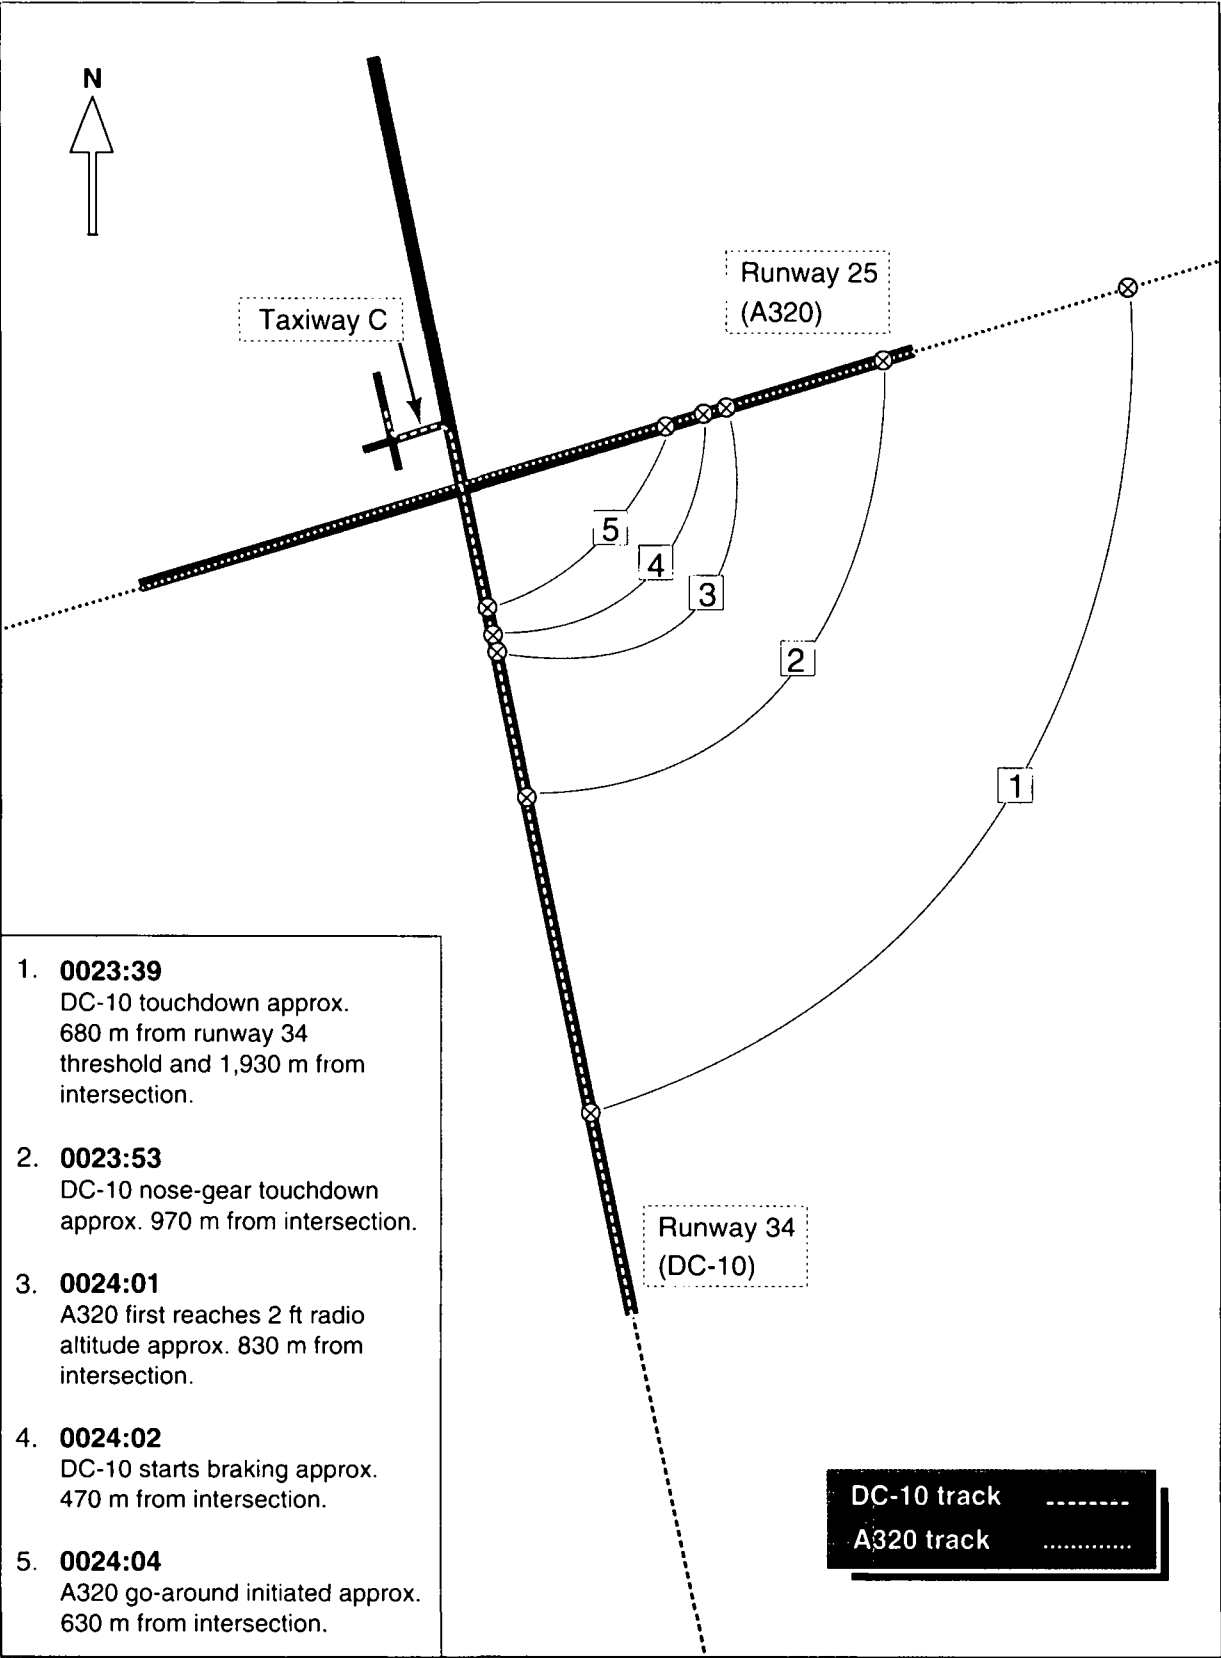
Relative positions of A320 and DC-10 at five instances during sequence.

Positions estimated from aircrafts' flight data recorders
Grid size 100 m and aligned to true north.

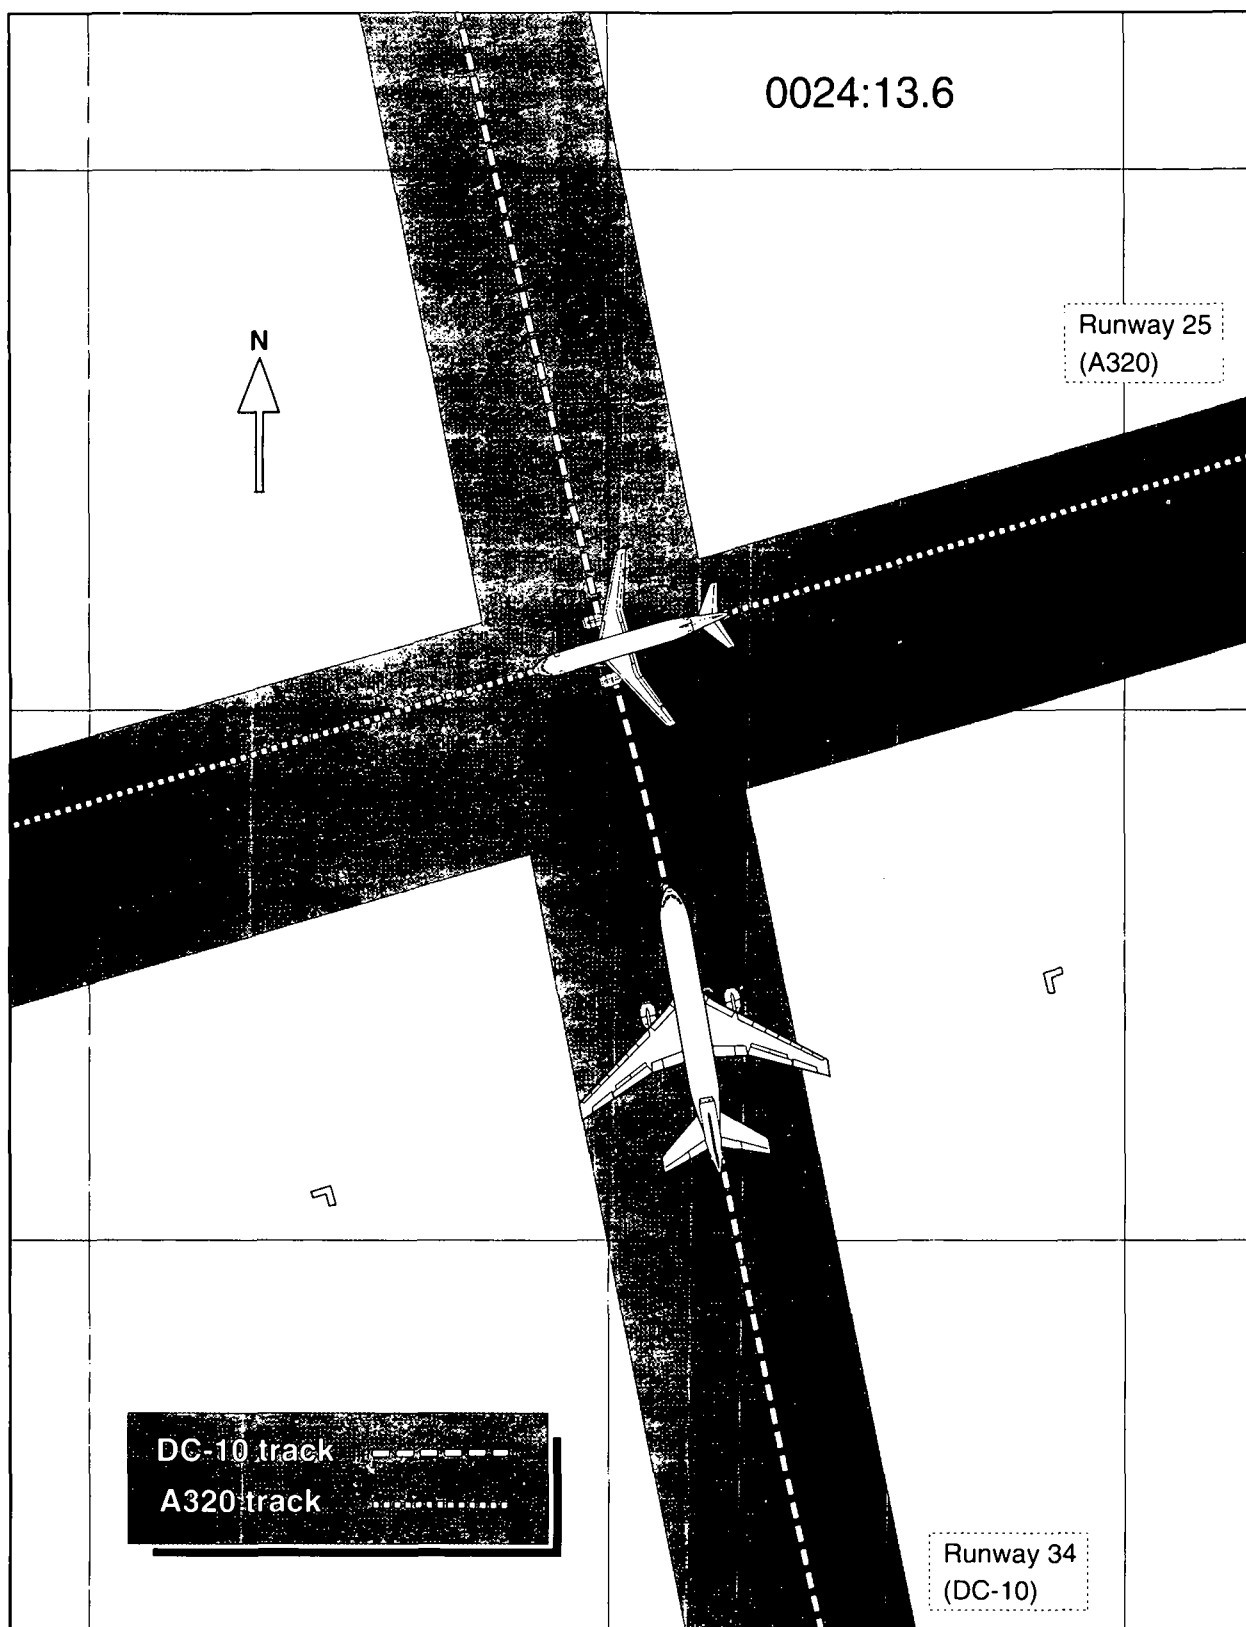
A320 passing through intersection at radio altitude of 52 ft.

Positions estimated from flight data recorder information.
