MARINE SAFETY INVESTIGATION

REPORT 179

Independent investigation into a fatality aboard  
the Panama flag bulk carrier

# Western Muse

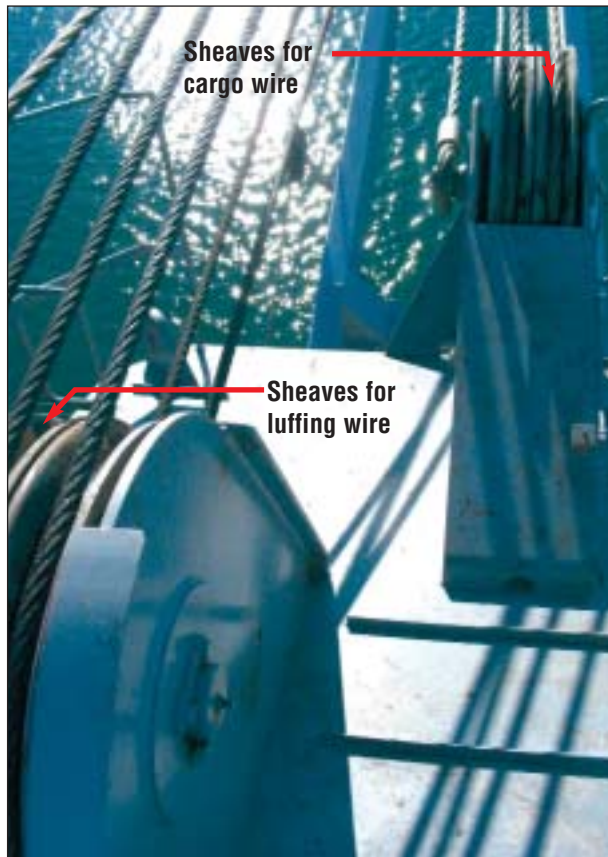
**FIGURE 2:**  
**Top of crane: platform and sheaves for cargo and luffing wires**

The platform on top of the crane was not horizontal, nor was there much room to work. The platform, measuring about 2 metres by 2.15 metres, sloped down towards the front of the crane at an angle of about 15°. In addition it was fitted with two housings for sheaves for the luffing and cargo wires which took up space. Protective railings were fitted only to the sides and back of the platform, due to the lead of the wires.

The other seaman heard the bosun cry out 'Stop, stop' and immediately used his radio to tell the cadet to stop the crane. The rope lanyard on the bosun's safety belt was entangled in the sheaves and, by this time, the bosun's left leg and hip had been drawn in between the sheaves and the luffing wire.

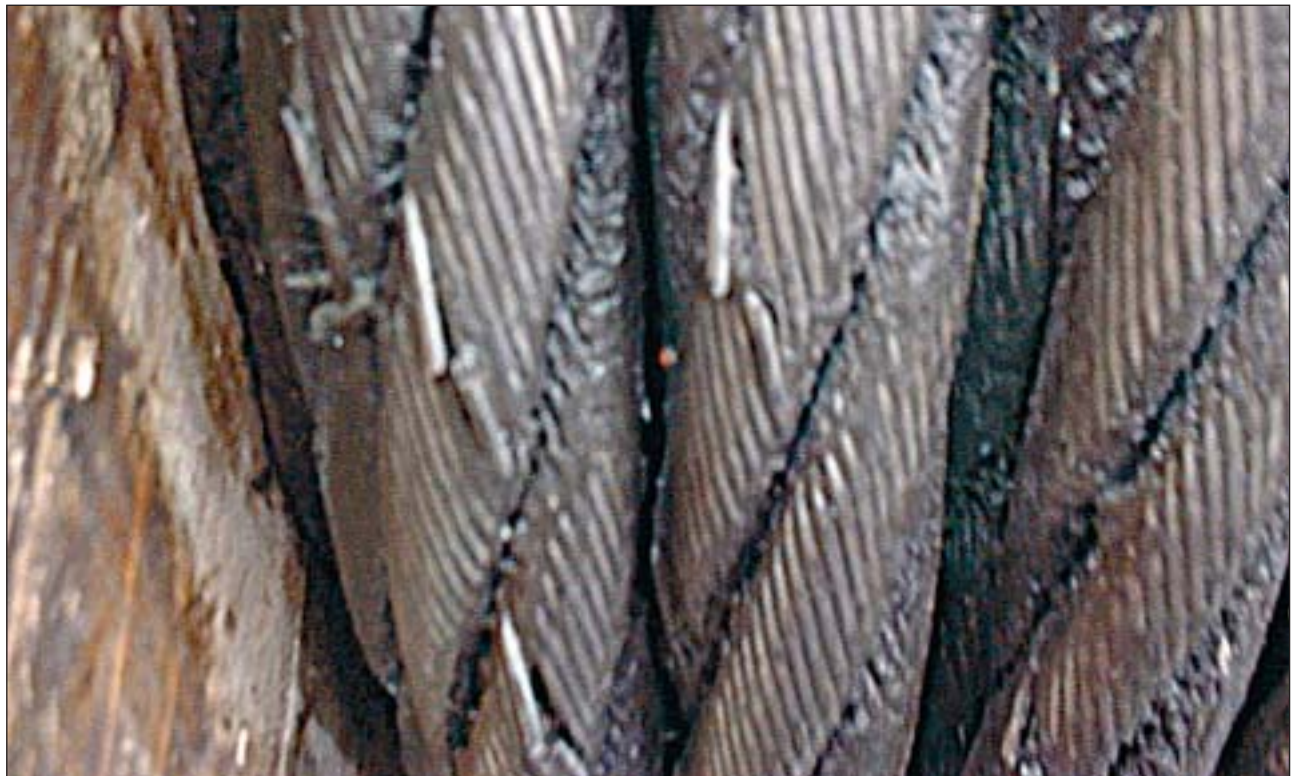
**FIGURE 3:**  
**Wire from No. 2 crane showing breaks within strands**

Main working area has multiple broken outer wires with adjacent crown wire breaks evident;

Broken wires exceed retirement criteria as per Marine Orders Pt 32 and relevant Australian Standard guidelines;

- The actual average diameter of the rope was 33.9 mm, within the usual manufacturing tolerances of –1% to +4%;
- There were numerous broken wires throughout the section where most cycling would occur on a normal hoist rope for a crane;
- At about 50 metres from one end, a 3 metre section of heavy wear was examined and 140 broken wires were counted;
- The external surface of the rope was well lubricated;
- Abrasive wear on the rope surface was moderate and commensurate with the amount of fatigue failure of the wires examined.

- The rope exhibited normal patterns of deterioration for this construction and application; and
- The judgement to change the rope was correct, based on the rope having exceeded normal discard criteria through wire breaks within strands (reference Australian Maritime Safety Authority Marine Orders Part 32).

Based on the result that, over a 3 metre length of the cargo wire, there were 140 broken wires, over a length of 33.5 cm, there could be expected to have been an average of between 15 and 16 broken wires.

This would be well in excess of the criteria permitted by section 2.2 of Appendix 15 of Marine Orders Part 32 and the wire was therefore not fit for use.

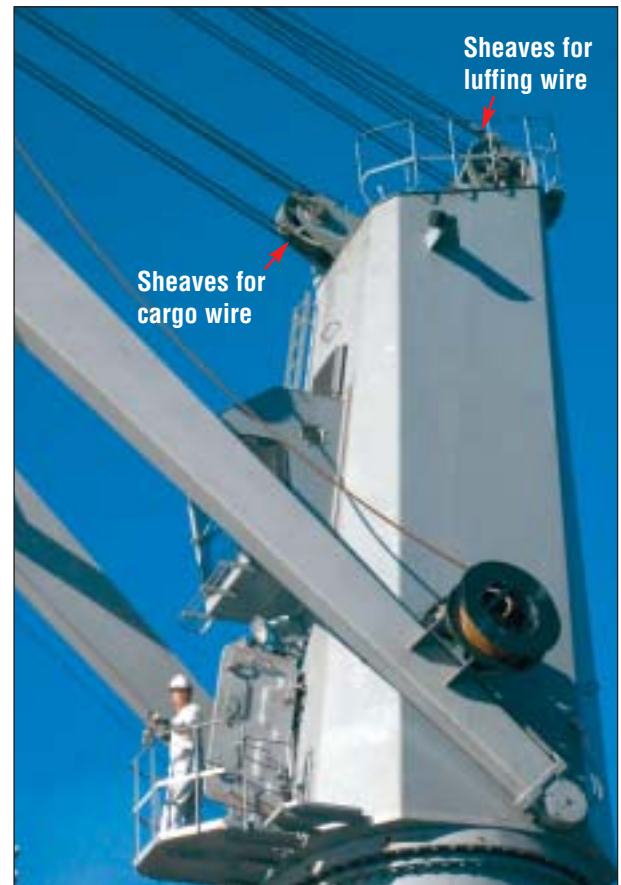
**FIGURE 4:**  
**No. 2 crane on *Western Muse***

However, replacing the wire took a full day. The work involved in renewing the cargo wire, given its size, length and the height of the crane, would have been arduous and physically demanding, requiring a high level of concentration. At the end of a long day, the nature of the task and the fact that he was working in low lighting levels on a sloping cluttered platform at a considerable height above the deck may have affected the bosun.

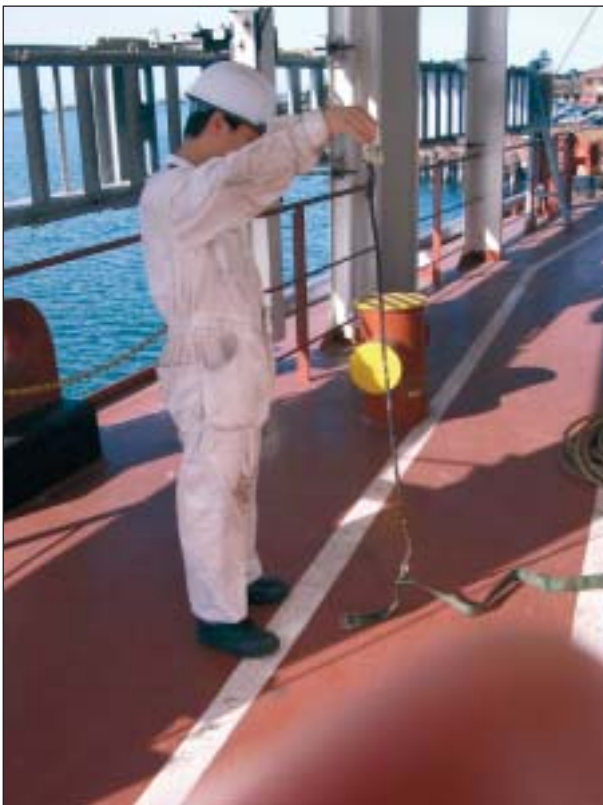
**FIGURE 5:**  
**Crew member demonstrating length of lanyard attached to safety belt**

Advice from professional riggers is that any loose clothing or equipment that can be caught in moving machinery is a major hazard. Though the Code of Safe Working Practices for Merchant Seaman recommends that personnel working aloft use a safety harness with a lifeline, there is the danger that a lifeline could be caught in moving machinery, as occurred in this incident.

Shipowners' and operators' procedures and precautions for personnel working aloft should include warnings that loose clothing or personal safety equipment might become entangled in moving machinery.

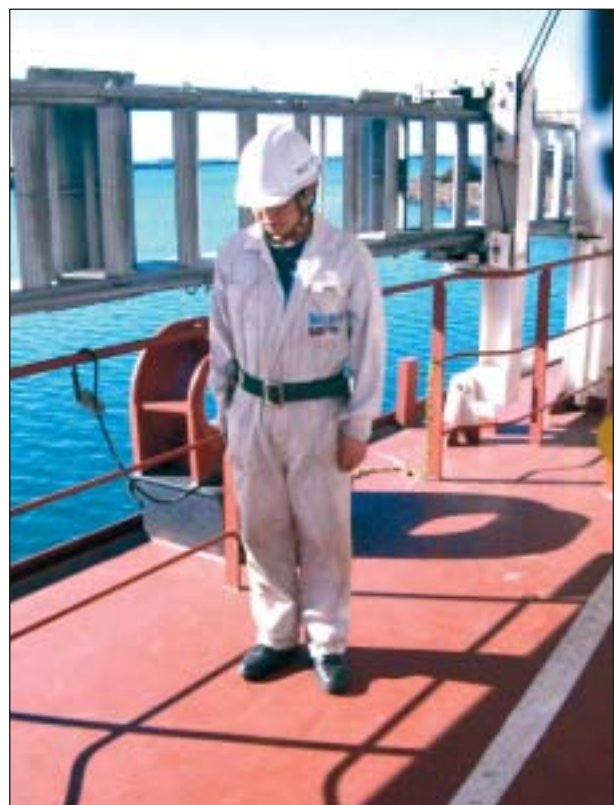
**FIGURE 6:**  
**Crew member demonstrating the use of the safety belt and lanyard**

1. After the bosun released the rope lanyard on his safety belt, the lanyard became entangled in the luffing wire or was drawn into the sheaves for that wire, dragging him in between the sheaves and the wire.
2. The task of changing the cargo wire, in addition to being arduous and lengthy, was physically and mentally demanding, possibly causing the bosun's concentration to lapse at the end of the day.
3. The conditions of lighting under which the crew were operating at the top of the crane
