MARINE SAFETY INVESTIGATION REPORT
No. 200

Independent investigation into the grounding of
the Bahamas registered passenger ship

Astor

in Platypus Channel, Townsville, Queensland
26 February 2004

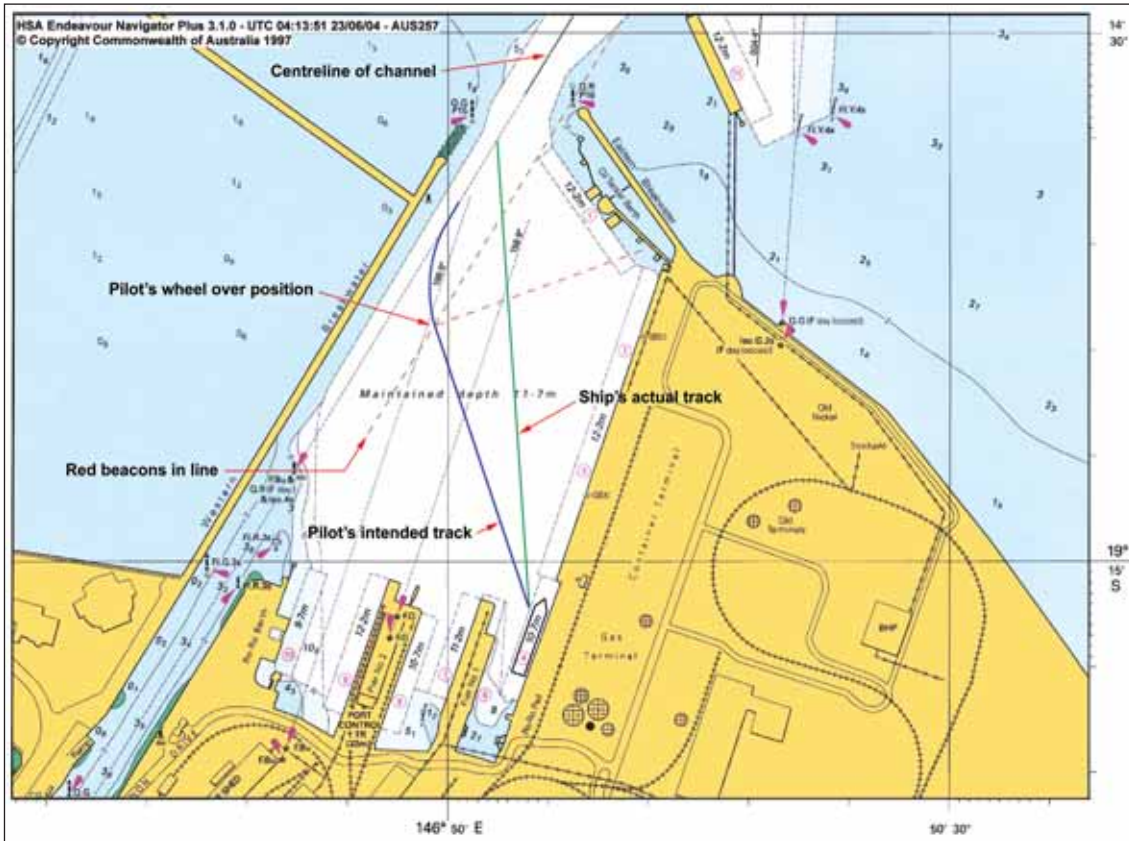
FIGURE 4:
Portion of chart Aus 257 showing the pilot's intended track and ship's actual track

Astor turned to starboard to enter Platypus Channel, but the ship was to the west of the centreline. The ship subsequently grounded on the western side of the channel at 1908, about 135 m northeast of beacon number 15 (see Fig. 5). The ship heeled about three degrees to starboard and, during the time it was in contact with the bottom, its speed was reduced.

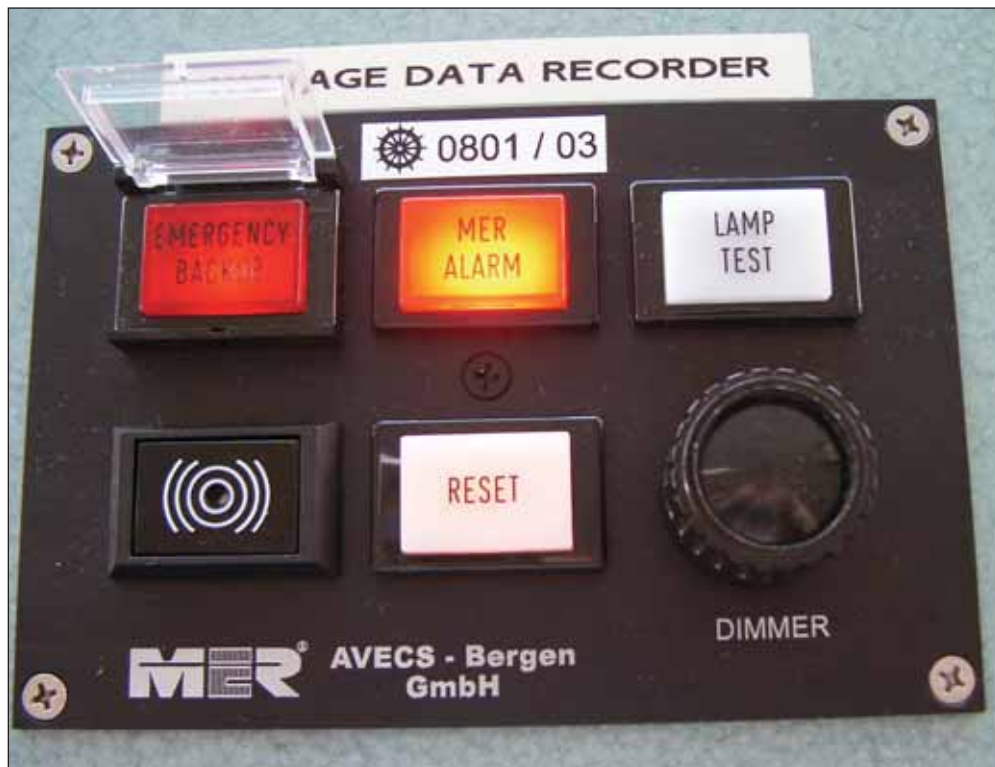
FIGURE 6:
VDR wheelhouse control panel

ATSB investigators examined the VDR control panel on the bridge console. They noted that the 'emergency backup' button lamp was permanently lit. If the lamp was dimmed (as it would be at night), an untrained operator could believe that the backup process had commenced if the dimmer control was adjusted to provide more illumination. This is what had happened in this incident.

It became apparent to the investigators that none of the ship's officers interviewed knew how to correctly save the VDR data. This is a serious deficiency in the training of the ship's officers. There was no shipboard procedure to instruct the crew, other than the manufacturer's operational manual. It also demonstrated how easy it would be for a person to deliberately fail to back-up important navigational data and plead ignorance, if it was in their interest to do so.

ATSB investigators also found that the procedure for activating the emergency backup system, as contained in the instruction manual provided for the VDR unit by AVECS, was incorrect. AVECS have since amended this procedure to reflect the correct method of 'emergency backup' activation.

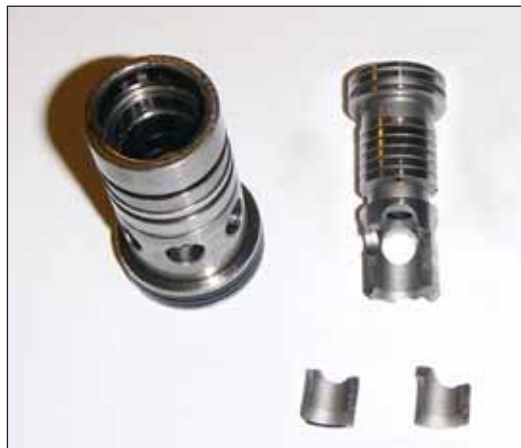
FIGURE 11:
Broken stop valve pieces

On 3 March, a broken valve insert (as shown in Fig. 11) was provided to the investigators. Ship's staff stated that this was the part that had failed, causing the steering malfunction and that the failure of this valve had been the cause of the 'hard to port' movement of the port rudder moments before the grounding. The effect of the failure of this valve must have been to over-ride the port steering gear number one pump, which was operating correctly.

Expert metallurgical examination shows that the fracture of one of the internal components was caused by crack growth over a period of time. The features of the fracture surfaces are consistent with crack growth by the mechanism of fatigue (the result of alternating stresses in the component).

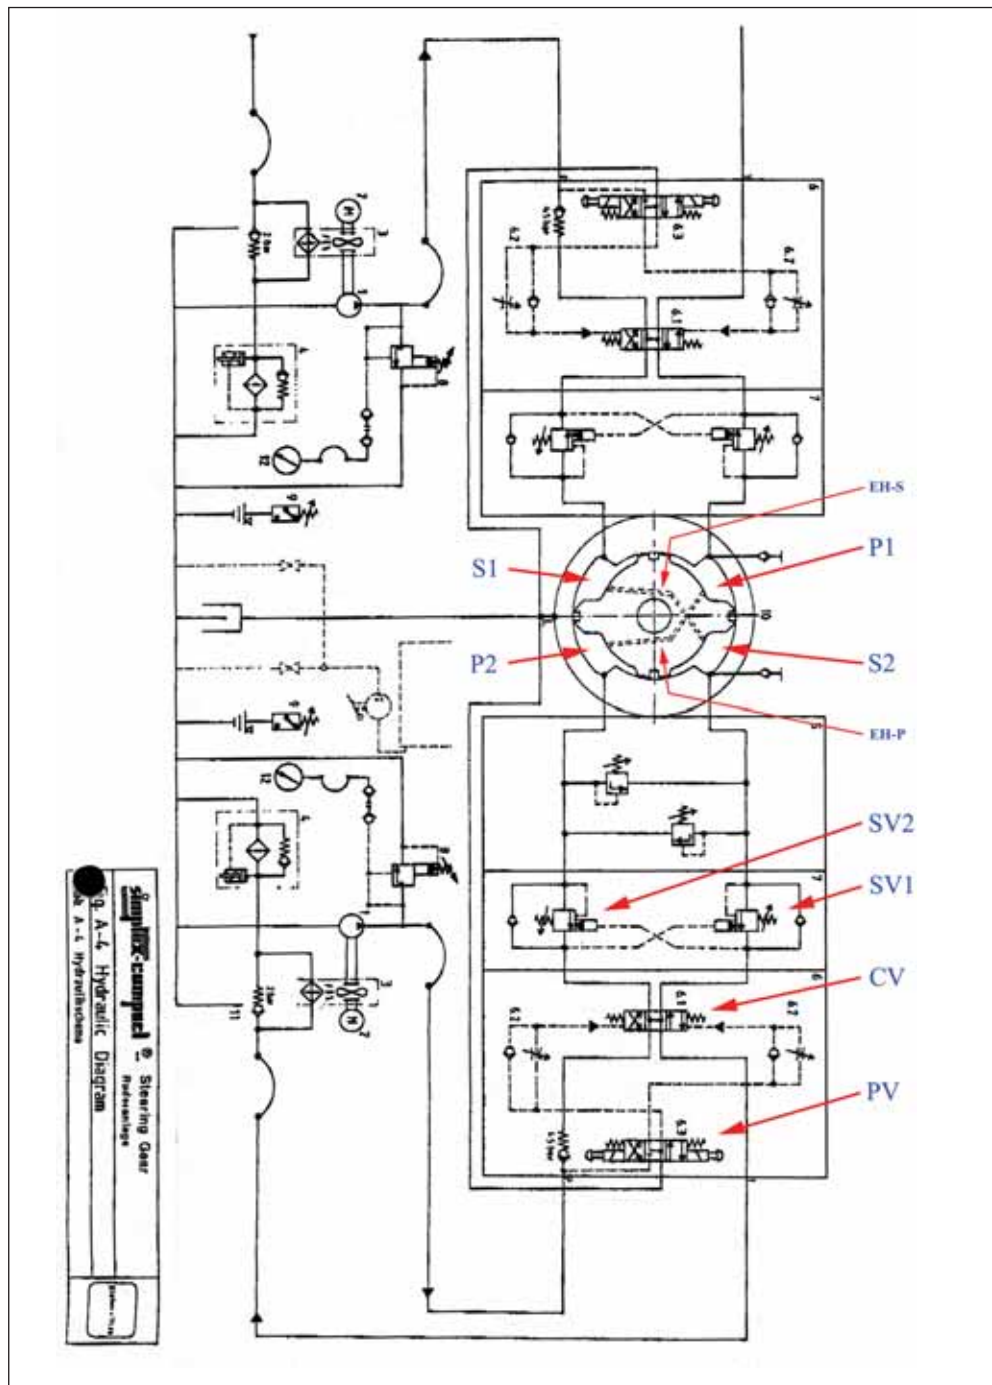
FIGURE 13:
Steering gear hydraulic arrangement diagram

The fractured pieces of the component were reported as having been taken from an automatic stop valve on number two hydraulic system (SV1 in Fig. 13), which supplied the port steering rotary vane unit. However, the components, although similar, were not consistent with the drawing supplied to the vessel by the manufacturers in the steering gear operating manual. To be able to correctly analyse the hydraulic system, the ATSB obtained a more up-to-date hydraulic system drawing from the steering gear manufacturer.

In each of the above instances, there appears no means by which the 'port movement' chamber P2 could become pressurised, with the 'starboard movement' chamber S2 connected to the return line, thus moving the rudder to port. In any of the failure modes above, the rudder should still move under the influence of number one pump.

In view of the above, it appears that movement of the port rudder to port, with starboard helm applied, is highly unlikely. At best, its operation would have become sluggish in comparison with the starboard rudder, at worst it would have 'failed set' with the rudder in whatever position it was in at the time of the failure.

An examination of drawings of the hydraulic system, together with consultation with the manufacturers of the steering gear, has failed to reveal any means by which the port rudder could have moved to the 'hard to port' position of its own accord after the failure of an automatic stop valve.
