ACCIDENT INVESTIGATION REPORT

**Ansett General Aviation,
Piper PA 31-310
Navajo aircraft VH-CIZ
at Golden Grove
on 13 July, 1972**

Prepared by:
Air Safety Investigation Branch Melbourne

May, 1973

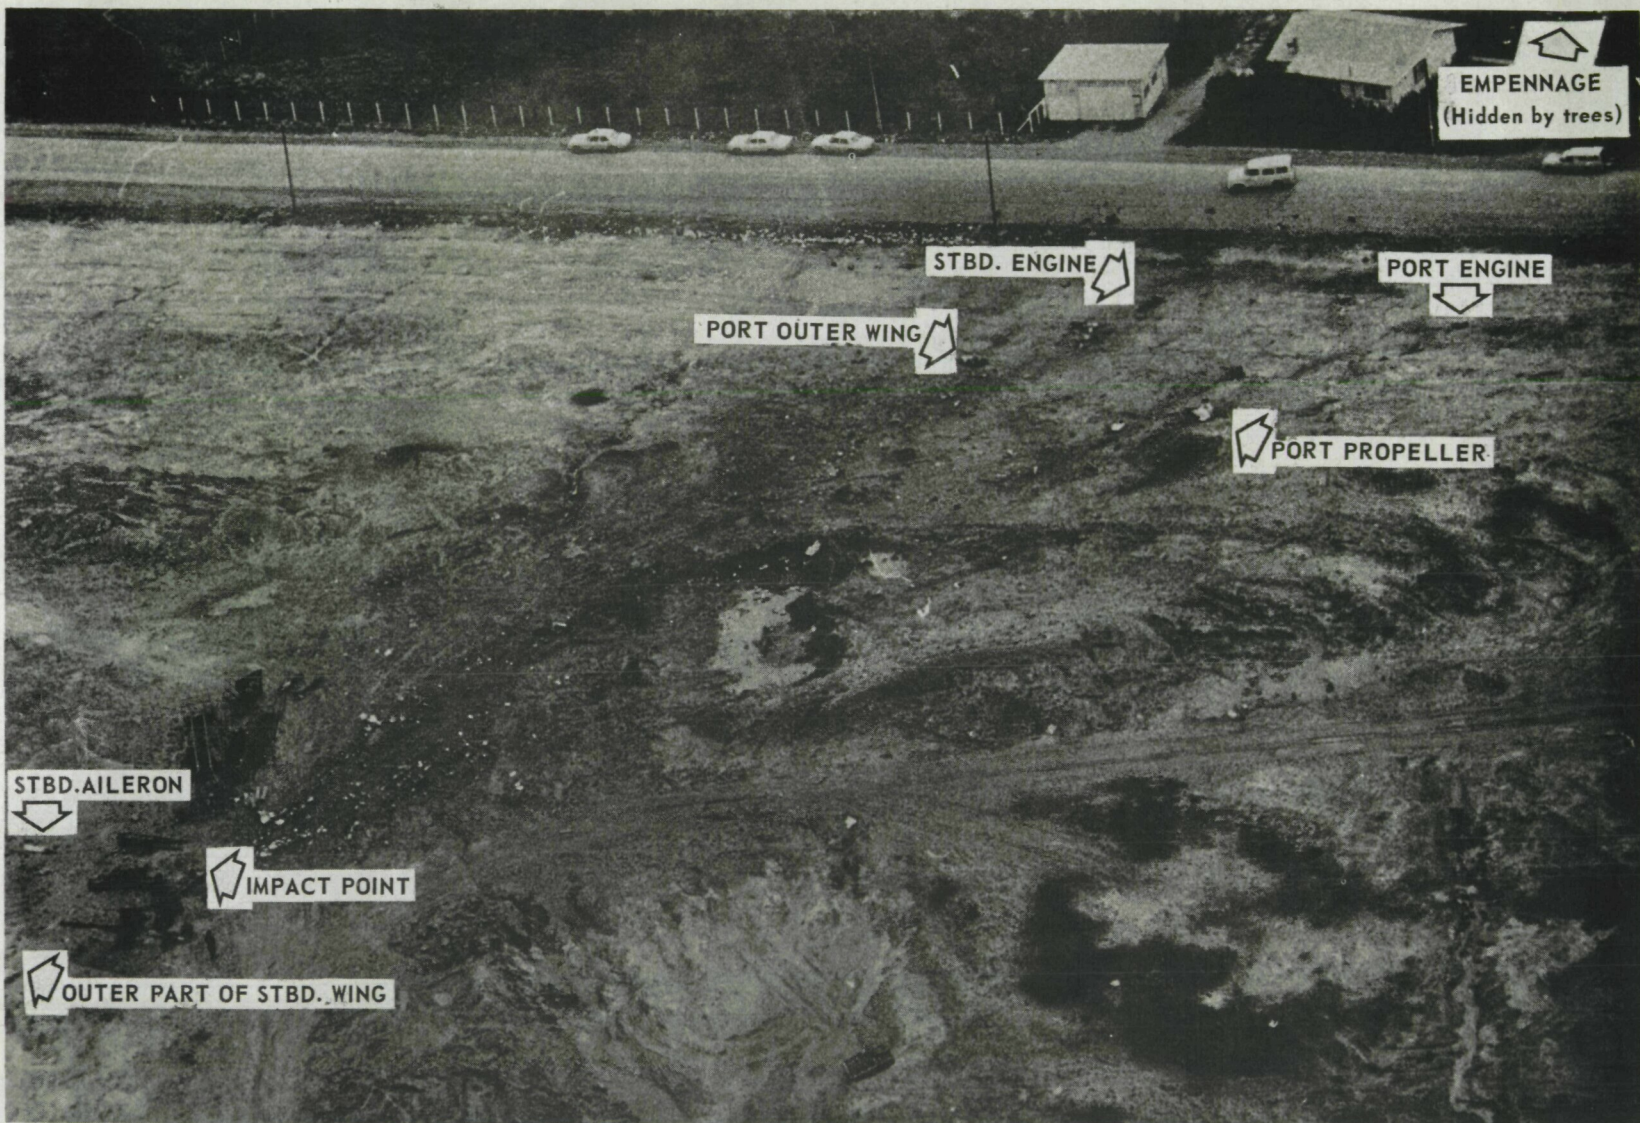
FIG. 1

The extreme degree of fragmentation which occurred and which can be seen in Fig. 1, is consistent with high forward speed at impact. Several portions of a structural steel framework, which had been lying on the ground in the impact area, contributed to the extreme nature of the structural break-up. The steel sections themselves sustained severe damage and one of them, an "A" frame about 15 feet long and built up of tubing and channel sections, was broken into three pieces which were distributed along the wreckage trail at varying distances up to 250 feet from the main impact point, where it had originally lain.

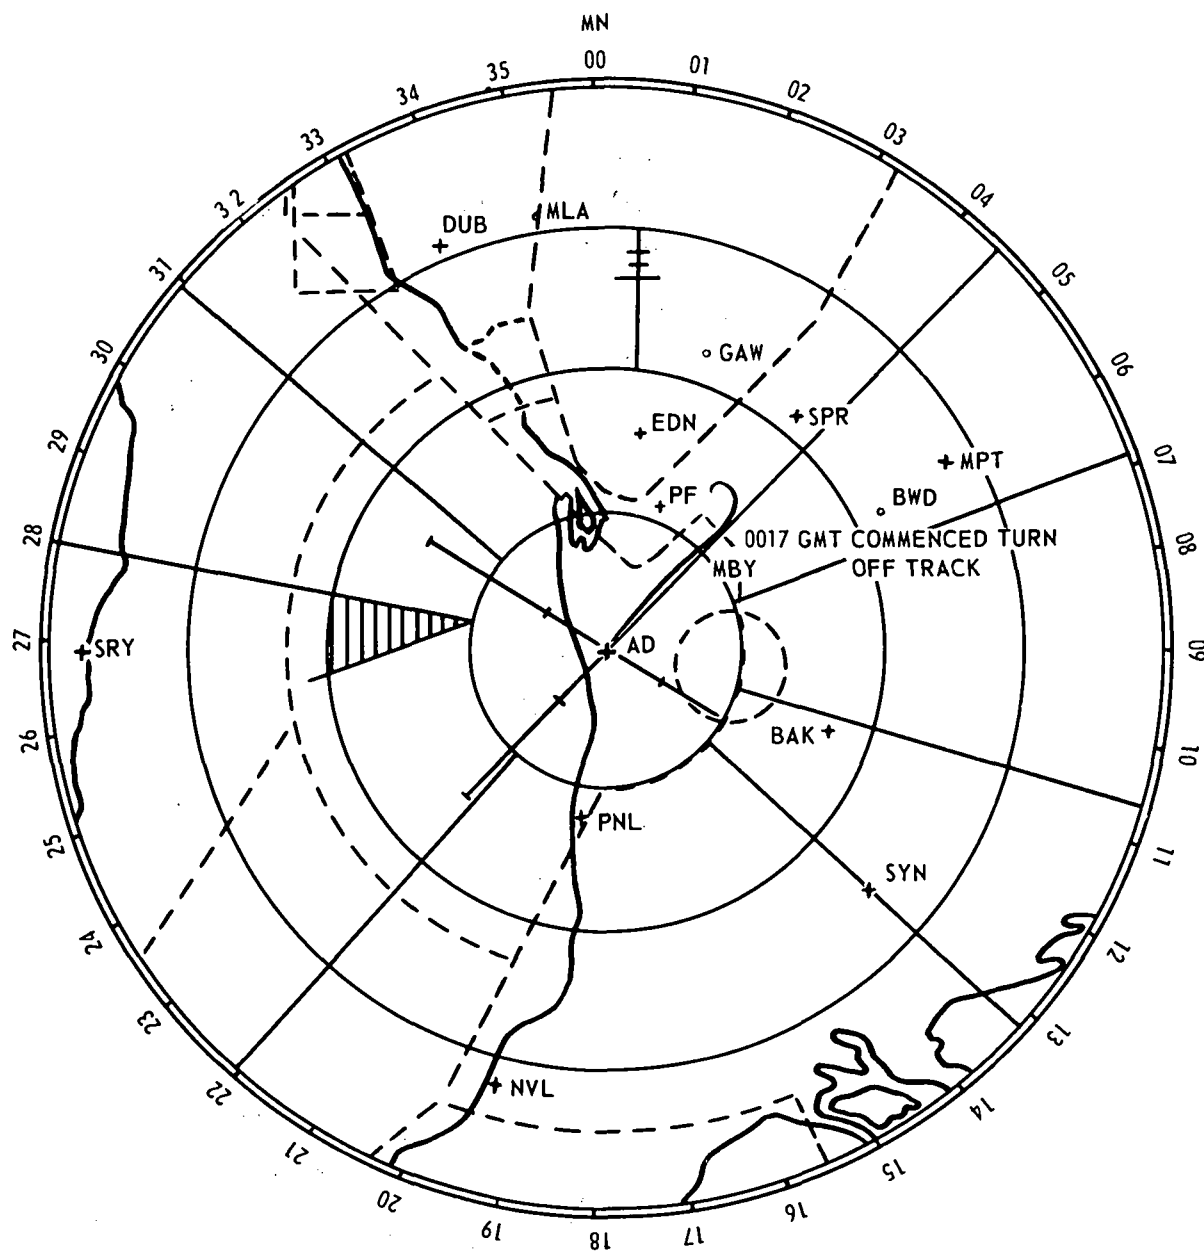
FIG. 2

The radar plot (Fig. 2) is the basis of definition of the first segment of the final flight path. The radar plot is a small scale drawing completed by the controller some minutes after the event and is a line joining the controller's recollection of the position of a series of transient pulses, at 12 second intervals, observed on the radar screen. The radar plot so obtained has been replotted on a large scale map of the accident area (see Fig. 3) and the resultant flight path falls well outside the impact area. This is quite understandable when the small scale of the original drawing is taken into consideration. However, the evidence from the radar plot is

DATE. 13/7/70 TIME. 0747 CST AIRCRAFT VH-CIZ
 ROUTE ADELAIDE TO MOOMBA FLIGHT CONDITIONS IFR
 REMARKS. AIRCRAFT OBSERVED ON RADAR TO DEVIATE OFF
TRACK. AT 0748 RETURN DISAPPEARED AND COMMUNICATION
WAS LOST

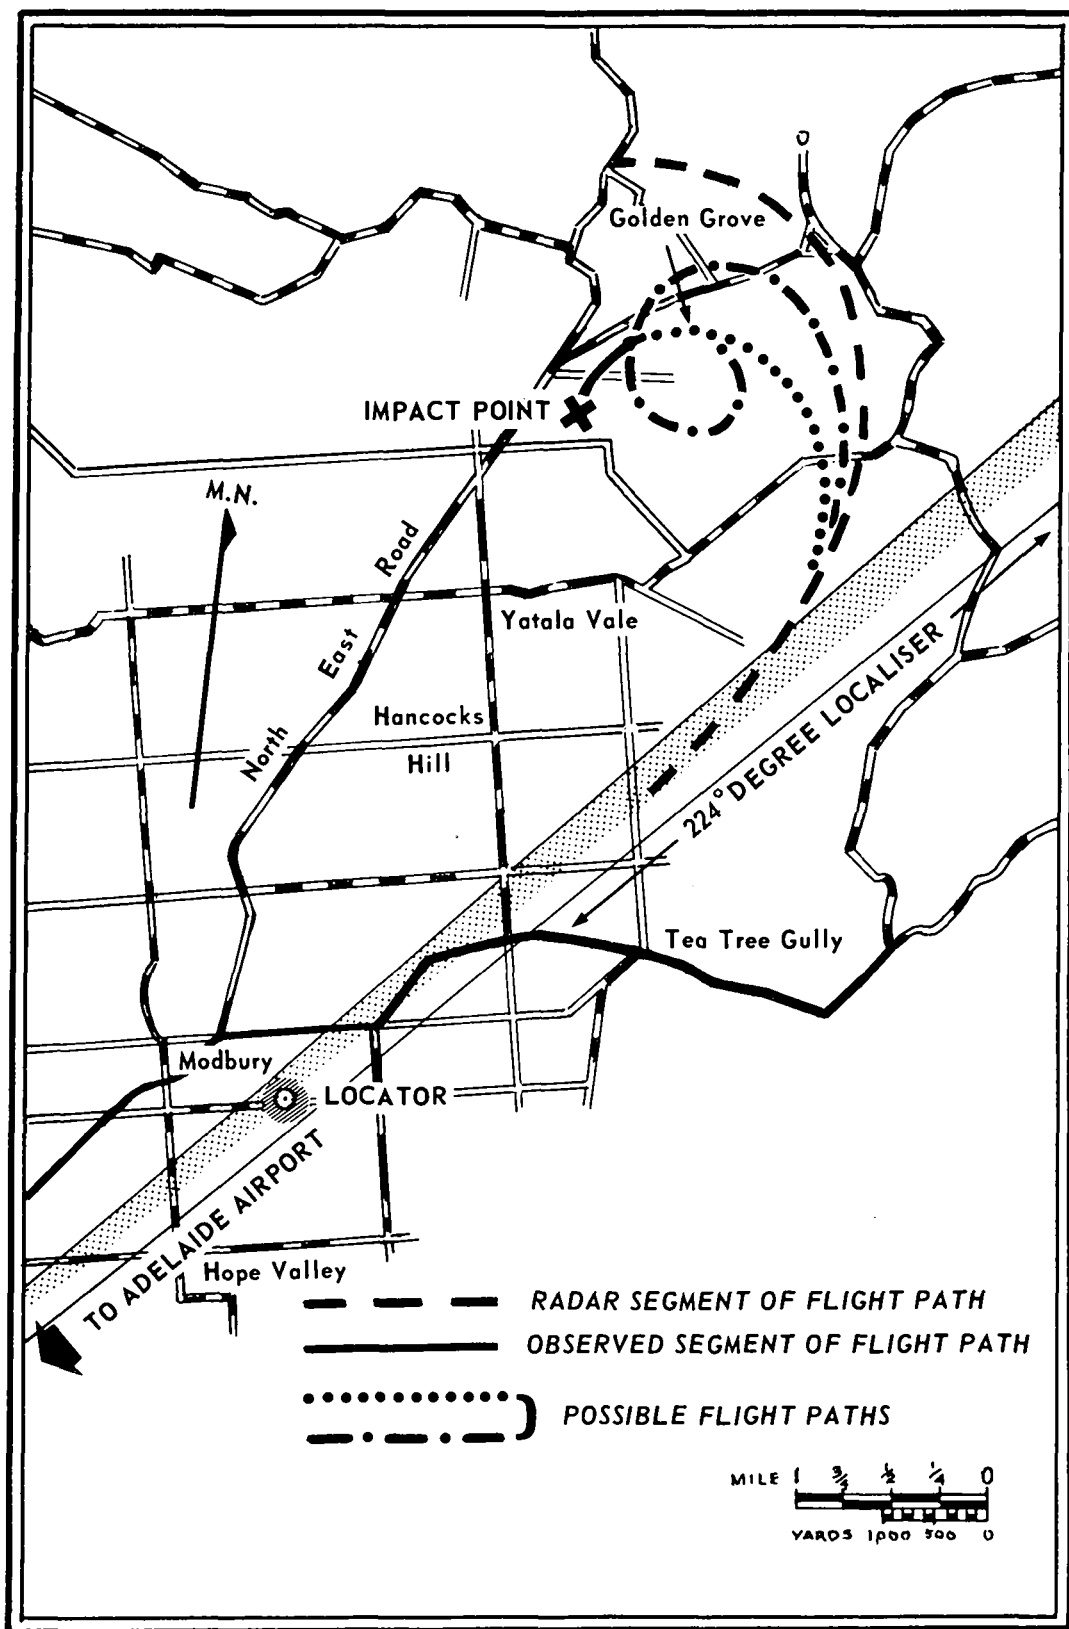
FIG. 3

It is possible to construct a final flight path in which the visually observed flight path is a direct continuation of a turn similar to that shown by the radar plot (see Fig. 3). Such a flight path would imply a smooth uninterrupted turn from the point of diversion from the localiser track to the ground impact point. The distance traversed in such a flight path is some 18,300 feet and during this time, if 3,500 feet of height had been lost, the average descent angle would have been about 11 degrees. Assuming an air-speed between 140 knots and 220 knots, the maximum angle of bank would have been between 30 and 45 degrees and a mean rate of descent of the order of 3,500 feet per minute would apply.
