## INCIDENT INVESTIGATION REPORT

**Fokker F28-1000  
Aircraft VH-FKA,  
at Broome Airport,  
Western Australia,  
on 17 January 1974**

## Special Investigation Report 75-1

## **MacRobertson Miller Airline Services F-28-1000 Aircraft VH-FKA at Broome Airport, Western Australia, on 17 January 1974**

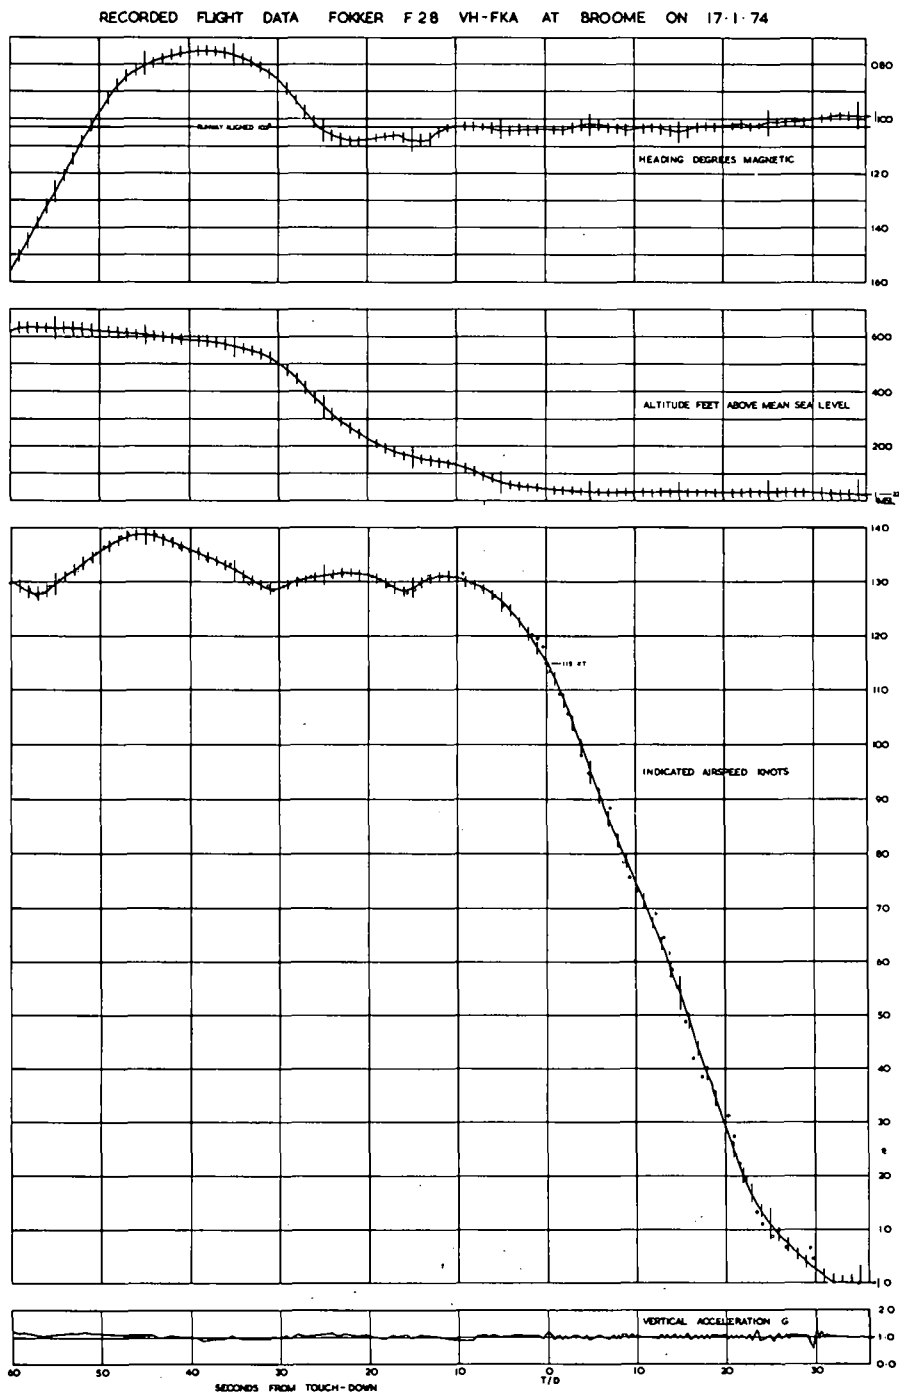
APPENDIX A

The section of the foil which recorded the movements of the aircraft during the 22 minutes prior to completion of this landing has been examined. At Appendix A there is a representation of the flight data record for the final 60 seconds. The flight data recorder information indicates that the aircraft crossed the runway threshold at an altitude of approximately 140 feet, that is a wheel height of about 80 feet, and it then followed a descent path slightly above but parallel to the normal 3 degree approach slope. Throughout the approach the flight data recorder reflects an indicated airspeed varying about 130 knots, but there was an excursion to 139 knots 45 seconds before touchdown. The recorded indicated airspeed over the runway threshold was 131 knots which decreased to 115 knots at touchdown.

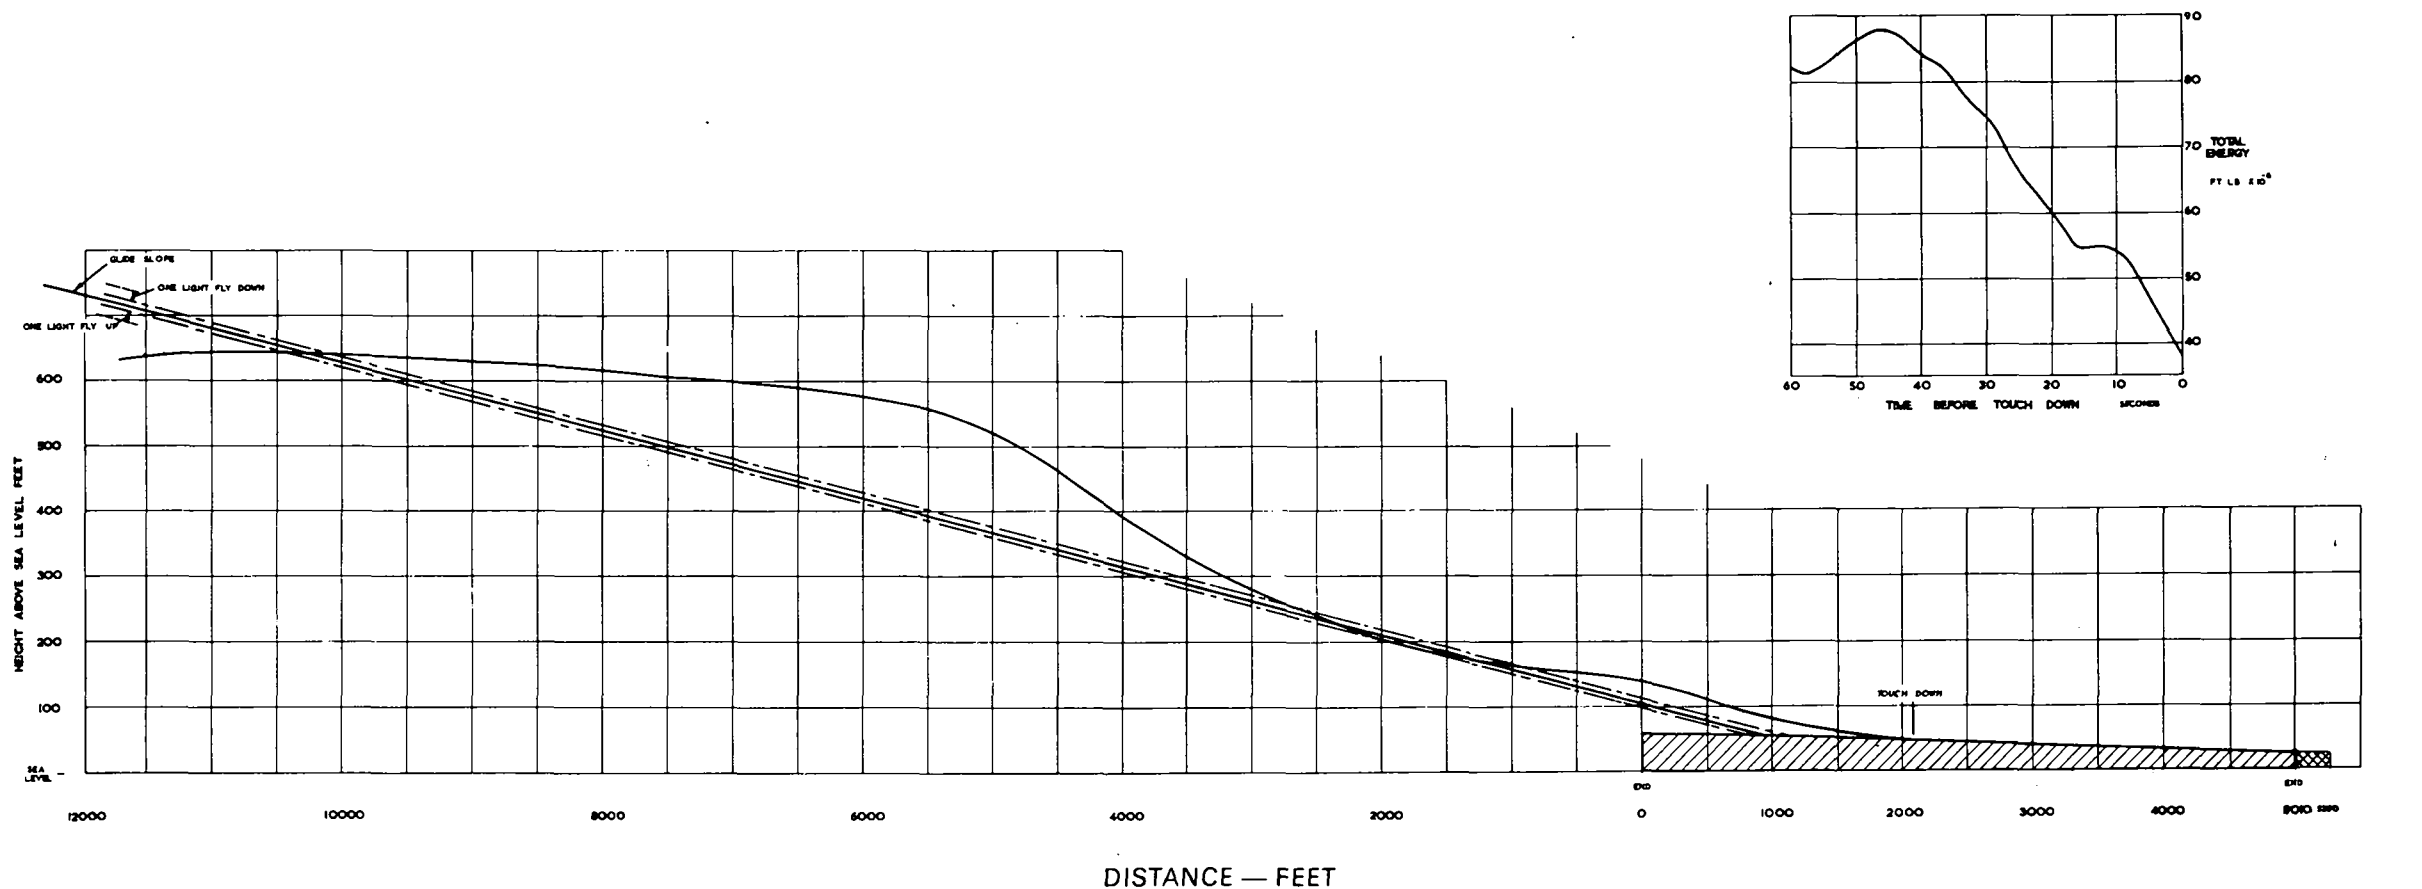
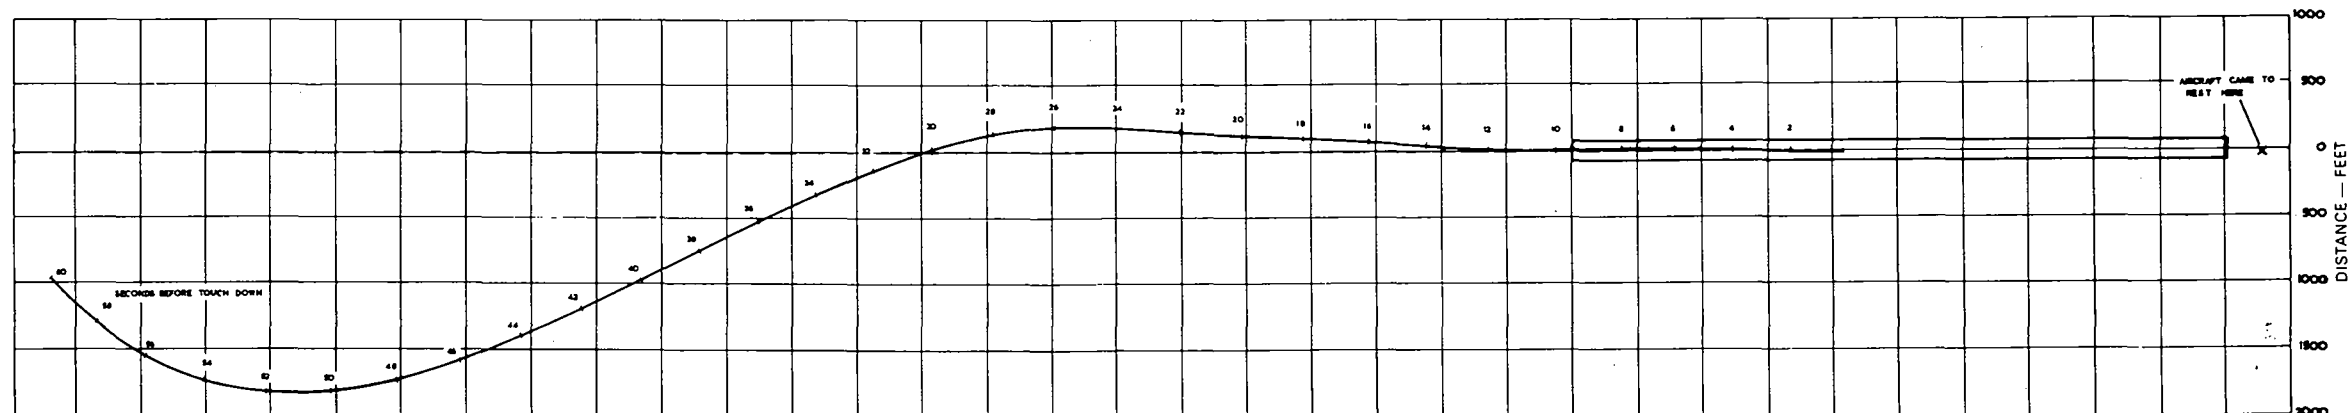
FLIGHT PATH DERIVED  
FROM RECORDED FLIGHT DATA  
F2B VH-FKA BROOME 17-1-74

During the turn onto this final approach the aircraft again overshot the runway alignment and calculations based on the flight data recorder information (Appendix B) indicate that, some 52 seconds before touchdown, it was 548 metres to the right of runway alignment, approximately 3000 metres from the runway threshold, and at an altitude of about 620 feet. It was flying substantially horizontally and passing from a position below the normal 3 degree approach slope to a position above it. Additionally, it was turning left at an estimated bank angle of 35 degrees.
