A U S T R A L I A N T R A N S P O R T S A F E T Y B U R E A U

MARINE SAFETY INVESTIGATION

Independent investigation into the collision
between the Hong Kong flag bulk cargo vessel

off the south coast of Western Australia
on 18 January 2001

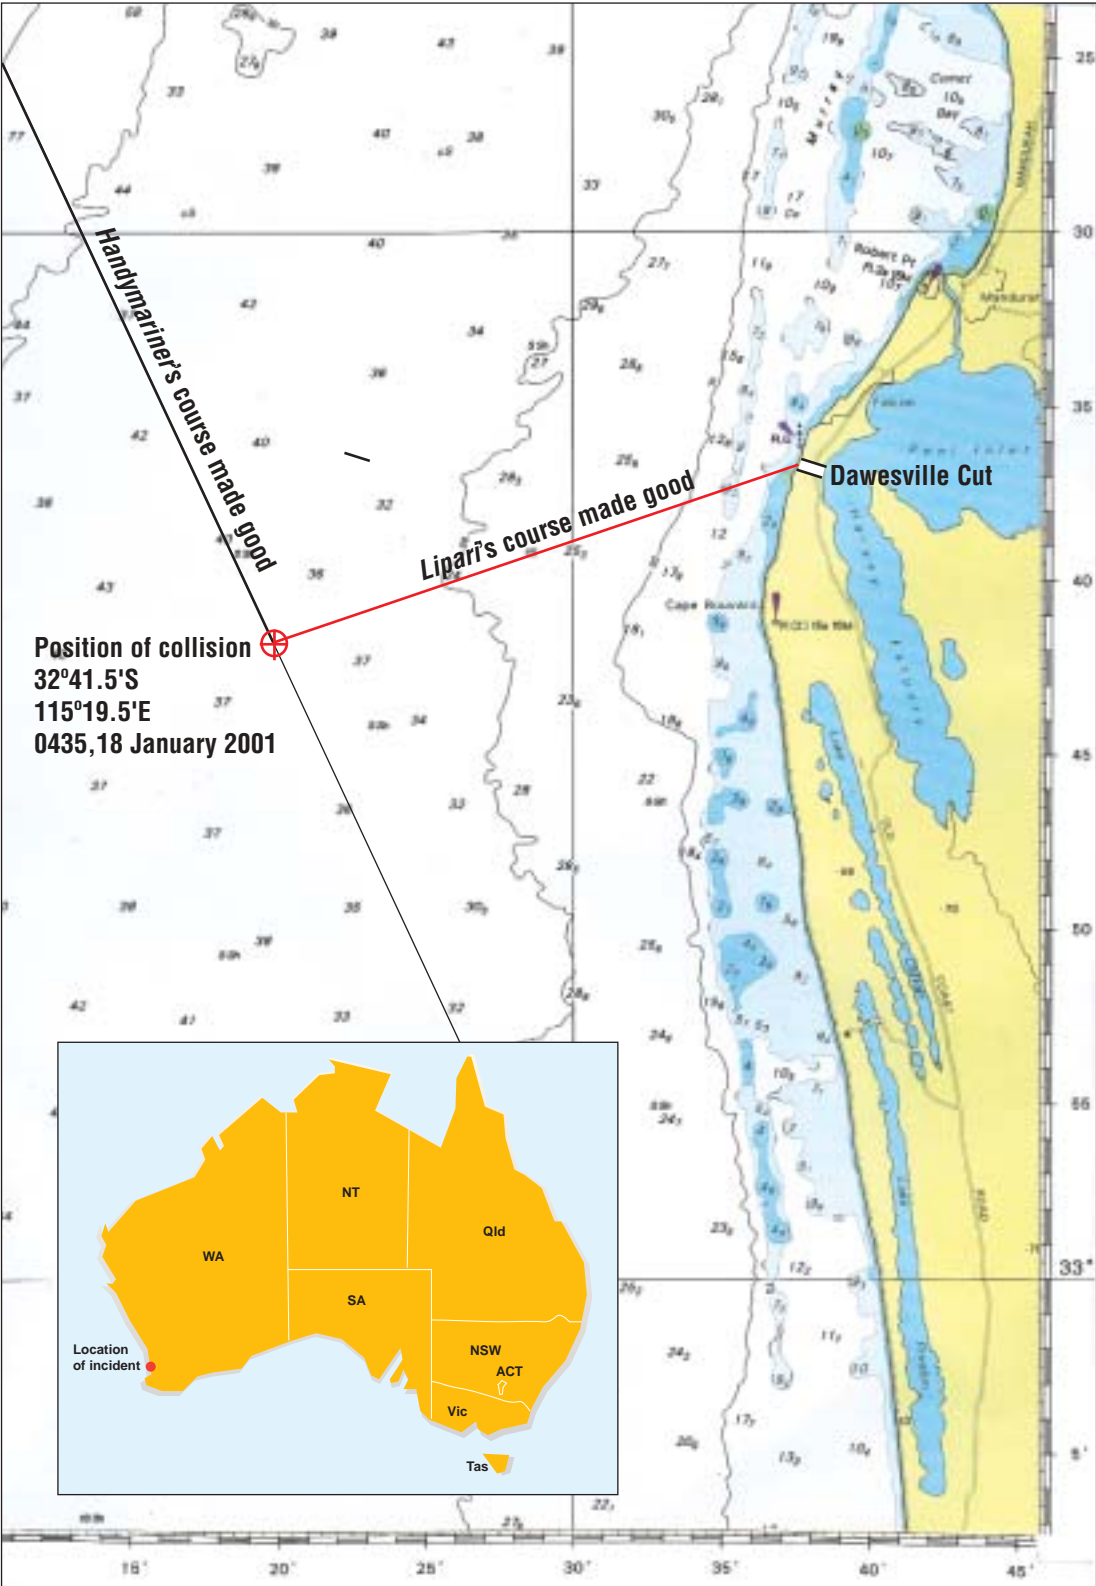
FIGURE 3:
Extract from Aus 334 showing vessel courses and position of collision

Figure 3 is an extract from navigation chart AUS 334 which shows each vessel's course prior to the collision and the position of the collision.

Handymariner and *Lipari* collided at 0435 on 18 January 2001, at a position of 32° 41.5' S 115° 19.5' E, 14 miles west-south-west of Cape Bouvard. This was the GPS position and time recorded by the crew of *Handymariner*. *Lipari*'s skipper verified the time of the collision and the general area.

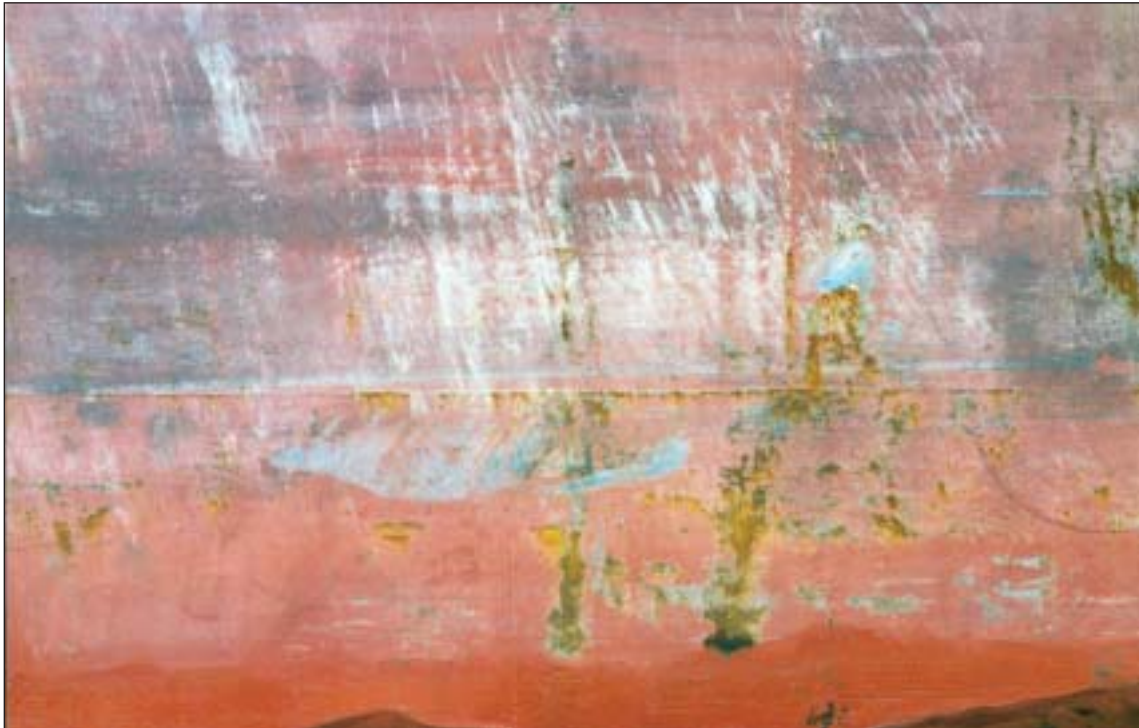
FIGURE 4:
Point of impact on *Handymariner*

An investigator from the Australian Transport Safety Bureau (ATSB) attended *Handymariner* in Bunbury on 19 January 2001. Various evidence was obtained from the ship including copies of the ship's navigation charts, log books, movement book, passage plan and course recorder trace. The master and mate were interviewed and provided accounts of the incident. Inspection of the ship revealed some fresh scores in the hull paint on the port side adjacent to number one hold (figure 4). Samples of the hull paint and some blue paint, which had been deposited on the hull, were taken for analysis. There was no damage evident to either the framing or hull plating.

The location of the blue paint deposited on *Handymariner*'s hull plating adjacent to number one hold indicates the fishing vessel's point of impact and is consistent with the mate's observations at the time.

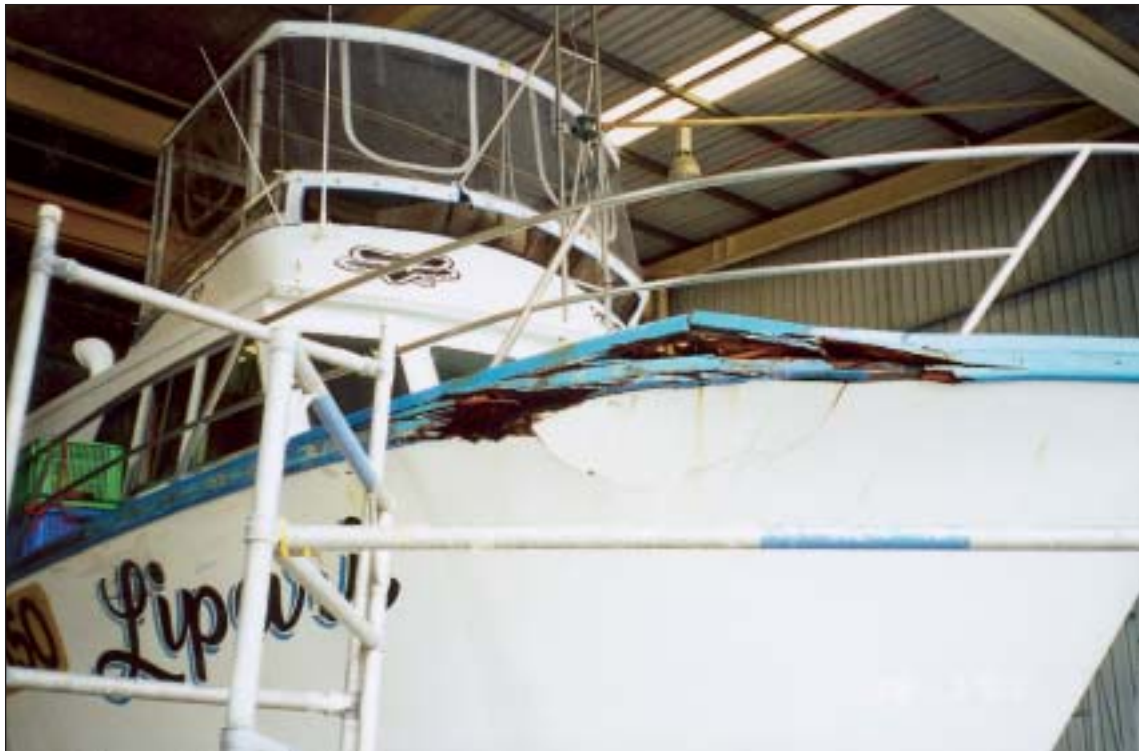
FIGURE 5:
Damage to *Lipari*

Lipari was examined in Fremantle on 20 January 2001 at the repair facility of North Port Boat Lifters. The vessel had been lifted from the water and was sitting on a cradle inside a workshop. *Lipari* presented as a well-maintained and well-equipped fishing vessel. Damage was noted in the area of the starboard bow with a hole in the marine ply hull planking and damage to the internal timber framing (figure 5). Samples of paint in the area of the damage were taken for analysis. It was noted that the VHF radio and GPS plotter had been removed from the cabinet adjacent to the conning position on the fly bridge.

The location and the extent of damage to *Lipari*'s starboard bow indicates that the fishing vessel and *Handymariner* were at an oblique angle at the point of impact and supports the skipper's assertion that he was turning to port when the collision occurred. The damage to *Lipari* would have been significantly worse if its angle of attack with respect to the ship had been greater, given the speed of the fishing vessel at the time.
