MARINE SAFETY INVESTIGATION
No. 195

**Independent investigation into
collision between the Panamanian
registered ship *Asian Nova*
and the Queensland registered
fishing vessel *Sassenach*
off Townsville, North Queensland
on 29 May 2003**

February 2005

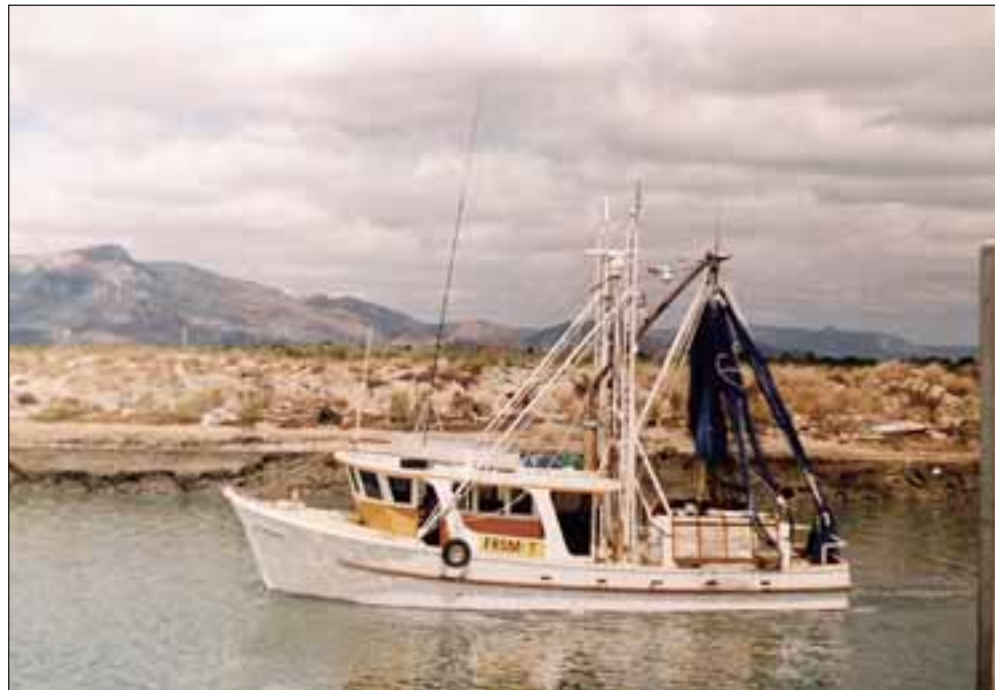
FIGURE 2:
Sassenach

Evidence was obtained by the divers employed on 4 and 5 June to examine *Sassenach* and recover the skipper's body. Further evidence was obtained when the boat was recovered on 23 August. There was damage to the hull in way of the port quarter and damage to the booms. In the main cabin, the position of switches and other equipment was noted and the boat's GPS unit and radar were recovered for scientific examination by the Australian Federal Police forensic services. The switch for the port side sidelight was found to be in the off position. While falling debris may have caused the switch to open, the probability is that the port side light was not illuminated.

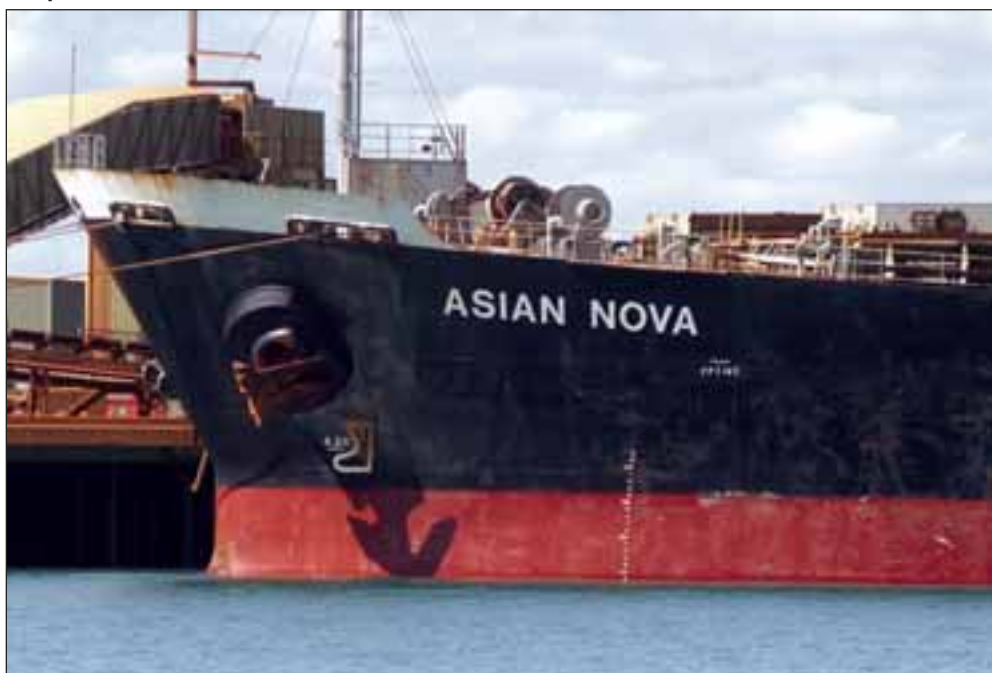
FIGURE 4:
The port bow of *Asian Nova*

Initially there was no direct contact between the hulls of the two vessels. *Sassenach*'s capsize was primarily the result of the *Asian Nova*'s bulbous bow fouling the fishing vessel's trawl warps. The contact between the hulls occurred when the fishing vessel was dragged in toward the ship's hull by the bulk carrier's forward momentum and swing to starboard which caused the damage to *Sassenach*'s port quarter and the subsequent capsize.

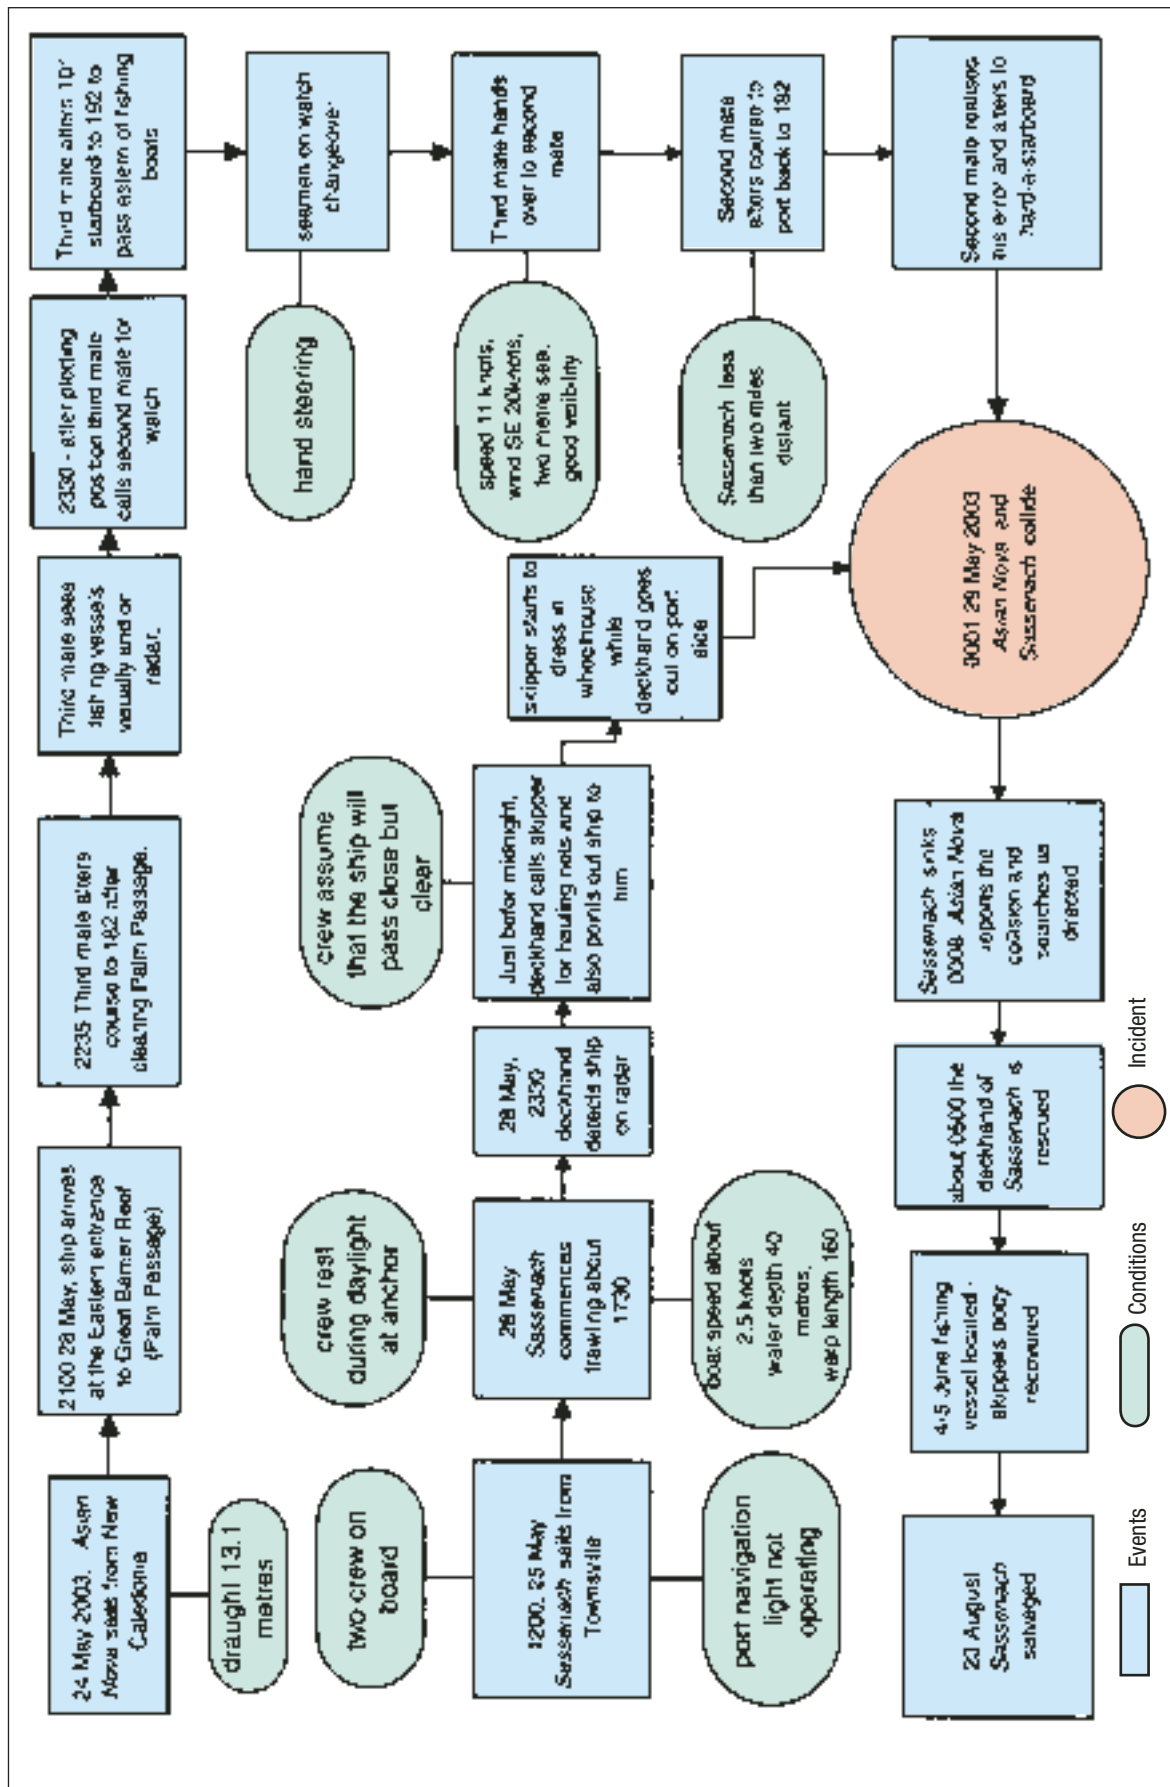
FIGURE 5:
Asia Nova/Sassenach: Events and causal factor chart

5. Neither the second nor third mates followed the recommended practice, nor company requirements, or the ship's standing orders when handing over control of the navigational watch.

8. Inter-personal relations were possibly a factor in the deficient hand-over between the third and second mates.
9. The assessment by the fishing vessel crew that *Asian Nova* was passing clear was made on scanty information.
