ATSB TRANSPORT SAFETY REPORT  
Aviation Occurrence Investigation A0-2011-017  
Preliminary

# Collision with terrain Near Bathurst Island Aerodrome, Northern Territory 5 February 2011

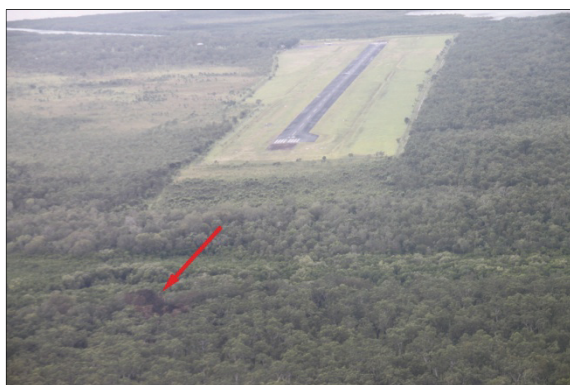
Shortly after takeoff, a number of witnesses reported hearing a loud noise or seeing a light from the direction of departure. A search and rescue operation was initiated, with both air and ground responses. VH-XGX was found to have impacted terrain approximately 1 km from the upwind end runway 33 (Figure 1).

**Figure 1: Accident site (arrowed) with respect to runway 33, Bathurst Island Aerodrome**

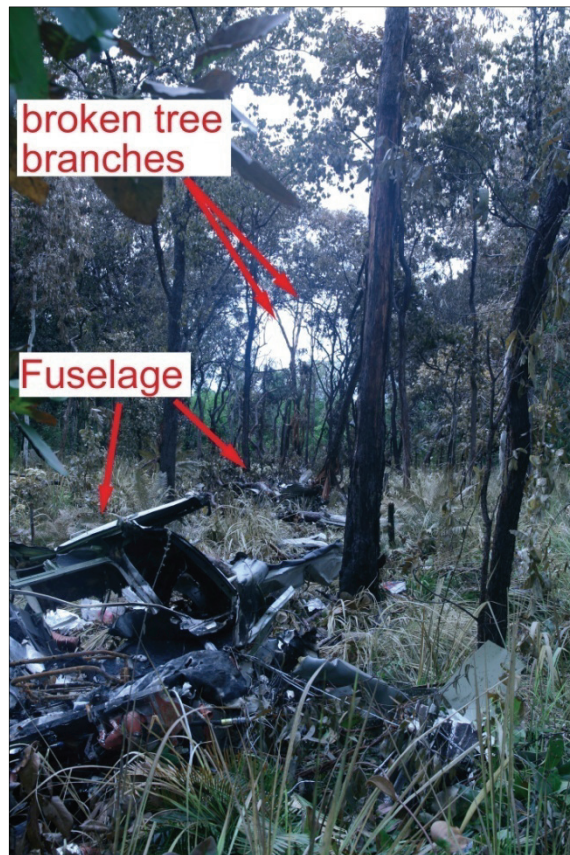
The aircraft impacted terrain in a heavily wooded area (Figure 2). Contact marks on a number of trees suggested that the aircraft probably had a shallow angle of descent into the ground, and that the wings were level.

The wreckage trail was approximately 120 m in length, and was oriented in line with, and on the same heading as runway 33. All major aircraft components were accounted for at the accident site.

Both engines had detached from the aircraft during the accident sequence. The extent of the rotational damage observed on both propellers suggested that both engines were producing significant power at the time of impact.

Heat damaged wreckage and foliage in the local area indicated that a significant fire had engulfed the area during the impact sequence.

Figure 2: Overview of wreckage towards approach direction
