MARINE SAFETY INVESTIGATION

REPORT 170

Independent investigation into the disabling of the  
Antigua and Barbuda flag general cargo vessel

# ANL Purpose

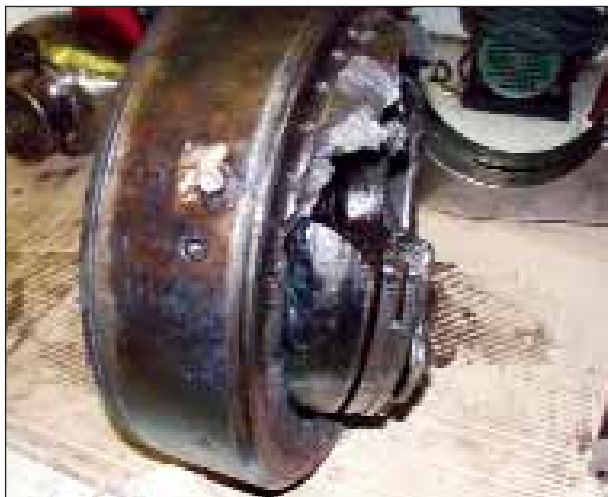
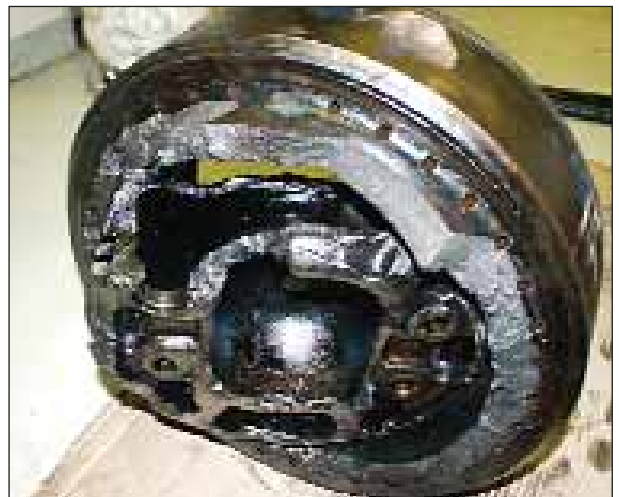
**FIGURE 4:**  
Top of cylinder liner with remains of piston crown jammed within it

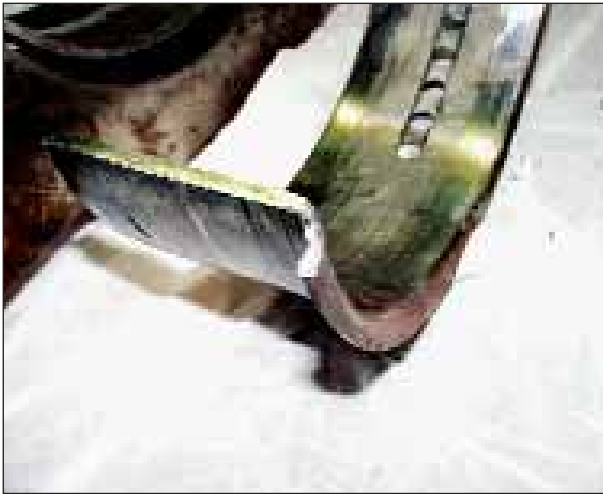
**FIGURE 5:**  
Front edge of upper half of bottom-end bearing shell splayed back in way of crank web

found that the bearing shells had moved forward out of the bottom-end partially obstructing the oil flow into the oil gallery around the bottom-end of the connecting rod. In addition, it was found that they had moved out at an angle being displaced approximately 10 mm on one side and 20 mm on the other. The locating tangs on the shells were not distorted but neatly folded inwards, a further indication that the bearing cap may have been tightened with the shells in an incorrect position during assembly of the bottom-end at the last overhaul in May 1999 at 2195 running hours. Incorrect assembly would have resulted in the loss of the 'crush' force which retains the bearing shells in the correct position. This, in turn, would allow the bearing shell halves to work their way very slowly out of the correct position, over the intervening period before the failure.

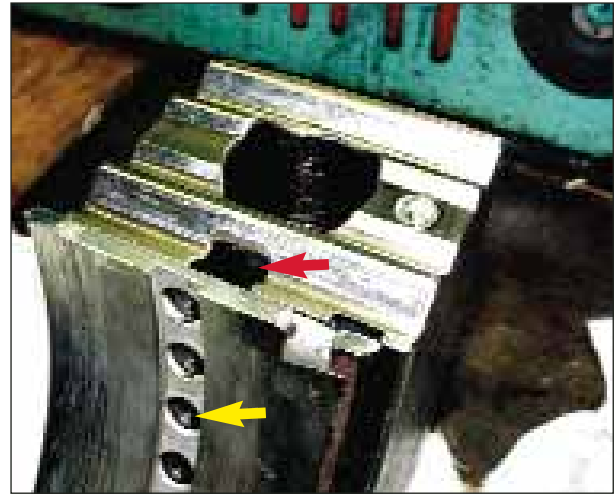
**FIGURE 6:**  
Bottom-end bearing cap and shell, showing relative movement between oil gallery (red arrow) and oil holes in shell (yellow arrow)

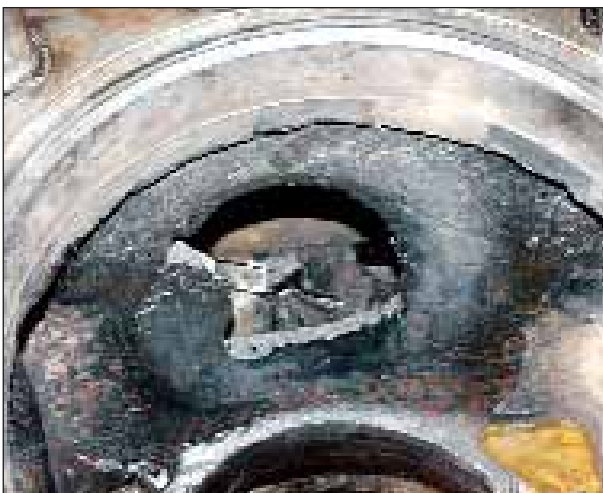
When the cylinder head and the top, remaining, part of the liner had been removed at sea, a hole, about 14 cms in diameter, was found in the engine entablature passing from the jacket cooling water space through to the charge-air

**FIGURE 7:**  
Hole through engine entablature from jacket cooling water to charge air spaces

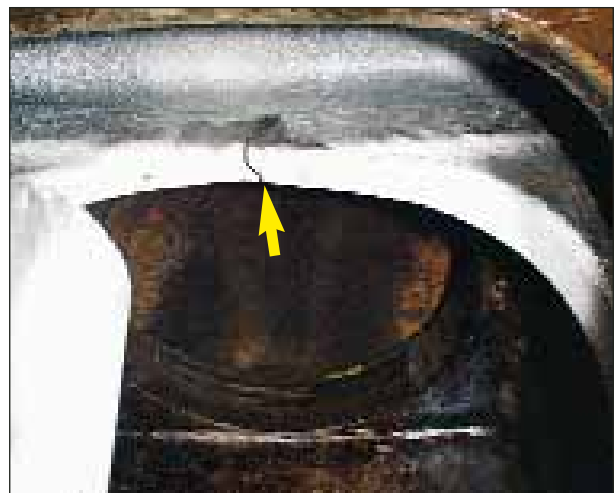
manifold. In addition, but less obvious, was a vertical crack extending through a longitudinal stiffening web of the engine block casting. This crack, which was found later when a more thorough examination of the damage was carried out in Brisbane, was just above the no. 4 unit starboard crankcase door. A number of options for repairing this crack were later considered, such as by the 'Metalock' process, but none was likely to prove satisfactory and it was eventually decided that there was no option but to replace the engine block. This was a relatively major undertaking which required shipping a new block from the engine manufacturer's works in Vasa, Finland and

**FIGURE 8:**  
Crack (enhanced) through stiffening web in entablature at no. 4 unit

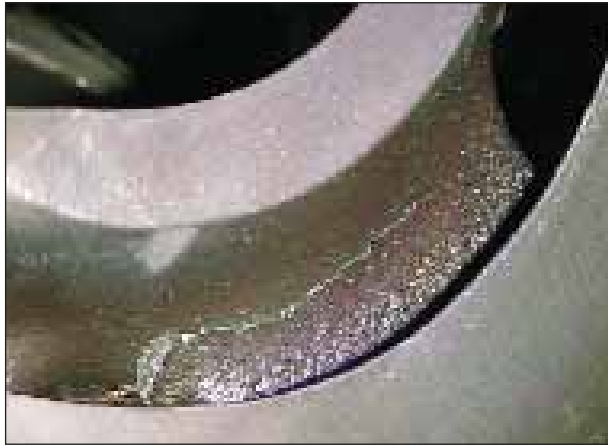
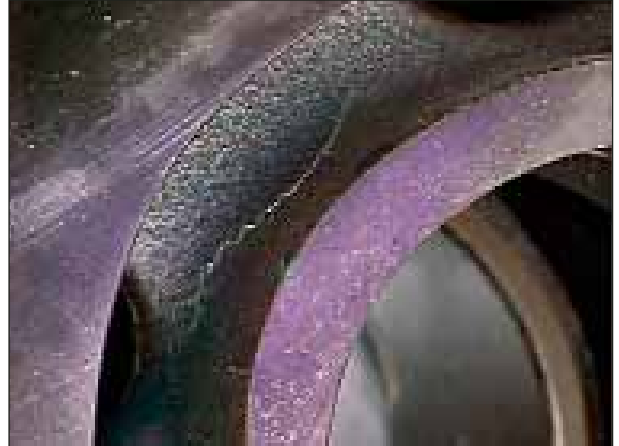
**FIGURE 9:**

**Fatigue cracking detected in no.1 piston (left) and no.2 piston (right) in the gudgeon pin support webs of both pistons**  
(Forgacs Engineering Pty Ltd.)

In the metallurgical examination of the piston fragments, conducted by ETRS, consultants on behalf of the Salvage Association, there was clear evidence of cracking in the nodular cast iron of the piston, particularly around the supports for the gudgeon pin bore. Similar cracking was found in the pistons removed from nos. 1 and 2 units.

4. The piston in no. 4 unit contained pre-existing fatigue cracks in the gudgeon pin support webs and at the base of no. 4 ring support groove. These cracks weakened the piston to the point where the additional loading on the gudgeon pin, caused by the partial seizure, was sufficient to cause its disintegration.

The report recommends that the engine manufacturer consider issuing a service bulletin covering the crack-detecting of any of the earlier, one-piece, pistons which may still be in service.

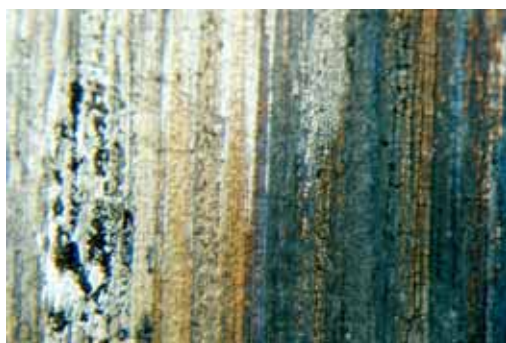
had broken up while in operation. Fragments of the piston skirt and the cylinder showed evidence of heavy scoring and frictional overheating of the running surfaces (figures 1 & 2). Evidence of pre-existing cracking was found within the fragments of the piston that made up the gudgeon pin support pillars and the base of the number-four ring groove. When the other five pistons from the engine were inspected using crack detection techniques, two of the units also revealed significant crack indications around the gudgeon lateral supports and pillars. Confirmed as fatigue cracking by subsequent fracture surface examination, the general nature of the cracking was very similar to that shown by the fractured remnants of the number-four piston.

**Figure 1.** External surface of a fragment of the piston skirt – shows appreciable axial scoring and frictional heat tinting.

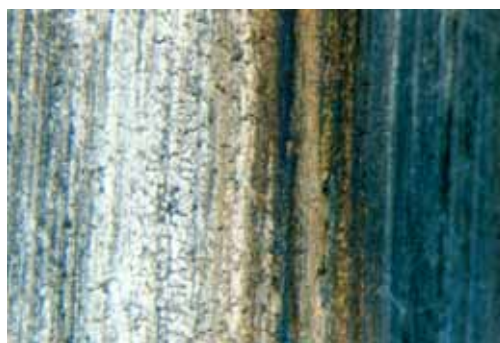
**Figure 2.** Internal surface of a fragment of the cylinder liner – shows very similar characteristics to the piston skirt.

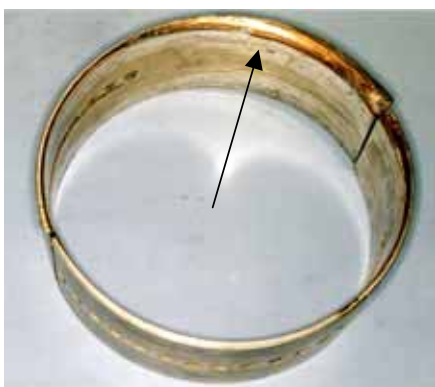
The connecting rod bearing shells from the number-four cylinder assembly had sustained flaring and splaying damage to the forward edge as a result of the axial movement of the shells and subsequent contact with the crank-pin journal radius. The splaying damage was biased to one side of the assembly (figures 3 & 4), suggesting a degree of axial misalignment between the shells and the bearing housing. Both locating tangs at the shell ends had collapsed (figures 5 & 6). The supply of oil to the pistons was channelled via galleries within the crankshaft and through the crank-pin journals into the connecting rods. The axial movement of the bearing shells within the number-four journal had reduced the effective width of the flow path for the oil moving from the crankshaft, through the bearing space and into the connecting rod. The movement of the shells, however, was insufficient to completely obstruct the oil flow.

**Figure 3.** Connecting rod bearing shells from the number-four assembly. The outward splaying of the forward edge is clearly visible (arrowed).

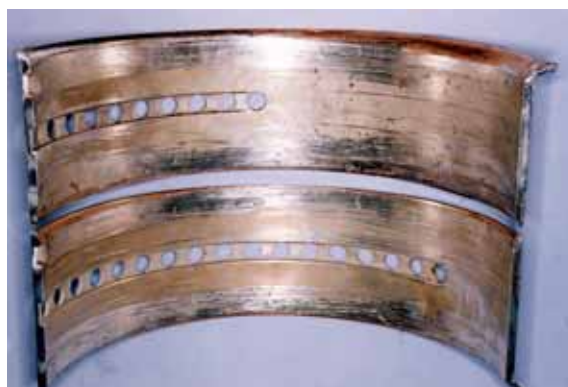
**Figure 4.** Internal (running) surfaces of the bearing shells illustrating the forward edge damage and the wiping of the surface white-metal layer.

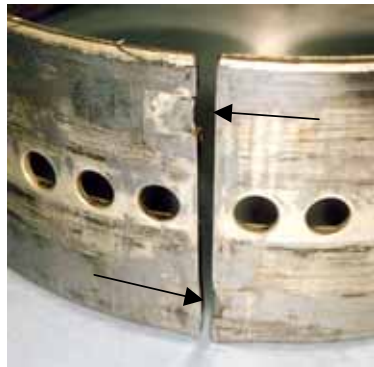
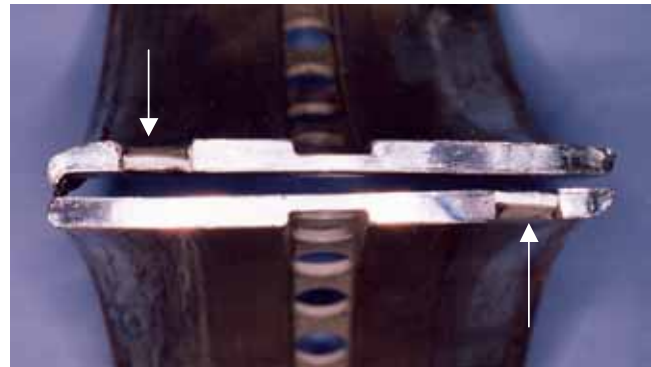
**Figures 5 & 6.** Axial movement of the bearing shells while the engine was in operation flattened the locating tangs as shown.
