Taharoa Express: Fatality while sailing from Dampier, Western Australia – 11 July 2002

ATSB
Australian Transport Safety Bureau

August 2003

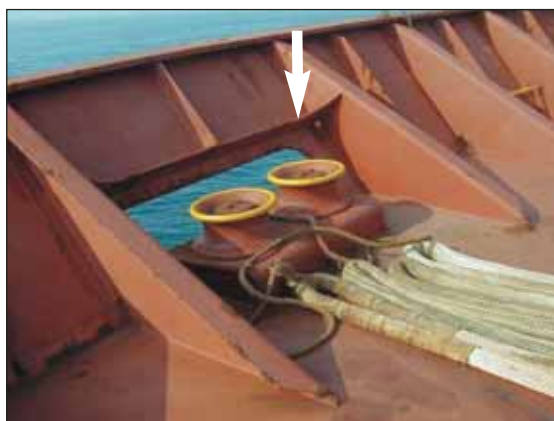
FIGURE 1: Position of seaman

The seaman who was killed was standing almost directly over the fairlead roller for the breastline that struck him.

The seaman was not under direct supervision of the mate in the moments leading to the accident. The mate's position on deck and the bosun's position at the controls of the mooring winch meant that the mate, and possibly the bosun, did not have the seaman directly in their line of sight.

ISM documentation for harbour stations should include appropriate procedures from the ILO publication 'Accident prevention on board ship at sea and in port' to assist seafarers to operate safely during anchoring, mooring or towing operations.

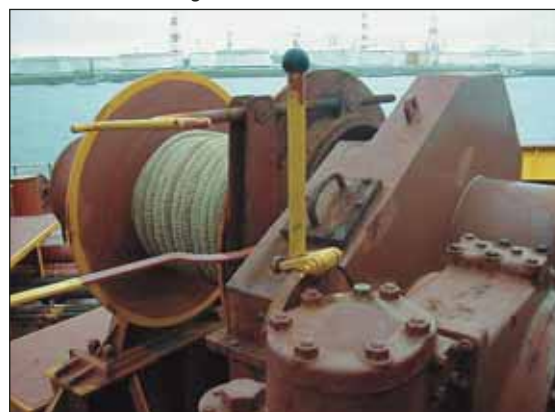
FIGURE 2: Mooring winch controls

There were no passing vessels and the tugs were pushing the ship against the jetty. The breastline had been slack and there was no external force that would have caused the ship to surge and the breastline to tighten. It seemed, therefore, that the bosun might have operated the winch to heave on, instead of slacken, the breastlines before both lines were released.

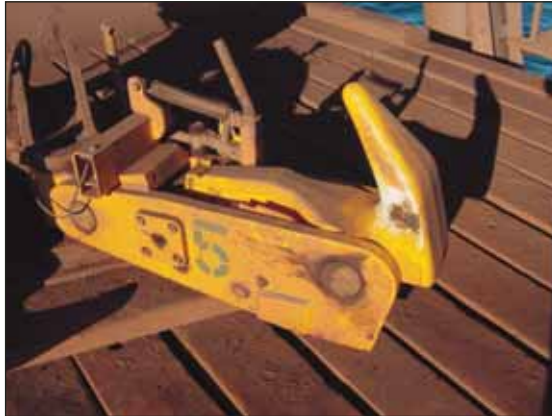
FIGURE 3: The hook that tripped

The hook that had released under load was one of a batch that had been supplied to the owners in 1982 for use at Parker Point after being load tested in the factory on 20 January 1982. Since then, to prevent corrosion, modifications to the hooks had been carried out by Hamersley Iron without referring any proposed changes to the manufacturers.

There was no apparent reason for the failure of the remote release to operate the hook when the breastline was slack. The original hooks had sometimes failed to release because of dust in the release mechanism or mechanical or electrical malfunction. However, although this particular hook had been modified, there was no evidence of any previous problems with premature release of the modified hooks.

There is a possibility that the hook involved in this incident had not been reset correctly before *Taharoa Express* had berthed. Each hook is fitted with an indicator to show when it is

correctly reset. The operator who had reset the hooks for the breastlines said that he had not noticed anything abnormal about the hooks. However, it is possible that, on this occasion, the indicator was faulty or that the operator had not noticed the position of the indicator.

With mooring equipment being critical to the safety of ships in port, modifications to such equipment should be referred to the manufacturers of the equipment. In addition, after any modification, the equipment should be examined and tested for correct functioning.

A thorough investigation of the modifications to the remote release mechanisms for mooring hooks should be undertaken to ensure that the hooks operate safely and reliably.

Regular maintenance and testing of mooring equipment should be carried out and recorded.

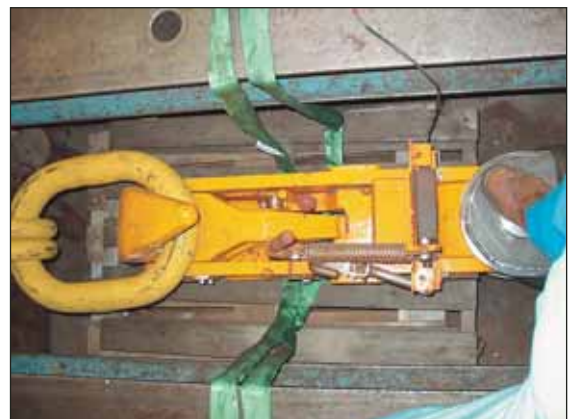
On 31 July and 12 September 2002, as part of the investigation, a series of tests were carried out on this hook. During the tests, representatives from Hamersley Iron, the hook manufacturer, the Australian Maritime Safety Authority (on behalf of the ATSB) and the testing establishment were present. The hook was tested satisfactorily with a proof load of 130 tonnes and released normally at loads of 25 and 100 tonnes.

The results of tests on the hook were inconclusive in demonstrating any definitive cause for it to have released unexpectedly while the rope was under tension. Disagreement exists between Hamersley Iron and the manufacturers of the hook as to whether the modifications which had been carried out might have contributed to this unexpected release.

- The initial attempt to release the hook may have partially altered the position of the release system, resulting in a release under extreme tension;
- Dirt or rust had interfered with resetting of the hook;
- The hook had not been correctly reset.

FIGURE 4: Hook under test
