# Collision between suburban passenger trains G231 and 215A in Adelaide Yard, South Australia 24 February 2011

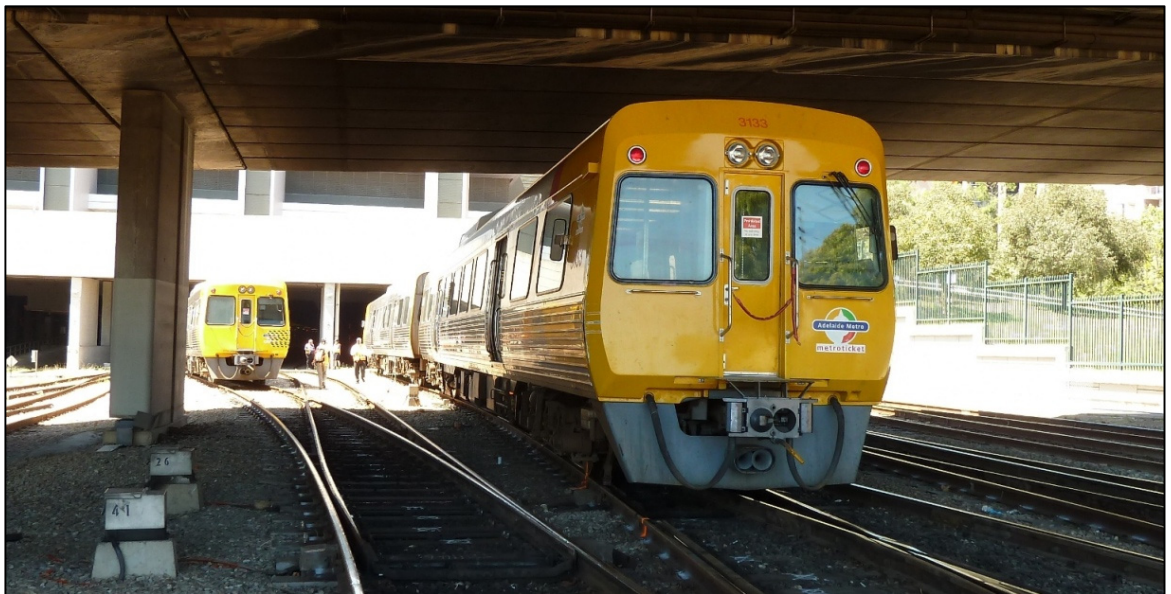
Figure 1: Leading railcar 3133 of train G231, looking towards Adelaide Station

A short time later the drivers of both trains realised that they would come into conflict and applied their train's brakes, too late to avoid a collision. There were no injuries as a result of the collision but both trains sustained minor damage.

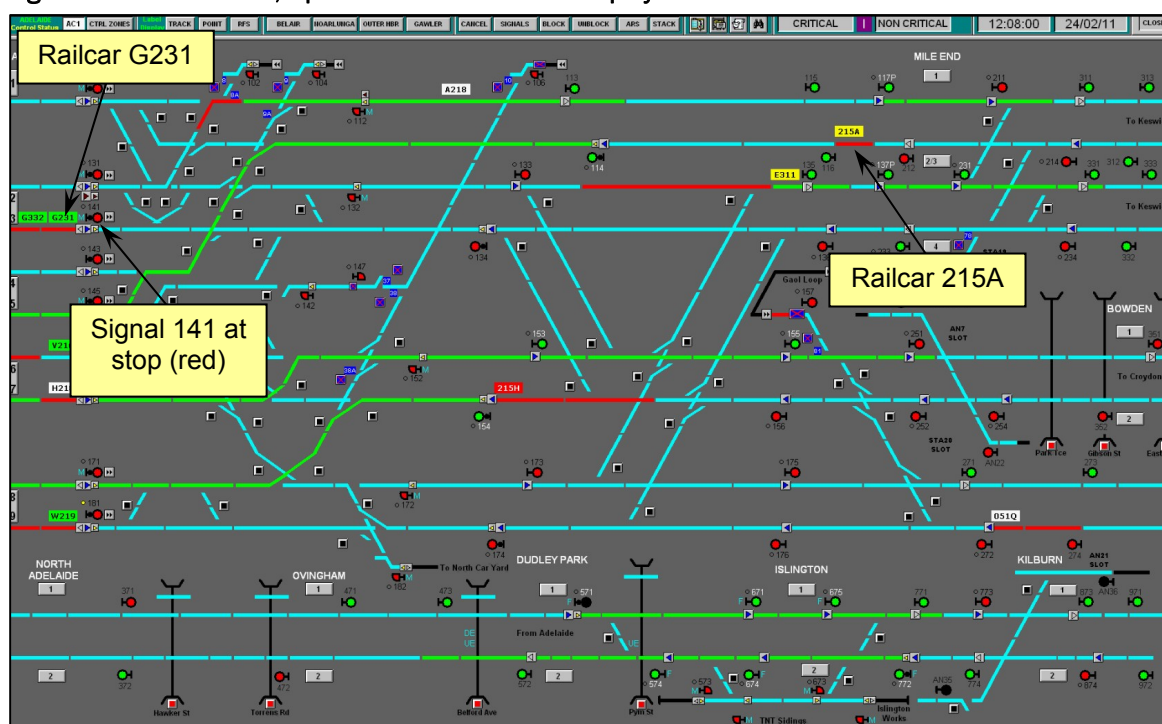
Figure 3: Adelaide Yard, Operations Control Centre replay 1208:00.

Based on a preliminary examination of this information including the driver's account of events, it was concluded that signal 141 was displaying a stop (red) indication when the PC correctly gave the 'yellow' RoW flag.

This was corroborated by the Train Control data replay log (Figure 3) that shows signal 141 was at stop (red) at 1208:00 which coincided with the time the PC gave the RoW.

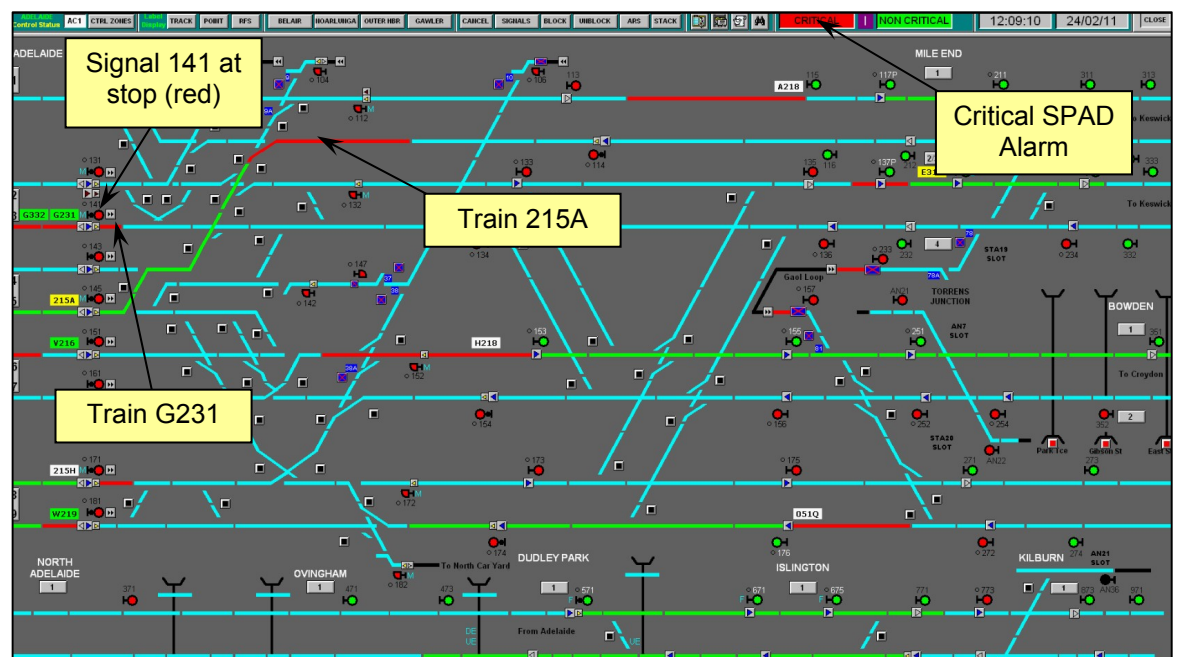
The examination of the Train Control data replay log (Figure 4) and the computerised safety interlocking data show that signal 141 did not clear at any time as train G231 approached it and was displaying a stop (red) indication as the train went past it.

**Figure 4: Adelaide Yard, Operations Control Centre replay 1209:10 showing train G231 having just passed signal 141, displaying a stop (red) indication, illumination of SPAD alarm and position of train 215A.**
