ATSB TRANSPORT SAFETY REPORT
Aviation Occurrence Investigation
AO-2009-077
Final

**Visual flight into instrument
meteorological conditions
Dorrigo, NSW
9 December 2009
VH-MJO, Bell Helicopter 206L-1
LongRanger**

**Visual flight into instrument meteorological
conditions
Dorrigo, New South Wales
9 December 2009
VH-MJO
Bell Helicopter Company 206L-1 LongRanger**

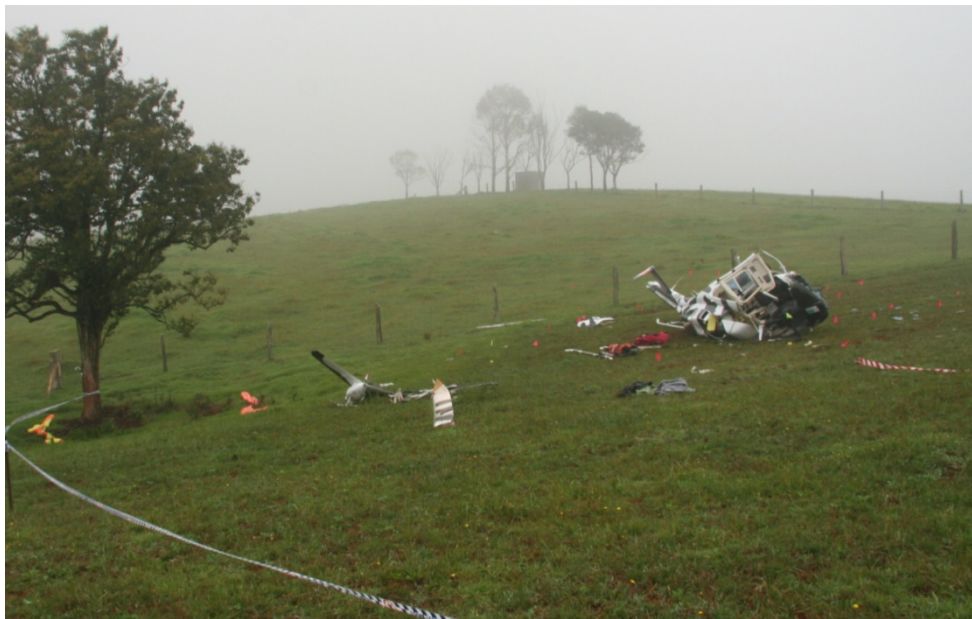
Figure 1: Helicopter wreckage

At about 1120 Eastern Daylight-saving Time¹, during the second flight from Dorrigo that day, the pilot lost all external visual reference and the helicopter impacted the ground with significant vertical force, fatally injuring the sole passenger who occupied the front left cockpit seat, and seriously injuring² the pilot. The helicopter was seriously damaged³ (Figure 1).

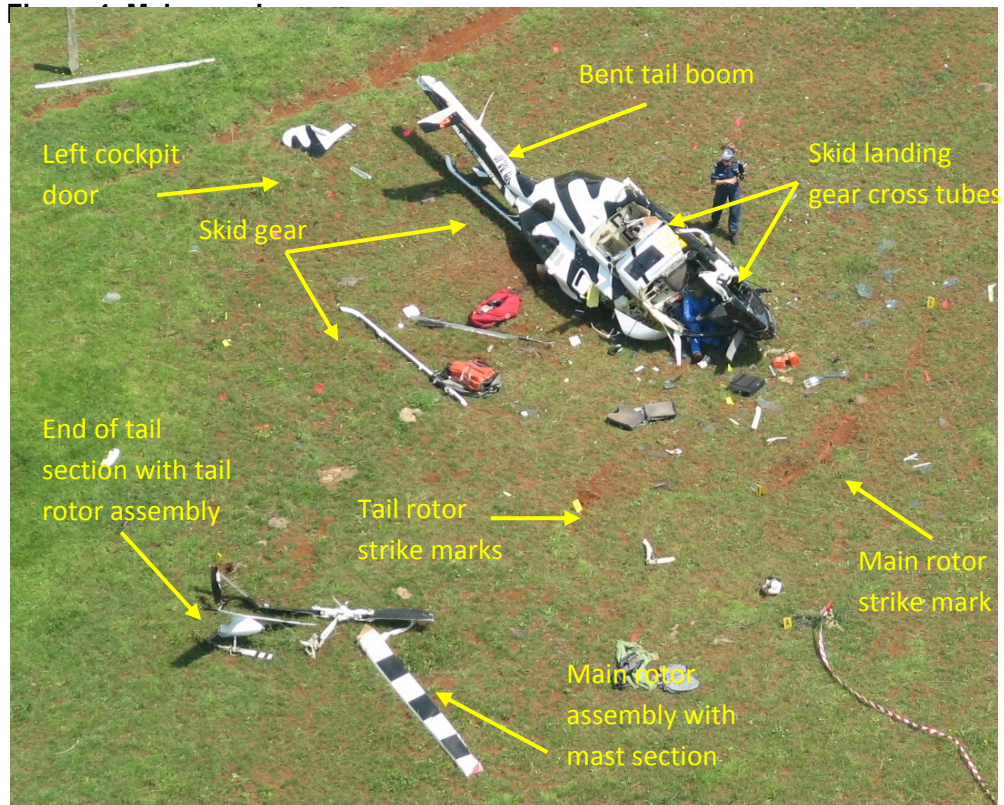
The majority of the wreckage was contained within an area of about 10 m in diameter (Figure 4). The only wreckage outside that area included one of the tail rotor blade tips, which was about 16 m from the main wreckage, and the outboard section of one main rotor blade, which was about 56 m from the main wreckage. The surrounding terrain was slightly undulating and sloped downwards to the south at about 10°.

The helicopter came to rest on its right side. Both left and right landing skids had separated from the helicopter and were located parallel and adjacent to the fuselage, oriented in the opposite direction to the orientation of the main wreckage. Both forward and rear skid landing gear crosstubes were splayed and rotated forward and upwards. The tail boom was bent in a downward direction and the tail rotor assembly had separated from the boom, consistent with a ground strike. The main rotor mast had failed in overstress and separated from the transmission at the base of the mast. Two of the three hydraulic servo actuator connecting tubes had also failed in overstress. All of the helicopter components were accounted for at the accident site.

There was a crescent-shaped ground scar just forward of the fuselage that showed signs of paint transfer from the main rotor blades. A second ground scar, consisting of a smooth-edged vertical cut into the soil, was found between the fuselage and crescent-shaped main rotor ground scar. That ground scar was consistent with a tail rotor strike.

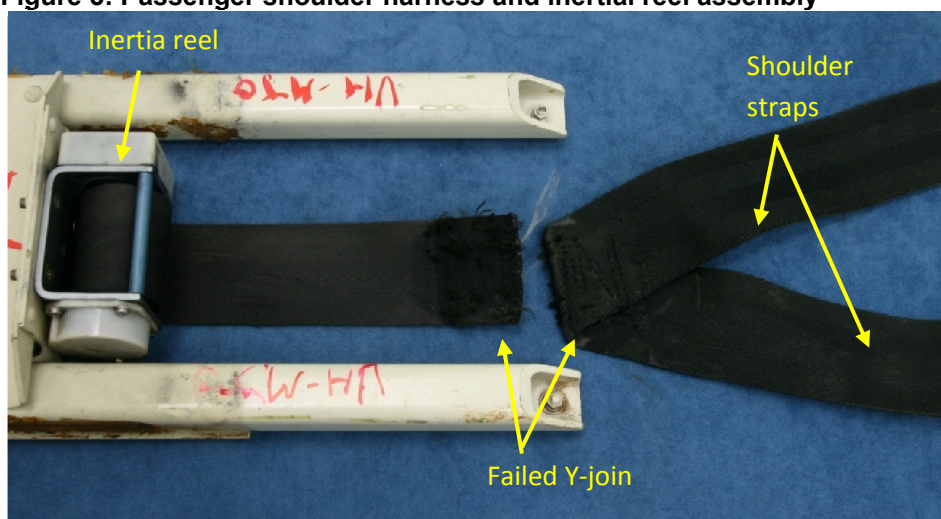
Figure 5: Passenger shoulder harness and inertial reel assembly

The passenger's seat belt had failed at the shoulder harness/inertia reel Y-joint stitching (Figure 5), while the pilot's seat belt was undamaged. The passenger's shoulder straps were located outside the aircraft. The pilot and passenger's seat belt assemblies were recovered from the wreckage for technical examination.

An examination of the passenger's seat belt shoulder harness revealed that the harness had failed in overstress at the stitched Y-joint between the shoulder straps and the inertia reel webbing (Figure 5).

The pilot's survival, and nature of the injuries sustained by the passenger suggested that the initial impact forces were survivable. However, the overstress failure of the passenger's shoulder harness at the Y-join meant that the passenger was not restrained in the upper torso area by the time the helicopter came to rest.

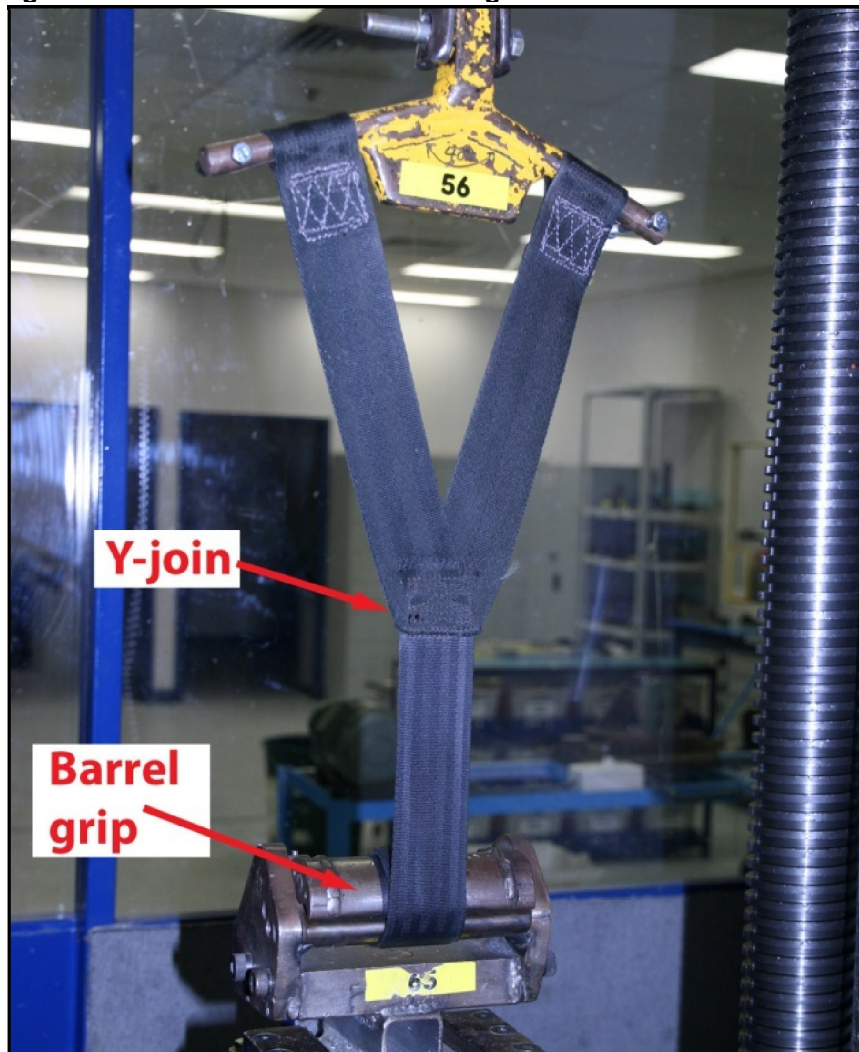
Figure 6: Shoulder harness load testing

At test, the pilot's shoulder harness Y-join failed at about 70% of the strength of a newly-manufactured Y-join. That degradation in strength was consistent with the effect of a combination of the higher-than-usual stresses placed on the harness during the accident sequence, and the general degradation of the harness due to ageing.
