# Collision with terrain, VH-TCG 44 km WSW Rolleston, Queensland 9 November 2010

## Abstract

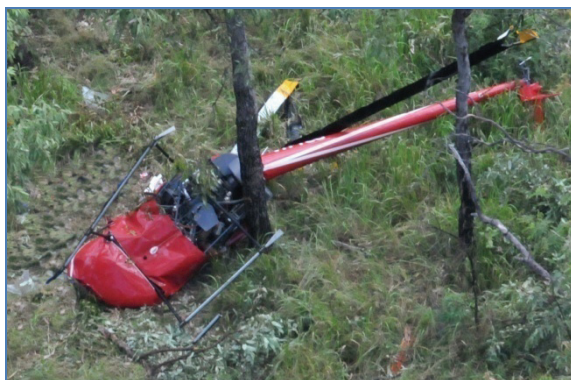
**Figure 1: Accident site<sup>4</sup>**

The wreckage was located in a heavily-timbered valley at about 1,800 ft (Figure 1). The trees in the area were reported to be up to about 150 ft tall.

Photographic and witness information indicated that the main wreckage was located at the base of an iron bark tree. Score marks on the tree were consistent with the helicopter sliding down the trunk. The helicopter had impacted the ground in an almost inverted, right side-low, nose-down attitude. All of the major components, including the main rotor blades, tail boom and tail rotor were attached to the helicopter. Several branches from a gum tree were identified amongst the wreckage.

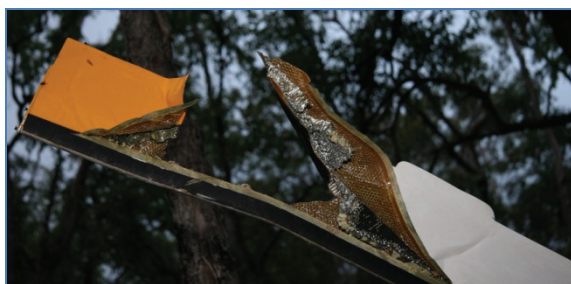
**Figure 2: Main rotor blade damage<sup>5</sup>**

As evidenced in the photographs provided to the investigation, one of the main rotor blades had an impact mark and forward bending on the leading edge, near the blade tip. In addition, that blade had rearwards chord-wise bending along its span. The other blade was bent in several directions, most likely as a result of the impact.

The impact mark, forward bending and chord-wise creasing on the main rotor blades was consistent with the rotor system contacting at least one tree. The level of disruption to the main rotor blades as a result of contacting foliage would have significantly reduced the effective lift from the main rotor system, resulting in an uncontrolled descent into terrain.
