## ACCIDENT INVESTIGATION REPORT

**Cessna 172M Aircraft VH-UGC and  
Piper PA28-180 Aircraft VH-UQN  
Parafield Airport  
South Australia  
on 1 February 1976**

## Special Investigation Report 76-3

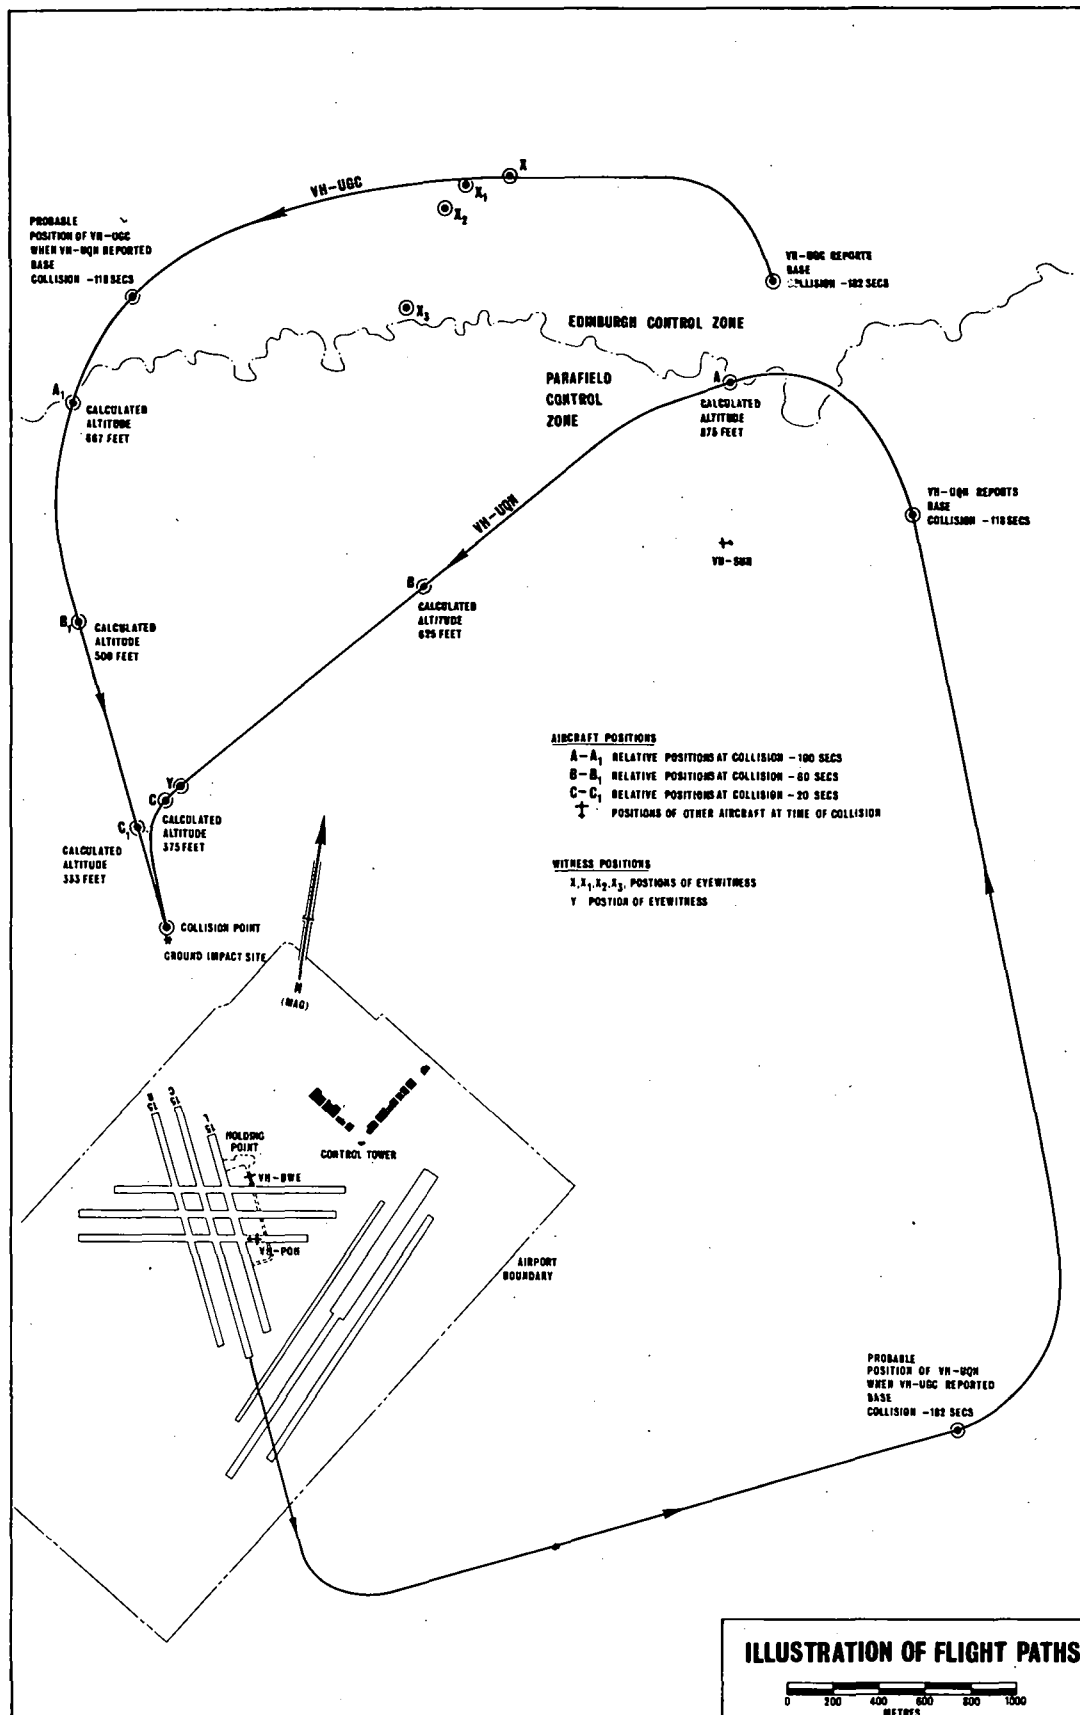
At Appendix B the probable flight paths of the aircraft are shown and three positions deemed to be significant were selected for study. These positions are notated as A, B and C on the probable flight path of the Piper, the corresponding positions in time being notated as A1, B1 and C1 on the probable flight path of the Cessna. These positions are calculated to have been 100 seconds, 60 seconds and 20 seconds prior to collision.

proximity to each other with the Piper in a 30 to 40 degree banked turn to the left, positioned above, to the left, and a little behind the Cessna. The positions from which this witness observed the aircraft are shown on Appendix B as X, X1, X2 and X3.

Another witness was located 1525 metres north-west of the threshold of Runway 15 Left and 290 metres to the left of the extended centreline of the runway. She has stated that she first saw a Cessna aircraft, on a bearing subsequently measured as 290 degrees magnetic, in descending flight, with the wings level and on a heading of approximately 150 degrees magnetic. She then saw a Piper aircraft approaching directly towards her position on a bearing subsequently measured as 062 degrees magnetic. The Piper was higher than the Cessna and it appeared to be descending at a faster rate. When directly over her head, at a time calculated to have been 23 seconds prior to the collision, the Piper banked about 30 degrees to the left still descending and after it had turned onto the same heading as the Cessna, its wings levelled and it continued descending until the aircraft collided. The position of this witness is shown on Appendix B as Y.

The probable flight paths of Cessna VH-UGC and Piper VH-UQN are illustrated at Appendix B, and it can be seen that the downwind leg of the circuit pattern flown by the Cessna was longer than the norm, with an incidental result that when the Cessna was on the base leg of its circuit it was flying within the Edinburgh Military Control

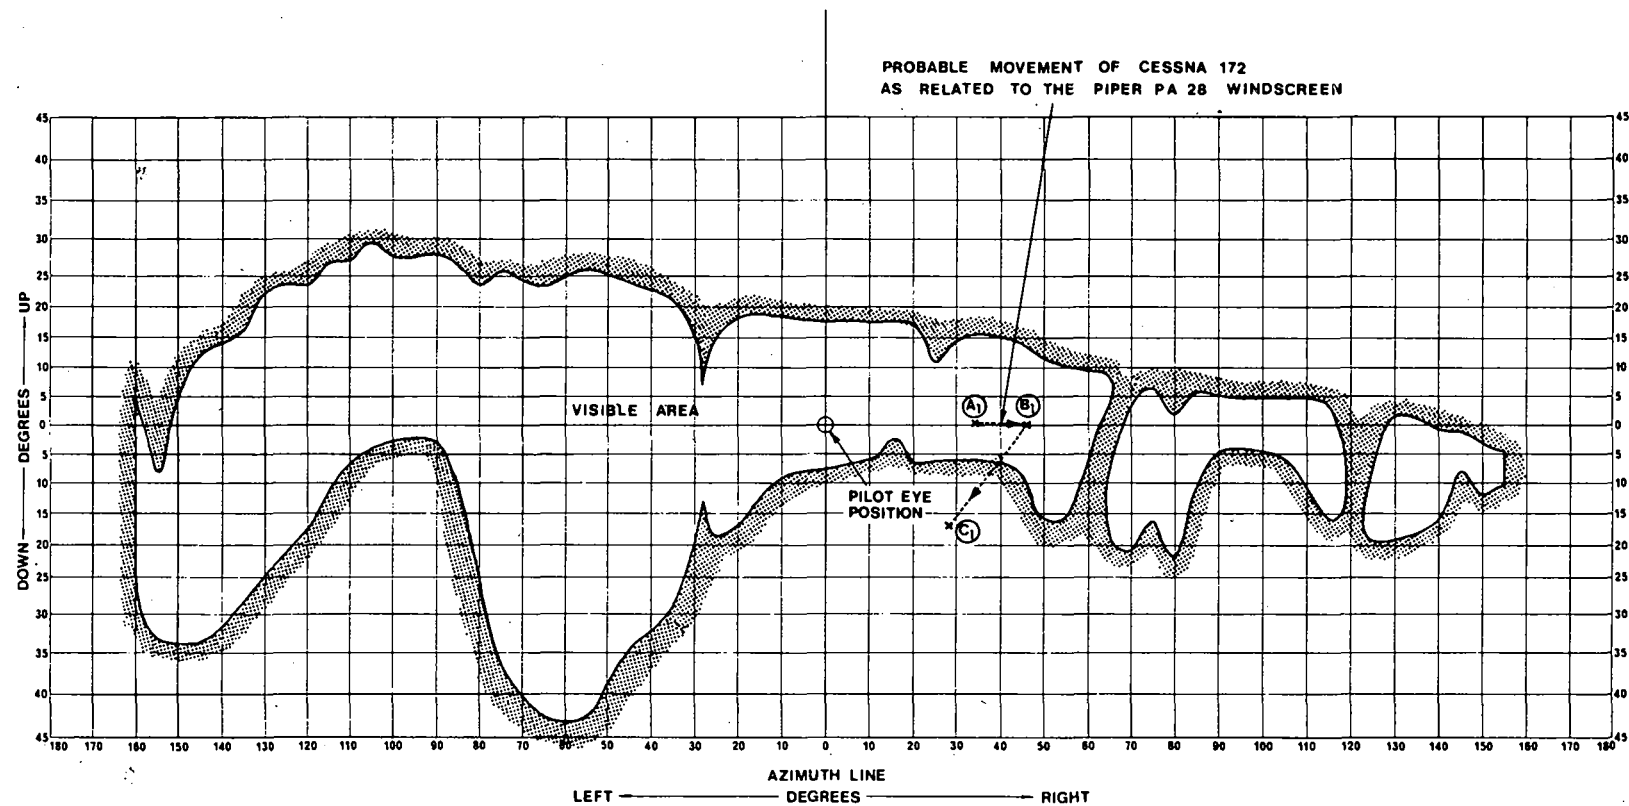
PIPER PA 28 - 180  
COCKPIT VISIBILITY DIAGRAM

A chart for each aircraft was then prepared showing angles of azimuth horizontally and the limiting angles of elevation and declination in a vertical plane. These charts are presented at Appendixes C and D. When used in conjunction with the probable flight paths flown by the Piper and the Cessna, Appendix C indicates that provided the wings of the Piper were level, there was no obstruction to the sighting of the Cessna by the pilot of the Piper when the Cessna was at Positions A1, B1, and until about 25 seconds prior to the collision; but the Cessna would have been obscured when it was at Position C1 and the Piper was at Position C (20 seconds prior to the collision) at which position the Piper was banked some 30 degrees to the left. Appendix D indicates that in respect of the pilot of the Cessna, the Piper would have been either obscured, or likely to have been obscured by the port wingtip area of the Cessna during the time the Cessna was initially banked some 5 degrees to the left, through Position A1, and as it then continued on its final approach in a wings level attitude.

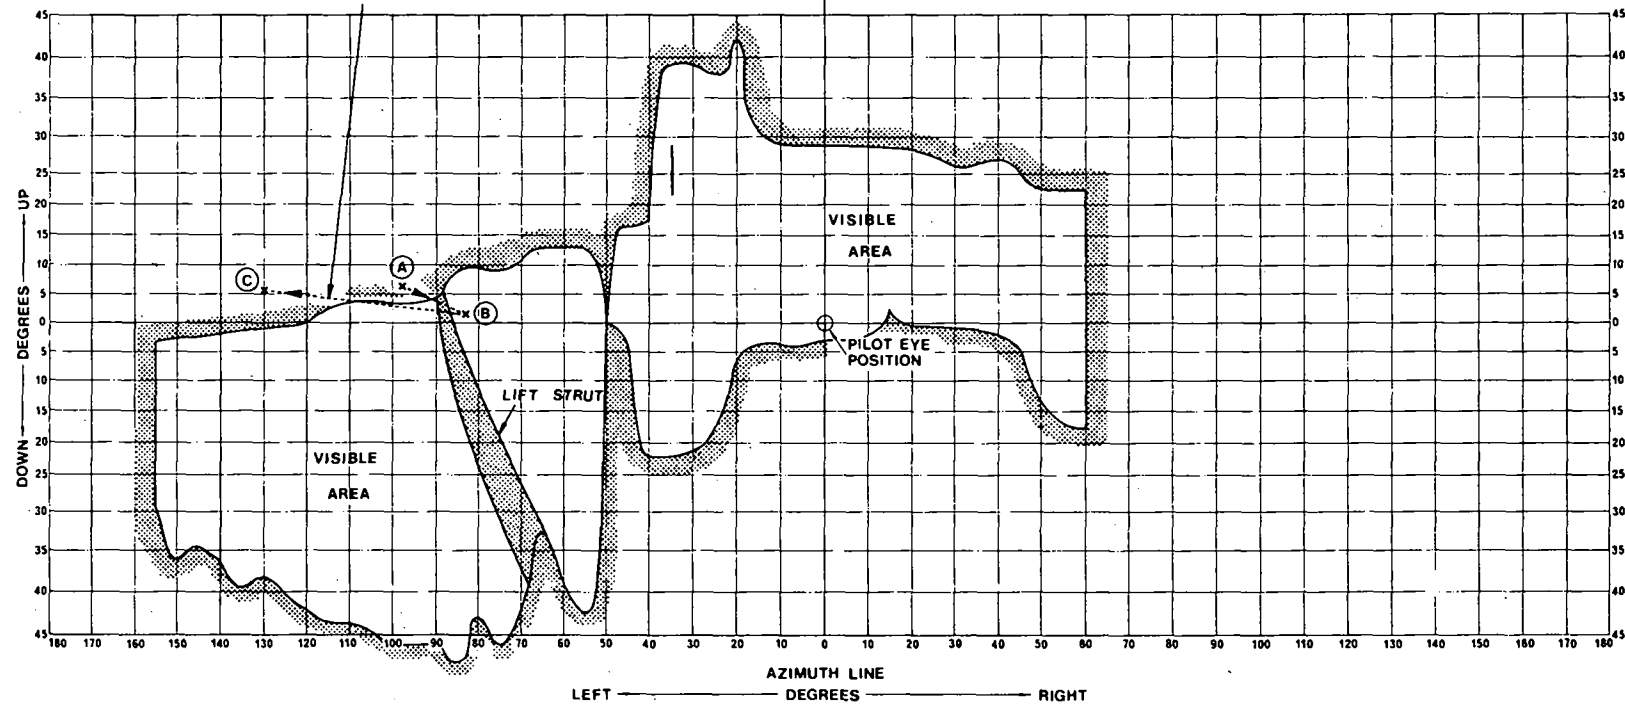
**CESSNA 172M**  
**COCKPIT VISIBILITY DIAGRAM**

PROBABLE MOVEMENT OF PIPER PA 28  
AS RELATED TO THE CESSNA 172 WINDSCREEN
