ATSB TRANSPORT SAFETY REPORT
Aviation Occurrence Investigation
AO-2008-059
Final

**Midair collision
3 km NW of Moorabbin Aerodrome, Victoria
27 August 2008
VH-UPY, Cessna Aircraft Company A150M
VH-CGT, Piper Aircraft Corp PA-28-161**

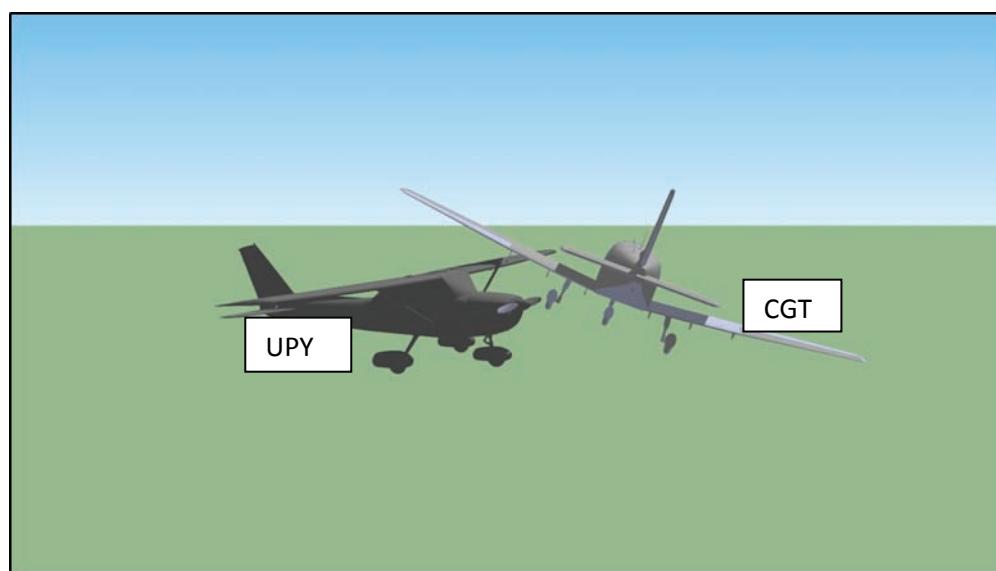
Figure 5: Representation of the early collision sequence

The two aircraft collided at 1237:52 (Figure 5).

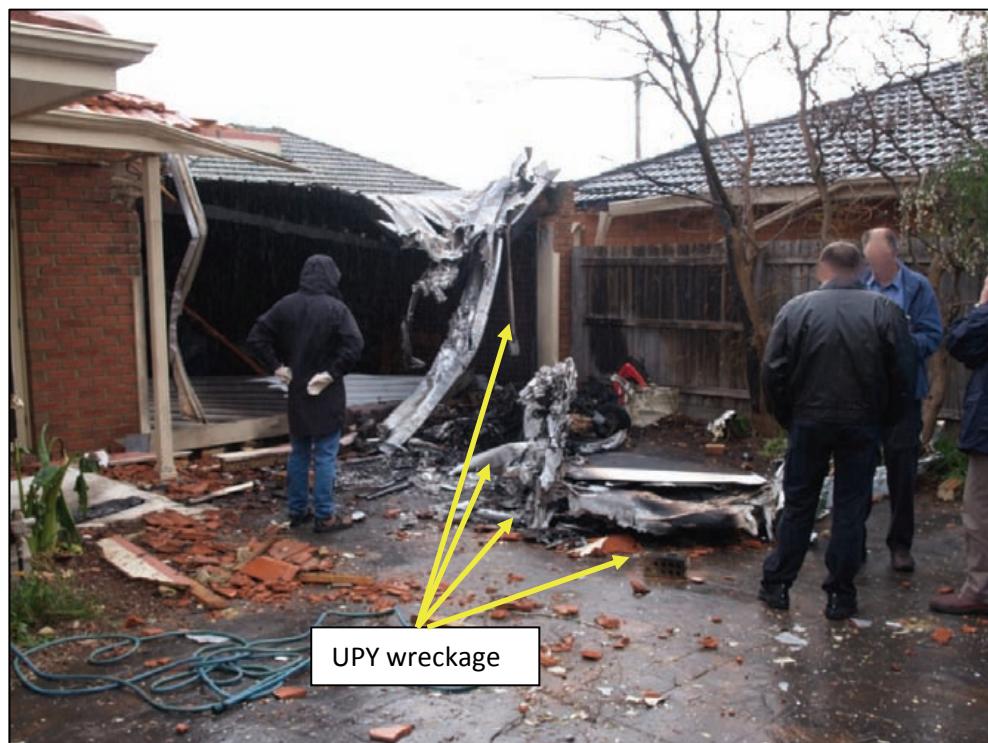
Figure 6: Impact and fire damage to the private residence

Damage was sustained by a private residence from UPY's impact with terrain. A post-impact fire was fed by aviation fuel from the aircraft that drained into one of the residence's drains. The fire damaged a fence, parts of the residence and a vehicle that was parked in the driveway, and a neighbour's house (Figure 6).

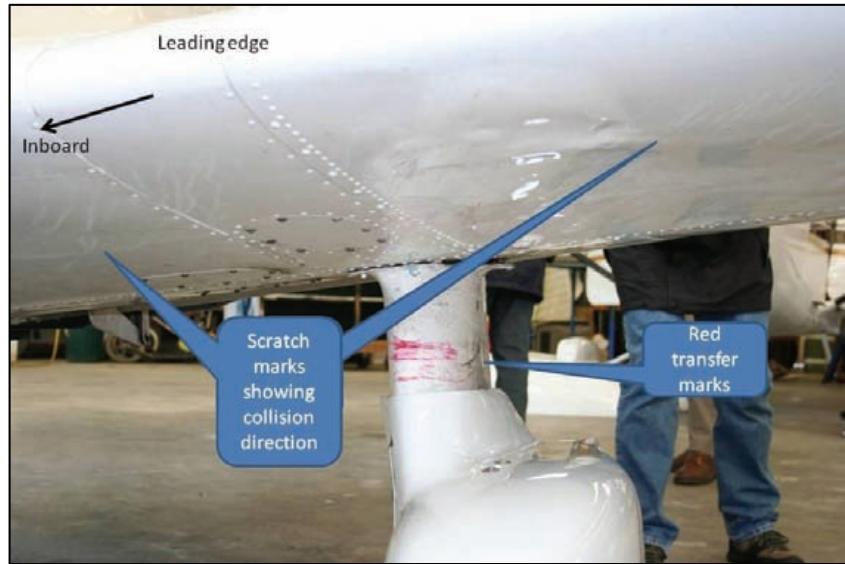
Figure 8: Scratches and wiring insulation transfer marks on CGT's left wing and landing gear

The damage to UPY that was attributed to the midair collision was consistent with the nature of the impact as described in witness reports. That was, the aircraft's left wing collided with the lower inboard section of the left wing of CGT near the left main landing gear (Figure 8). The fuel drain to CGT's left fuel tank appeared to have broken off during the collision, as both pilots in that aircraft reported the development of a fuel leak from that area. The fuel drain was subsequently unable to be located.

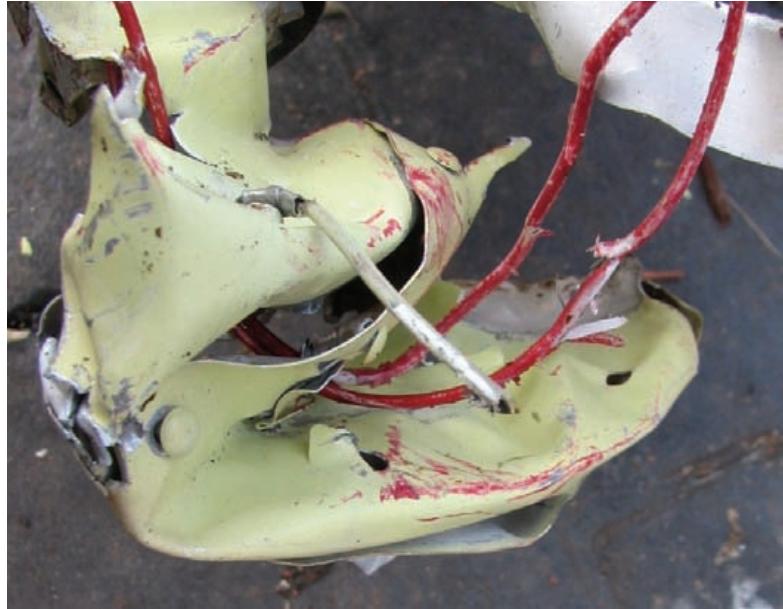
Figure 9 Damaged red electrical insulation from UPY's left wing

The red paint transfer on CGT's left landing gear and other surfaces was consistent with contact with the red Teflon lining of the insulated electrical wiring that was connected to UPY's wingtip navigation lights (Figure 9).

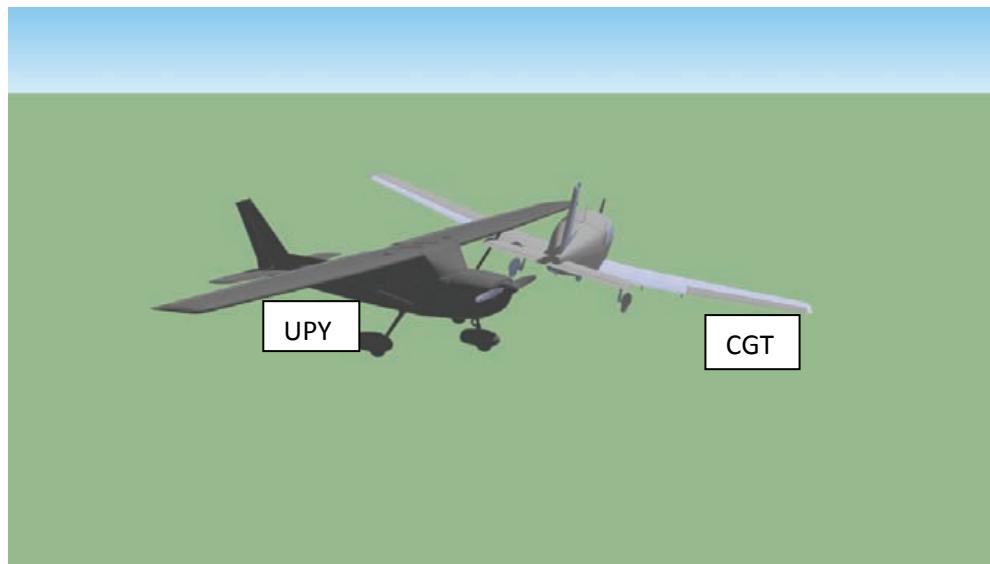
Figure 10: Representation of the latter stages of the impact sequence

The left wing of UPY also struck the left wing and flap, and the left rear fuselage, of CGT. During the subsequent impact, the outer section of CGT's tailplane detached and became entangled in the outer-left wing strut mounting on UPY (Figure 10). That section of tailplane was found at the accident site with the wreckage of UPY.

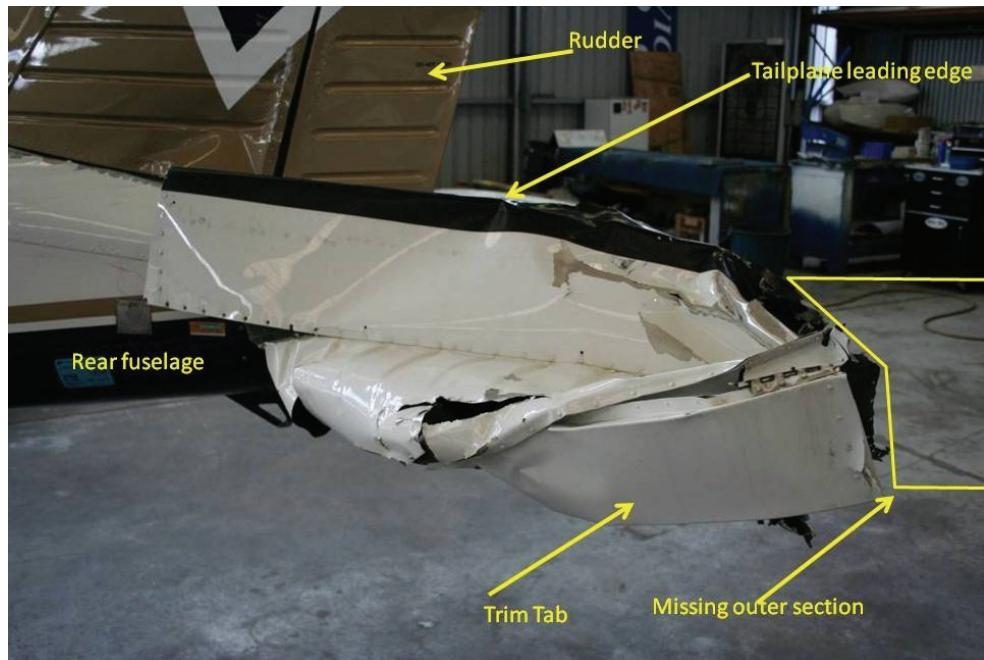
Figure 11: Left tailplane damage to CGT

The remainder of CGT's left tailplane was folded upwards and rearwards by the force of the impact (Figure 11). There was also impact damage to the left side of the aircraft's fin and rudder.

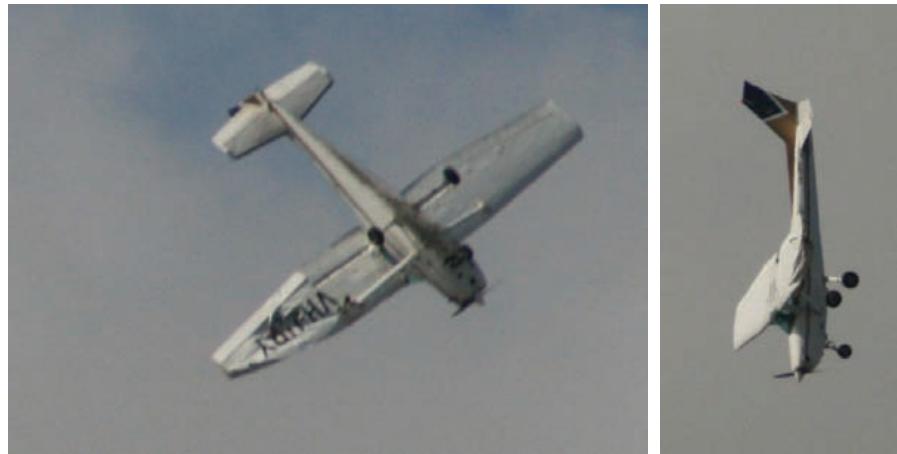
Figures 12: Witness images of the damage to UPY

The outer section of the UPY's left wing was severely damaged, forcing the leading edge and wing structure rearward against the left aileron and compromising the aileron control system. The aircraft was reported to have descended almost vertically after the collision (Figure 12), and was seen by witnesses to roll a minimum of three times before impacting the ground.

The impact with the ground ruptured UPY's wing fuel tanks and a post-impact, fuel-fed fire consumed the aircraft's fuselage, the inner section of the right wing, the mid-rear section of the left wing, the right tailplane and the fin and rudder. The

cockpit and fuselage structures were destroyed by impact forces and the post-impact fire.

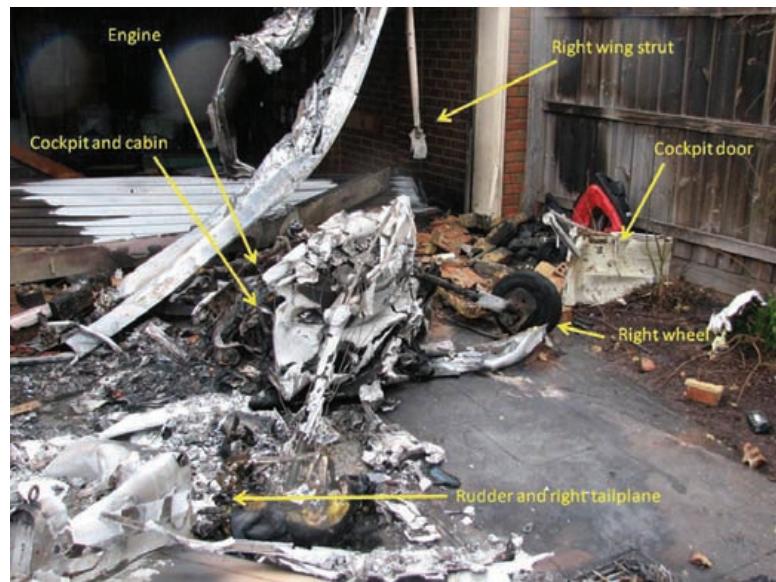
Figure 13: Aircraft wreckage

Consistent with the witness reports of the almost vertical descent of UPY after the midair collision, the aircraft impacted terrain at high speed in a steep, nose-down attitude. The aircraft was destroyed by the impact and post-impact, aviation fuel-fed fire (see Figures 6, 13 and 14). The roof of the double garage and front of a private residence was damaged before the aircraft came to rest to the side of the adjoining house.

The aircraft's propeller impacted a courtyard at the rear of the house, about 30 cm from the edge of the garage floor. The engine, the lower part of the engine nacelle and the engine cowling were located slightly further away from the house, immediately beyond the propeller (Figure 14). The remains of the cockpit floor, cabin and one seat were found immediately behind the engine, the second seat was to the right of the engine.

Parts of the aircraft's instrumentation were found in the vicinity of the cockpit floor and engine. No useful information could be obtained from those instruments because of the degree of damage.

There was a substantial overstress failure of the aircraft's primary structures as a result of ground impact, resulting in compression and separation of the left wing's upper skin, outboard of the flaps. The spars, ribs, frames and bulkheads of both wings were twisted and bent as a result of the impact.

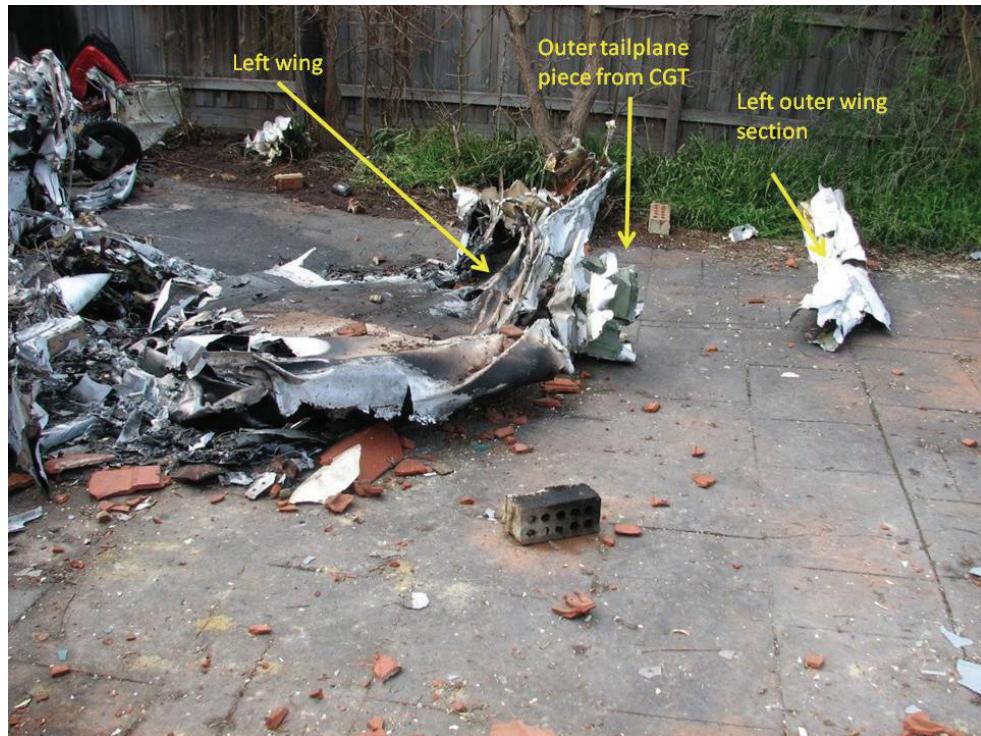
Figure 14: UPY's left wing and a section of CGT's left tailplane

Pieces of perspex were found over an area measuring 100 m from the accident site. The outboard section of CGT's left tailplane was found in the vicinity of UPY's left wing (Figure 14).
