**ATSB TRANSPORT SAFETY REPORT**  
Aviation Occurrence Investigation  
AO-2009-031  
Final

**Collision with terrain**  
**120 km west of Paraburdoo**  
**Western Australia**  
**25 or 26 June 2009**  
**VH-HXO**  
**Robinson Helicopter Company R22 Beta II**

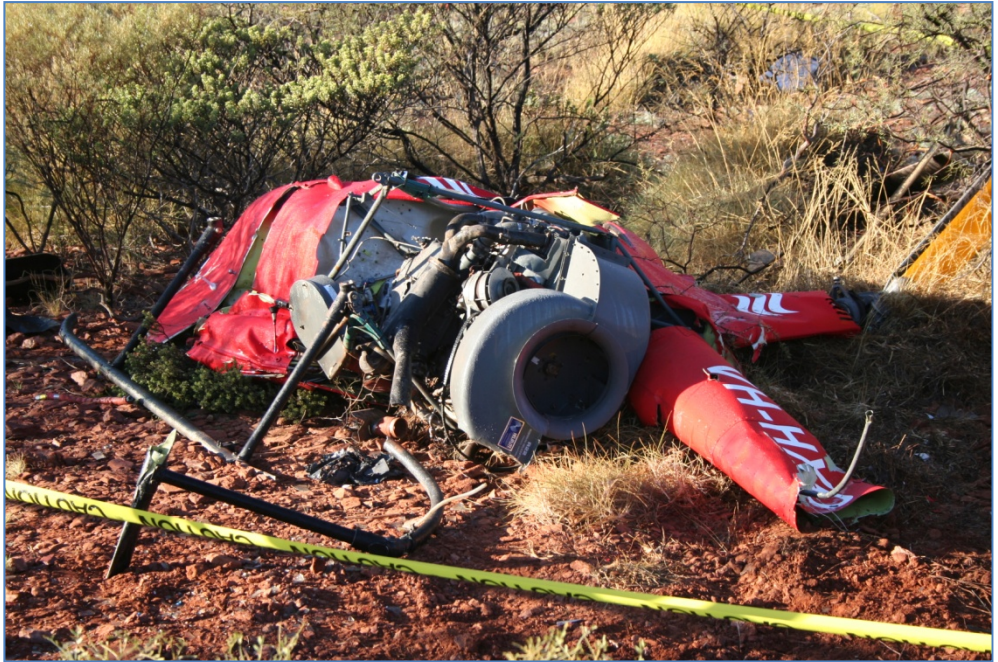
**Figure 2: Main wreckage**

The damage to the helicopter would have rapidly decreased its forward speed. That would explain the close proximity of the initial ground impact mark of the helicopter to the main wreckage. The severe deformation of the helicopter's main structure was most likely as a result of an almost inverted, right-side low, vertical descent.

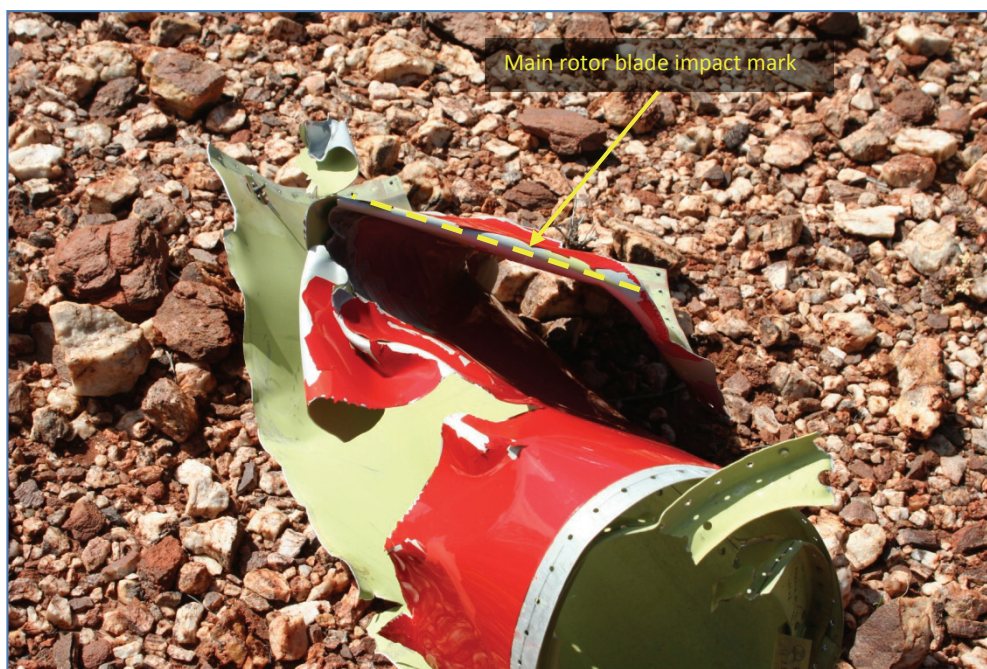
**Figure 4: Tail boom section with main rotor blade impact**

The distribution of the tail boom assembly along the wreckage trail, and damage to the assembly showed that it had separated from the helicopter in flight. There was extensive deformation of the assembly and indications of at least two main rotor blade contacts (Figure 4). There was also paint transfer from the red tail boom onto the main rotor blades (Figure 5).

The impact damage to the tail boom showed that the main rotor blades struck the tail boom at least twice before the helicopter impacted the ground. That was consistent with the fracture surfaces of the tail rotor driveshaft, which were due to impact with the main rotor blades, and not a result of an in-flight failure.

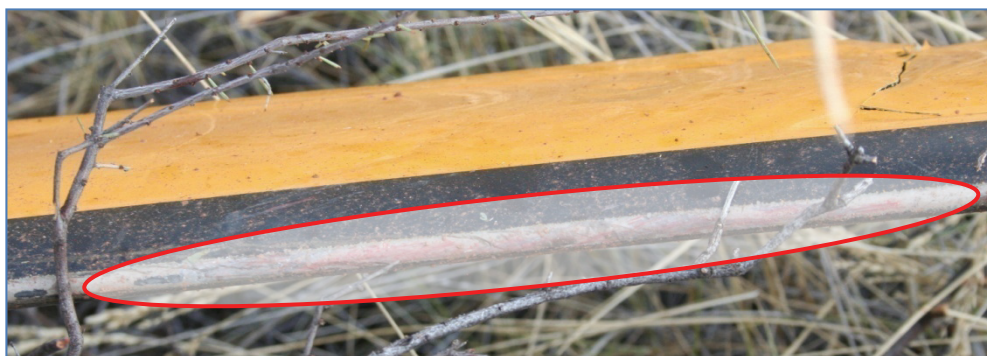
**Figure 5: Red paint transfer onto the leading edge of the main rotor blade**

Both of the main rotor blades remained attached to the main rotor hub. Both of the blades displayed chord-wise creasing from bending rearwards, as well as paint transfer from contact with the tail boom.

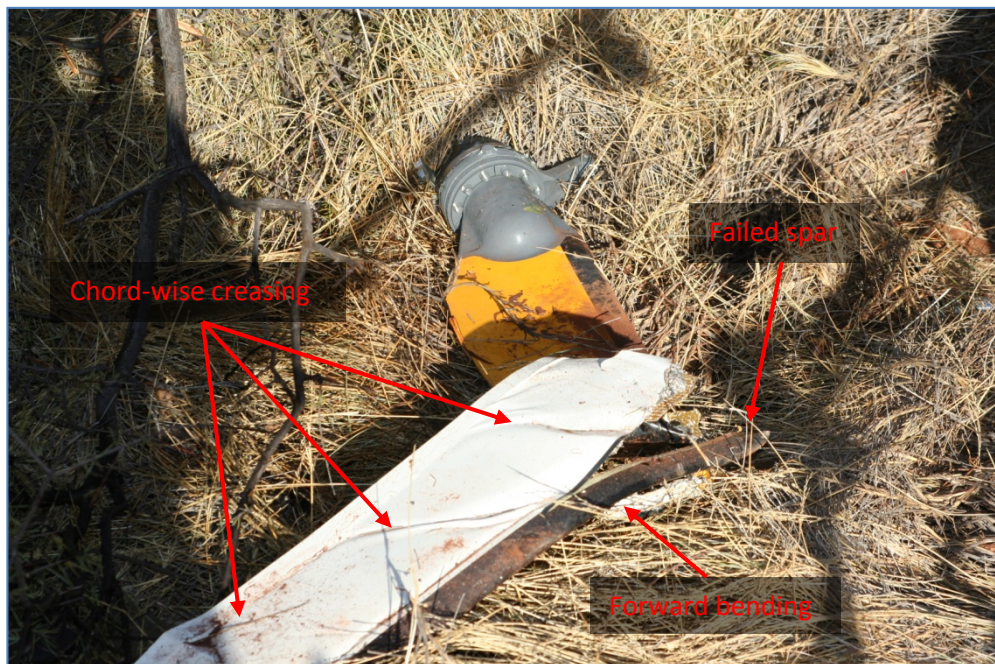
The spar had failed on one main rotor blade, near the root end of the blade, consistent with an overstress failure (Figure 6). Forward bending was evident just outboard from the point of failure. The droop tusk had also failed in overstress on that blade.

**Figure 6: Main rotor blade removed from hub, showing chord-wise creasing, forward bending and failed spar.**

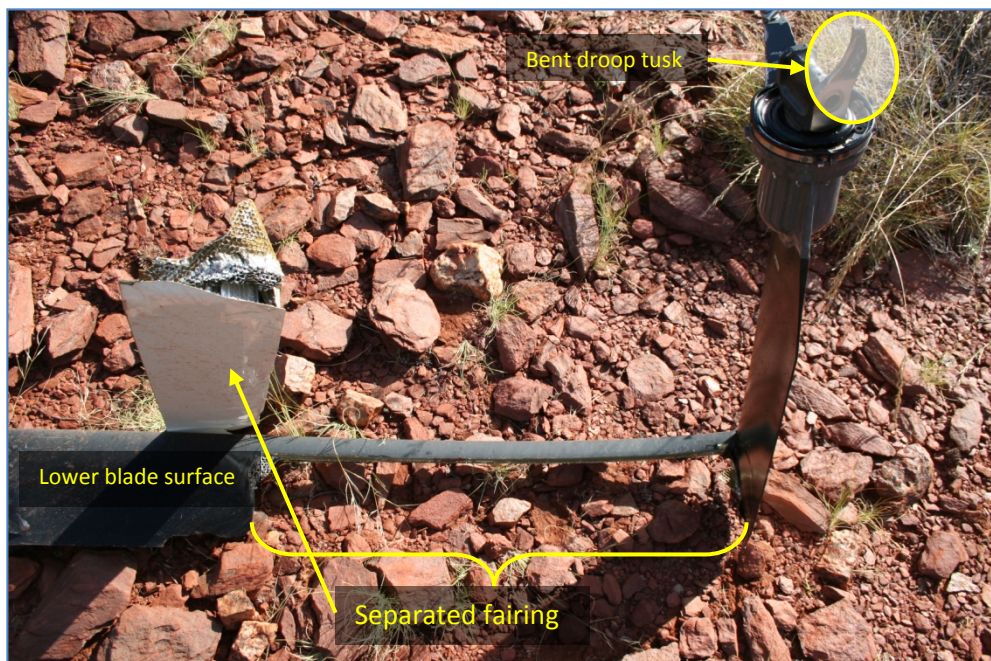
The other main rotor blade had bent downwards at right angles close to the blade root (Figure 7), and the tip of that blade had been compressed inwards. A section of the main rotor blade fairing had separated from the spar, outboard from the right angle bend, and the droop tusk had been bent down.

**Figure 7: Main rotor blade removed from hub, showing downward bend and separated fairing**

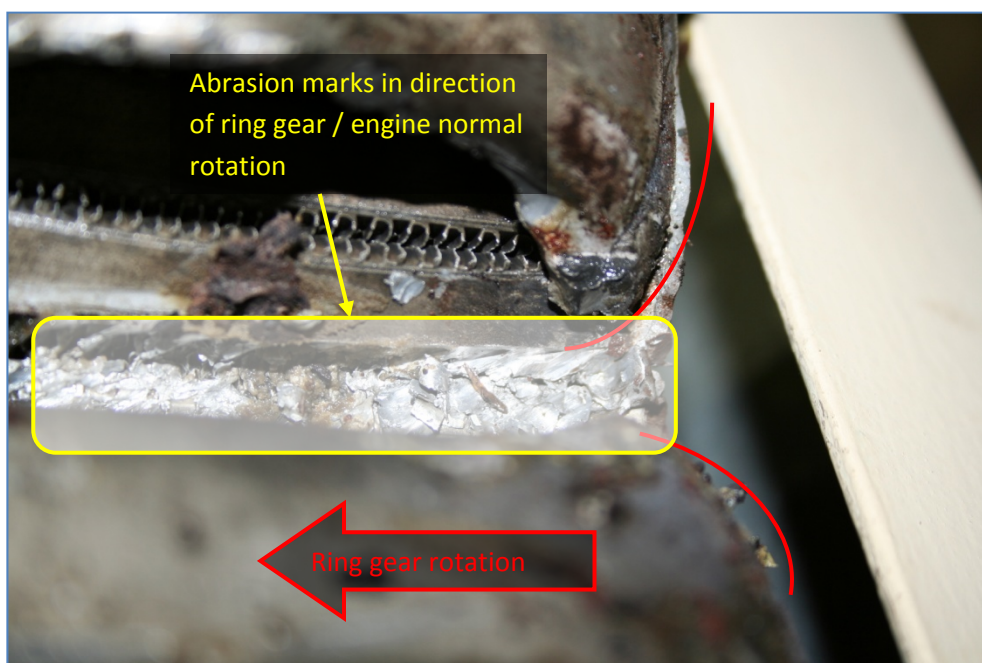
The engine was subsequently examined at an approved engine overhaul facility. That examination did not reveal any condition that would have precluded normal operation of the engine. Several of the engine components were also examined in an attempt to determine if the engine was operating at the time of the accident. The engine oil cooler had two impact marks consistent with contact with the starter ring gear during the impact sequence. One impact mark indicated a rotational abrasion in the direction of normal engine operation (Figure 8). The other mark, also from the ring gear, showed a static imprint of the ring gear teeth into the side of the oil cooler (Figure 9).

**Figure 8: Rotational abrasion marks on the engine oil cooler**

While the evidence indicated that the engine ring gear was rotating when the aircraft initially contacted the terrain and ceased rotating prior to the final impact, the investigation could not establish with certainty whether the engine was driving the main and tail rotors. It is possible that the pilot was reacting to a carburettor icing event and thus subject to a total or partial engine failure, when the main rotor blades impacted the tail boom.

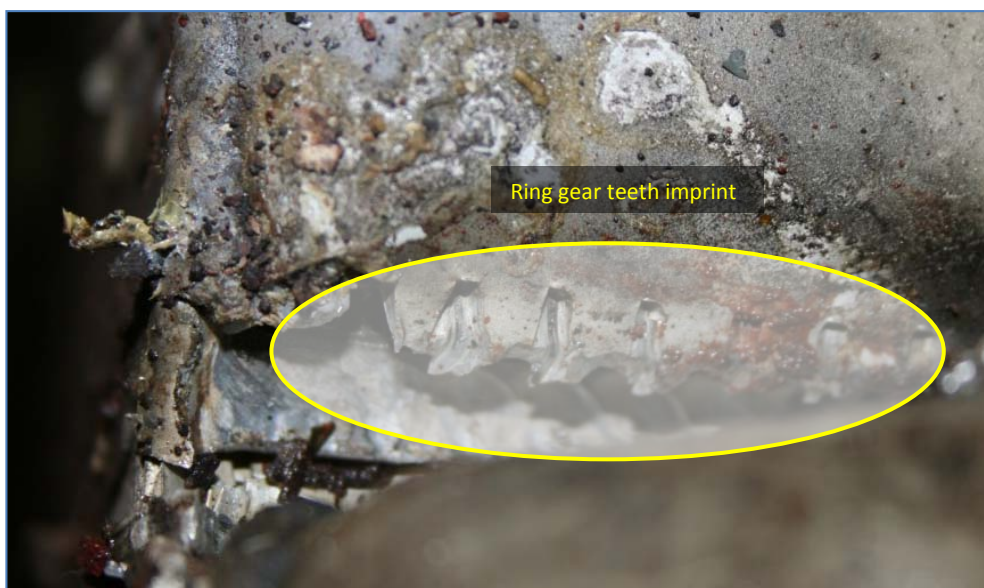
**Figure 9: Static ring gear teeth imprint on the engine oil cooler**

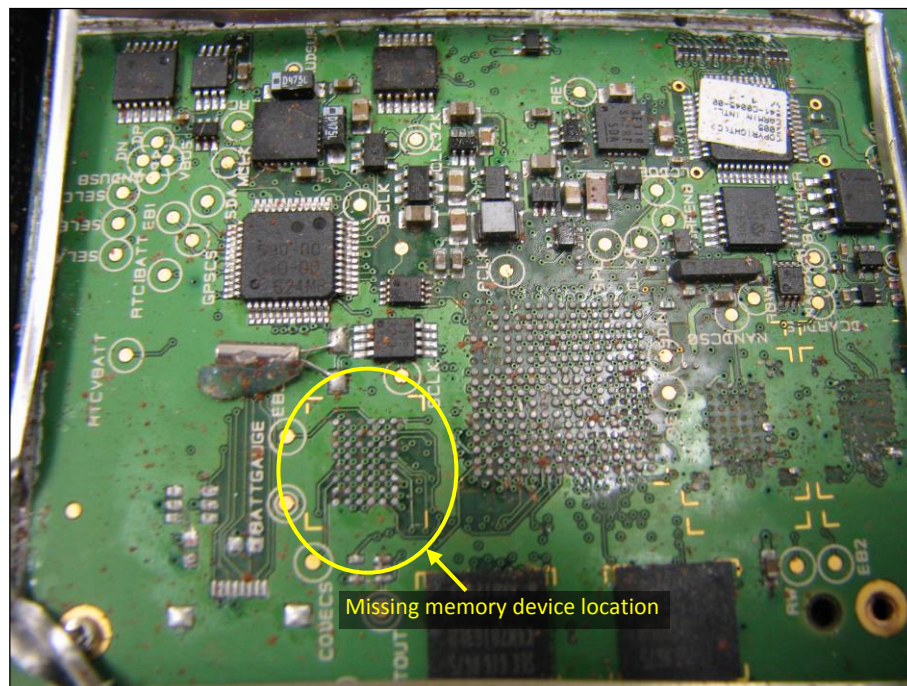
A Garmin GPSMAP 296 global positioning system (GPS) was recovered from the accident site and sent to the ATSB facility in Canberra for detailed examination. Data was unrecoverable due to the absence of the memory device (chip) containing the GPS data for the occurrence flight. The chip was most likely dislodged during the accident sequence, and was not identified at the accident site.

**Figure 10: GPS circuit board showing location of missing memory device**

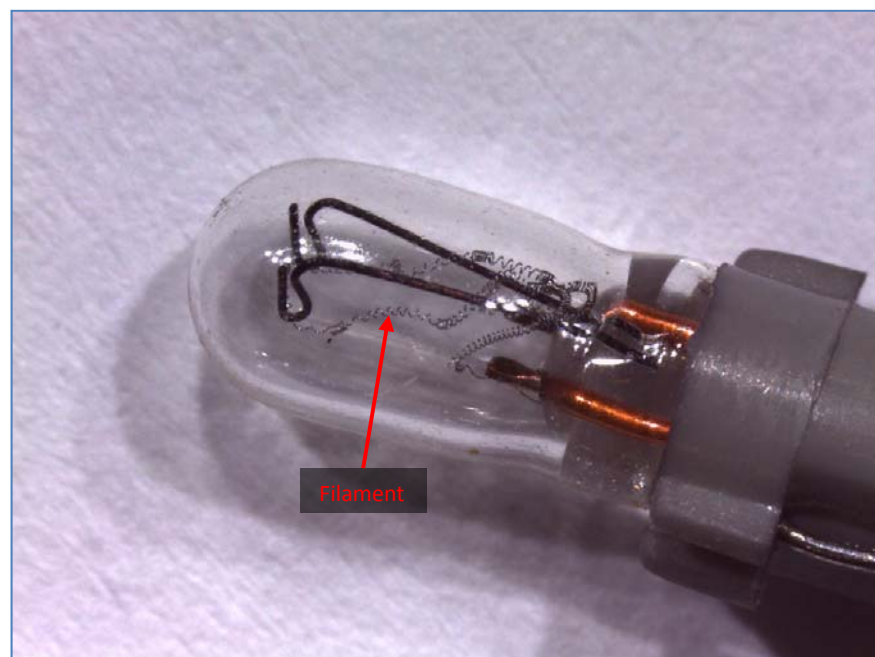
The landing light, left navigation light and instrument lighting (Figure 11) was examined. Filament stretch was identified on all of the lamps examined indicating that these lamps were illuminated at the time of impact.

**Figure 11: Instrument lamp displaying filament stretch**

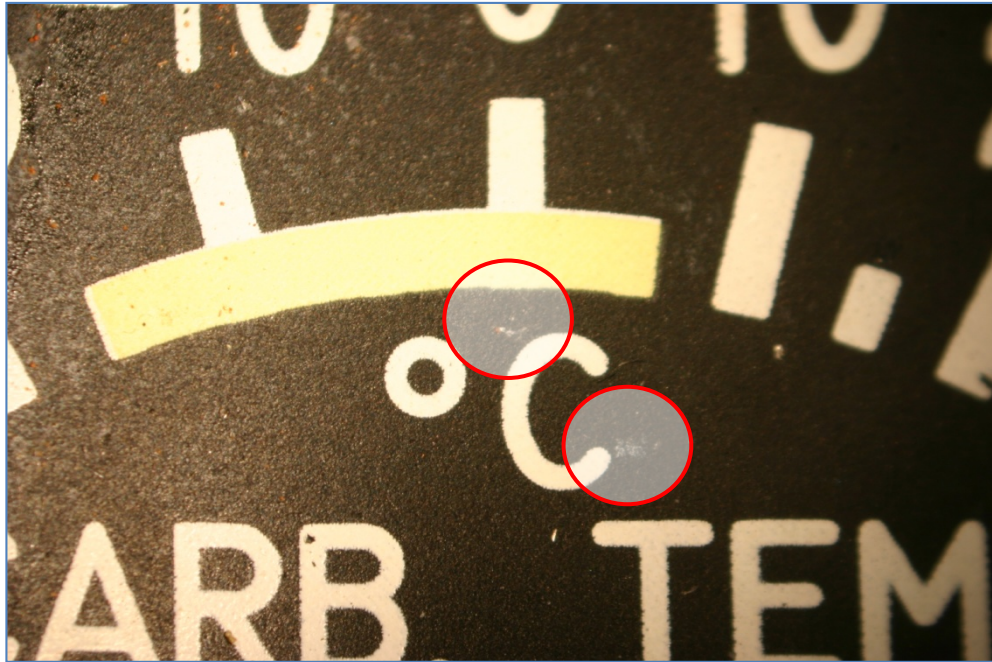
Examination of the carburettor air temperature gauge found evidence of pointer contact, possibly from impact forces. The examination found white paint particles from the rear of the instrument pointer at the 0° C and +5° C positions on the face of the gauge (Figure 12). Black paint particles were also found on the rear of the instrument pointer.

**Figure 12: Carburettor air temperature gauge displaying needle contact paint transfer**

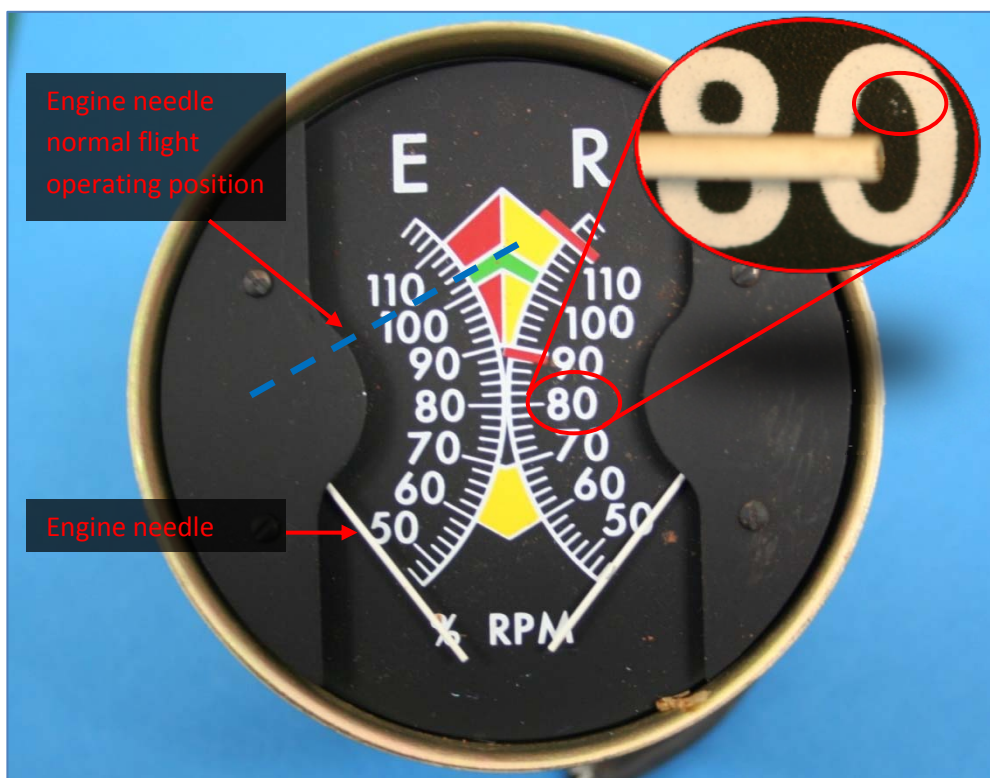
Examination of the dual engine and main rotor revolutions per minute (RPM) indicator showed signs of contact between the gauge needle and the face of the instrument at about 80% engine RPM (Figure 13). The normal operating range for the engine was 101% to 104%, with a maximum continuous RPM of 104%. The engine RPM had to be maintained within this tolerance for the main rotor system to provide effective lift.

**Figure 13: Dual indicator, engine needle displaying needle contact paint transfer**

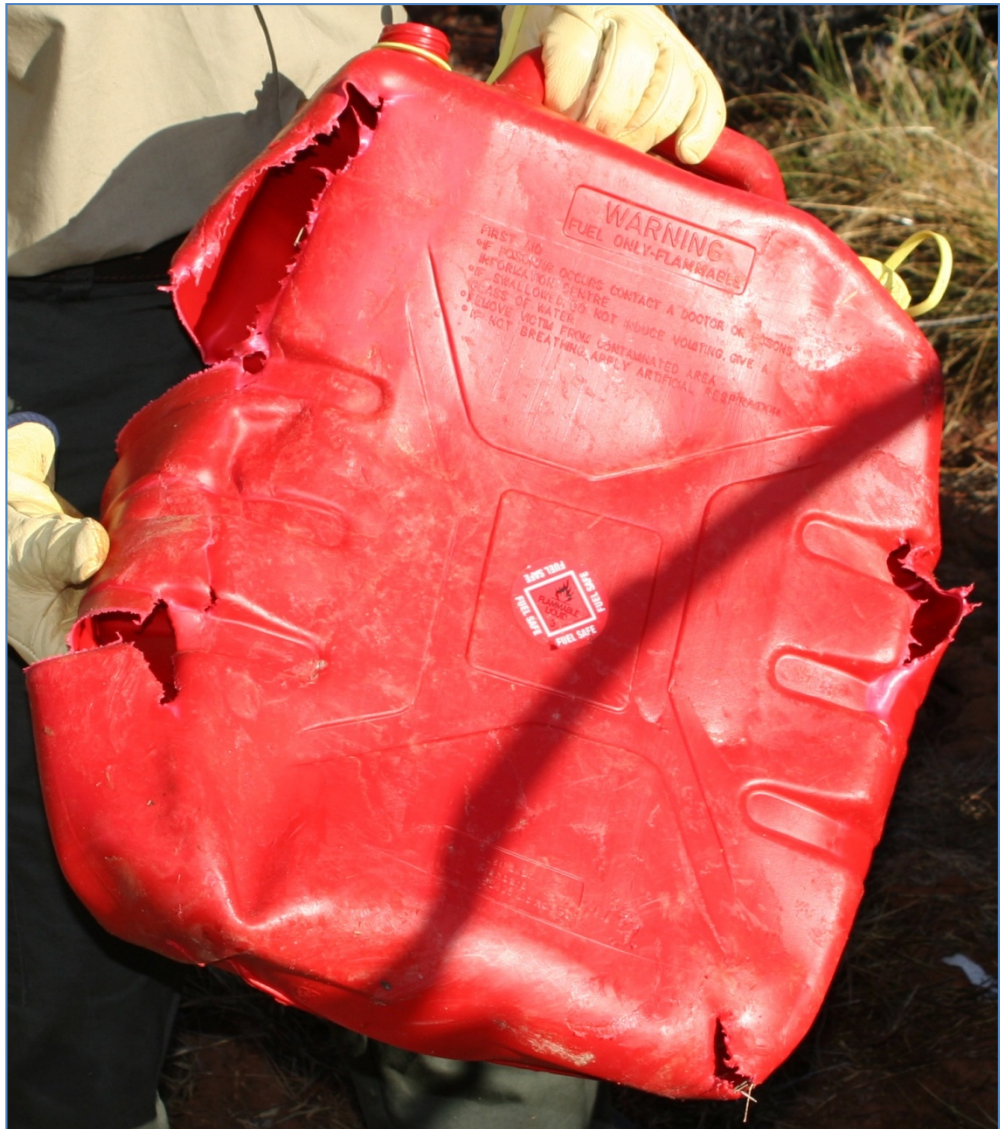
**Figure 14: Burst fuel container**

The pilot had loaded three plastic 20L fuel containers on board and was known to be utilising these to extend the range of the helicopter while in transit between available refuelling locations. One of the three fuel containers exhibited signs of a hydrostatic (burst) rupture (Figure 14). That fuel container was located under the main wreckage. The other two fuel containers were found empty, but intact with the caps secured, forward of the main wreckage. The last recorded purchase of fuel was at Newman Airport, with about 128 L uplifted.

There was no evidence that the amount or quality of the fuel on board was a factor. The pilot would have had to refuel en route to complete the journey from Newman to Uaroo, Western Australia (WA). At least two of the fuel containers had been utilised along the route as evidenced by them not being ruptured during the collision with the ground and that their caps were secure. The most likely place for refuelling would have been at Paraburdoo WA, as it had an airport and was on the track between Newman and Uaroo, and the pilot had made several phone calls within mobile coverage of Paraburdoo.
