REPORT OF THE PRELIMINARY INVESTIGATION
INTO THE CIRCUMSTANCES OF THE COLLISION BETWEEN
THE M.V. IRON CUMBERLAND AND THE F.V. SALTFIORD
IN APPROXIMATE POSITION 140° 06.0'S 144° 07.3'E
IN THE AREA OF PRINCESS CHARLOTTE BAY
ON 6 JULY 1985

OUTLINE OF INCIDENT

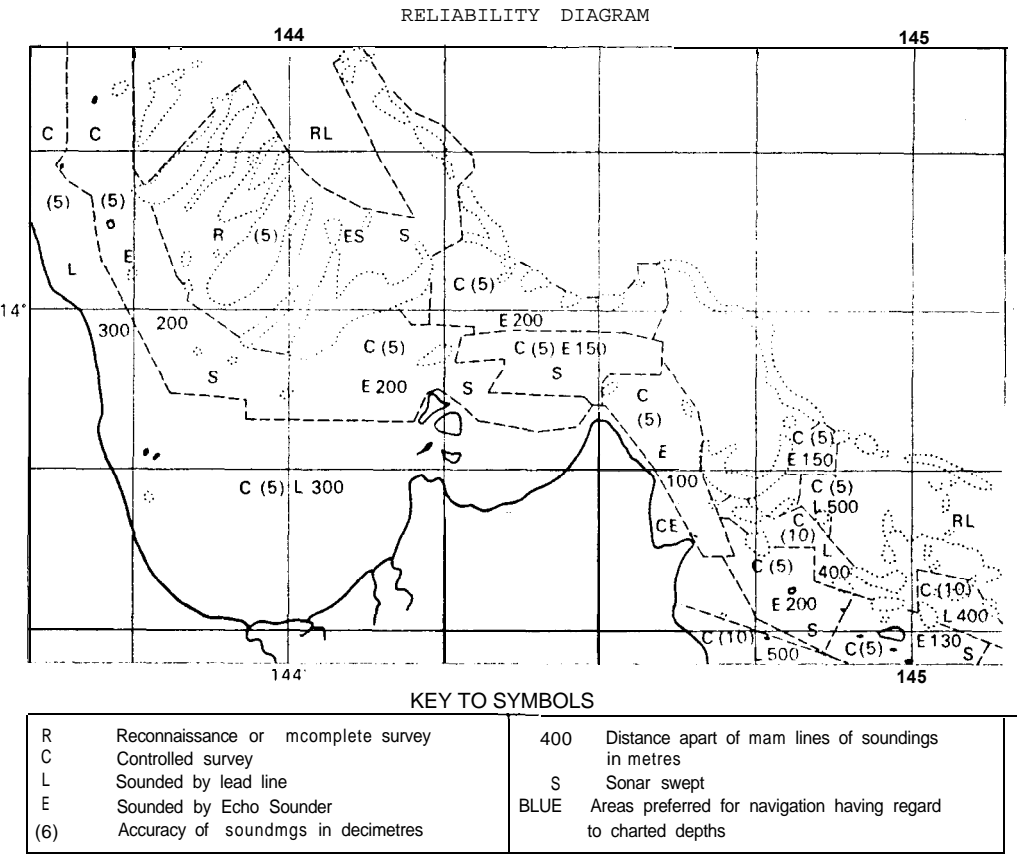
RELIABILITY DIAGRAM AND NOTES ON TWO WAY ROUTE
FROM AUS 833

The chart reliability diagram clearly indicates that it would have been safe to deviate from the route. Furthermore, the chart notes referring to the recommended two-way route inform mariners that the route is not a traffic separation route and that the International Regulations for Preventing Collisions at Sea apply. That is to say it is not a prescribed traffic separation scheme to which the special requirements of Rule 10 apply. Accordingly, as a power driven vessel, the IRON CUMBERLAND was not only obliged to keep clear of a vessel engaged in fishing (Rule 18(a)(iii)) but was also obliged to pass at a safe distance (Rule 8(d)) which, in the case of a fishing vessel, would need to take into account outlying fishing gear. By neither taking action prior to the Master assuming responsibility at 2033(A) nor calling the Master or pilot at an earlier stage, if in doubt, I find the Third Officer failed to discharge this obligation.

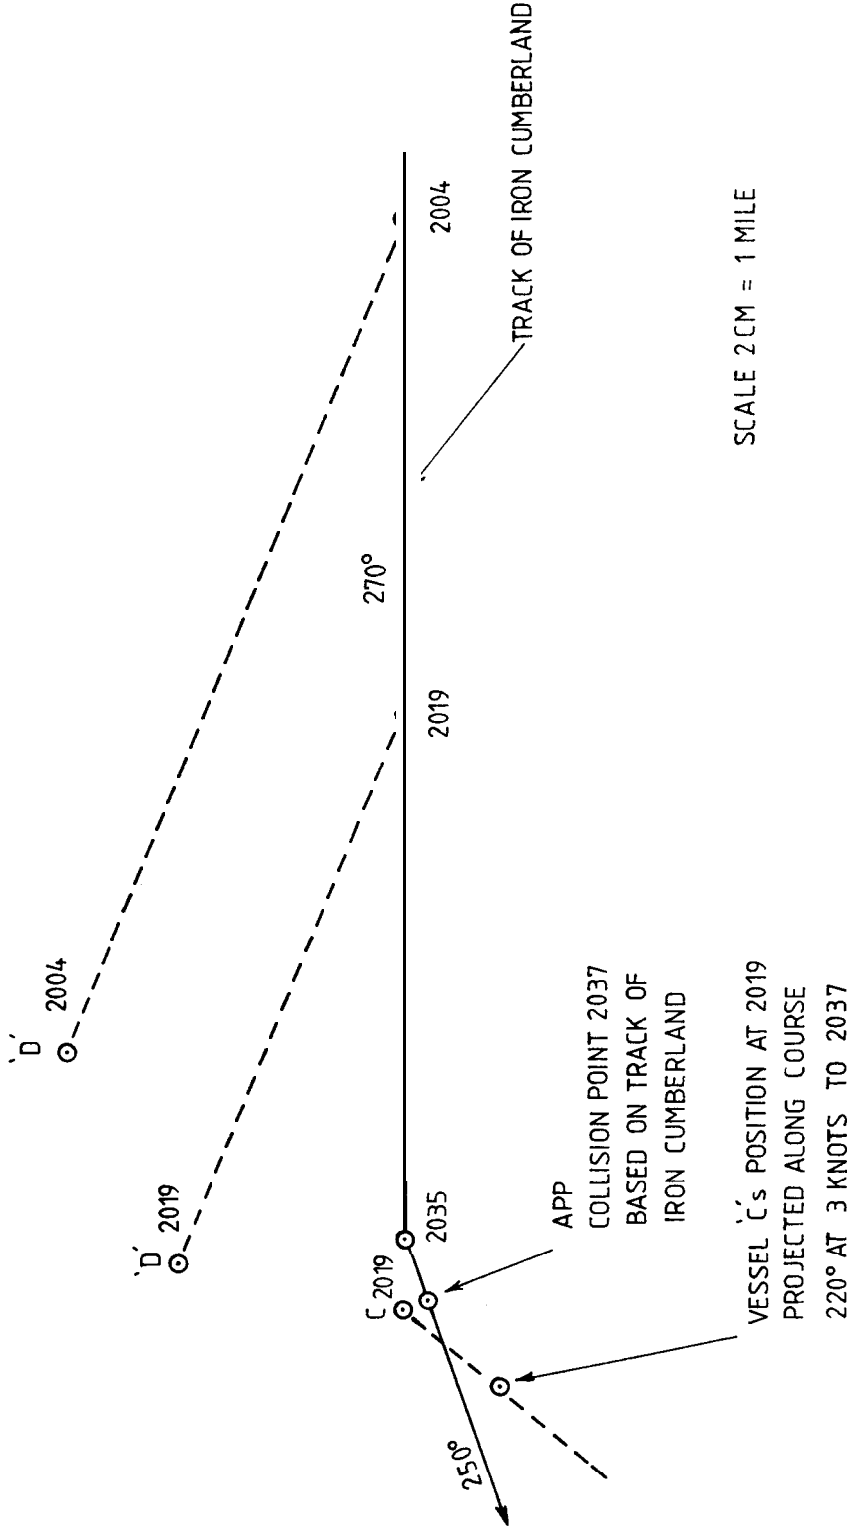
FIGURE 1 DIAGRAM OF IRON CUMBERLAND THIRD OFFICER'S OBSERVATIONS OF VESSEL 'D' AT 2004 (A) AND 2019 (A) AND OF VESSEL 'C' AT 2019

1. The Third Officer's observation of bearings and ranges of vessel 'D' and the SALTFIORD Skipper's estimation that his vessel's speed was 2.7 to 3 knots is not consistent with SALTFIORD being vessel 'D' (see Attachment 4, figure 1).

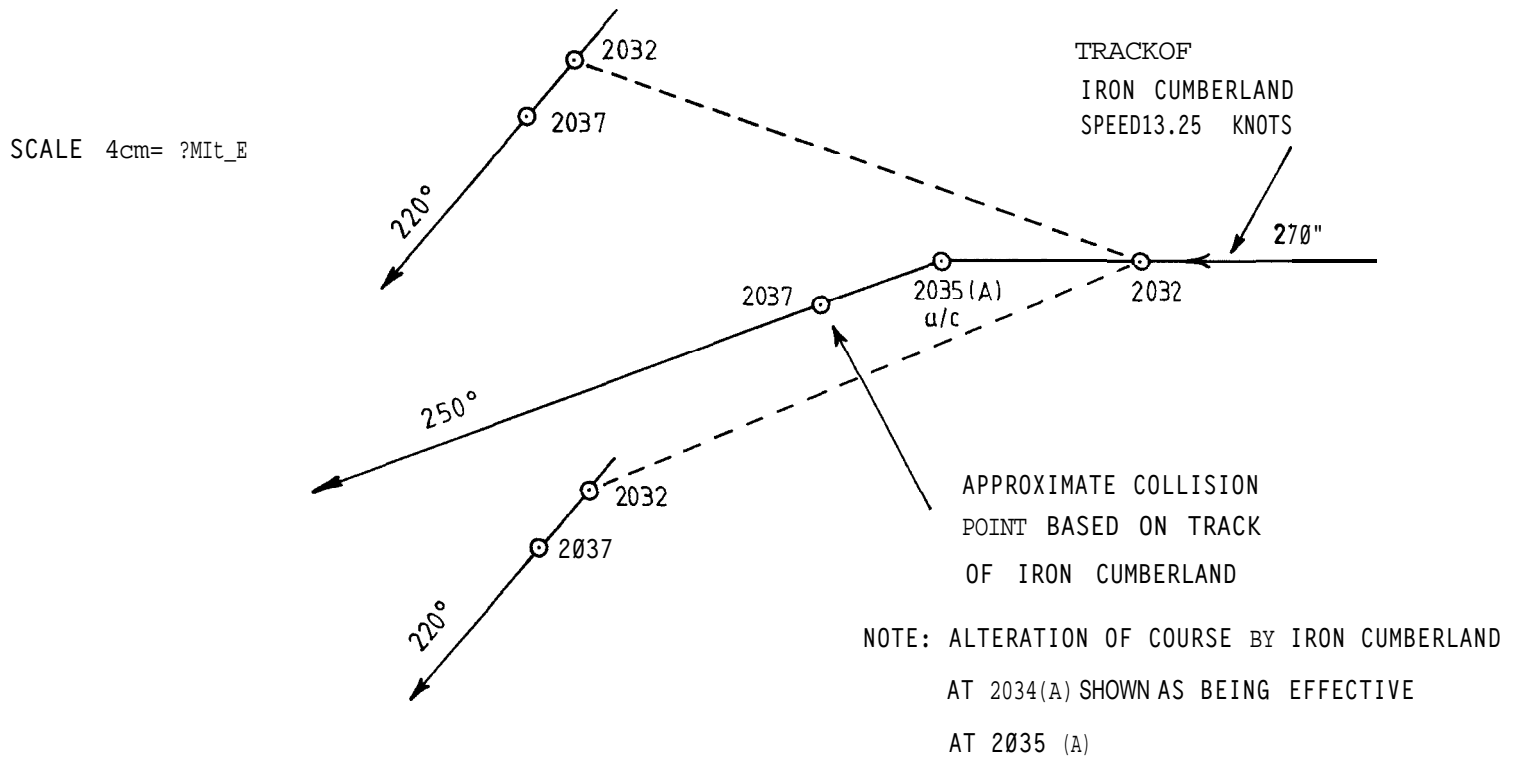
FIGURE 2

2. The Master's observation of bearings and ranges of vessels 'C' and 'D' at 2032(A) are not consistent with a collision with either vessel at 2037. The Master's observations were clearly in error and the fishing vessels closer to the IRON CUMBERLAND than he stated. This possibly could have been brought about if the Master misread the scale settings on the radar and mistook the one mile ring on the six mile range for the two mile ring on the twelve mile range (see Attachment 4, figure 2).

Diagram of Iron Cumberland Master's stated radar observations at 2032(A).

Fishing vessel on starboard bow about 13 to 2 points (shown as 15 points) at 2 miles.

Fishing vessel on port bow about 2 points at 2 miles.

Note: Tracks of both vessels have been projected on a course of 220° at 3 knots to 2037 (approximate time of collision).

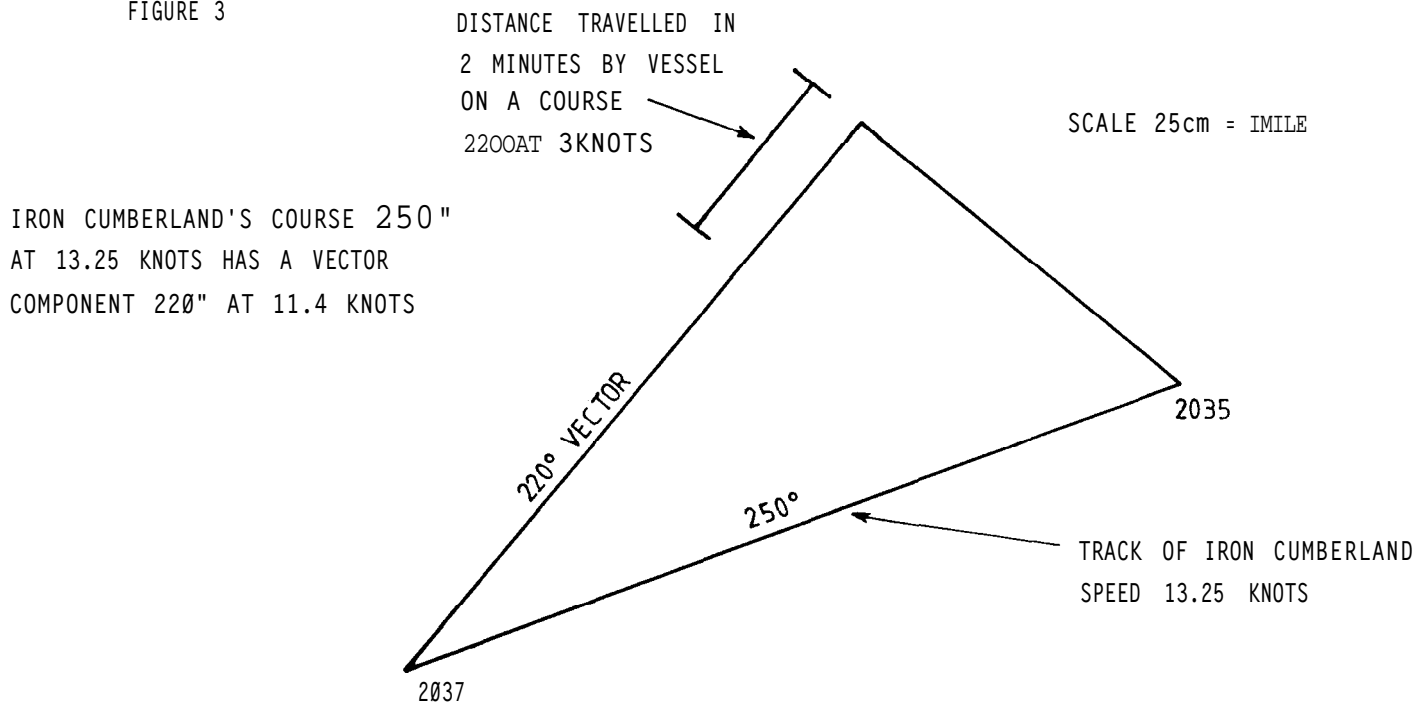
FIGURE 3

3. It is probable the SALTIFORD was vessel 'C'. Vessel 'D' was on the starboard bow when the IRON CUMBERLAND altered course to 250°(T), This course at a speed of 13.25 knots has a vector component of 220°(T).at 11.4 knots. This vector component compared to vessel 'D's speed of about 3 knots shows a collision with such a vessel on the starboard bow to be impossible (see Attachment 4, figure 3).
