**Aviation Safety Investigation Report
200102695**

Boeing Company 737-476

18 June 2001

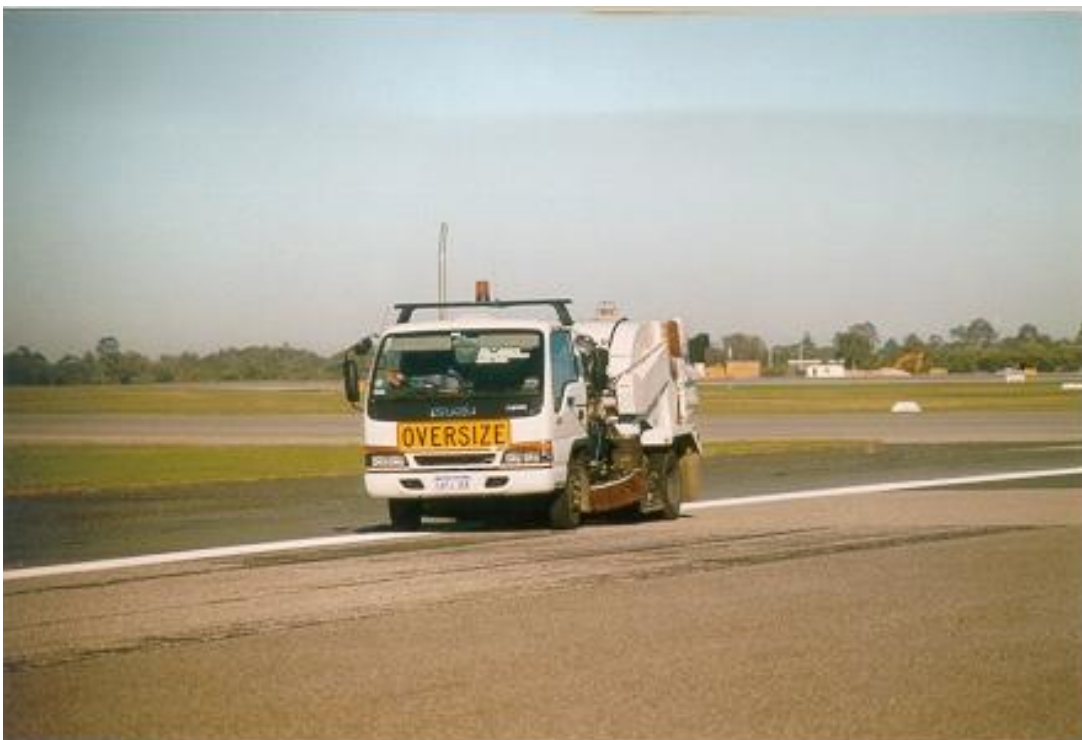
FIGURE 1:
Runway sweeper vehicle

As the Boeing 737-476 (B737) operating a scheduled passenger service to Adelaide, accelerated during the take-off roll on runway 06 at Perth International Airport, the driver of a sweeper vehicle (see Fig. 1) operating on that runway saw the aircraft approaching in the vehicle's rear view mirror, turned right and vacated the runway. The crew of the B737 saw the vehicle vacating the runway and continued with the take off.

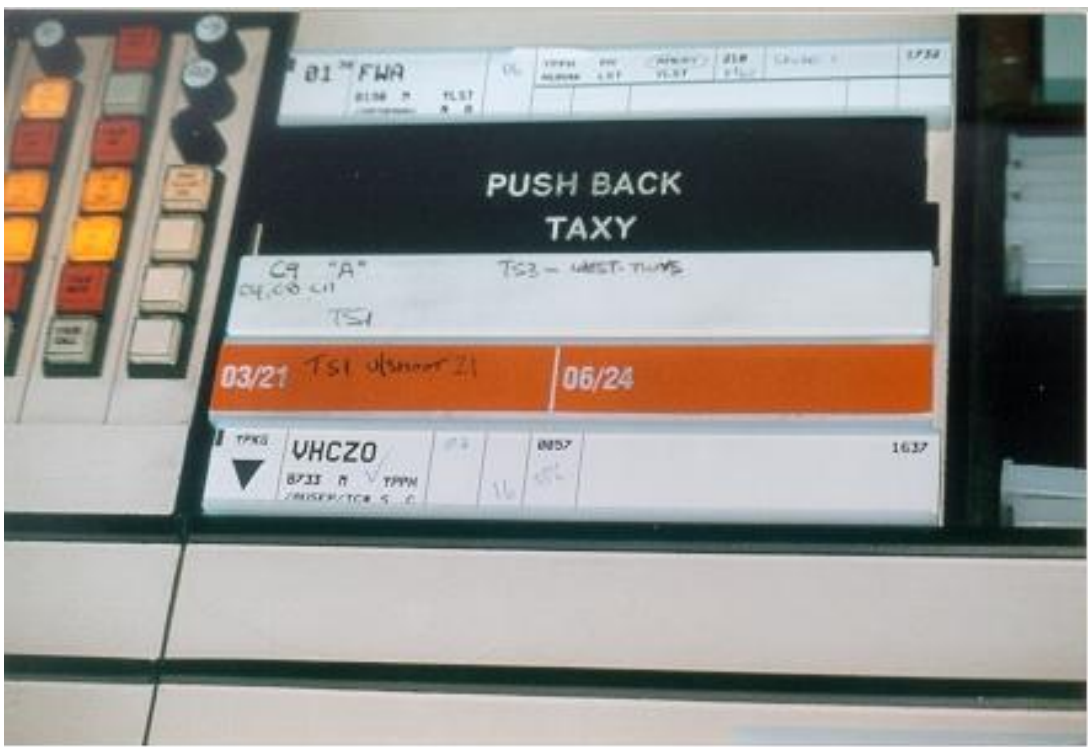
FIGURE 2:
Example of surface movement controller's red runway occupied strip in the taxi bay

The use of a runway occupied strip was a common practice among air traffic controllers. The runway occupied strips were brightly coloured to maximise their visibility from most control positions in control tower cabins. In the Perth control tower, the surface movement controller used a red flight progress strip that was divided into two sections. The left half of the strip was engraved with 03/21 in white. There was a dividing line engraved vertically at the centre of the strip and the right half of the strip was engraved with 06/24. There was space on both sides of the strip to write additional information, such as the vehicle callsign, with a chinograph pen. In addition, the surface movement controller used a white strip to write details of all other vehicles that were operating on the airfield that were using his frequency. If used, both the strips would normally be placed in the taxi bay of the surface movement controller's console (see Fig. 2). If an aircraft called for a taxi clearance, the aircraft's flight progress strip would be placed in the taxi bay and the strips, used as memory prompts, should alert the controller to the disposition of the traffic on the aerodrome.

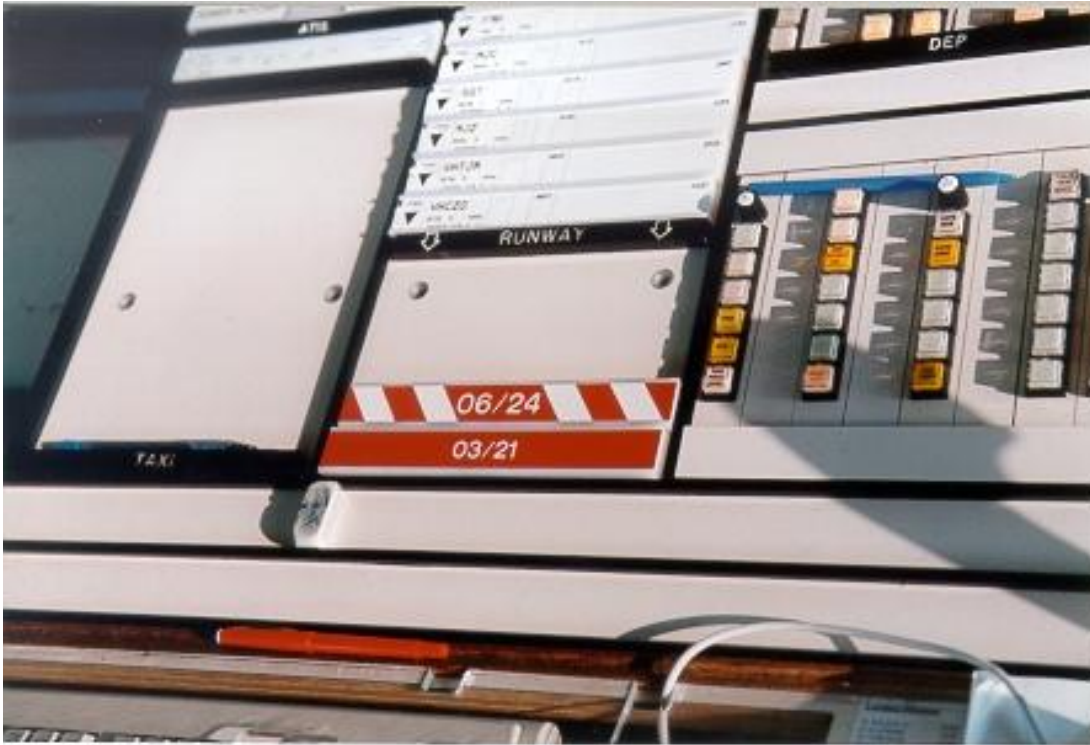
FIGURE 3:
Example of aerodrome controller's runway occupied strips in the runway bay

At Perth, the aerodrome controller used a red coloured strip with 03/21 engraved in white on the centre of the strip when runway 03/21 was occupied. For runway 06/24, the controller used a strip that was striped diagonally in bands of red and white, engraved in the centre with 06/24. When both runways were occupied, both runway occupied strips were placed in the runway bay (see Fig.3).

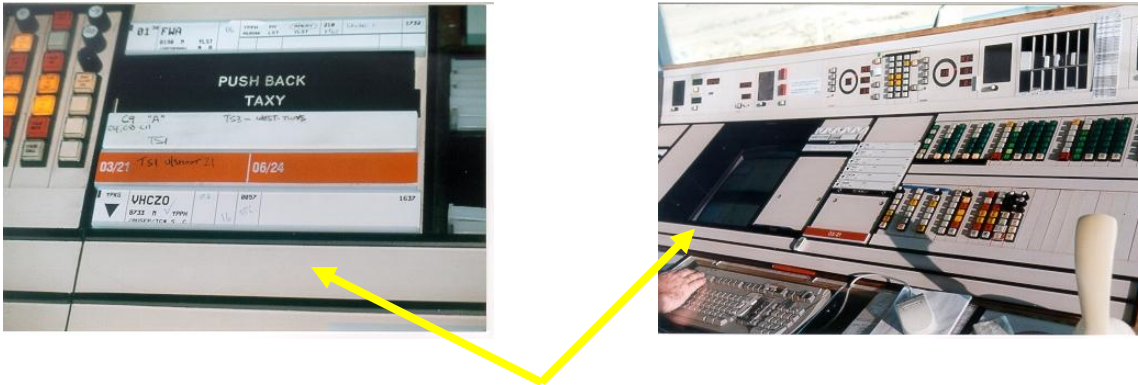
FIGURE 4:
Arrow highlighting position of top transfer slots

strip would be ticked with a red pen and then moved along the transfer slot to the aerodrome controller, before the crew of the aircraft reported ready for departure.

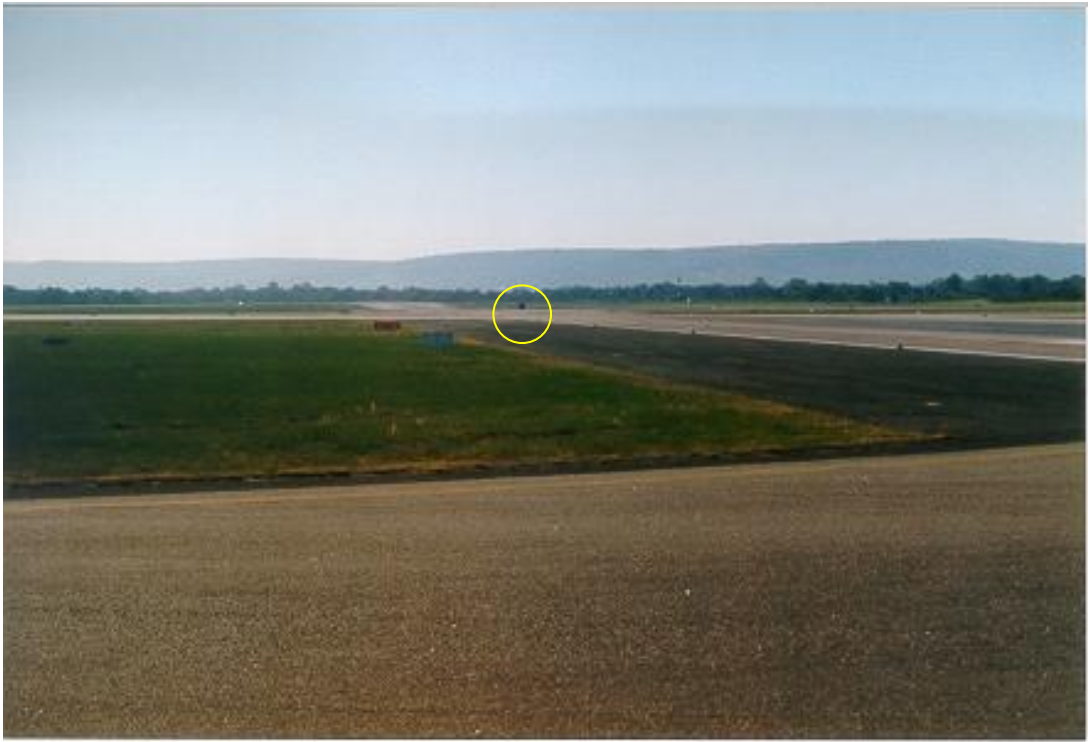
FIGURE 5:
View from aircraft of sweeper vehicle from taxiway Juliet

At about 11:05, the B737 crew reported to air traffic control on the aerodrome control frequency that they were ready for departure. The aircraft was on taxiway Juliet approaching runway 06 (see Fig. 5). At the time, the aerodrome controller was coordinating an overhead transit of a light aircraft with approach control. He instructed the B737 crew to enter and backtrack on runway 06 and line up.

The airport sweeper driver observed the B737 at taxiway Juliet but did not see it enter the runway. He had turned the sweeper at taxiway Charlie 1 to head in the opposite direction towards the upwind end of runway 06. The sweeper commenced travelling down the right side of the runway. The driver was monitoring the surface movement control frequency in accordance with local procedures and did not hear the crew's transmissions with the aerodrome controller. The crew of the B737 did not notice the sweeper prior to turning their aircraft onto the runway. The sweeper and the B737 were now on the same runway but moving in opposite directions away from each other.

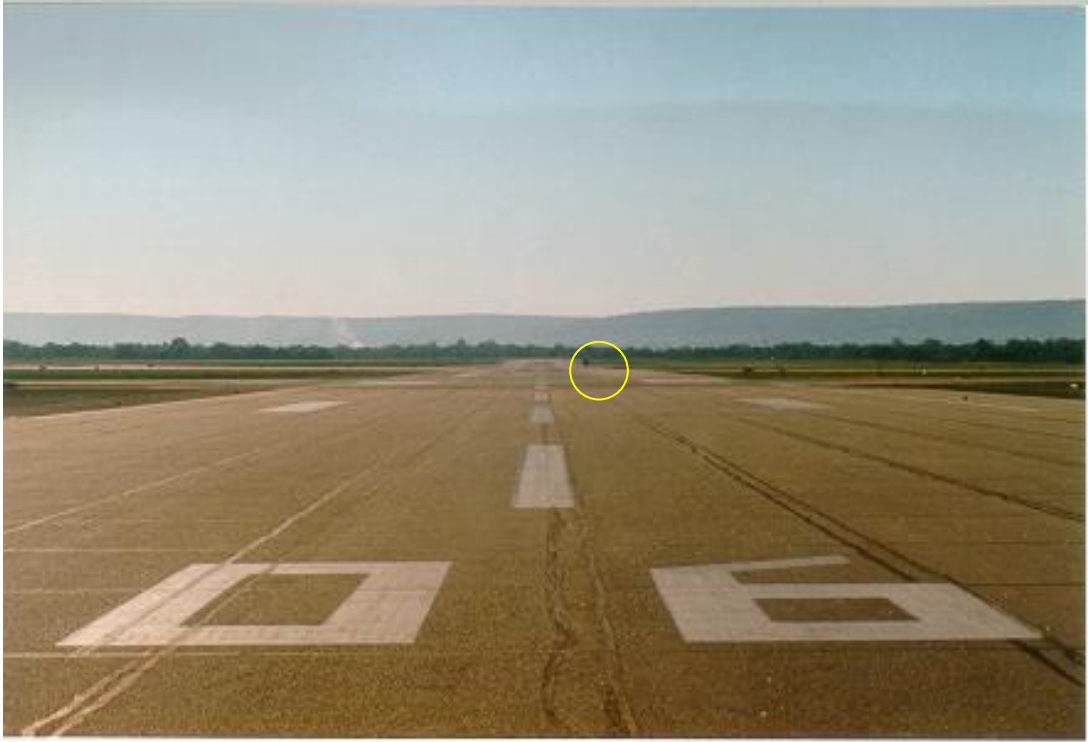
FIGURE 6:
View from aircraft of sweeper from runway 06 threshold

About 10 seconds later, at 11:06:40, the crew of the B737 had completed the pre-takeoff checklist and commenced the take-off roll. The pilot in command was the handling pilot and the co-pilot was looking down adjusting the thrust controls. Neither of the flight crew saw the sweeper on the runway (see Fig.6).

The sweeper was still travelling in a north-easterly direction on the southern edge of the runway facing away from the aircraft. The sweeper observed the lights and heat plumes of the aircraft in his rear vision mirror accelerating towards him. He immediately turned the sweeper to the right and vacated the runway at a position approximately 1,470 m from the runway threshold.

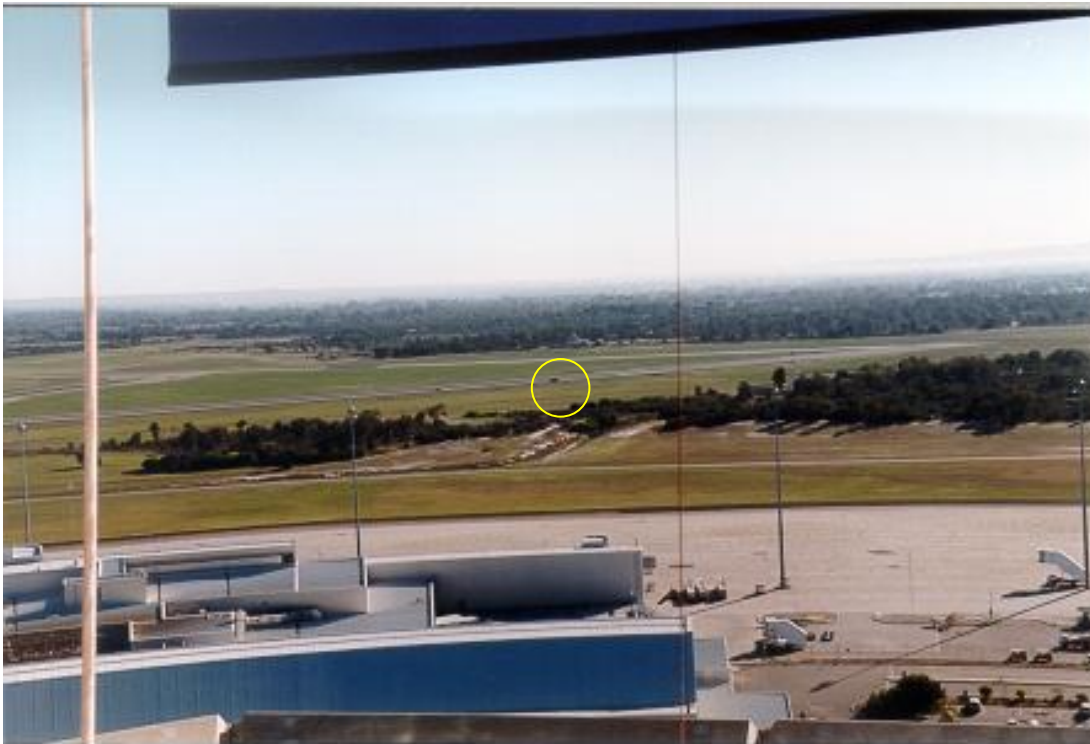
FIGURE 7:
View of sweeper from the control tower

The visual acuity required to detect the sweeper from the tower was within the range for normal vision. The colour of the sweeper (white with black hoses) meant that the sweeper blended with the grey runway providing limited perceptual contrast. From the controller's perspective the sweeper was in the shade, given the position of the sweeper, runway and sun at the time of the incident, although the hazard beacon and strobe light were unobstructed. At the position from where the B737 commenced its take-off roll, the flight crew was looking at the smaller surface area of the rear of the sweeper truck. Due to the position of the sun at the time of the incident, the rear of the sweeper was in the shade, reducing visual contrast. The rotating beacon and strobe were in partial alignment. Tests during the investigation showed that it was possible to observe the sweeper vehicle from the runway 06 threshold and from the air traffic control tower, despite the unfavourable lighting conditions and the vehicle's colour scheme that made observation more difficult.

The aerodrome controller did not detect the sweeper on the runway when he carried out his runway scan. Despite limited perceptual contrast, the calculated visual acuity required to detect the sweeper from the tower indicated that the sweeper was sufficiently large enough to be visible, particularly as the strobe and rotating beacon were operating.

In addition, a trial period was introduced with one vehicle painted red. Local ATC suggested that that colour was far more prominent and WAC have elected to introduce red coloured safety vehicles for a longer trial.

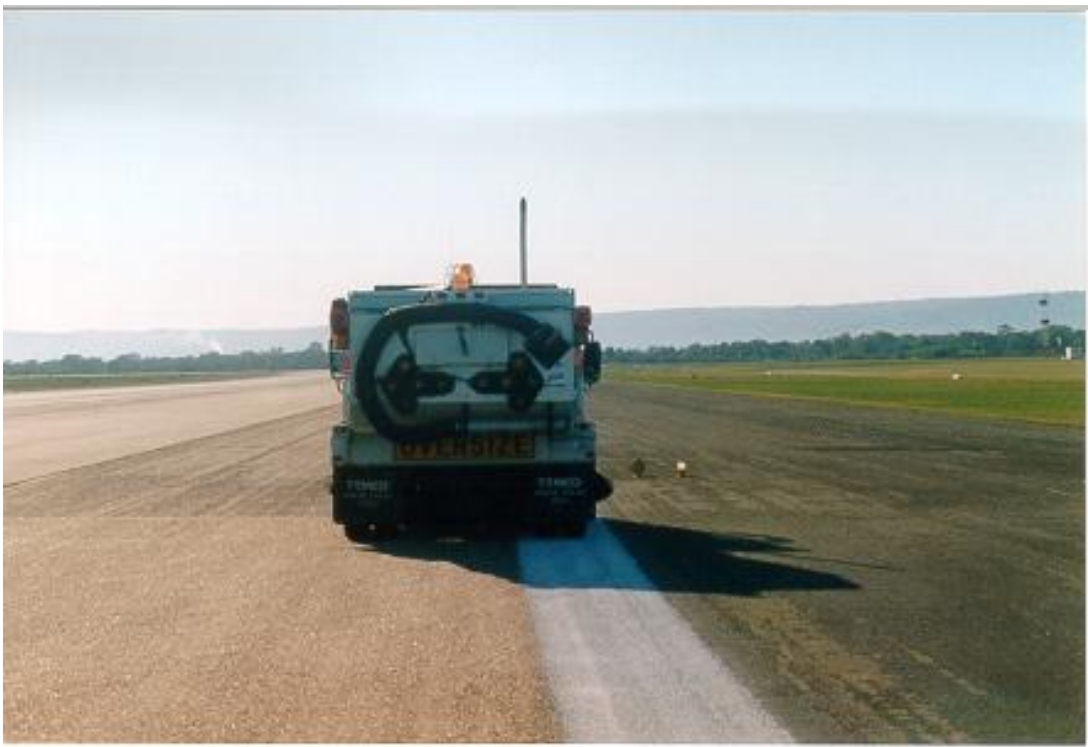
FIGURE 8.

At the time of the incident, the external lights active on the sweeper were the rotating beacon and strobe on the top of the cabin and body (see Fig. 8). Although these lighting devices were operating, neither the aircraft nor the tower crew observed them during their runway scans. The sweeper did not have, nor was it required to have, its vehicle hazard lights or any other external lights activated. The use of flashing or rotating lights increases the visual detection of objects, especially when illumination is reduced due to poor lighting or shade. The use of those additional lights may have improved the likelihood that the sweeper was detected in runway scans. The use of flashing or rotating lights on the rear of the vehicle may have increased the contrast of the sweeper against its surroundings, improving the likelihood of the B737 flight crew detecting the sweeper on the runway.

Close up view of sweeper from the rear. Lighting conditions similar to those occurring on the day of the incident. Note the alignment of the rotating beacon and strobe

For the main safety officer vehicle, which spends more time on the runways than any other vehicle, WAC installed headlight flashers similar to that used by many police and ambulance vehicles. WAC drivers use the headlight flashers in the daytime, usually on high beam, with each light flashing alternately. WAC advised that when facing oncoming traffic, the "wig-wag" type flashing helped visual acquisition.

That Airservices Australia, the Civil Aviation Safety Authority and the Australian Airports Association should jointly review airside vehicle operation with a view to establishing national operating standards and procedures (including vehicle colour, lights and procedures).
