In-flight engine malfunction and air turn-back 120km SW of Brisbane Airport 10 November 2009

Abstract

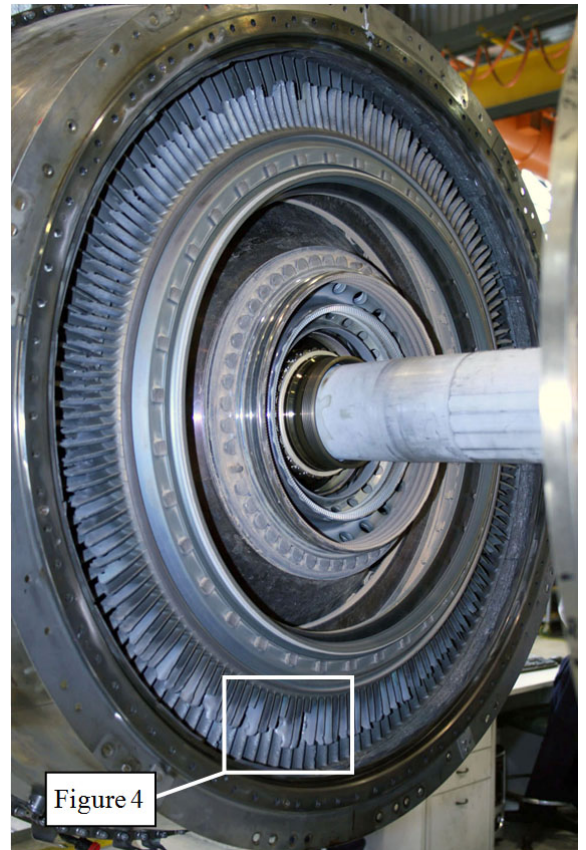
Figure 3: LPT stage 1 rotor disk and blades

The CFM56-3C-1 is a high-bypass, dual-rotor, axial-flow, turbofan engine (Figure 2). Separation of the LPT major module (Figure 3) revealed that all of the stage-1 LPT blades had fractured between the blade platform and mid-span (Figure 4).

Most of the stage-1 LPT blades exhibited significant cracks, nicks and dents consistent with multiple impacts from the blade debris. The surrounding air seal also exhibited extensive associated damage. Many of the blades showed a degree of bending opposite to the direction of rotation, consistent with a cascading collapse of

the blade set. There was no evidence of blade melting or distortion that might have been indicative of an extreme overtemperature event.

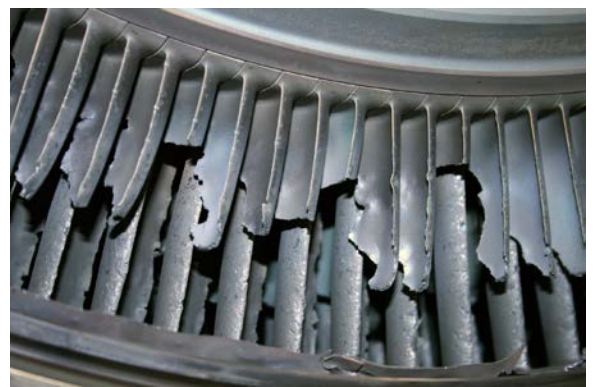
Figure 4: LPT stage 1 blades

assembly. Damage to the turbine blades was consistent with a cascading collapse of the turbine blade set, where an initiating failure event resulted in multiple consequent blade failures through contact with the circulating blade debris.

As a result of this occurrence and at the time of writing this report, the engine manufacturer is revising service bulletin SB 72-1113 to expand the range of blade manufacturing batch numbers that had previously been identified as being predisposed to creep-related failure. Blades in the batches identified in the service bulletin are to be withdrawn from service as soon as they are next removed from the engine.

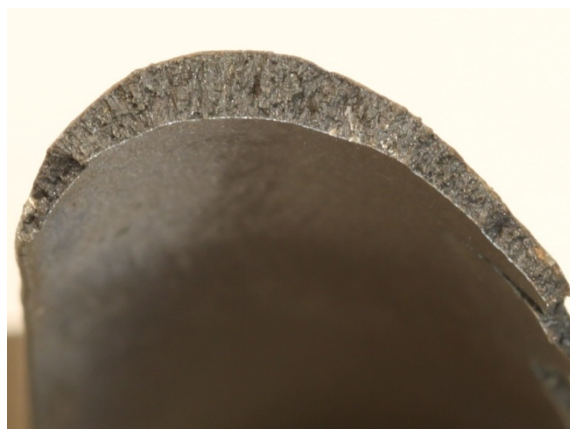
Figure 5: Typical appearance of blade fracture surfaces

The stage-1 LPT disk contained 174 blades, all of which exhibited semi-crystalline fracture surfaces, typical of overload fractures and consistent with the secondary fractures associated with impacts from blade debris (Figure 5). There were no indications of progressive failure or pre-existing defects on any of the blades.

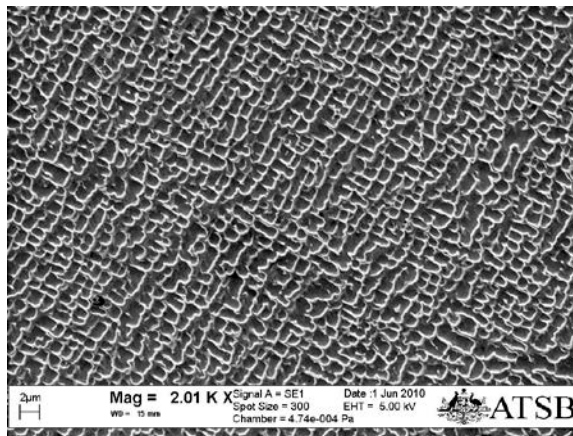
Figure 7: Microstructure through blade root showing finely dispersed γ' (Kalling's No.2 etch, 2000x mag.)

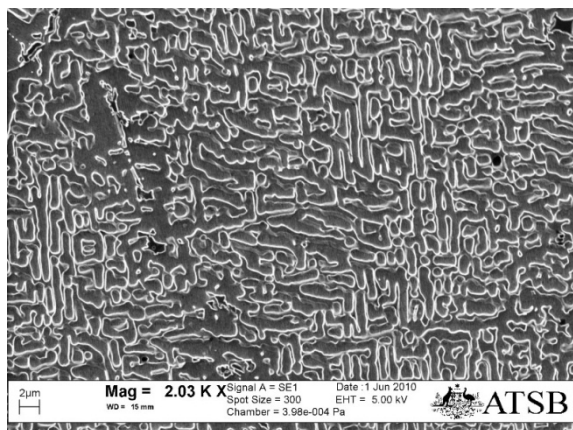
Airfoil section microstructures from the 'RB' and 'JB' prefixed blades exhibited a degree of thermal degradation in the form of γ' coarsening and coalescence, when compared to the baseline (root) microstructures of the same blades (Figures 7 and 8), as well as some grain boundary γ' re-precipitation. Similar degrees of γ' coalescence were noted in the exemplar blade microstructures. The 'DL' blade airfoil sections were similar in microstructural appearance to the blade roots and did not exhibit any coalescence.

Figure 8: Same blade as Figure 7. Airfoil microstructure showing γ' coalescence (Kalling's No.2 etch, 2000x mag)

Nickel-based superalloy microstructures are primarily comprised of gamma-prime (γ') precipitate in a gamma (γ) matrix. The strength of these alloys and their resistance to creep is heavily influenced by the volume fraction, size and distribution of γ' precipitate. Thermally-induced microstructural degradation of the alloy, in the form of coalescence or coarsening of the small, finely dispersed γ' precipitate, may predispose the turbine blades to a creep-related failure. The degradation is a cumulative effect and progresses more rapidly with increasing temperature.
