Bureau of Air Safety Investigation

INVESTIGATION REPORT

9400096

**Aero Commander 690 VH-BSS
Sydney, New South Wales
14 January 1994**

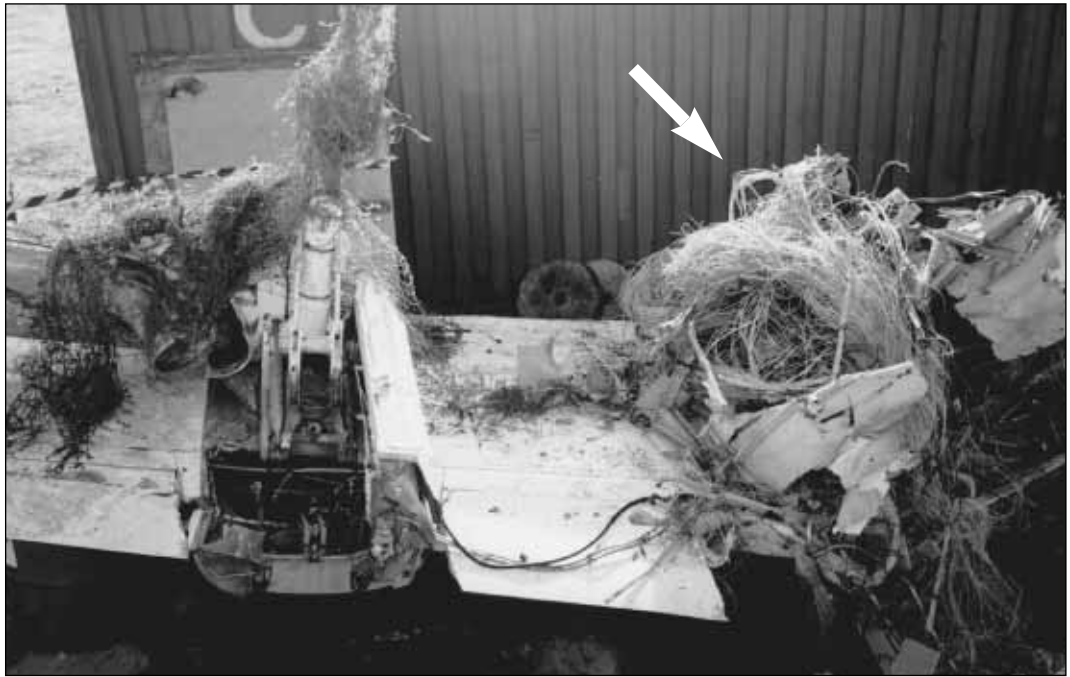
Figure 2. Massive destruction evident to fuselage centre section (arrowed).

Portions of the cockpit were recovered. These comprised structural components and portions of the plexiglass screens of the right upper cockpit structure. The engine throttle quadrant, overhead switch panel, sections of the main instrument panel and one control column were also found. Additionally, attached to the wings were components of the forward and rear fuselage (see figure 2), including the forward and rear bulkheads supporting

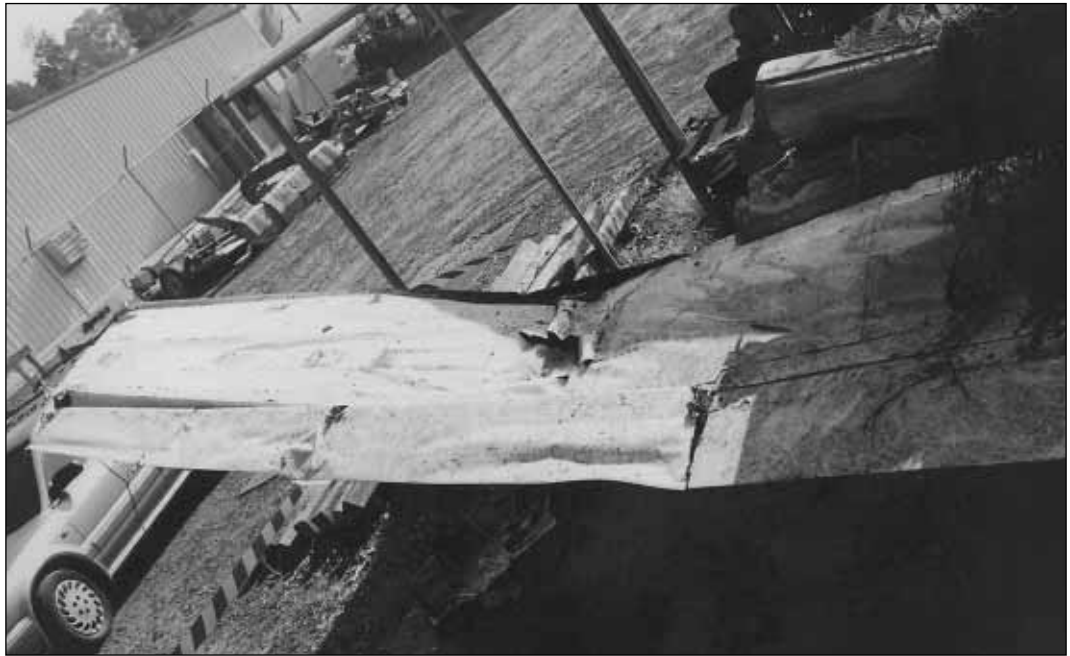
Figure 3. Right aileron (inverted) showed no evidence of 'flutter' or 'snatch'.

The right wing main spar had failed on the lower surface at approximately Wing Station 183.50, with associated failures of the two stringers immediately aft (in a diagonal line culminating at Wing Station 160.00). As a result of the main spar failure, the right wing had bent down and slightly aft, along a line of the failures of the main spar and stringers. There was corresponding tearing and buckling of the wing lower skin. The right main spar lower cap had failed at approximately Wing Station 24.00. No upper wing skin buckling or creasing was evident in the region of Wing Station 24.00. All right wing control surfaces were structurally attached and, except for the aileron, were in good condition. The right aileron was bent consistent with the damage to the right wing (see figure 3).

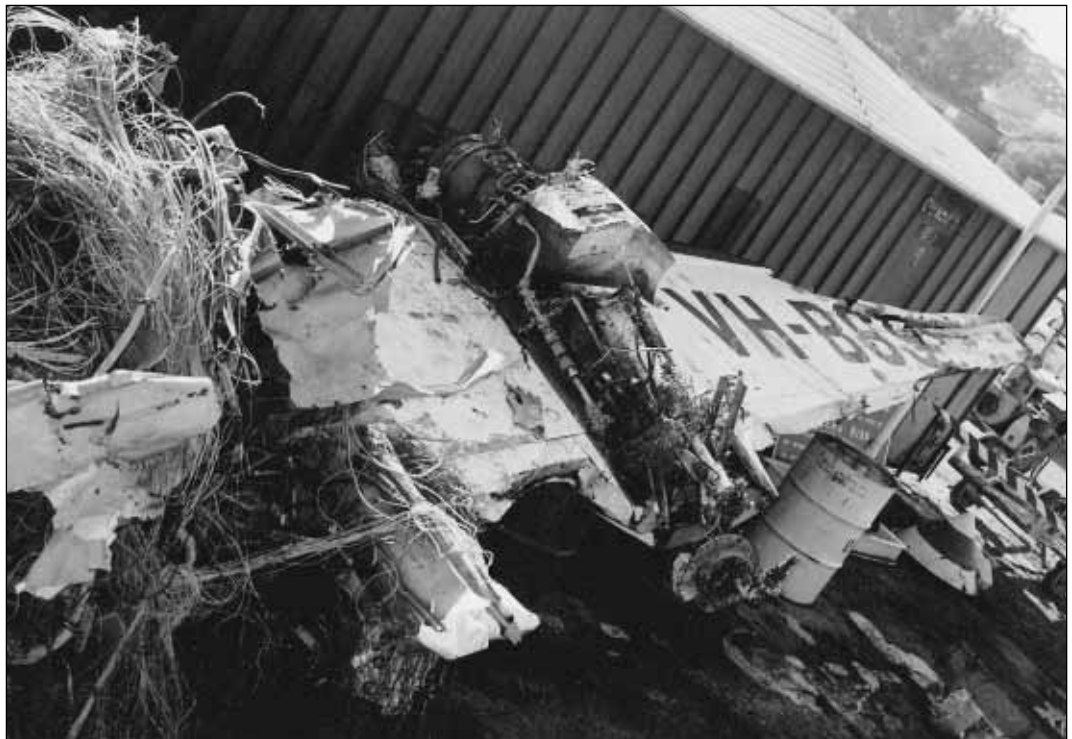
The main feature of the left wing was the crushing of the leading edge outboard of Wing Station 178.00 (see figure 4). This crushing extended rearward and upward to the main spar of the wing. The left outboard flap and aileron, and a large portion of the inboard flap, were missing. The left aileron control pushrod was bent towards the wing tip, having fractured in the threaded area of the rod-end attachment point. Also, one arm of the aileron control horn assembly had failed and had been pulled through the cable run holes on several inboard wing ribs. The failure surfaces of the hinges for both the missing flap and aileron indicated failure due to bending in an outboard direction. Finally, the left aileron cove exhibited signs of being torn towards the wing tip. This tearing exhibited little evidence of corrosion on the exposed surfaces.

Figure 4. View of left wing (inverted). Crush damage to outer leading edge consistent with high speed water impact.

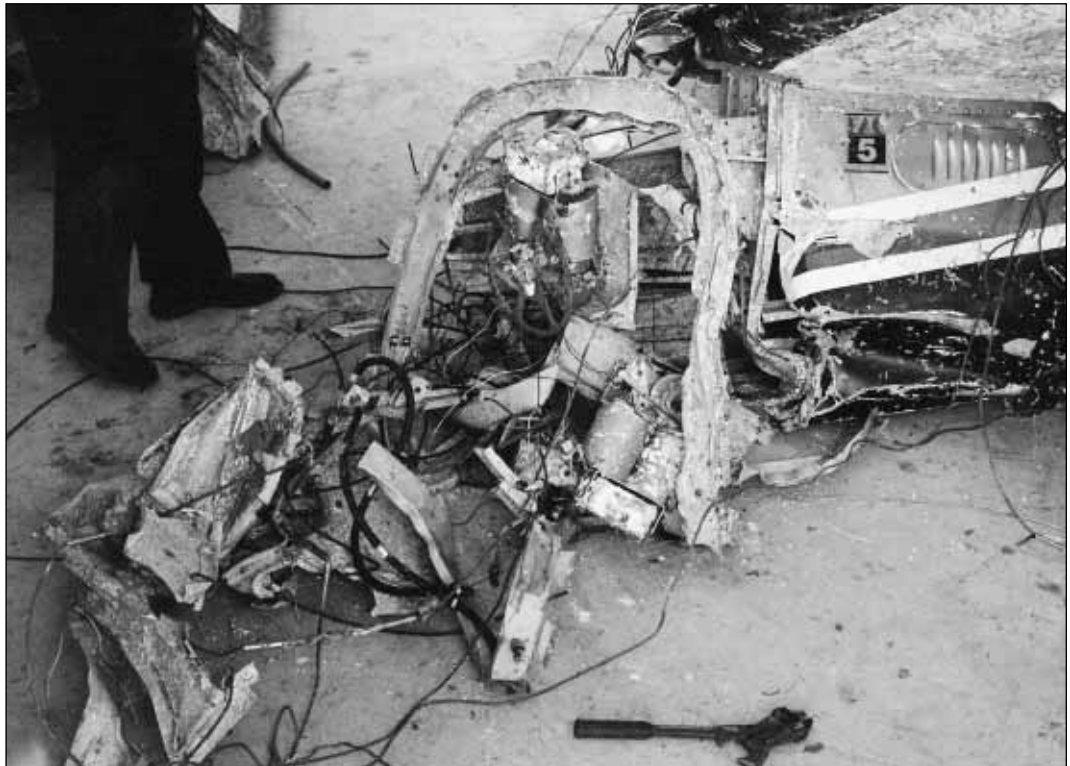
Figure 5. Shattered rear fuselage as recovered from sea.

out from the root for approximately 2.03 metres. The empennage had broken off the aft fuselage at approximately Fuselage Station 366.00 (see figure 5). Skin fractures and rivet pull-outs indicated failure was due to overload in bending (forward and to the right side of the aircraft).

Due to the observed damage to the left horizontal tail and elevator, it is reasonable to conclude that this side of the empennage impacted the water first. Given this large side loading on the empennage, the rear fuselage failed in bending at Fuselage Station 386.82 on the left side, and Fuselage Station 346.00 on the right side. Symmetrical skin tear-outs around rivet locations on the left side attest to the bending failure of the fuselage to the right and forward. As the empennage (and rear fuselage) failed in bending due to impact loads, in-flight structural failure is not a consideration. Accordingly, there is considerable evidence to support the conclusion that the aircraft was structurally intact prior to impact with the water.

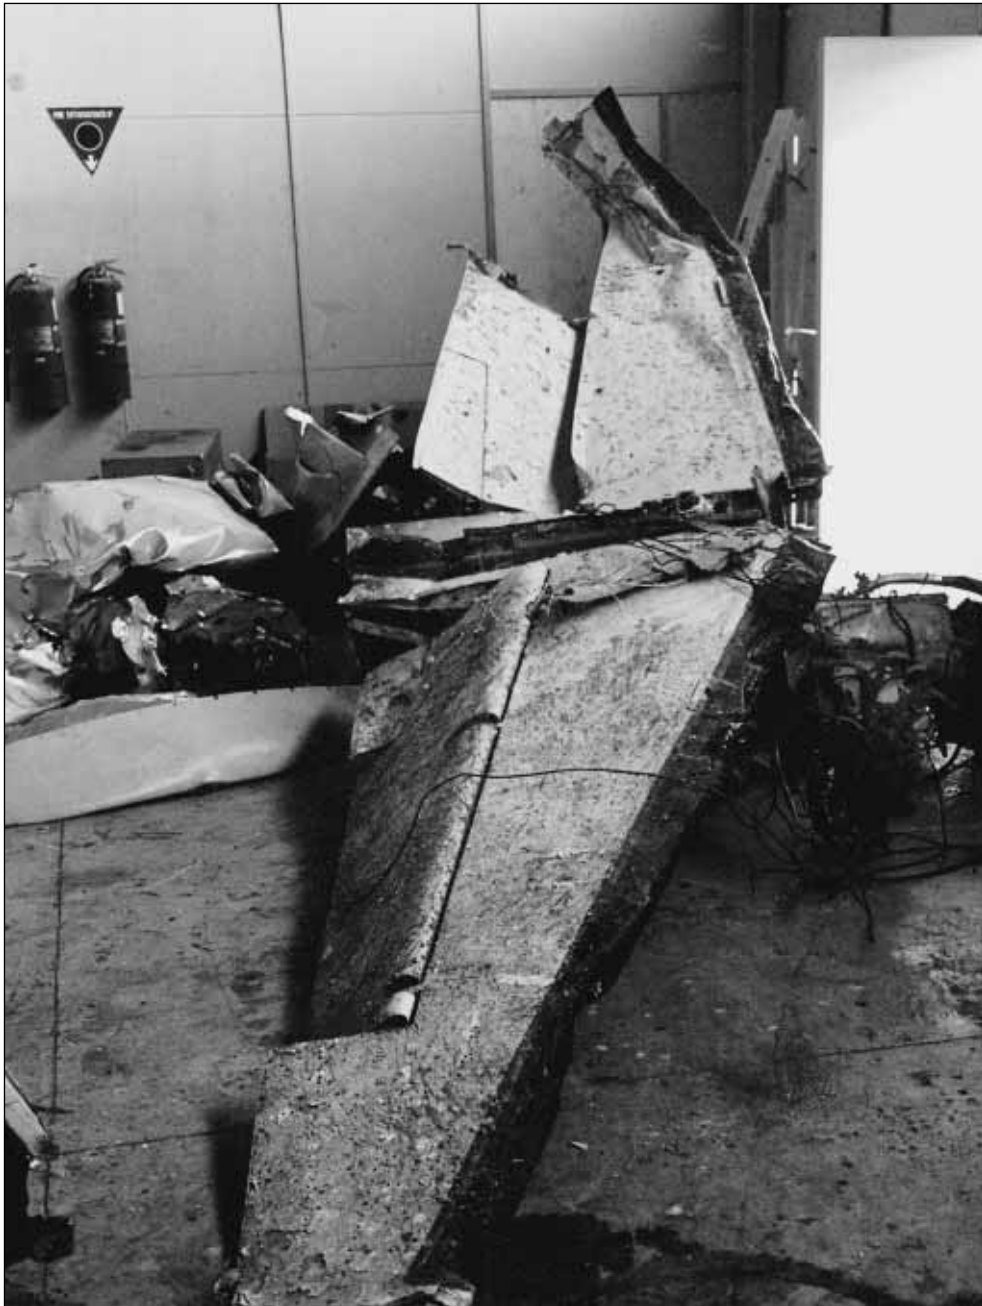
The rudder and right elevator were intact, along with their respective balance weights, but 1.14 metres of the outboard section of the left elevator was missing. The outboard section of the left horizontal tail was deformed up and inboard, and exhibited numerous dents along its leading edge (see figure 6). The left elevator control torque tube was broken off at its connection with the inboard edge of the elevator. The aft control horn for this elevator had impacted the top of the bulkhead at Fuselage Station 437.19, indicating a severe upward load on the elevator. The vertical tail had broken away from the aft fuselage at the root, but was still attached via control and antenna cables. The vertical tail leading edge exhibited numerous minor dents.

Figure 6. Left tailplane exhibited damage consistent with high speed water impact. Rudder (removed) and elevators showed no evidence of inflight failure.
