INVESTIGATION REPORT
9802830

Cessna 185E Floatplane, VH-HTS
Calabash Bay, NSW
26 July 1998

Bureau of Air Safety Investigation

INVESTIGATION REPORT

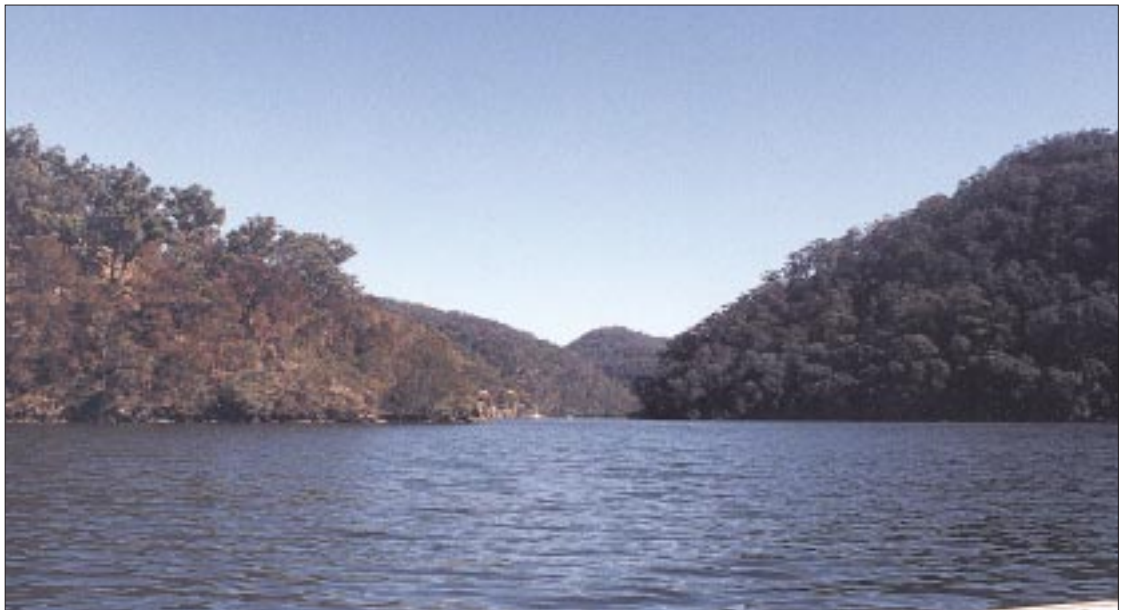
Calabash Bay as viewed by witnesses observing the aircraft from Deep Bay

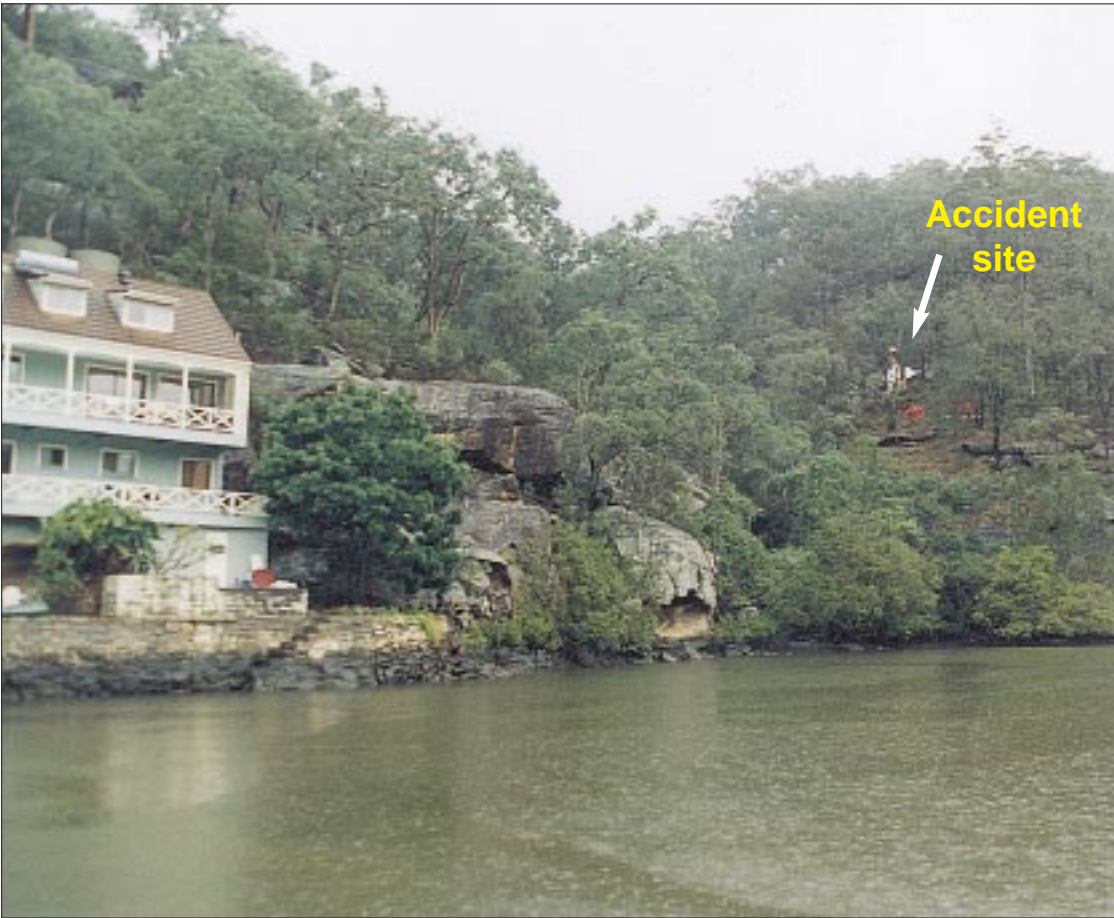
The aircraft crashed at about 1324 into heavily timbered sloping terrain, on the ridge forming the southern shore of Calabash Bay. All five occupants suffered fatal injuries.

The accident site as viewed from Calabash Bay

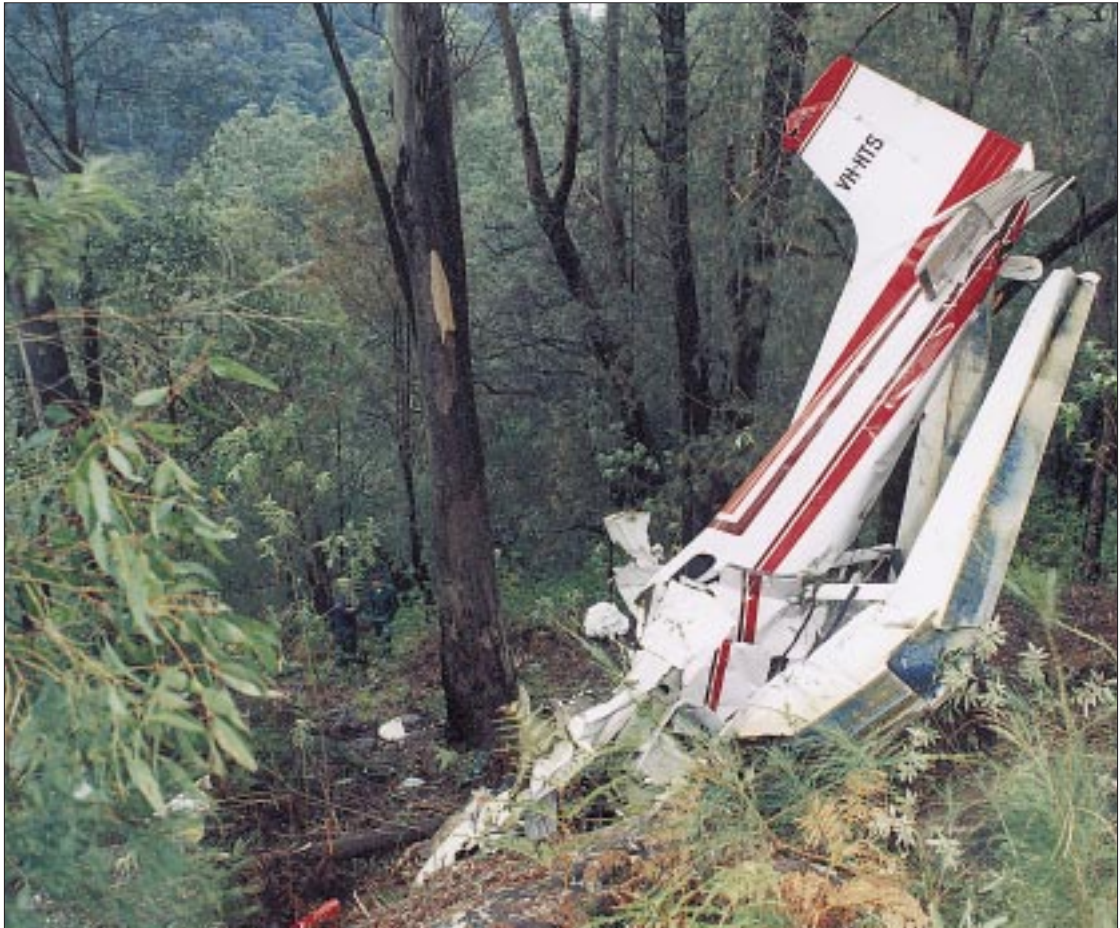
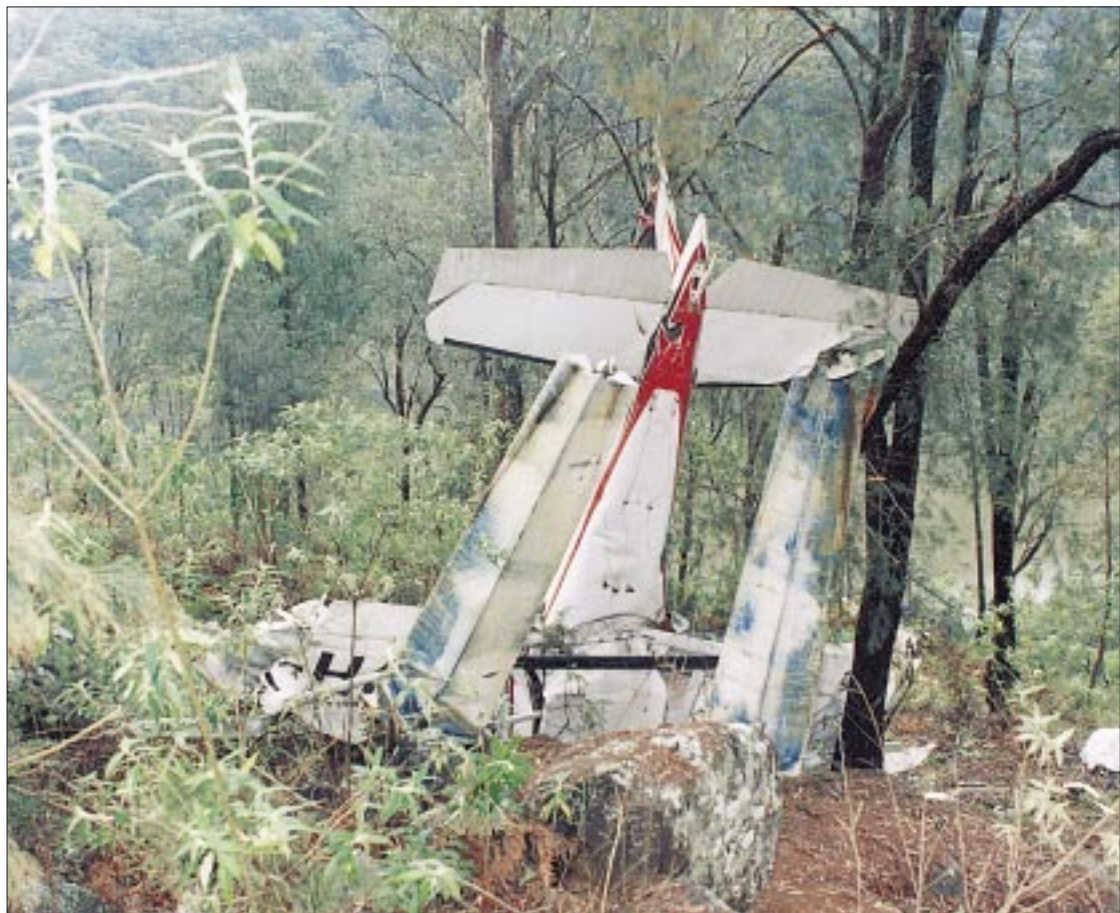
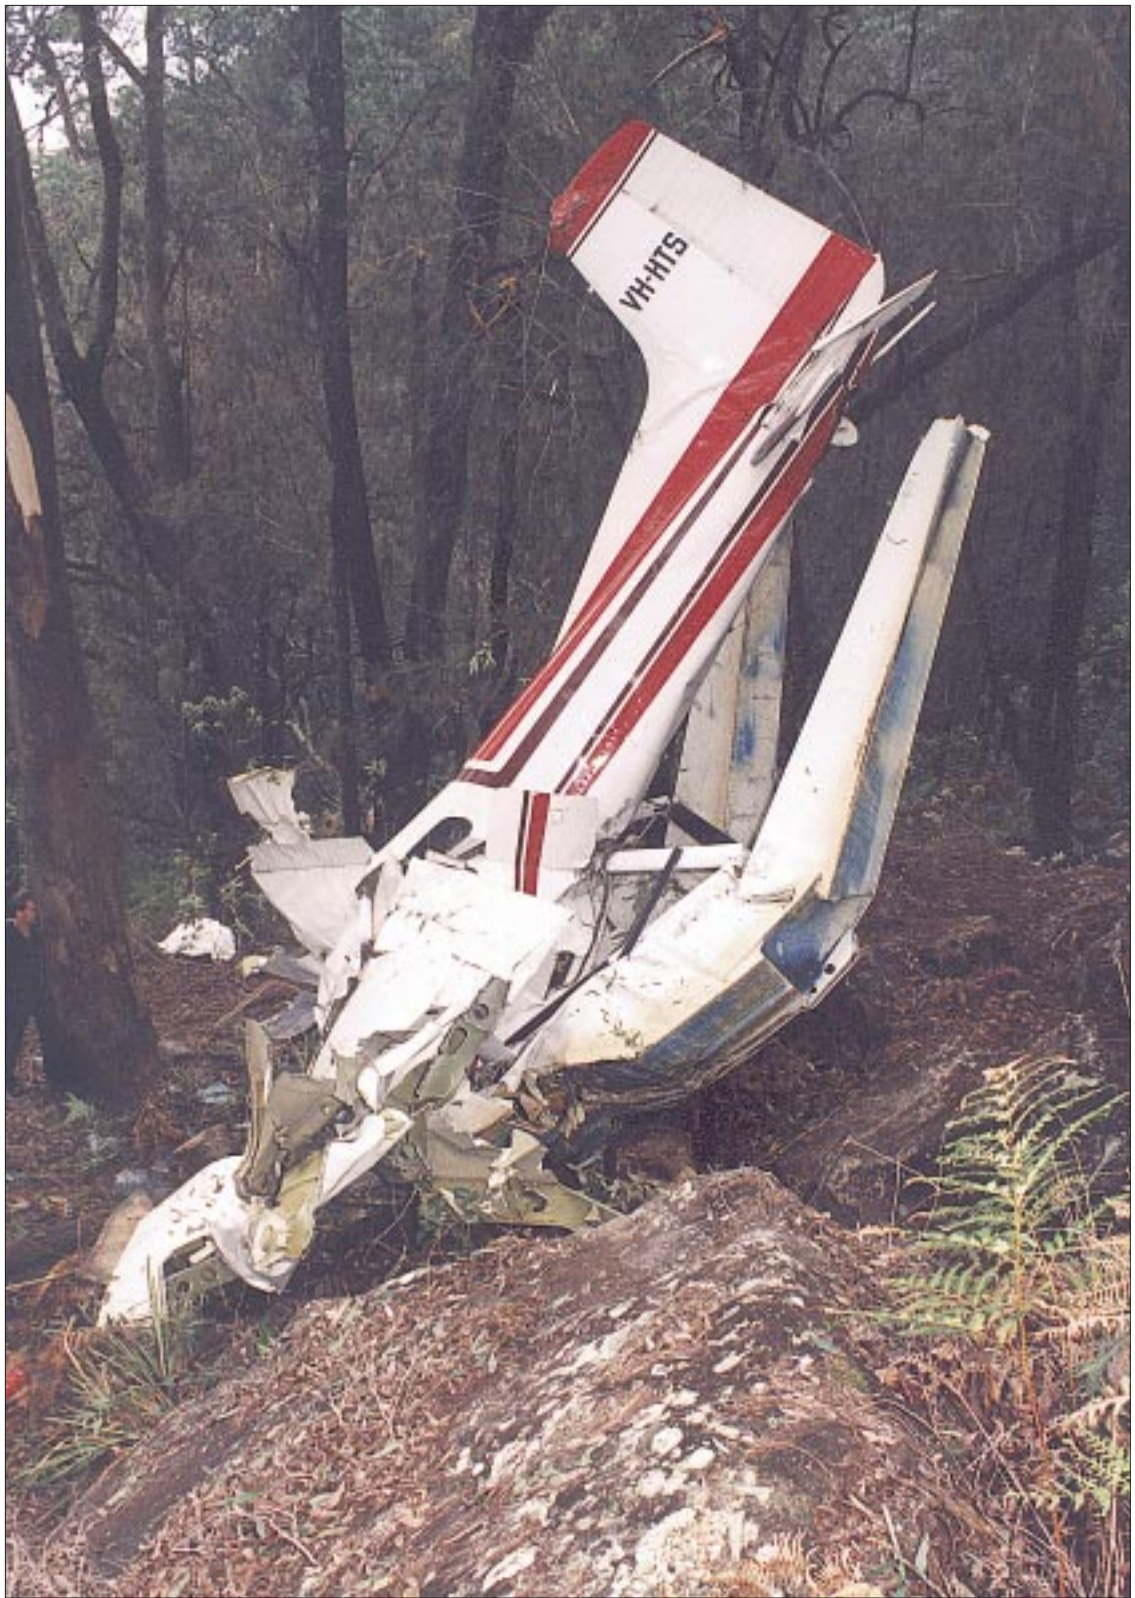
The aircraft had impacted nose-down in a near vertical attitude, into steeply sloping, heavily timbered terrain, at an elevation of about 120 ft. Both floats had collided with a large boulder and been driven rearwards, with the right float striking the right horizontal stabiliser. Both outboard wing sections were severely disrupted as the aircraft descended through trees. The right outboard wing restrained the aircraft in its final resting position.

The aircraft damage was consistent with a relatively low-speed, near-vertical impact with the ground. The engine and firewall had been driven rearwards, and the wings and supporting structure had moved forward and down until almost contacting the glareshield. The propeller was torn off in the impact. All extremities of the aircraft were found at the accident site, consistent with the aircraft being intact at the point of initial contact with trees. A considerable quantity of fuel remained in the ruptured fuel tanks, which continued to leak for about 24 hours after the accident. Both floats were torn and buckled rearwards to their respective steps, and the supporting struts were buckled and bent.
