**ATSB TRANSPORT SAFETY REPORT**  
Aviation Occurrence Investigation  
AO-2009-044  
Final

**Air system event**  
**74 km NE of Perth Airport**  
**Western Australia**  
**16 July 2009**  
**VH-TAM**  
**Beechcraft King Air C90**

Air system event - 74 km NE of Perth Airport, Western Australia – 16 July 2009 – VH-TAM, Beechcraft King Air C90

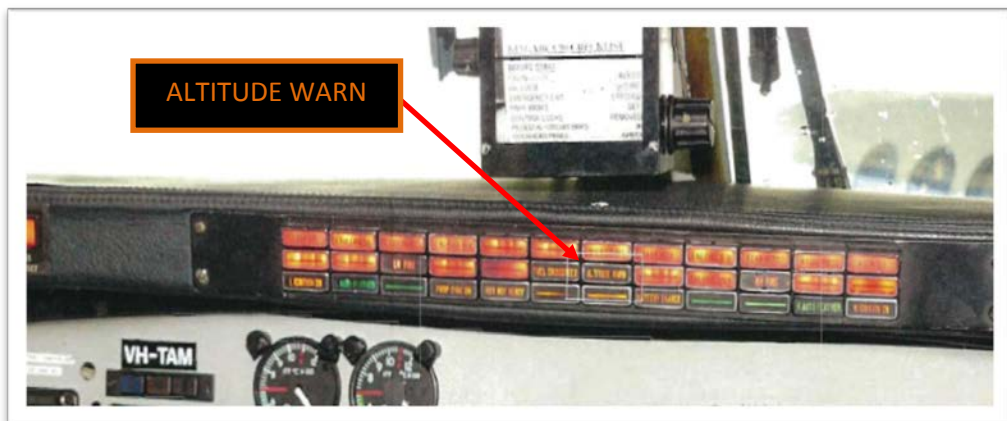
**Figure 3: Annunciator panel with ALTITUDE WARN annunciator indicated**

The aircraft's cabin altitude warning consisted of a back-lit amber annunciator<sup>10</sup>, which was located in the approximate centre of the glareshield-mounted annunciator panel. The words 'ALTITUDE WARN' were printed on the light's glass face (Figure 3).

The situation was further compounded by the failure of the aircraft's cabin altitude warning system to alert the pilot to the aircraft's unpressurised state due to a previously undetected electrical wiring connection fault. The timely operation of that system could have alerted the pilot to the unpressurised cabin at an altitude prior to the onset of hypoxia and potentially prevented the occurrence.

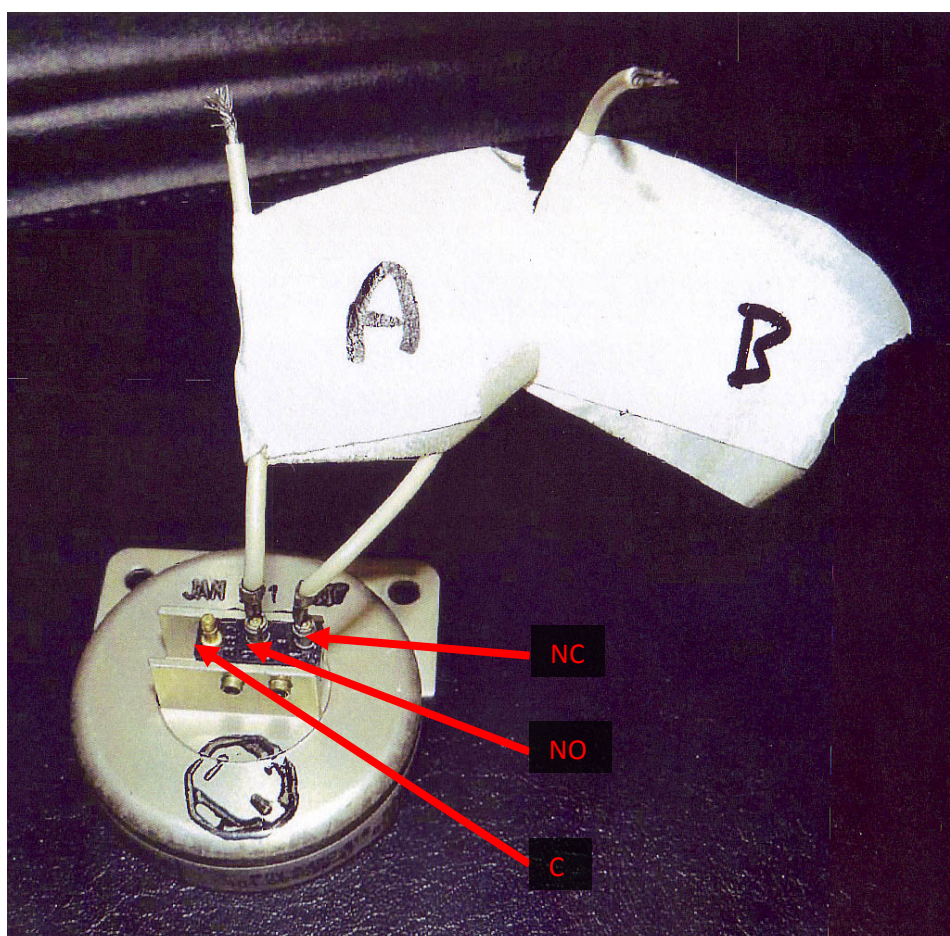
**Figure 4: As-found cabin altitude warning pressure switch wiring in TAM**

The wiring to the replacement switch was reported to have been 'shorted' together to test the operation of the ALTITUDE WARN caution annunciator before being connected to the same terminal posts on the new switch as on the original switch. No further testing of the assembled system was carried out.

During the post-occurrence maintenance checks it was also discovered that the aircraft's cabin altitude warning system was not operational. A detailed examination of that system found that the aircraft's cabin altitude warning system wiring was attached to the NO and NC terminals (Figure 4), rather than the NO and C terminals as stipulated in the MM.

The incorrect wiring of the cabin altitude warning pressure switch in 2007 prevented its operation during the occurrence. The undetected maintenance planning error meant that a 12-monthly operational test of the cabin altitude warning system was omitted from the aircraft's maintenance schedule. That omission meant that a functional test of the aircraft's cabin altitude warning system was not carried out on several occasions following the fitment of the replacement pressure switch. It could be expected that the test, if carried out, would have detected the system fault, enabling its rectification prior to the occurrence.
