# Derailment of freight train 5MP5 near Keith, South Australia 8 October 2010

## Abstract

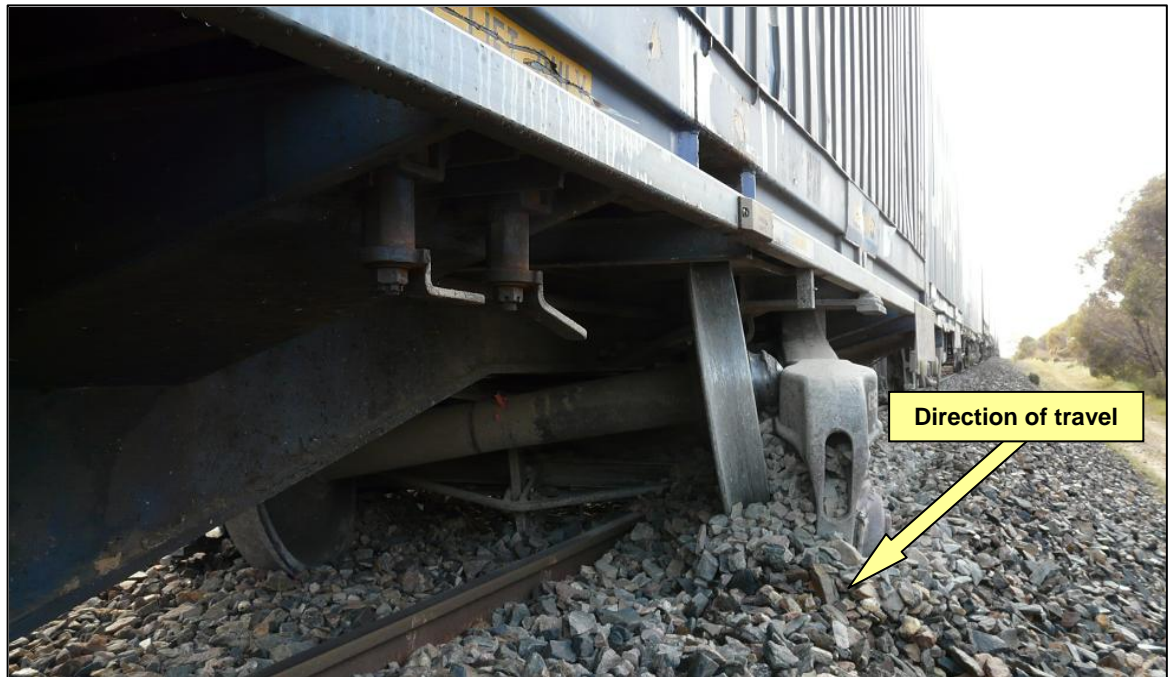
Figure 1: Derailed bogie (NWNB 0645) under wagon RQJW 22034D, looking towards Melbourne

It was established that the derailment was the result of a screwed journal<sup>2</sup> on the 12th wagon (RQJW 22034D) in the consist behind the locomotives.

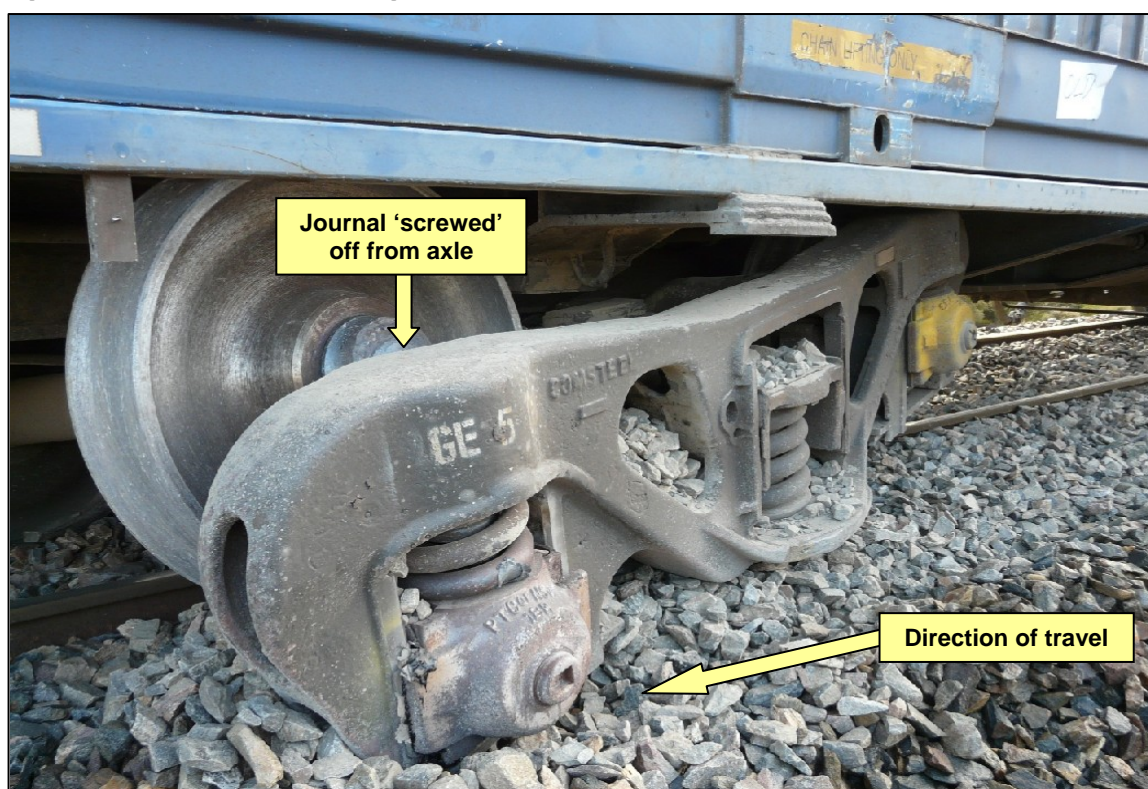
Figure 3: Derailed wheel-set of wagon RQJW 22034D

When the train had stopped the observer disembarked to check the rear of the train for any problems. After walking back about 900 m he reported to the incident driver that he had found that the trailing bogie on wagon RQJW 22034D, the 12th in the consist behind locomotive NR76, was derailed as a result of a screwed journal (Figure 3).

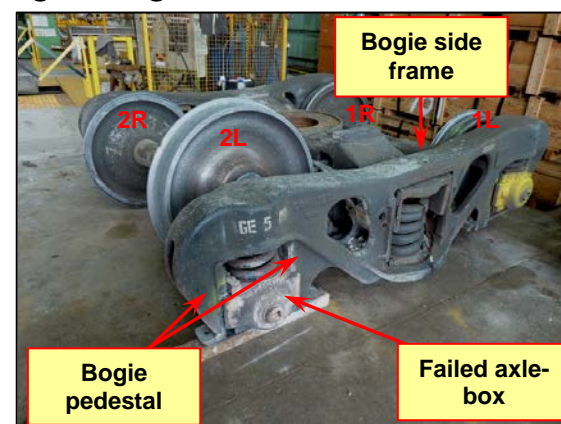
Figure 4: Bogie NWNB 0645

Observations undertaken at the EDI workshops confirmed that wheel-set 755837 of bogie NWNB 0645 (Figure 4) had failed as a result of the axle journal separating from the axle.

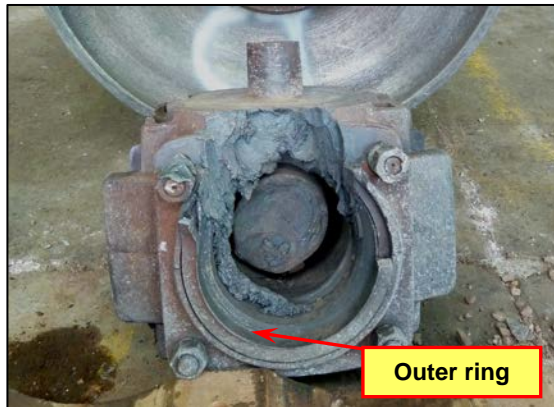
The wheel-set was removed from the bogie allowing it and the failed axle-box to be examined. As evidenced at Figure 5 the journal had separated from the axle within the 2L axle-box. Also visible within the axle-box was the inboard bearing's 'outer ring'.

**Figure 5: View inside failed '2L' axle-box with the screwed part axle journal remaining**

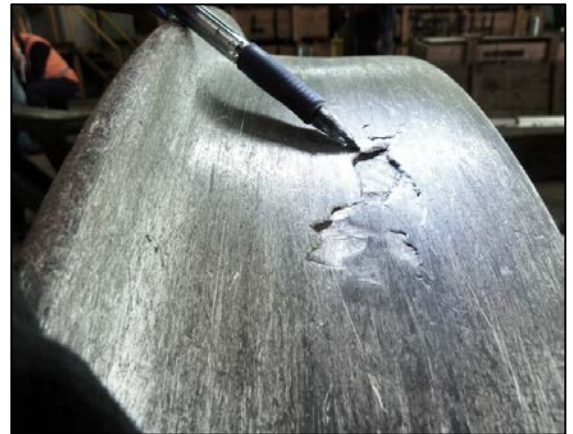
However, also of note on the 2L wheel (the wheel associated with the failed axle-box) was a

**Figure 7: Surface defect in 2L wheel**

significant surface defect<sup>6</sup> (Figure 7) on the wheel tread in one location.

After the 30 May, there were increases in wheel impact loadings, which reached a maximum of 320 kN on 30 September, and were a direct result of the growing wheel surface defect in wheel 2L, (Figure 7).

The working loose of the grease nipple was probably accelerated by vibrations associated with the surface defect on the 2L wheel. Had PN withdrawn wagon RQJW 22034D from service

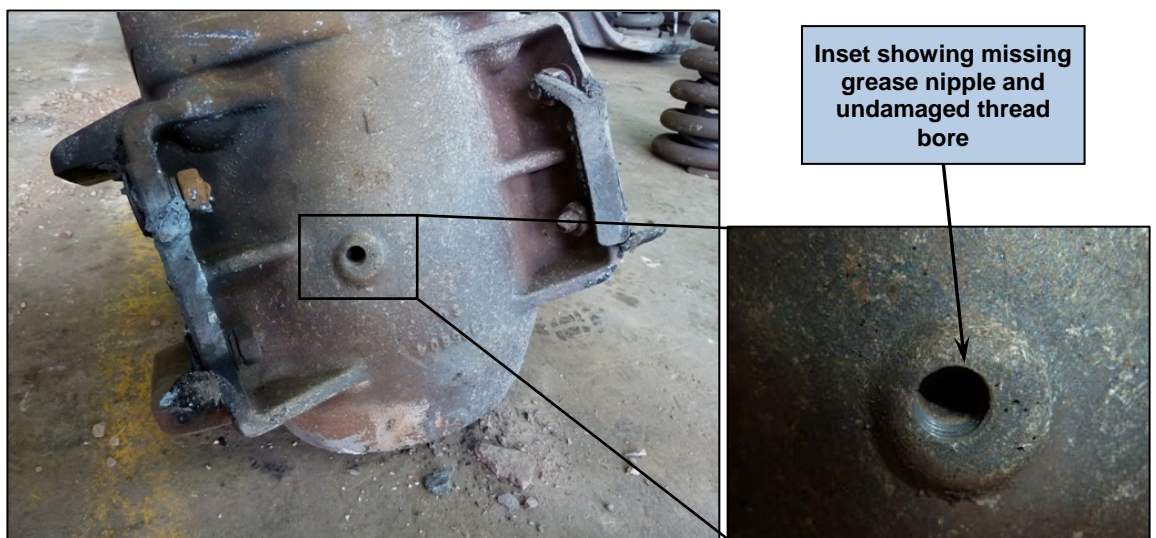
Further examination of the axle-box (Figure 6) established that the grease nipple, located on the under-side of the axle-box, was missing. On checking the grease nipple thread (Figure 6 inset) it was evident that it was largely undamaged (other than exhibiting signs of oxidation associated with the overheating of the axle-box during the failure sequence) indicating that the grease nipple had worked loose and was probably not in place at the time of the derailment.

**Figure 6: Failed axle-box showing missing grease nipple (inset view of grease nipple thread)**

It was concluded that, at some time before the derailment (and probably after the previous re-greasing), the grease nipple became dislodged from the failed axle-box. The undamaged condition of the threaded bore for the grease nipple suggests that in-service vibration probably contributed to the grease nipple working loose and falling out. Once the grease nipple was lost, the axle-box was open to the ingress of moisture and contaminants which eventually led to bearing rolling contact surface damage. As the condition

The loss of the grease nipple in the relatively short time between the previous service and the derailment suggests that the grease nipple was not properly tightened during the service which then allowed it to work loose during the subsequent 20,000 km in operation.

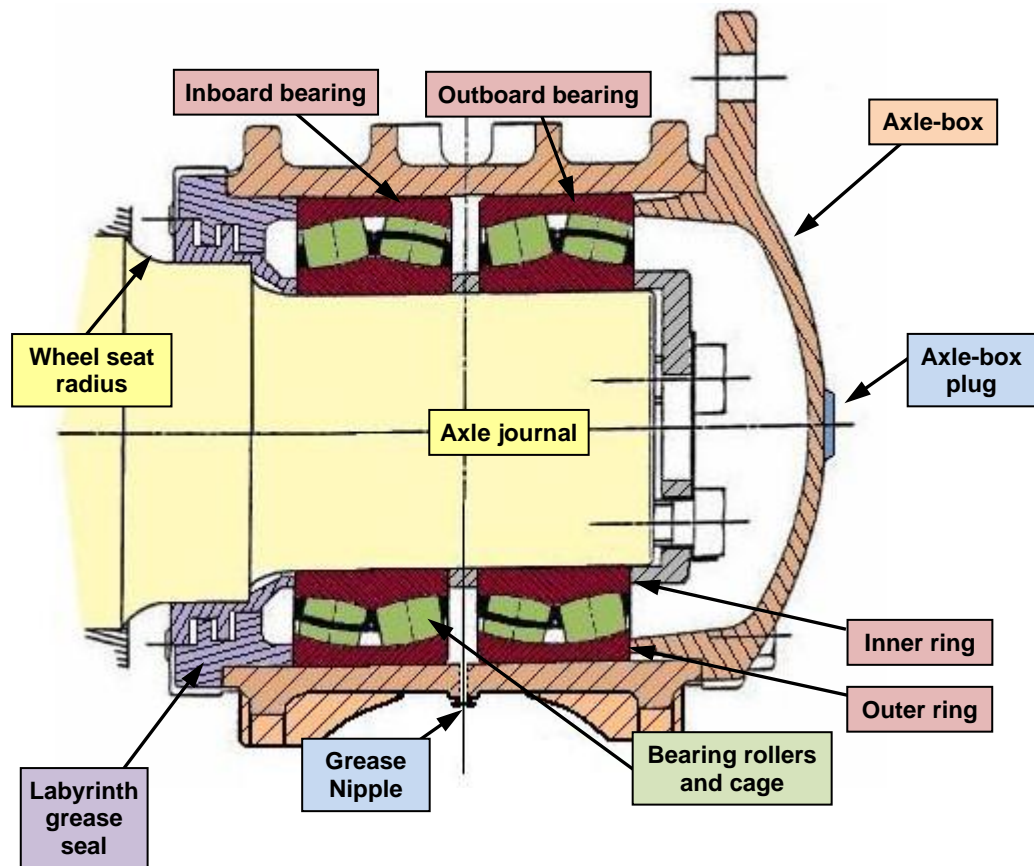
Figure 8: Axle-box schematic

On inspecting the axle wheel seat radius (inboard side, see Figure 8) of the failed axle-box there was no evidence of grease loss or carbon residue. The outboard side of the axle-box also showed no evidence of grease loss or carbon residue. The axle-box plug was firmly in place.

The axle-box at each end of a wheel axle houses two spherical roller bearings separated by a spacer with a labyrinth grease seal located outside the inboard spherical bearing (Figure 8). The labyrinth grease seal is of an air gap design and therefore a small amount of grease leakage is normal, requiring regular re-greasing. PN maintenance instructions require that axle-box bearings are regularly re-greased to maintain correct bearing lubrication.

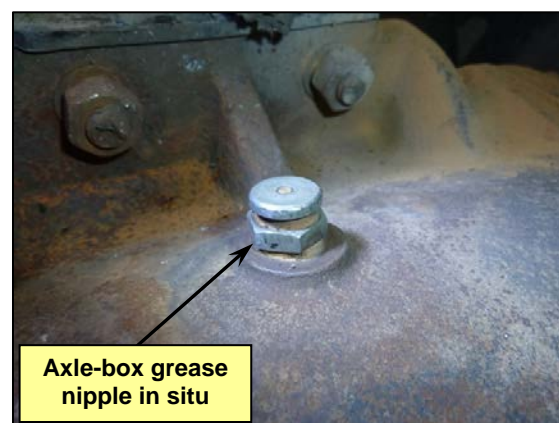
**Figure 9: View of grease nipple in situ**

It can therefore be concluded that the grease nipple was either fit for purpose (similar to that shown at photograph (Figure 9) or was replaced if leakage was observed. In either case the grease nipple should have been checked for tightness.

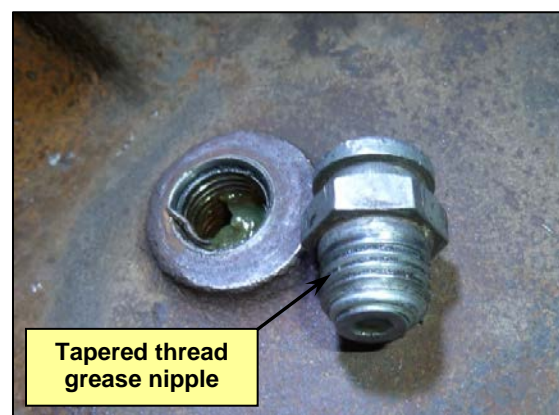
**Figure 10: View of grease nipple removed showing tapered thread**

The grease nipple used in the axle-box was of mild steel and a tapered thread design (Figure 10). Tapered thread fittings provide good sealing qualities and excellent resistance against working loose when properly installed. However, if loosely inserted and/or not tightened properly they can easily work free, particularly if exposed to high levels of vibration.

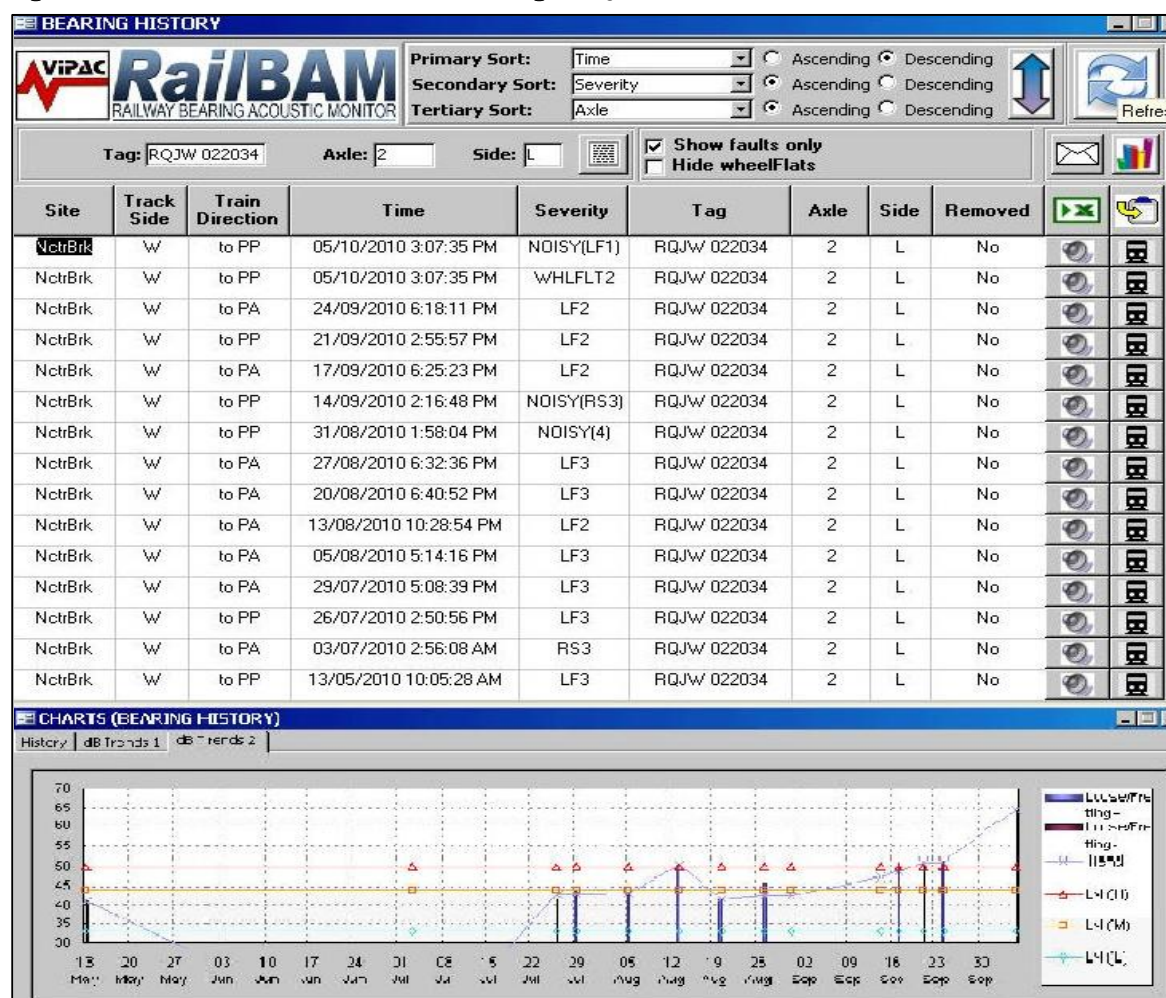
Figure 11: RailBAM readout for 2L wheel of wagon RQJW 22034D

Taking into account the likely event initiator, loss of the 2L axle-box grease nipple, data was sourced from the RailBAM® site at Nectar Brook, South Australia and interrogated (Figure 11) for a five month period preceding the derailment.

This established that before 8 July 2010 (date of re-greasing the 2L axle box) there was minimal evidence of bearing noise associated with the 2L axle-box. After 8 July 2010 the 2L axle-box had triggered one low level (3) RS alert and nine medium level (2/3) LF alerts before triggering one high level (1) LF alert on 5 October 2010, three days before the derailment. This alert was probably indicative of a growing wheel surface defect problem which is corroborated by the WILD data.

Based on PN maintenance documentation and RailBAM® data there was no requirement for PN to remove wagon RQJW 22034D from service to check for bearing faults. However it is evident in examining the RailBAM® data, particularly the graph at Figure 11, that there was a steady increase in the level of acoustic noise associated with the 2L axle-box and that inspection was probably warranted.

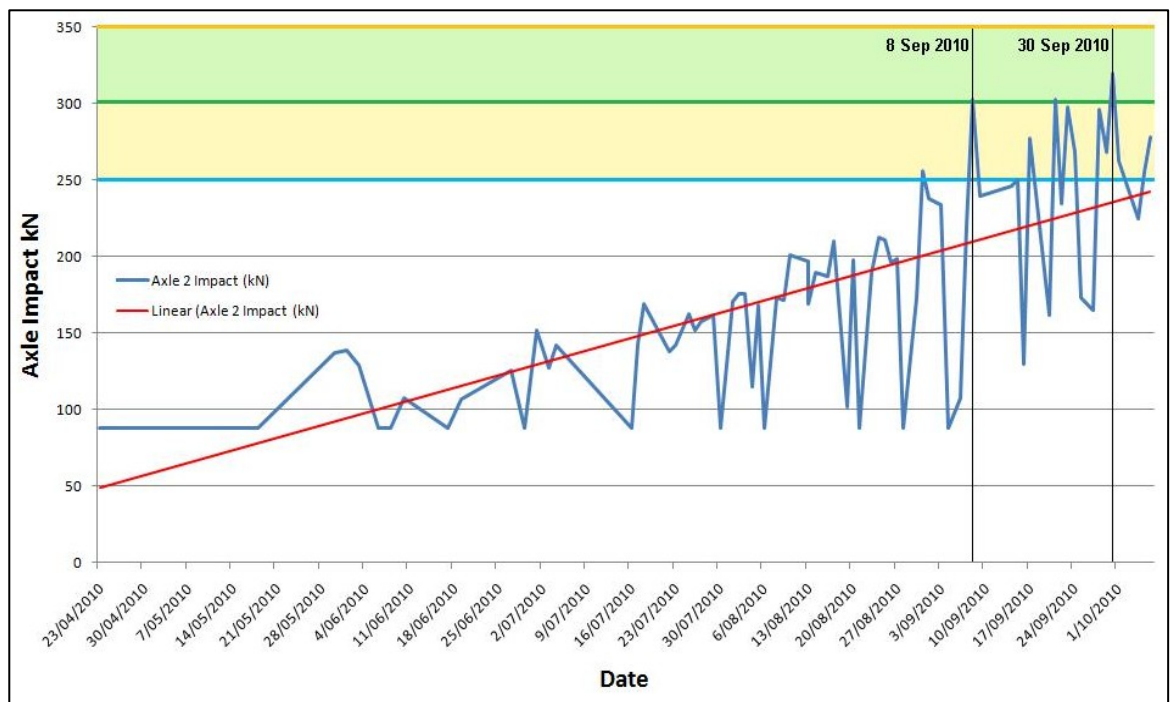
An examination of WILD data extracted for wagon RQJW 22034D for the period 23 April 2010 to 6 October 2010 (Figure 13) shows that until 30 May impact loadings generally did not exceed 88 kN which represents normal wheel loads.

An examination of PN's 'wheel-set removal decision matrix' (Figure 12) and the maximum wheel impact recorded by WILD, of 320 kN on 30 September, shows that there was no immediate requirement to take wagon RQJW 22034D out of service. However, a review the WILD data covering the period, 23 April 2010 to 6 October 2010, showed a clear trend indicating a growing wheel impact problem. The trend analysis (Figure 13) shows that it was probably inevitable that the wagon needed to be withdrawn from service for examination rather than relying on withdrawal based on simple exceedence criteria.

Figure 13: WILD data for period 23 April 10 through to 6 October 10
