**ATSB TRANSPORT SAFETY REPORT**  
Aviation Occurrence Investigation  
AO-2009-027  
Final

**In-flight fire**  
**427 km south-west of Guam**  
**10 June 2009**  
**Airbus A330-202**  
**VH-EBF**

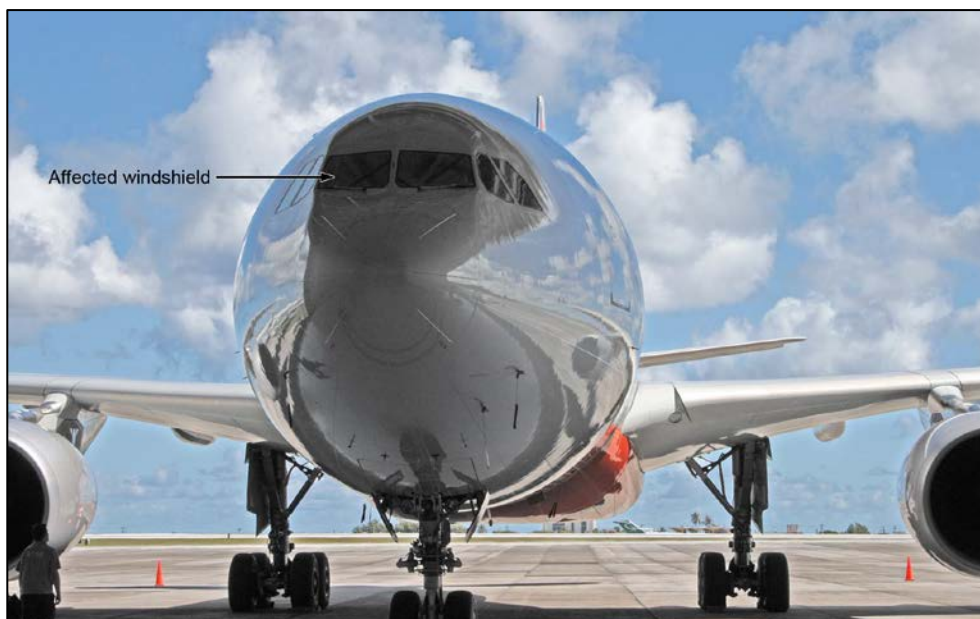
**Figure 1: VH-EBF undergoing repair at Guam showing the location of the right windshield**

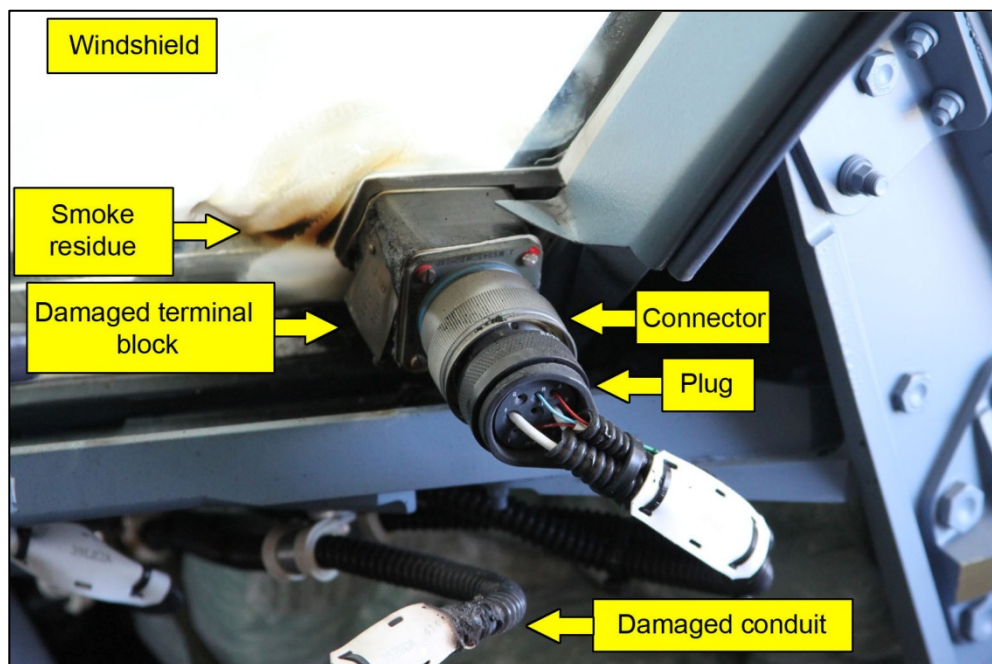
The damaged right windshield<sup>10</sup> was produced by Saint-Gobain Sully, France, in February 2007, and had been installed during construction of the aircraft. Inspection in Guam showed severe burning and melting of the right side windshield terminal block housing and minor heat damage to the glare shield and wire conduit around nearby loudspeaker wiring (Figures 3 and 4). The electrical plug from the window heat computer was firmly secured to the windshield connector and was undamaged. There was no evidence of loose fitting between the connector and the terminal block.

**Figure 3: Windshield heat electrical connector and terminal block housing (in situ)**

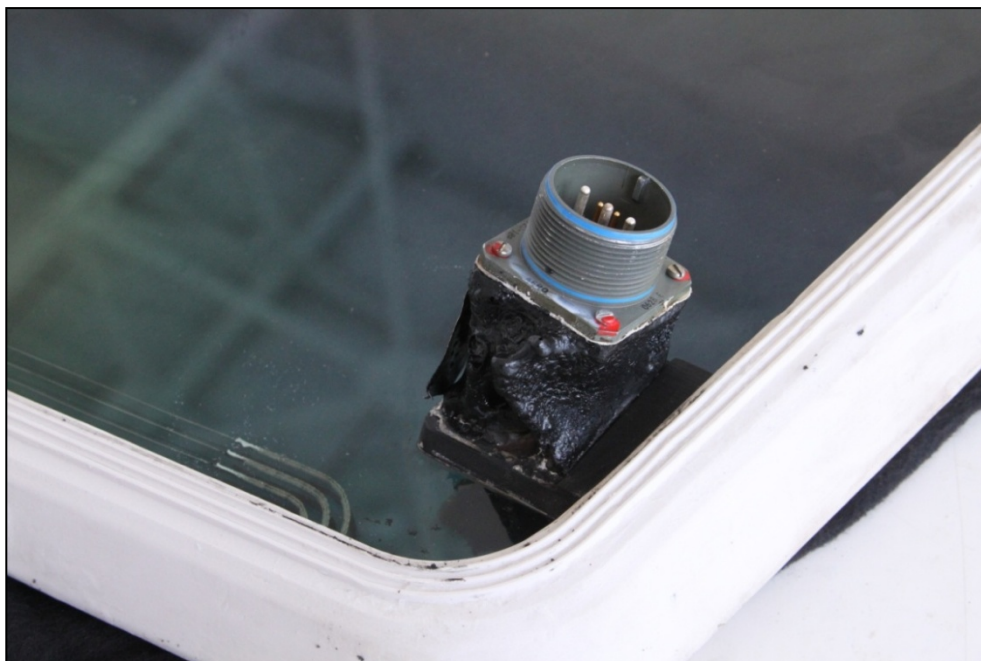
**Figure 4: Close-up view of the melted terminal block**

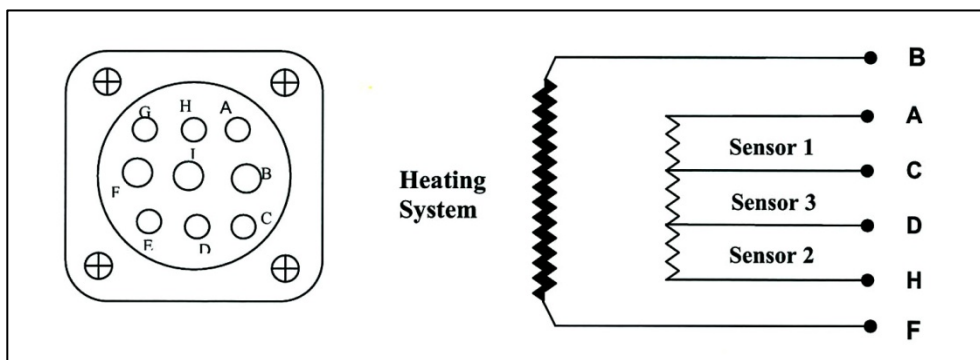
**Figure 5: Terminal block connector pin layout; pins B and F supplied power to the inter-laminate heating film and pins A, C, D and H were connected to the temperature sensors**

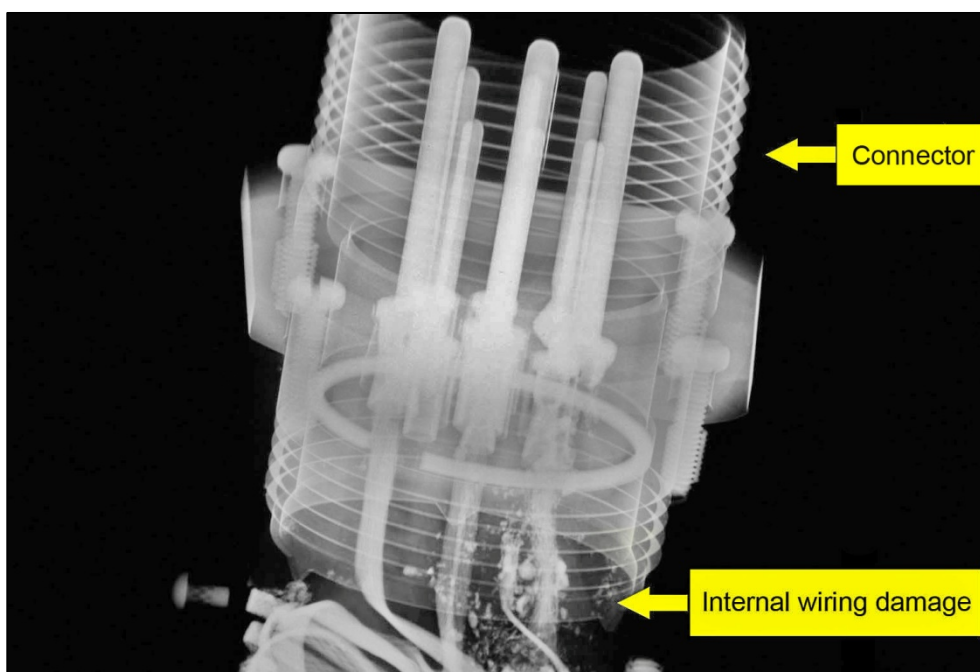
After the windshield from VH-EBF had been removed from the airframe and prior to any disassembly taking place, the terminal block was inspected by the ATSB using radiographic techniques. The x-ray inspections permitted an understanding of how the wires were organised inside the terminal block, with one of the braided wires showing severe localised damage. A schematic diagram of the terminal block and the pin connections is shown at Figure 5, with a radiograph showing the wiring damage at Figure 6.

**Figure 6: Radiograph showing disruption to the internal wiring within the terminal block**

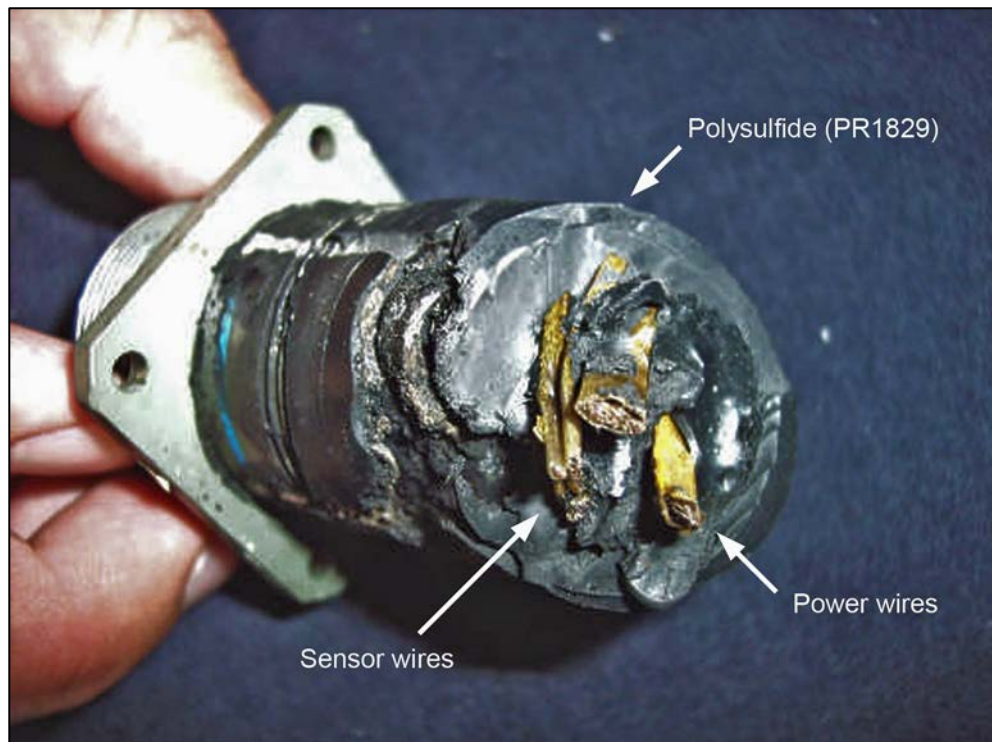
- In order to visually examine the physical condition of the power and sensor wiring, the terminal block was dismantled from its windshield mounted position and then destructively sectioned. That action showed that a plug of polysulfide sealant (PR1829) had been used to encase the wiring within the terminal block (Figure 7). The sectioning also showed that the silicone insulator surrounding the braided power wires (pin B) had partially burnt away from the effects of electrical arcing (Figure 8).
- The polysulfide sealant was removed from around the wire bundle to expose the general condition of the wires. Contact pin B that formed part of

- The aircraft manufacturer indicated that a polysulfide sealant (PR1829)<sup>16</sup> had been used to fill the terminal block for windshields manufactured between January 2007 and October 2008. For those windshields (1,500 in total), the terminal block cavity was filled with sealant prior to final assembly. The sealant's purpose was to prevent moisture and condensate from entering the terminal block. Of the windshields that had sustained an electrical failure (19 in total), it was indicated that all had been manufactured with a filling of PR1829 sealant.

**Figure 7: Partially dismantled windshield terminal block from VH-EBF with wiring shown encased in polysulfide sealant**

In May 2010, the aircraft manufacturer issued a service bulletin (SB) A330-56-3009 that implemented a windshield recall, removal and replacement program. The program applied to a batch of approximately 1,500 windshields that had been manufactured between January 2007 and October 2008 where PR1829 polysulfide sealant had been used as a filling agent within the terminal block. The SB recommended a visual inspection of the left and right windshields to determine whether they were part of the batch containing PR1829 sealant. If identified, Airbus recommended that the affected windshields be replaced within 900 flight hours. Airbus reported to the ATSB that the airlines which had been initially affected by in-flight windshield overheat events would be prioritised in the replacement program.

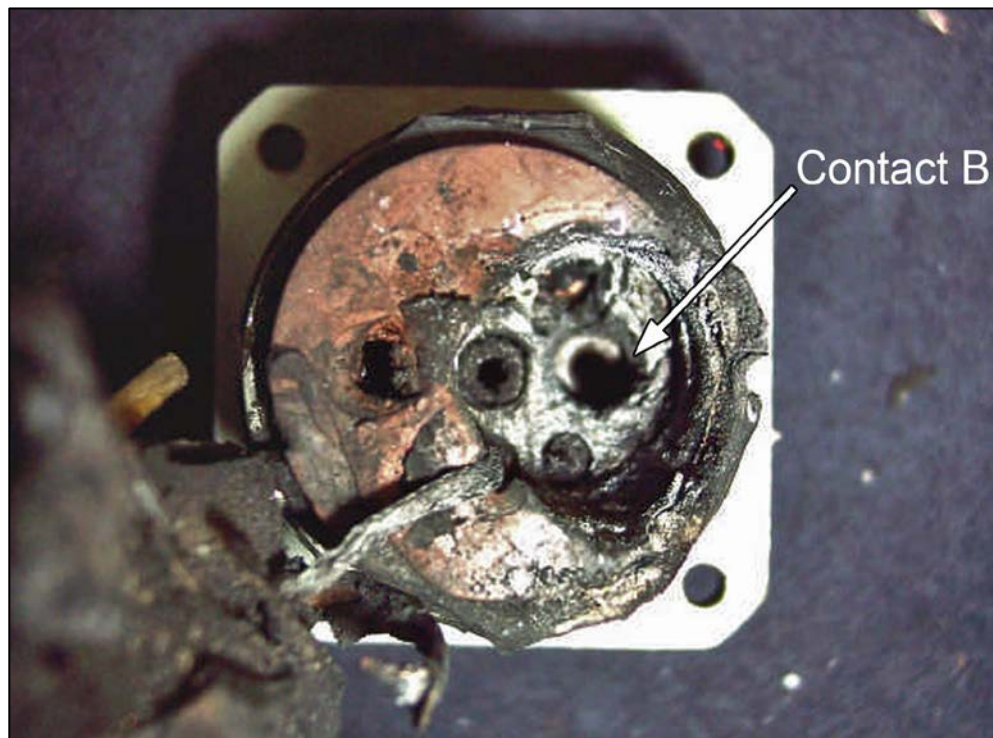
**Figure 8: Partially dismantled windshield terminal block from VH-EBF showing concentrated burning of the silicone insulator that surrounded contact pin B**

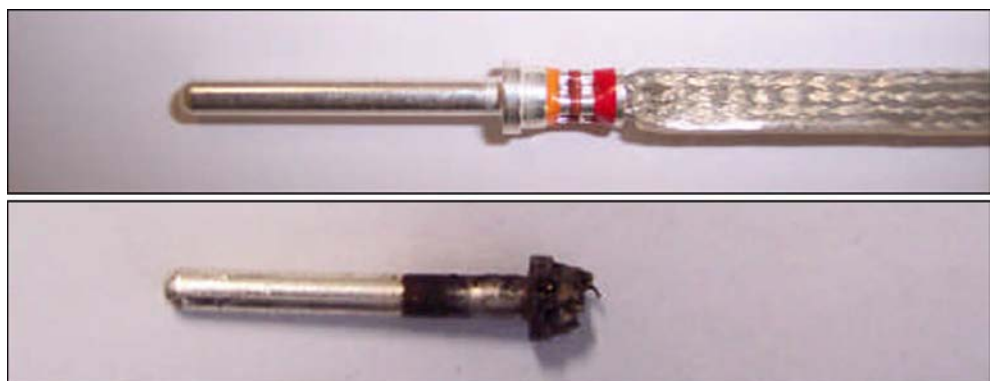
the electrical power circuit was revealed to have fragmented in a way consistent with extreme overheating damage (Figure 9).

**Figure 9: Comparison of electrical terminal block connector pins: burnt pin B from VH-EBF (lower) and that from an exemplar unit (upper)**

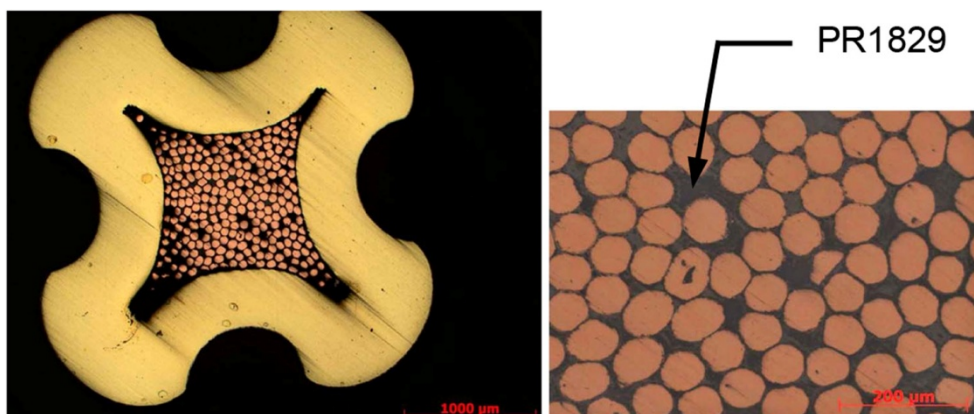
A transverse metallographic cross-section of the crimped region from a connector pin is shown at Figure 10. As noted in the extract<sup>19</sup> below, while the connector pin and braided copper wires had been crimped, sufficient residual space remained after that process to allow PR1829 to migrate into the voids between the wire strands.

**Figure 10: Metallographic cross-section through a connector pin displaying only partial compaction of the copper wire strands and migration of PR1829 sealant between the wires**

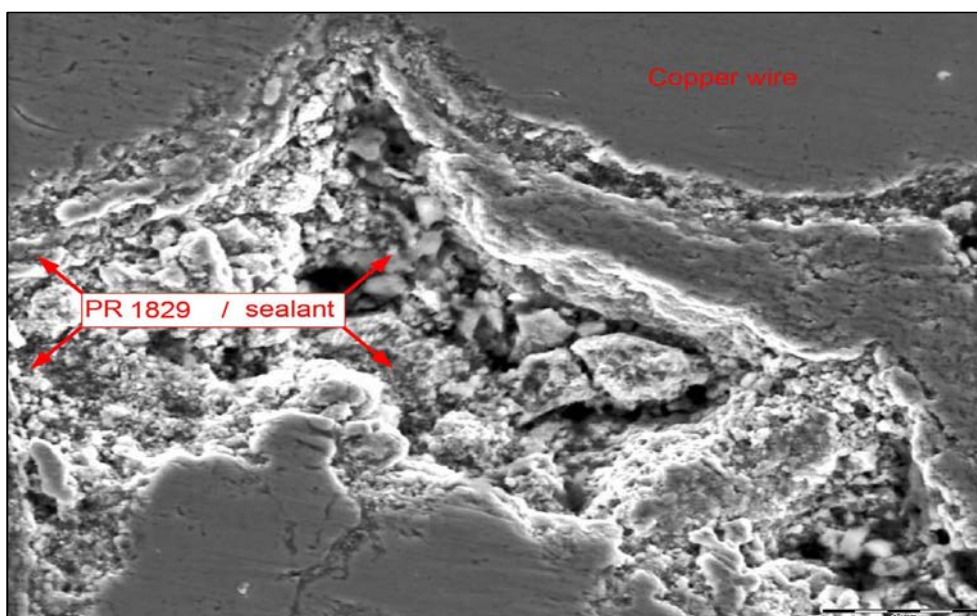
**Figure 11: Scanning electron image showing the presence of PR1829 sealant between the individual copper wires of the braid**

In the case of the connector pins examined by EADS, polysulfide sealant (PR1829) had migrated between the individual wire strands within the crimped power wire connector pins. PR1829 had been used on a batch of around 1,500 windshields to prevent moisture ingress into the terminal block. The crimped region within the connector pins should normally be devoid of PR1829 sealant – particularly between the conducting wires.
