ATSB TRANSPORT SAFETY REPORT
Rail Occurrence Investigation
RO-2011-002
Final

Collision between suburban passenger trains G231 and 215A in Adelaide Yard, South Australia

24 February 2011

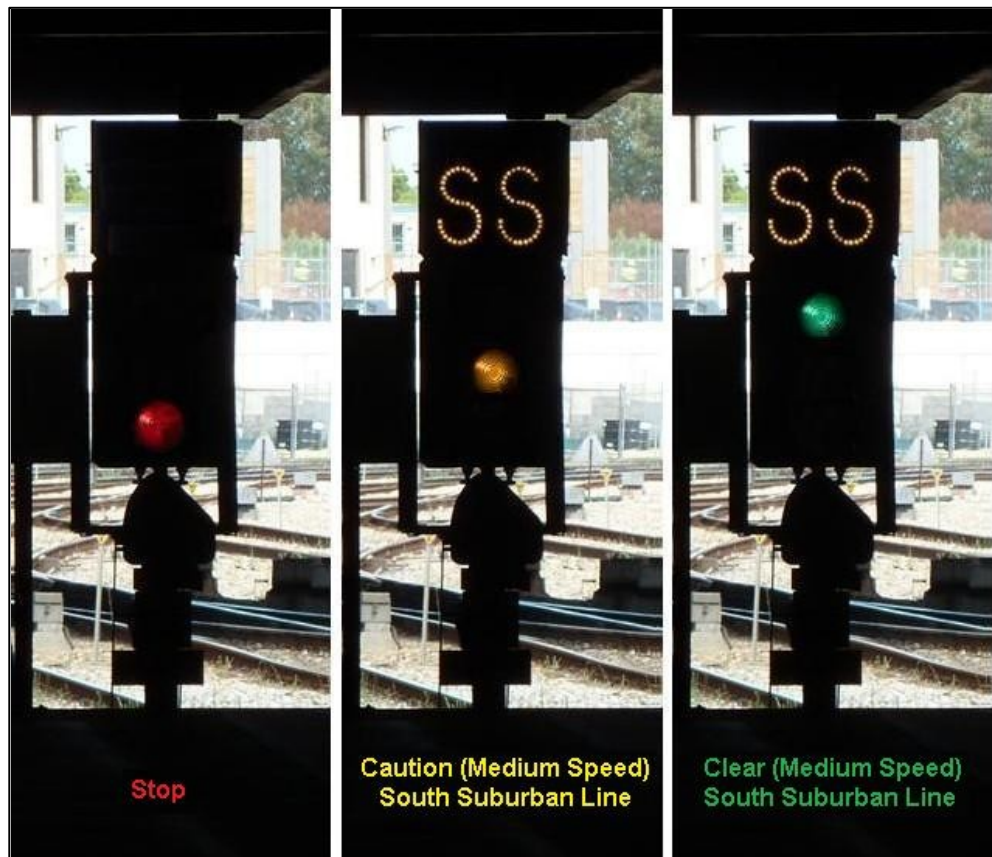
Figure 2: Signal 141 at end of platform 3 Adelaide Station

Signal 141, located at the end of platform 3 (Adelaide Station), was classified as a platform starter signal. It can display a red ‘stop’ aspect or a medium speed ‘proceed’ aspect (yellow/caution or green/clear) in conjunction with a ‘multilamp route indicator’ dependent on the status of the main line ahead. The multilamp route indicator displays alpha/numeric characters designating the route set for a train, for example ‘SS’ designates the South Suburban Main Line (Figure 2).

- Signal 141 displayed a stop (red) indication for the entire period train G231 was alongside number 3 platform up to and including when passed at stop. There was no evidence to suggest that the signalling system was faulty.
- Examination of the driver's (G231) rostered/actual hours worked indicates that roster related fatigue was an unlikely factor. However personal life style demands may have resulted in less than the ideal pre-requisite level of rest.
- The actions of the driver of train 215A did not directly contribute to the incident.
- Work undertaken by signal technicians in the vicinity of platform 9 at the time of the incident did not contribute to the incident.

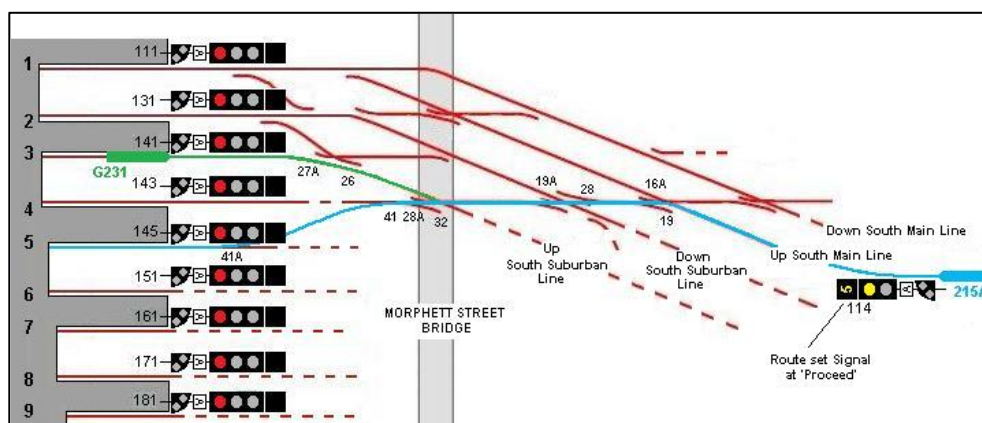
Figure 4: Adelaide Yard (part) showing path of trains 215A and G231

Train G231 arrived into platform 3 about three minutes before its scheduled departure time of 1208. The driver involved in the incident had a brief conversation with the driver he was relieving to ascertain whether there were any issues with the train; there were none. He then spoke with the PC, joined the train, completed pre-departure checks and passenger announcements. Shortly after 1208 the PC gave the driver of train G231 a yellow RoW flag indicating that passengers were clear of the train and the signal ahead (141) was at stop. The driver acknowledged the PC and also observed that signal 141 was at stop. He then made a final passenger announcement, closed the railcar doors, and accelerated slowly (green train as illustrated in Figure 4) towards the end of the platform.

At this time train 215A, travelling on the Up South Main Line, had just entered a network of points leading into platform 5 and would therefore cross directly in front of platform 3 (blue train as illustrated in Figure 4).

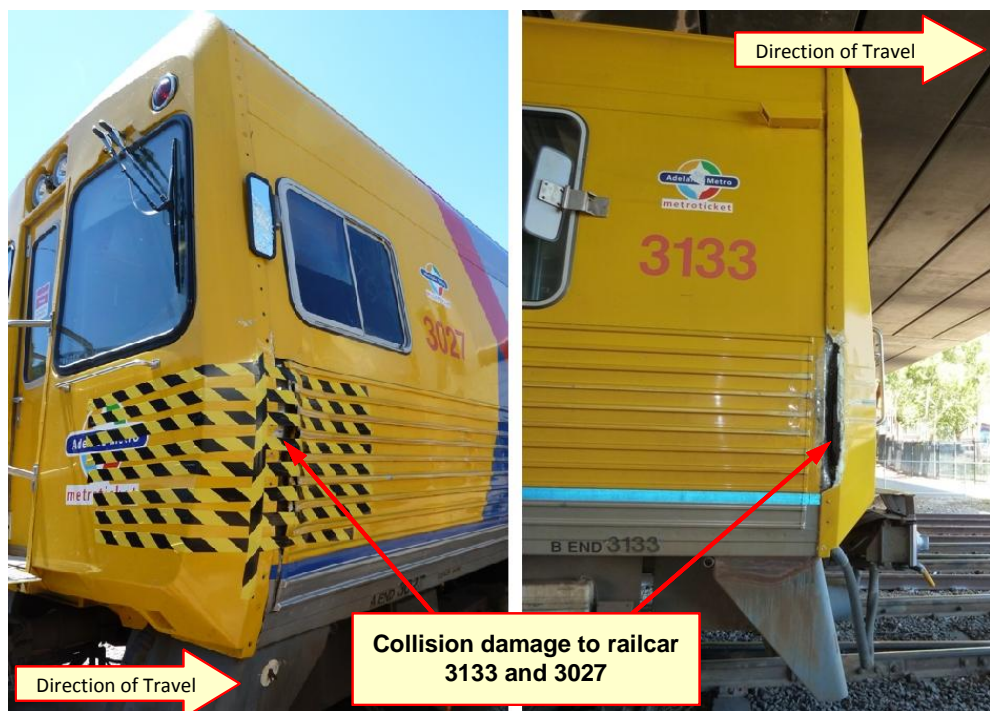
Figure 5: Evidence of collision damage on railcar 3133 and 3027

There were no injuries as a result of the collision; however, both trains sustained minor damage.

Immediately following the incident the driver of train G231 contacted the Operations Control Centre, over the radio system, stating that he had received a proceed indication on signal 141 but had collided with train 215A (Figure 5).

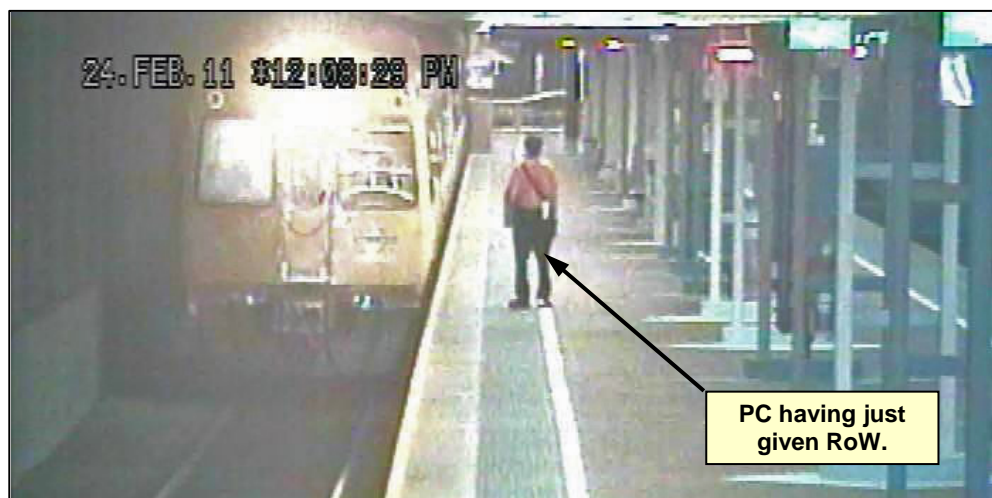
Figure 8: CCTV replay 1208:29 - PC has given RoW

At 1208:29 CCTV footage (Figure 8) shows that the platform coordinator (PC) has just given the driver of train G231 a RoW flag. The driver in his interview stated that he observed the RoW flag to be yellow in colour which indicated to him that signal 141 was at stop (red). He acknowledged the PC and also recalled observing that signal 141 was at stop. The driver made some final passenger announcements, closed the railcar doors, and began to accelerate slowly towards the end of the platform. When the train had passed the PC, he walked away to continue with his other duties.

The additional staff available for Platform Coordinator duties will result in all departures from Adelaide Railway Station being given Right of Way by a Platform Coordinator only when a proceed aspect is displayed on the starting signal, unless under direction due to a signal failure condition. It is anticipated that sufficient staff will be trained to implement this, with the procedure amended to reflect the process, by 15 September 2011.

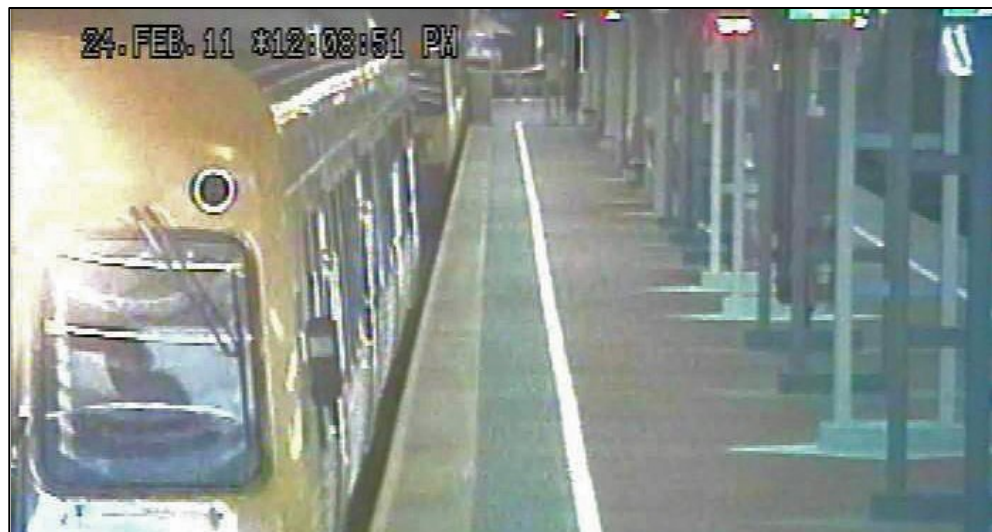
Figure 10: CCTV replay 1208:51 - driver turned sideways looking down

¹² After 1208:52 the driver's cab is no longer visible on CCTV footage.

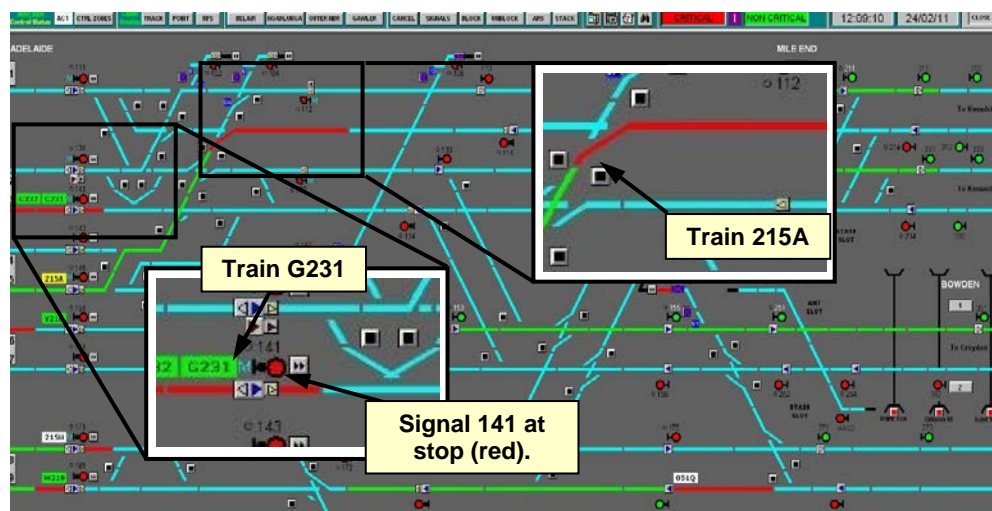
Figure 11: CTC replay 1209:11 - train G231 passing signal 141 at stop

When the train controller had confirmed that both trains had come to a stand he arranged for signals staff to examine the CTC and SSI signal replay files which showed that train G231 had passed signal 141 while displaying a stop (red) aspect.

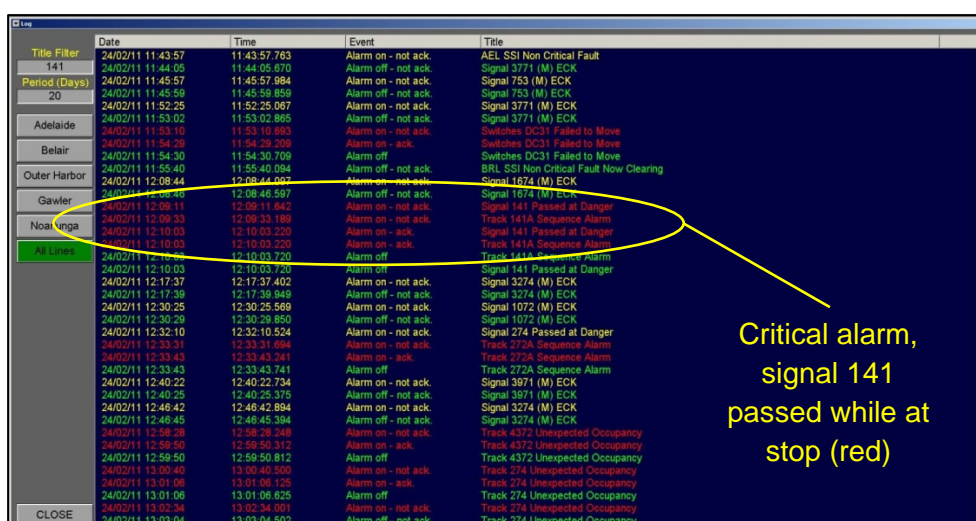
Figure 12: CTC replay 1209:11 - critical event alarm showing SPAD event

Title Filter	Date	Time	Event	Title
141	24/02/11	11:43:57	Alarm on - not ack	AEI SSI Non Critical Fault
	24/02/11	11:44:05	Alarm off - not ack	Signal 3771 (M) ECK
Period (Days)	24/02/11	11:45:57	Alarm on - not ack	Signal 753 (M) ECK
20	24/02/11	11:45:59	Alarm off - not ack	Signal 753 (M) ECK
	24/02/11	11:52:25	Alarm on - not ack	Signal 3771 (M) ECK
	24/02/11	11:53:02	Alarm off - not ack	Signal 3771 (M) ECK
Adelaide	24/02/11	11:53:10	Alarm on - not ack	Switches DC31 Failed to Move
	24/02/11	11:54:29	Alarm on - ack	Switches DC31 Failed to Move
Belair	24/02/11	11:54:30	Alarm off	Switches DC31 Failed to Move
	24/02/11	11:55:40	Alarm off - not ack	BRL SSI Non Critical Fault Now Clearing
Outer Harbor	24/02/11	12:08:44	Alarm on - not ack	Signal 1674 (M) ECK
	24/02/11	12:08:45	Alarm off - not ack	Signal 1674 (M) ECK
Gawler	24/02/11	12:09:11	Alarm on - not ack	Signal 141 Passed at Danger
	24/02/11	12:09:33	Alarm on - not ack	Track 141A Sequence Alarm

Noarunga	24/02/11	12:10:03	Alarm on - ack	Signal 141 Passed at Danger
	24/02/11	12:10:03	Alarm on - ack	Track 141A Sequence Alarm
All Lines	24/02/11	12:10:03	Alarm off	Track 141A Sequence Alarm
	24/02/11	12:10:03	Alarm off	Signal 141 Passed at Danger
	24/02/11	12:17:37	Alarm on - not ack	Signal 3274 (M) ECK
	24/02/11	12:17:38	Alarm off - not ack	Signal 3274 (M) ECK
	24/02/11	12:30:25	Alarm on - not ack	Signal 1072 (M) ECK
	24/02/11	12:30:29	Alarm off - not ack	Signal 1072 (M) ECK
	24/02/11	12:32:10	Alarm on - not ack	Signal 274 Passed at Danger
	24/02/11	12:33:31	Alarm on - not ack	Track 272A Sequence Alarm
	24/02/11	12:33:43	Alarm on - ack	Track 272A Sequence Alarm
	24/02/11	12:33:43	Alarm off	Track 272A Sequence Alarm
	24/02/11	12:40:22	Alarm on - not ack	Signal 3971 (M) ECK
	24/02/11	12:40:25	Alarm off - not ack	Signal 3971 (M) ECK
	24/02/11	12:46:42	Alarm on - not ack	Signal 3274 (M) ECK
	24/02/11	12:46:45	Alarm off - not ack	Signal 3274 (M) ECK

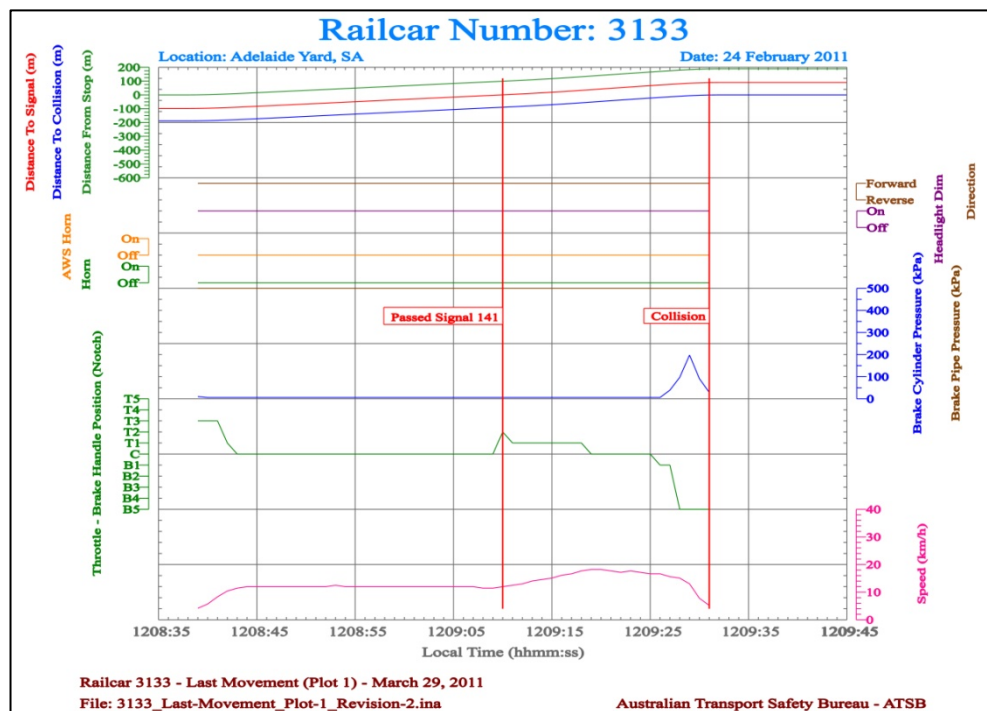
Figure 13: Loco log extract from railcar 3133

An examination of the recorded data for railcar 3133 (train G231) shown at Figure 13, established that at 1208:39, about the time the driver received RoW, the train slowly accelerated to 15 km/h¹⁴. After passing signal 141 the train then accelerated to a maximum speed of 18 km/h before the driver made an emergency brake application at 1209:25. It was probably shortly before the emergency brake application that he realised his train would collide with train 215A. At 1209:31 the two trains collided; train G231 was virtually at stop at that time.
