# Incorrect aircraft configuration, VH-OGP 1.5 km north of Sydney Airport, New South Wales 26 October 2009

## Abstract

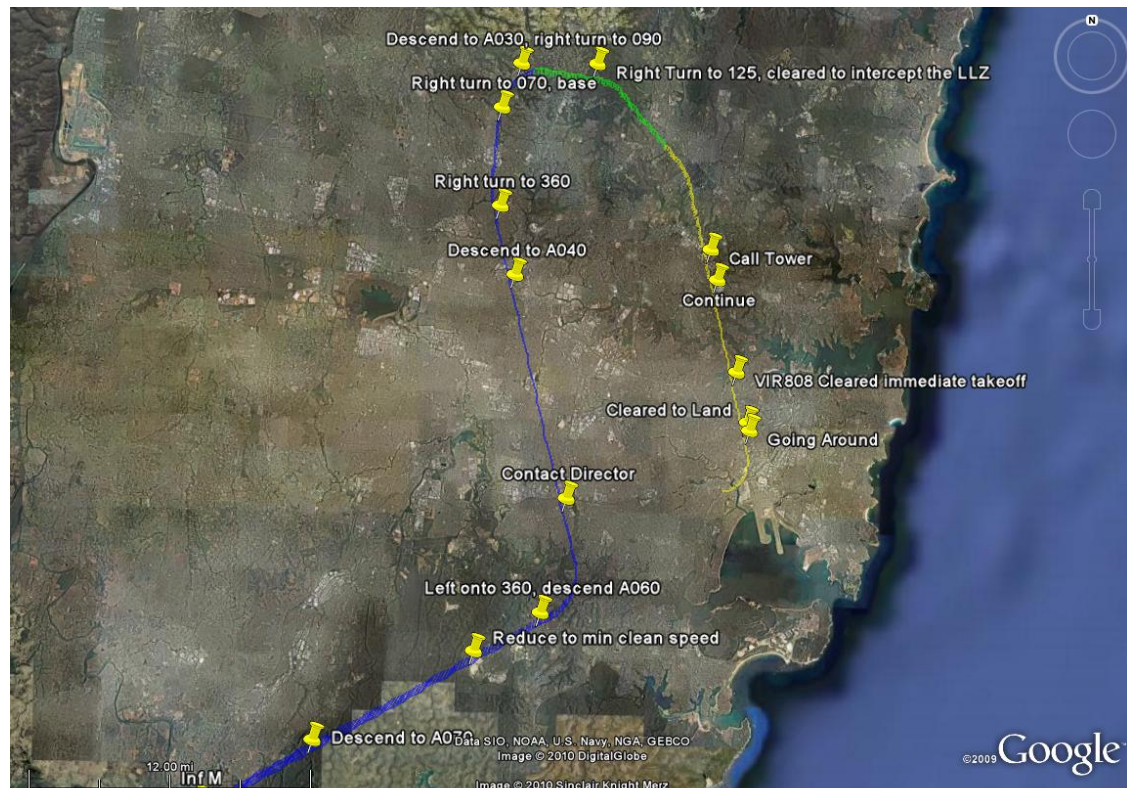
Figure 1: Recorded track into Sydney — image courtesy of Google Earth

The aircraft's track, and the radio communications with the aircraft from air traffic control (ATC) during the later part of the descent and approach into Sydney are at Figure 1. The blue line represents the portion of the approach with the aircraft in the clean (no flap selected) configuration, the green line the aircraft's track with the first stage of flap selected (Flap 1, leading edge slats only), and the yellow line the portion of the approach with the second stage of flap selected (Flap 5, which provided for leading edge slats and initial flap extension).

The descent and manoeuvring to intercept the ILS approach, depicted as the blue and green paths on Figure 1, followed a 'normal' profile in terms of the altitude and distance travelled.

The aircraft’s flight data recorder (FDR) recorded a large selection of aircraft parameters. That included the aircraft’s configuration and performance data, such as airspeed and power settings, the flight crew’s use of the automatics, and the activation of various warning devices. The aircraft configuration changes that were derived from the recorded data are included in the depiction of the approach at Figure 1.
