GROUNDING OF M.V. 'MOBIL ENDEAVOUR' IN THE
TORRES STRAIT OFF THE NORTH COAST OF AUSTRALIA
24 JULY 1986

A Preliminary Investigation into the incident was conducted by Captain W.A. Chadwick, Chief, Investigation Division, Office of the Commissioner of Maritime Affairs, and published by the Republic of Liberia.

Report of the Preliminary Investigation
In the Matter of the Grounding of the
M.S. MOBIL ENDEAVOUR (O.N. 7139)
In the Torres Strait off the
North Coast, Australia
on 24 July 1986

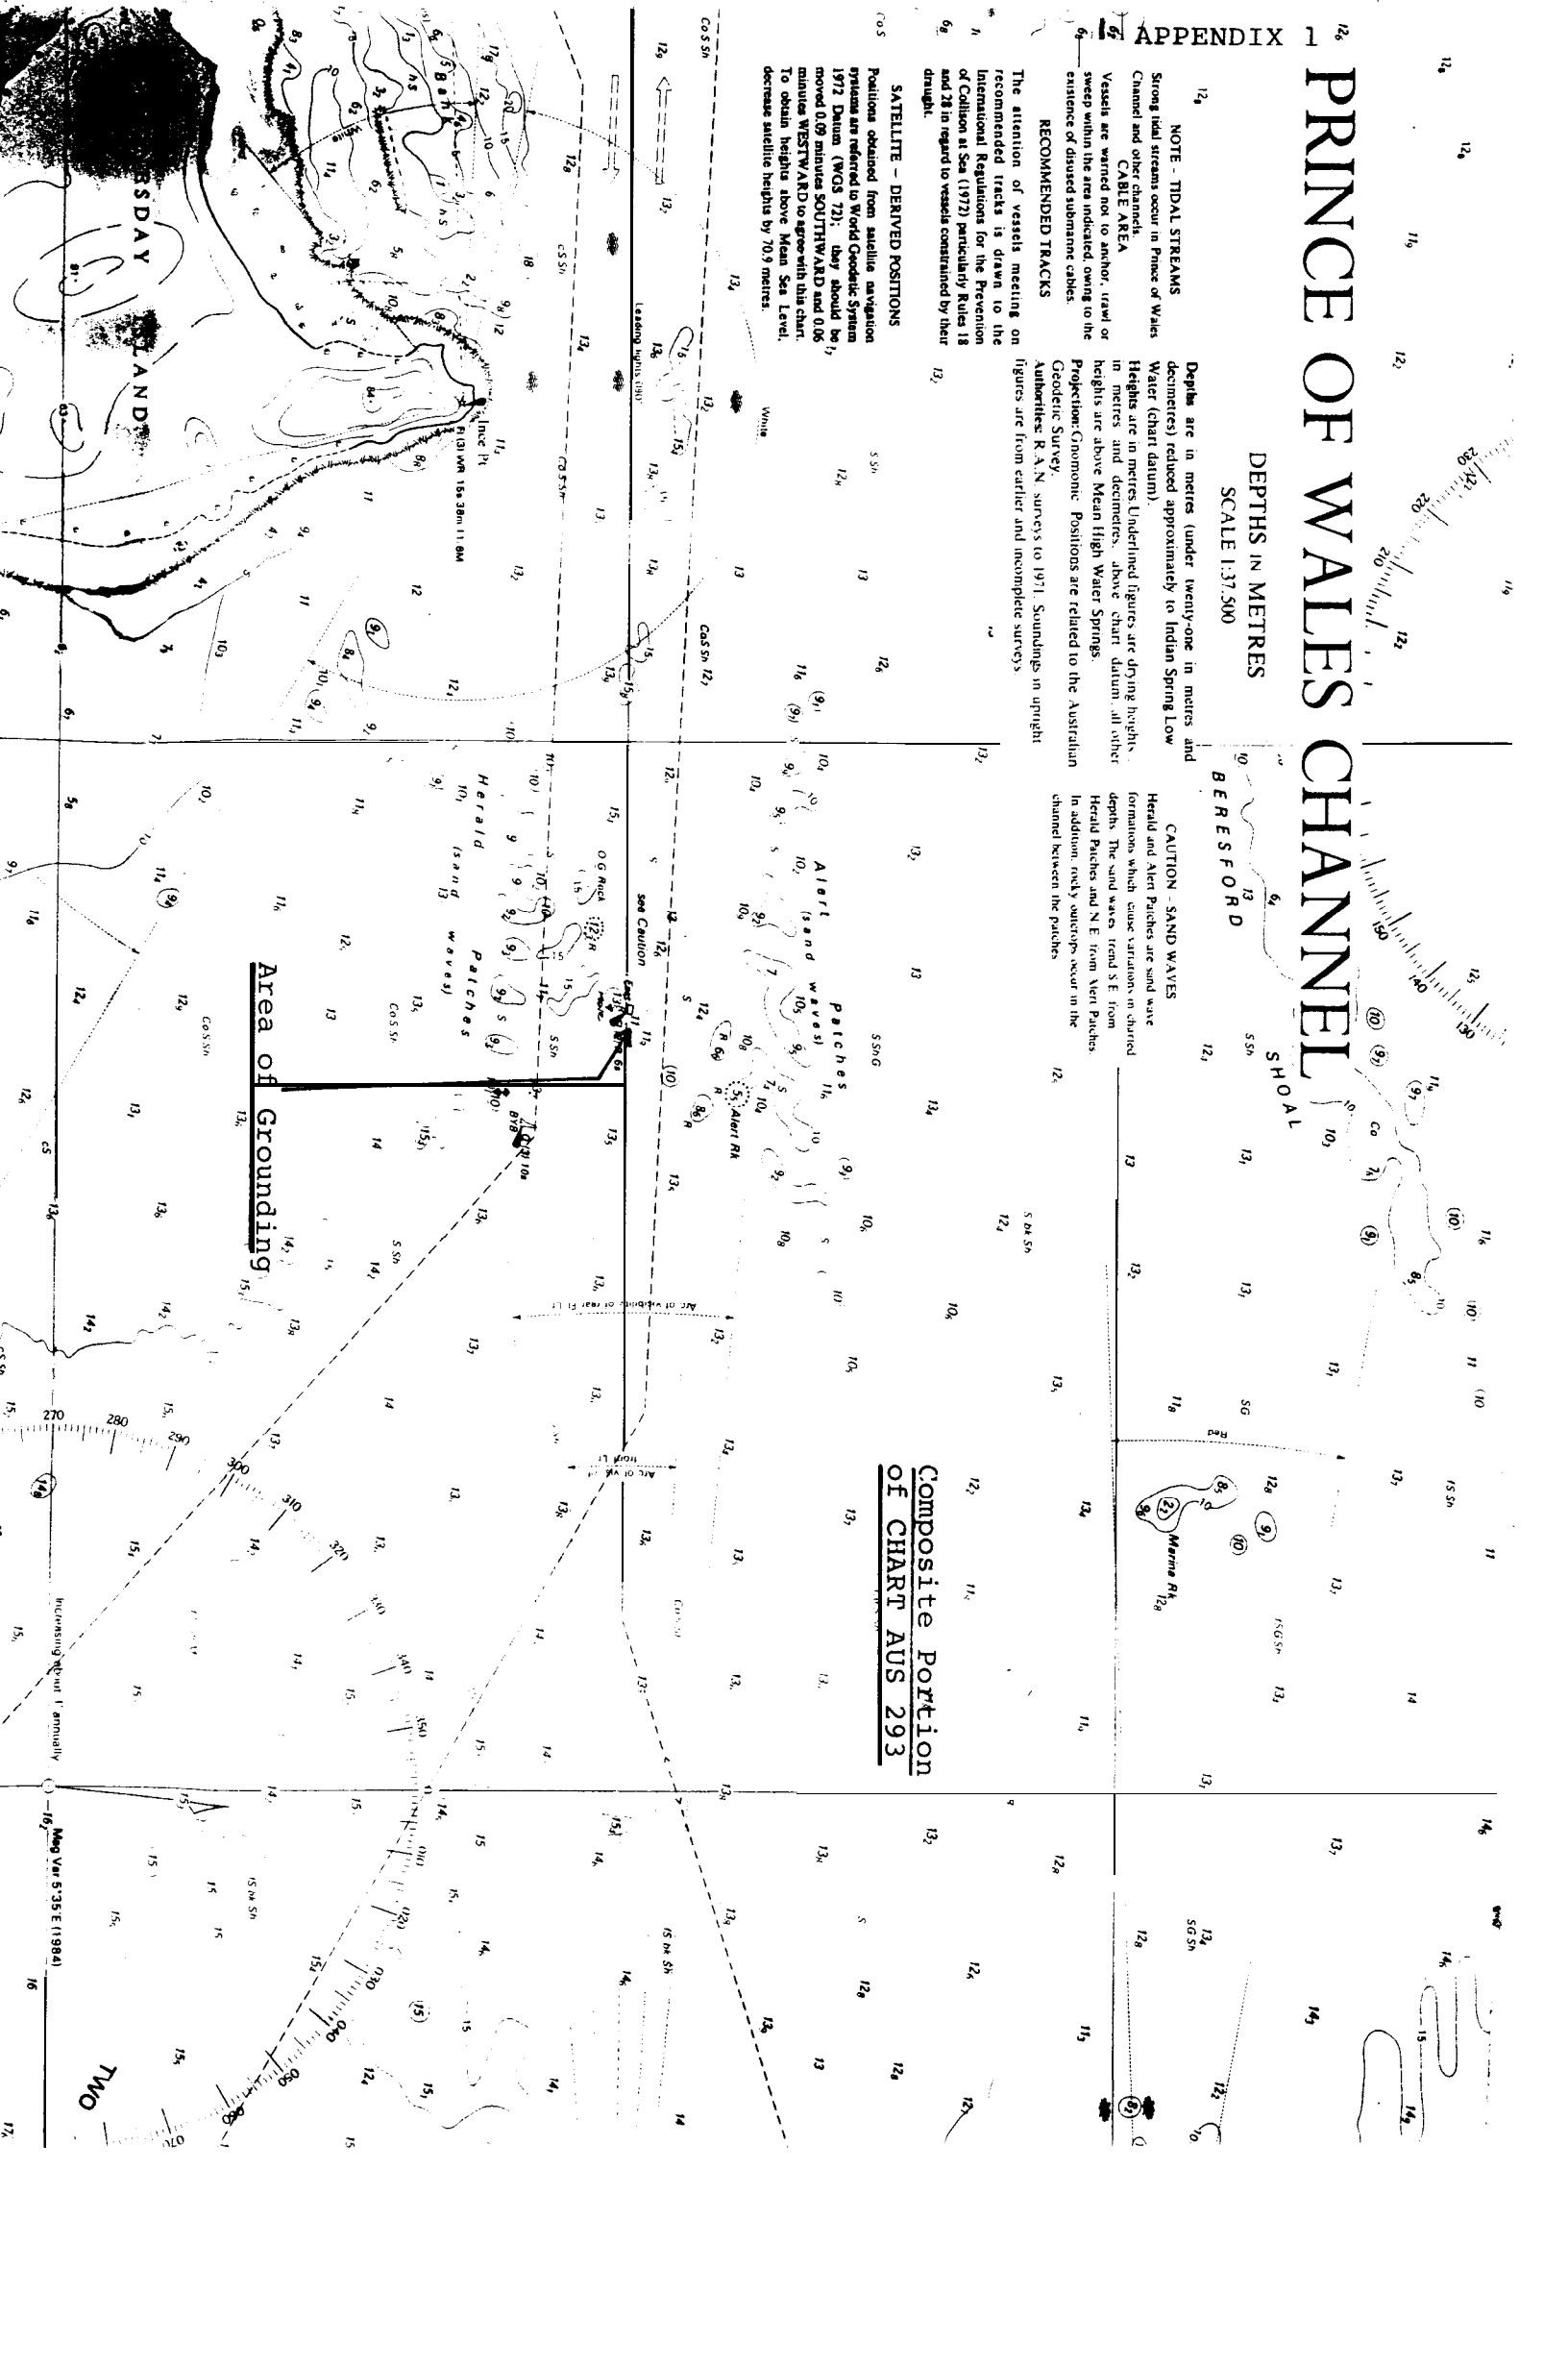
Composite Portion
OF CHART AUS 293

29. The ship touched bottom in an area to the north-north east of "East" buoy; the least charted depth in this area is 11 meters which with a tidal height of 1.5 metres gave a minimum depth of water of 12.5 metres. Contact position is marked on Annex 1, Aus chart 293.

31. The bow of the ship was approximately 1 cable east of the buoy and the 11m sounding and probably just touched one of the rocky outcrops in that area specifically mentioned by the Caution on Aus Chart 293.

Herald and Alert Patches are sand wave formations which cause variations in shoal depths. The sand waves trend S.E. from Herald Patches and N.E. from Alert Patches. In addition, rocky outcrops occur in the channel between the patches.
