**Oppama Spirit alongside at Gove**

# Summary

On 12 May 1993, the fully laden, 81,248 tonnes deadweight Bahamas flag tanker Oppama Spirit grounded at Gove, Northern Territory. The ship had been manoeuvring to go alongside the berth, when it experienced a total power loss as a result of the seawater cooling system becoming blocked. While under tow to the anchorage, the ship took a sheer and grounded forward.

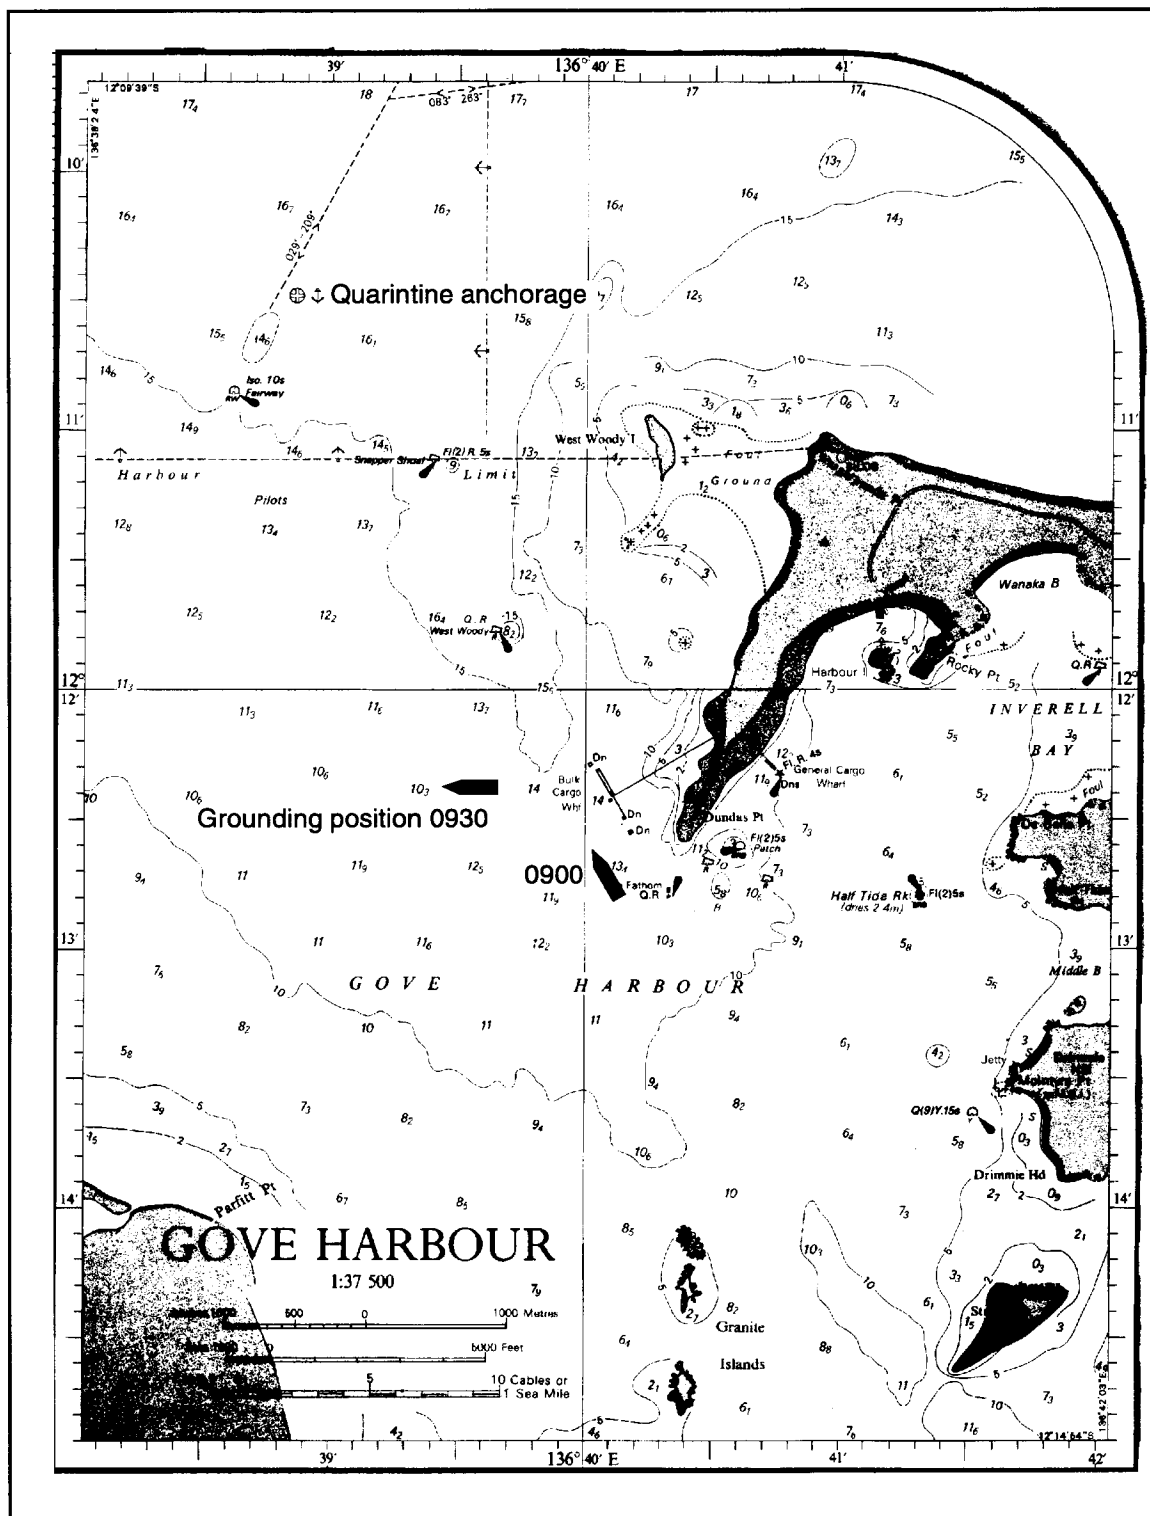
**Plan of Gove Harbour part of chart Aus 715  
showing position of grounding**

After proceeding only about a quarter of a mile, the ship took a sheer to port, which the tugs were unable to control, and at 0930 Oppama Spirit grounded forward, in soft mud.
