# Summary

A little before 1700 on 12 January 1995, the Australian flag tanker Conus sailed from the tanker berth, Townsville Harbour, under the direction of a pilot.

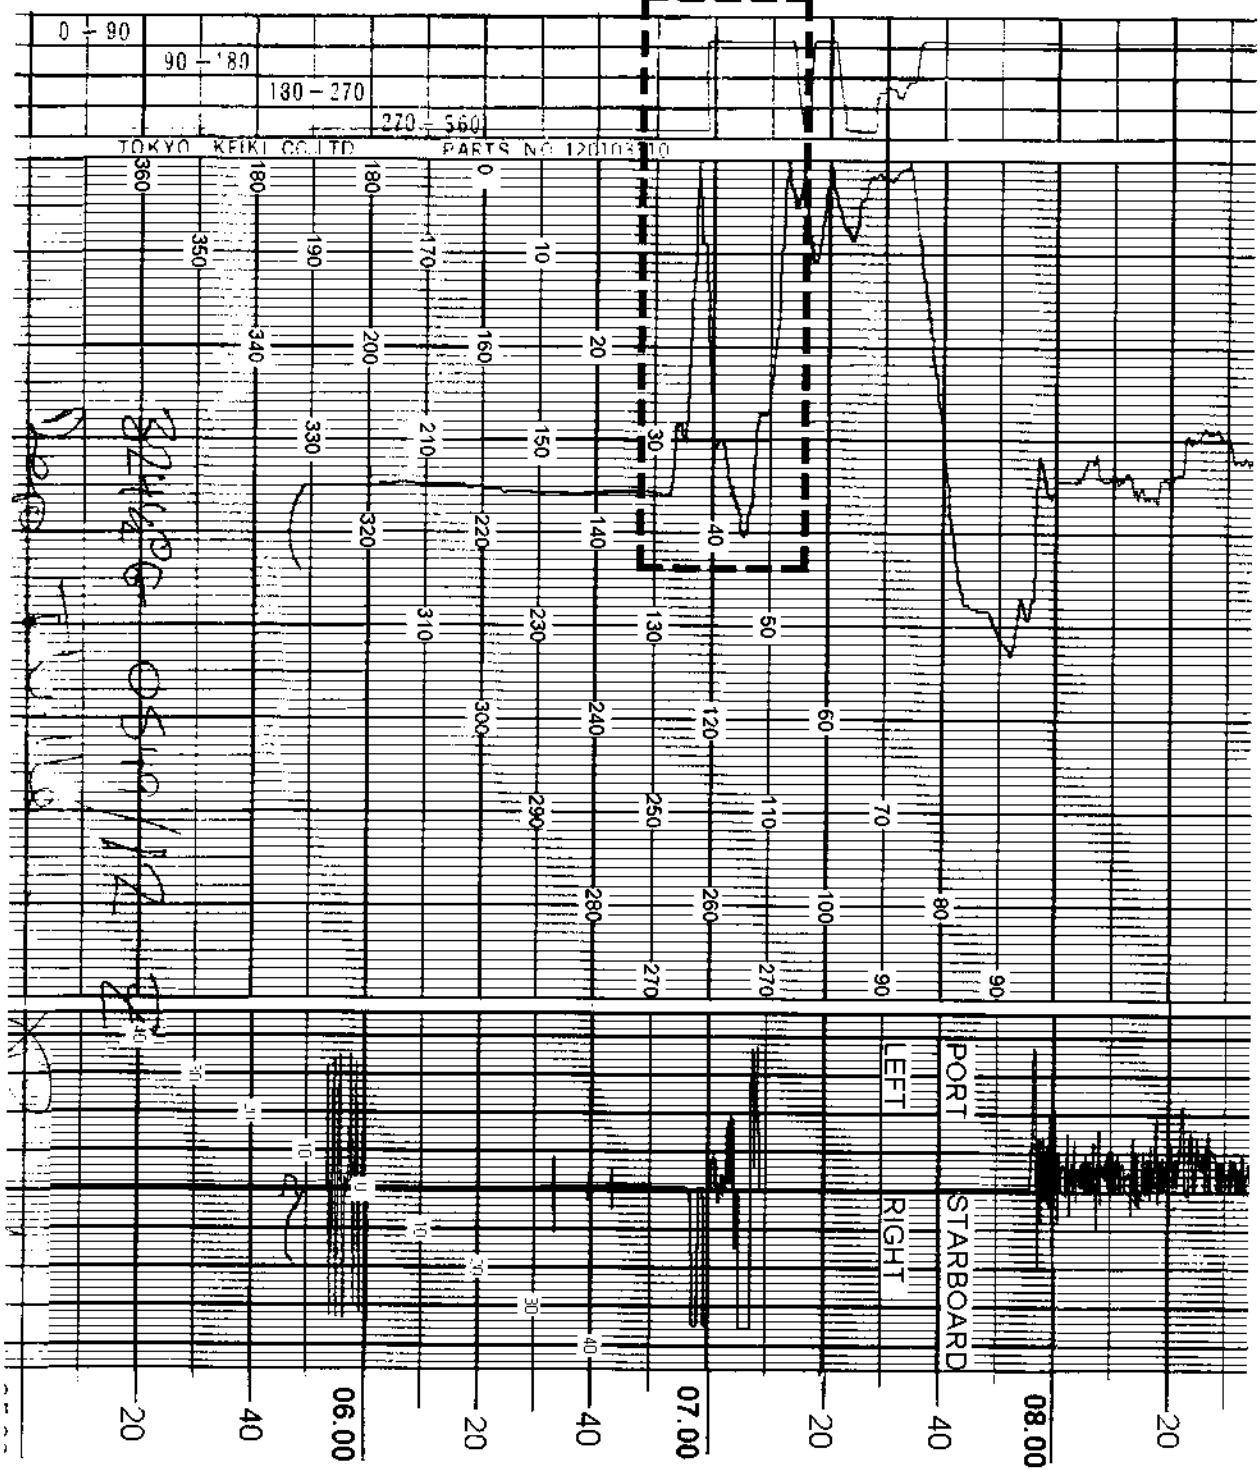
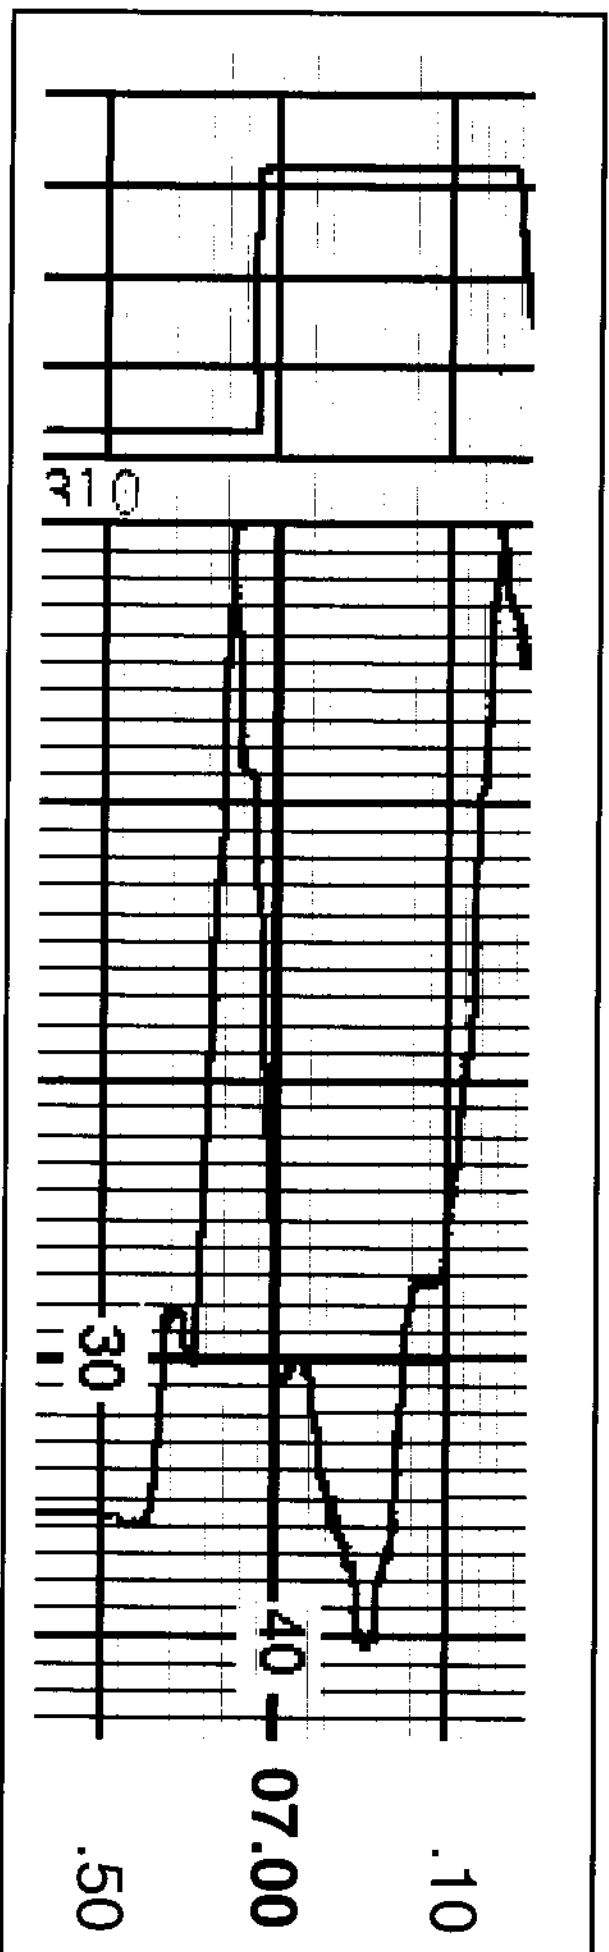
Under full starboard rudder, the ship's head swung 4 degrees to starboard from 036°, to a heading of 040°, and then at 1705, although full starboard rudder was still applied, the ship's head slowly swung to port. At 1706, the Pilot requested more engine speed and the Master moved across to starboard and rang 'navigation full ahead' (full sea speed) on the telegraph.

Section of course recorder

Enlargement with correction to the real time of the incident

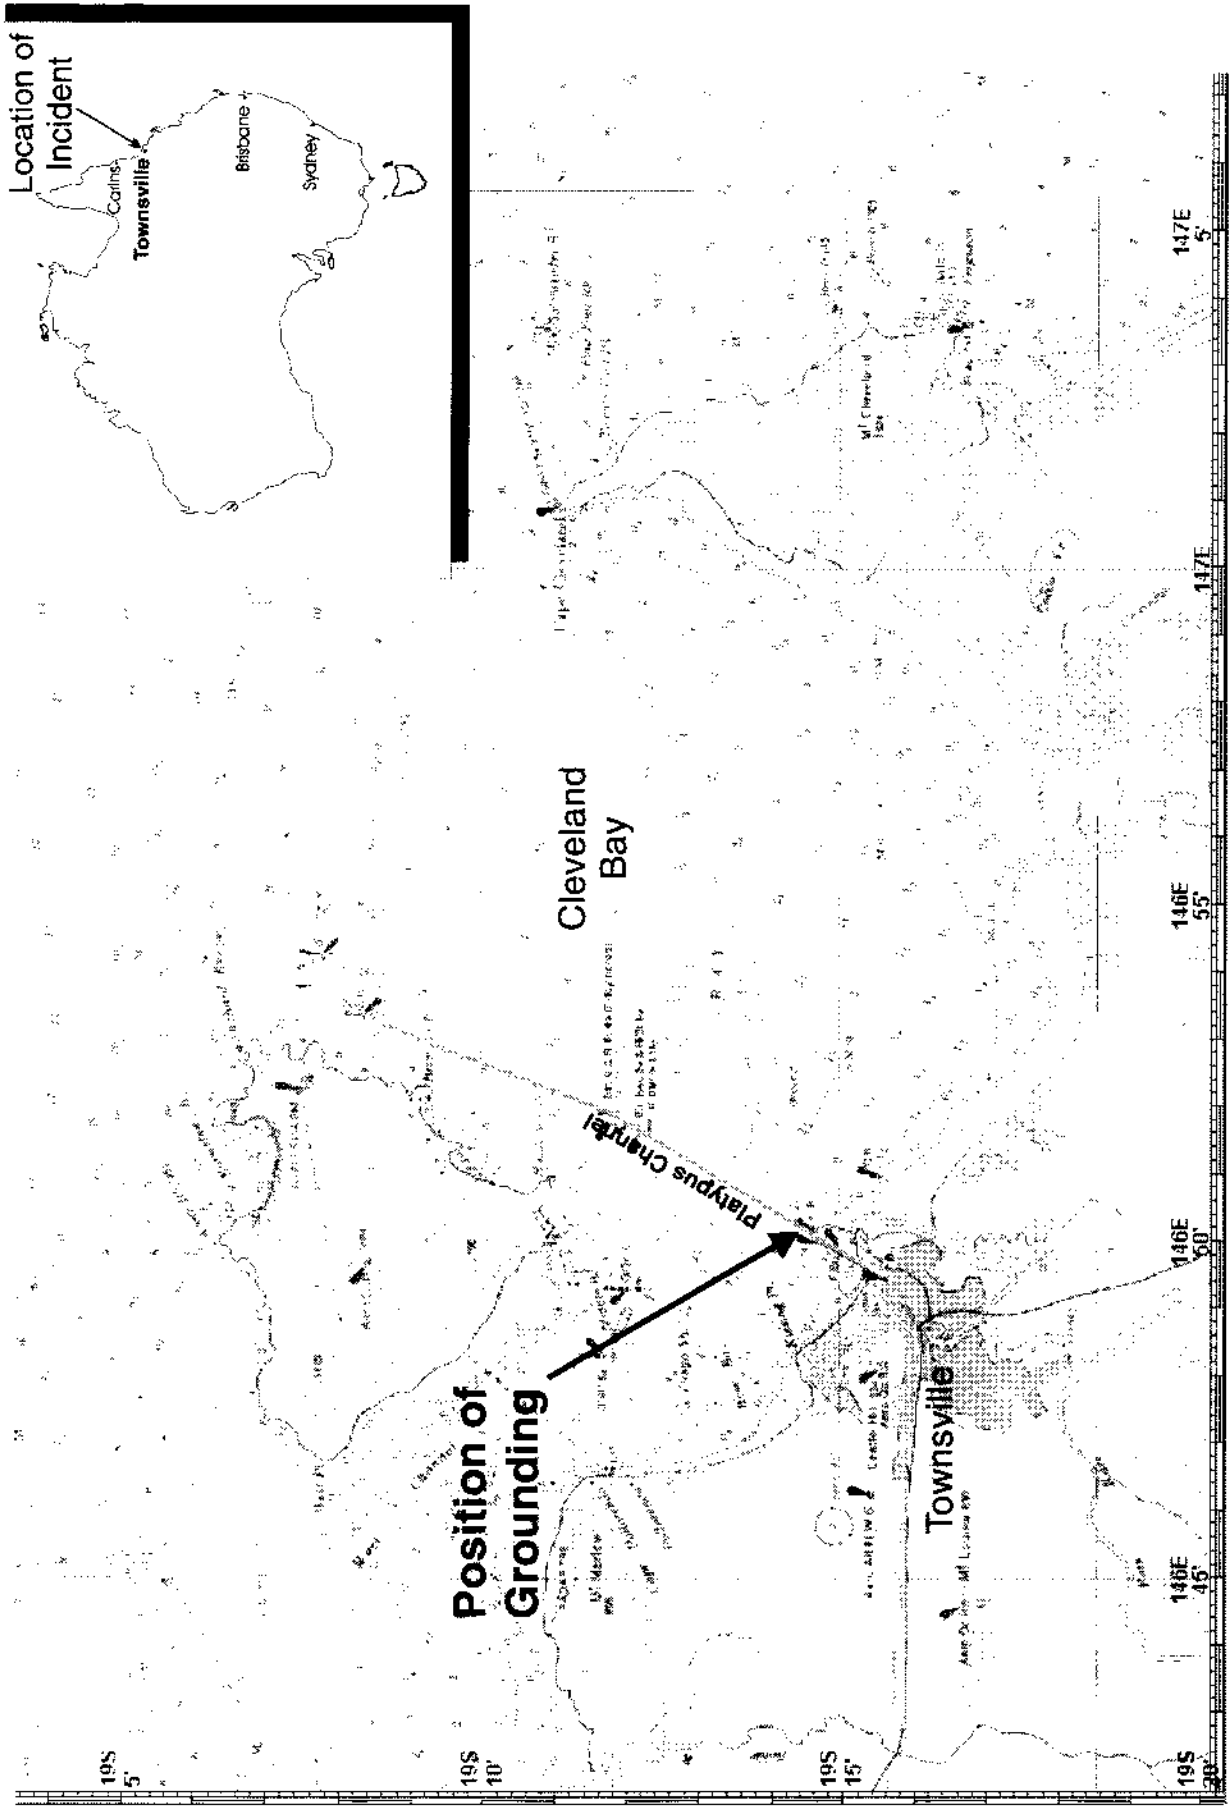
beacon, in an approximate position 19°14'S 146°50'E where the depth of water should have been about 5.5 m. The ship's head then paid off to port to lie in a northerly direction.

Portion of chart Aus 827 showing general position of grounding

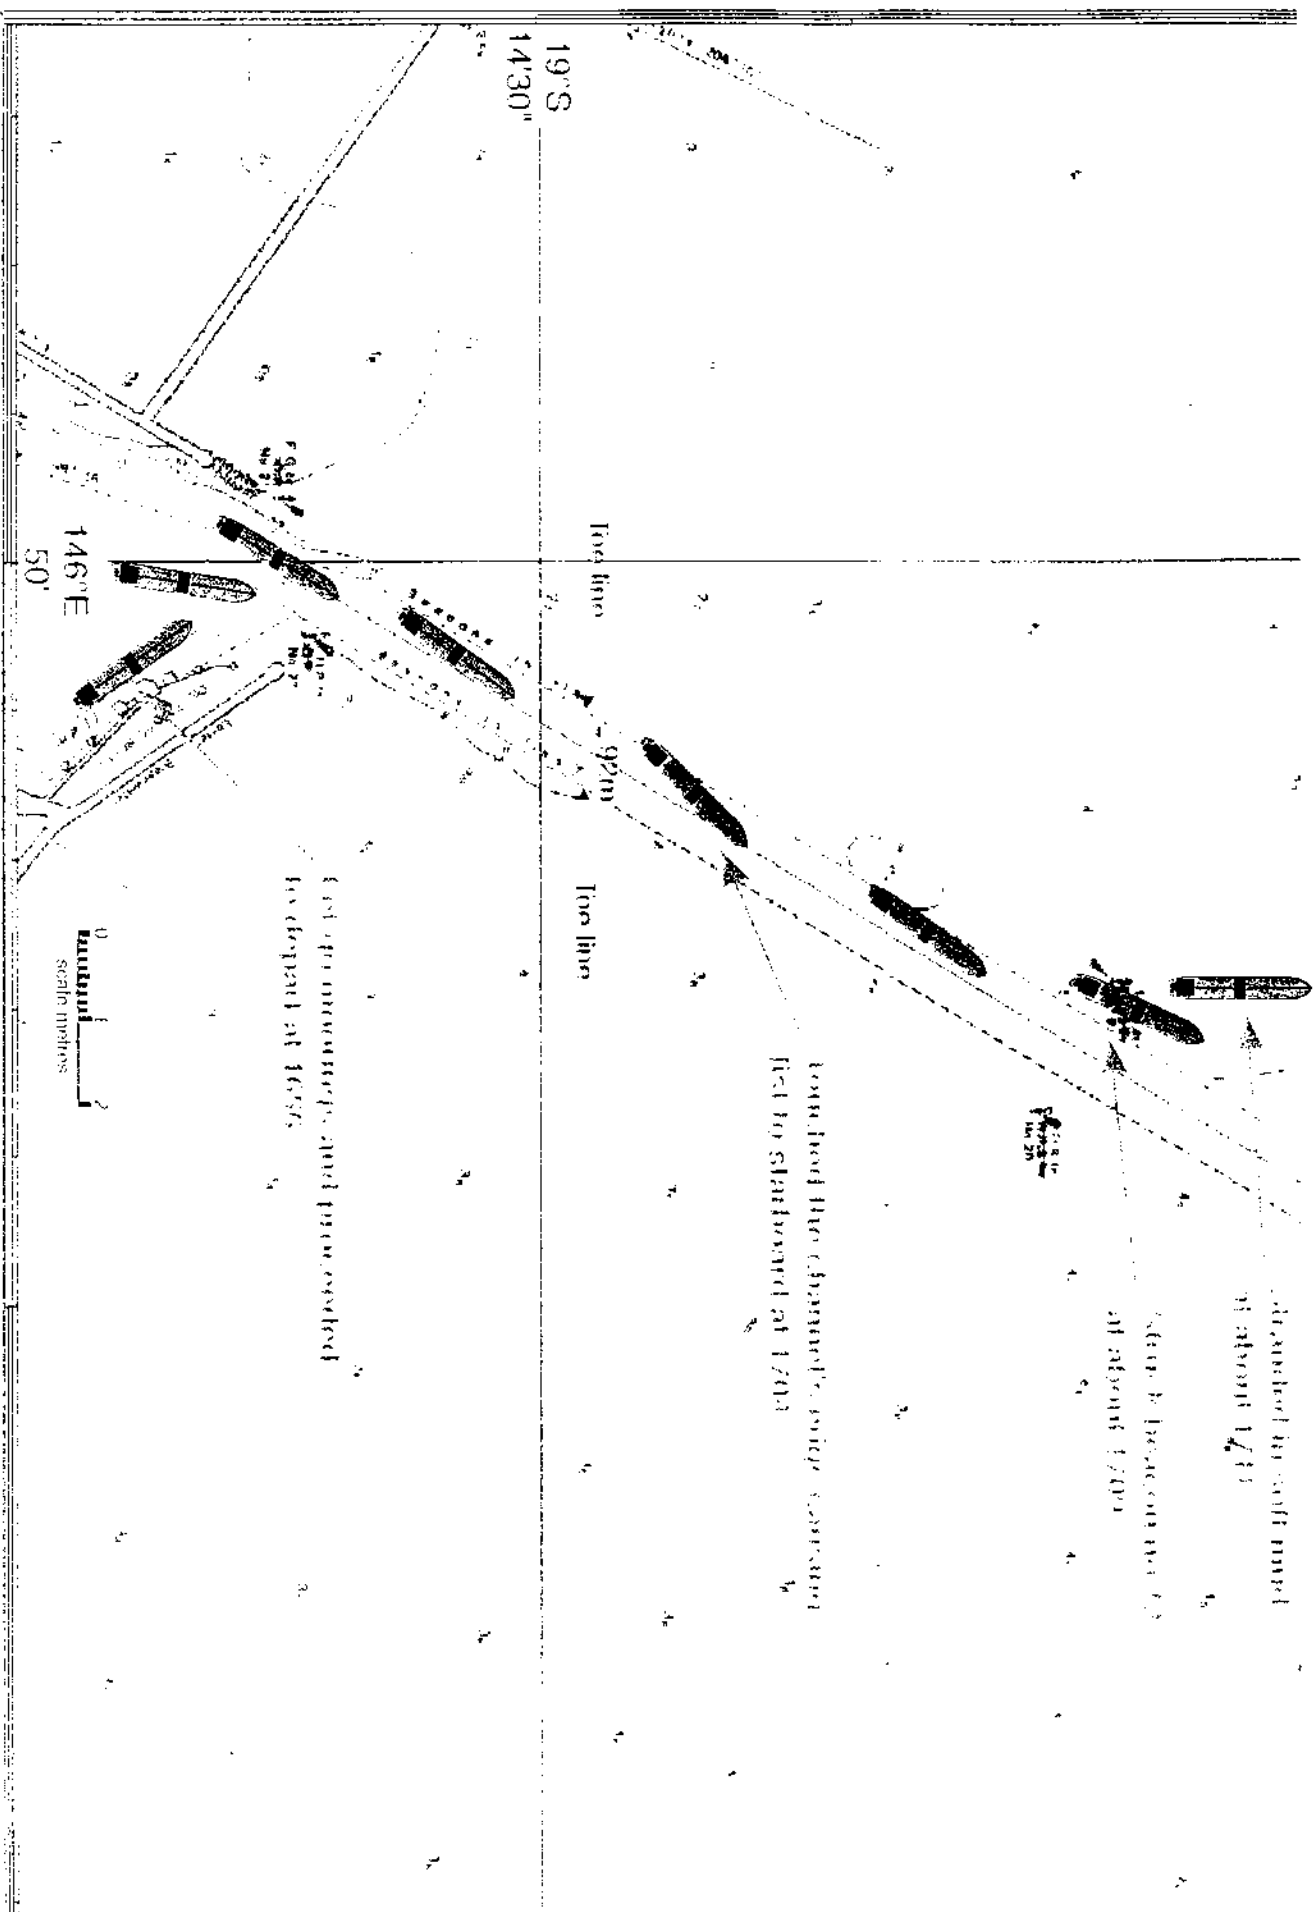
Reconstruction of Conus leaving Townsville - 12 January 1995

The ship actually took the ground about 500 m from the harbour entrance, when the ship's port quarter touched the shoal water outside the toe line, causing the ship to heel to starboard. Although the rudder was hard to starboard at this time, the ship pivoted aft and the bow swung steadily to port, while the ship continued to make headway along the channel.

Once the stern touched the northern limit of the channel control over the ship was effectively lost and there was no practical manoeuvre that could be undertaken to stop the ship's bow swinging to port, and the eventual contact with beacon no.13.

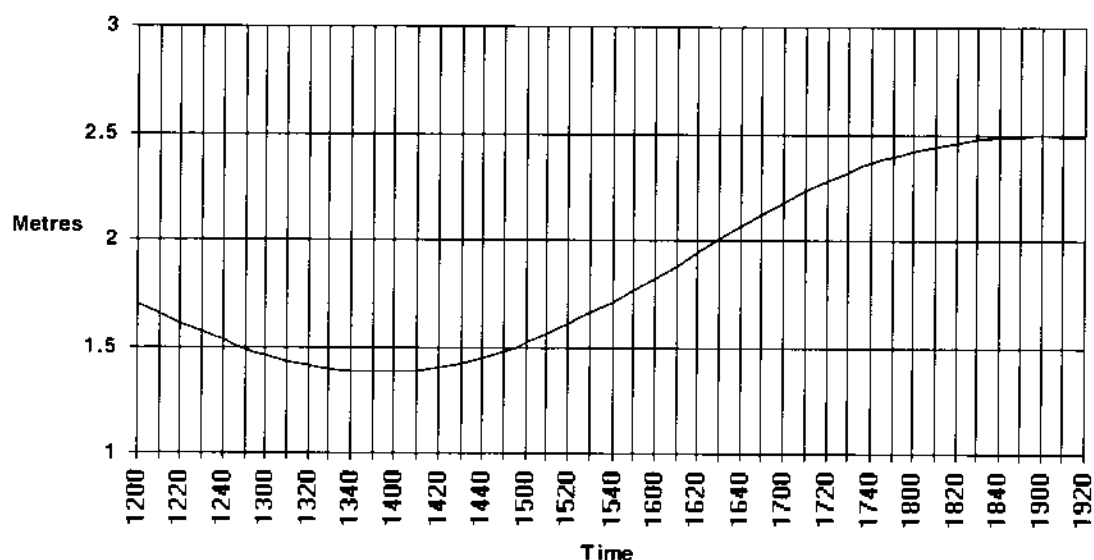
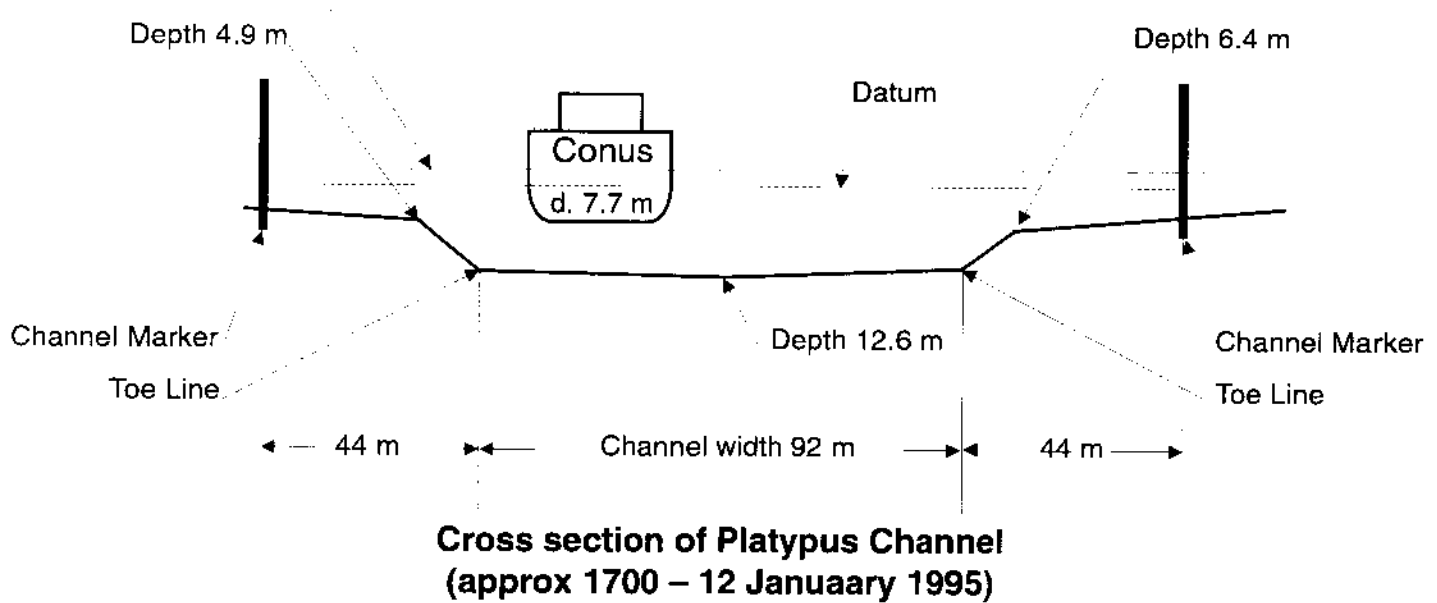
### Townsville 12 January – Tidal Curve

High water was predicted for 1905 at a height of 2.5 m. At 1700, the tide was at about 2.18 m and rising, resulting in a relatively strong set to the west and across the channel. While it is possible to quantify the wind force and direction, there is no means to know the strength of the tidal set, as there are no records of the rate of tidal flow and there is no current meter. Pilots have always accepted that the tidal flow was pronounced, countering the tide by guess work and the set experienced at the time, adjusting the ship's head by as much as ten degrees.

Rise of tide 2.2 m
