RAIL INVESTIGATION REPORT

**Derailment of passenger train 8622,
Sydney – Melbourne daylight XPT service,
Wodonga, Victoria**

25 April 2001

June 2002

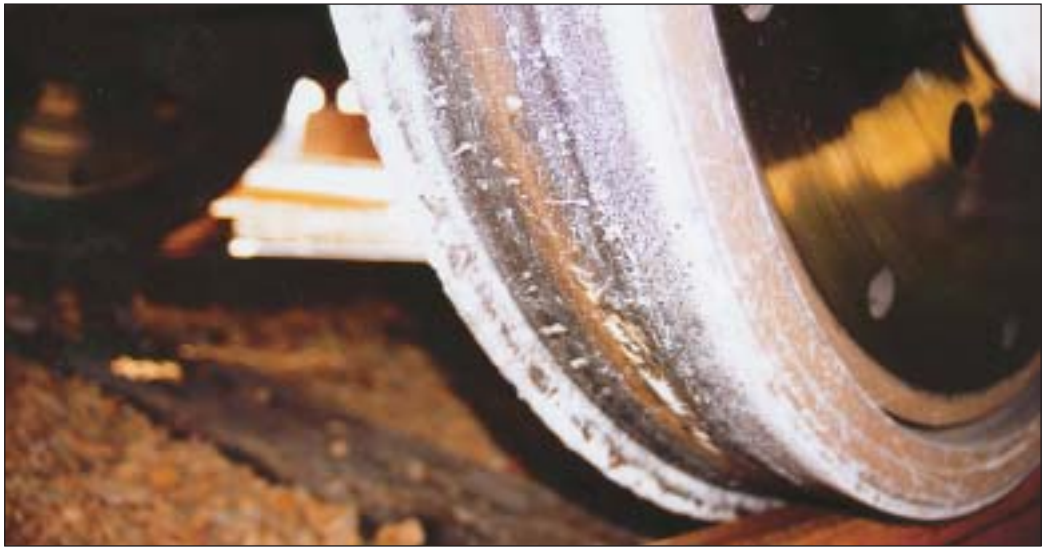
FIGURE 4:
Number-1 wheel showing damage to flange and tread

All wheels on the derailed bogie showed significant stone impact damage to flanges and treads as a result of running on the track ballast, over sleepers and other obstructions (see figure 4). Some components of the bogie showed signs of damage/impact as a result of lateral and vertical over-travel while the bogie was derailed:

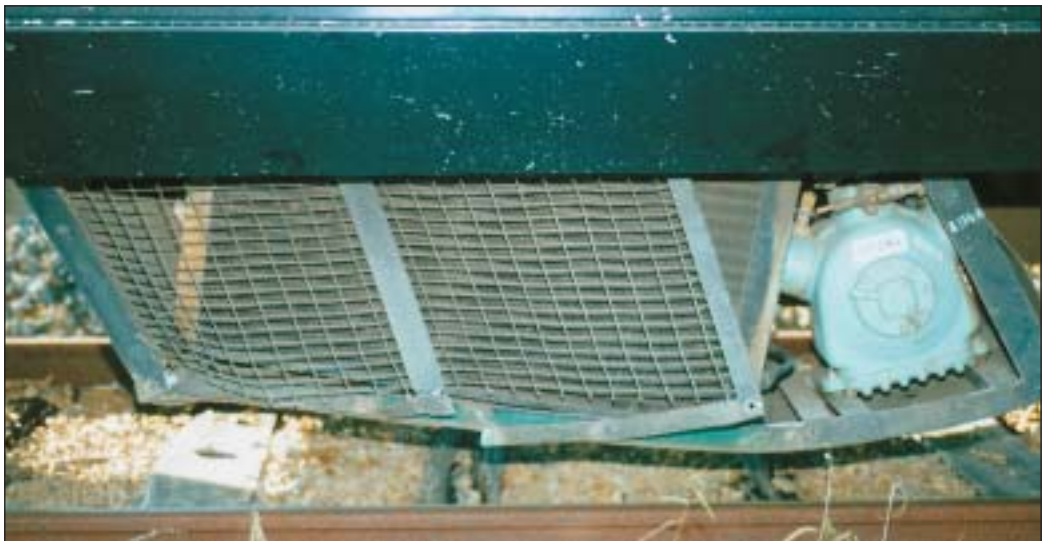
FIGURE 5:
Damaged refrigeration units under carriage

- both refrigeration units slung under the carriage were damaged as a result of the impact with the concrete block in the pedestrian crossing (figure 5),
- damage to water chiller refrigerant lines, and small hole in the carriage floor caused by the top of the primary suspension damper on number-1 wheel of the derailed bogie over travelling vertically,
- damage to the toilet holdover tank water fill line caused by derailed bogie over travel,
- a broken rubber stop on the coupling at the leading end on the car.

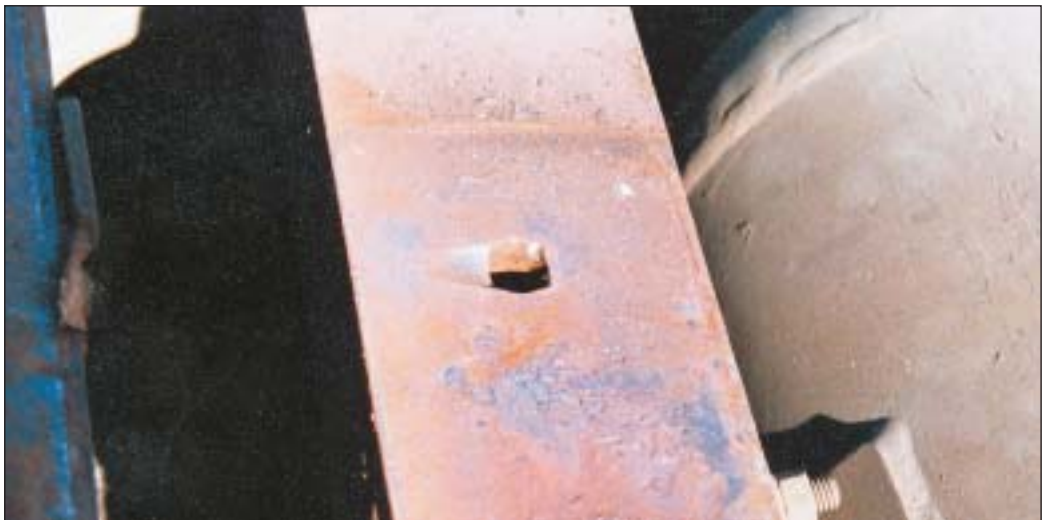
During the inspection a locating pin and some bearing material from a side bearer plate were found lying on the bolster between wheels 1 and 3 of bogie NHA 198B. Inspection of the side bearer plates and bogie bolster when the bogies were changed indicated that the locating pin originated from the side bearer plate adjacent to wheels 1 and 3 of the bogie. Damage to the side bearer plate and its seat on the bolster indicated that at some time the pin had been dislodged from the plate and become trapped between the plate and the bolster (see figures 6, 7, 8).

FIGURE 6:
Side bearer mounting surface on bogie bolster showing deformation around locating hole

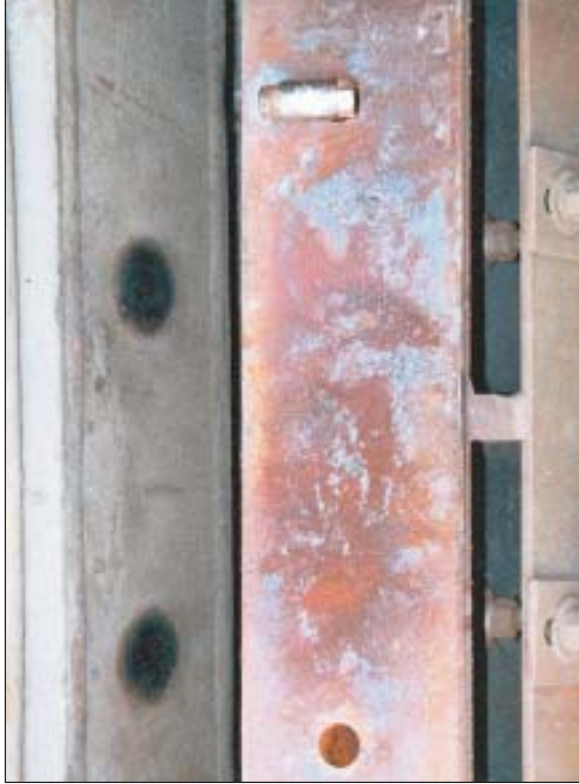
FIGURE 7:

Dislodged locating pin sitting on side bearer mounting surface in position of 'best fit' in the deformation around its locating hole

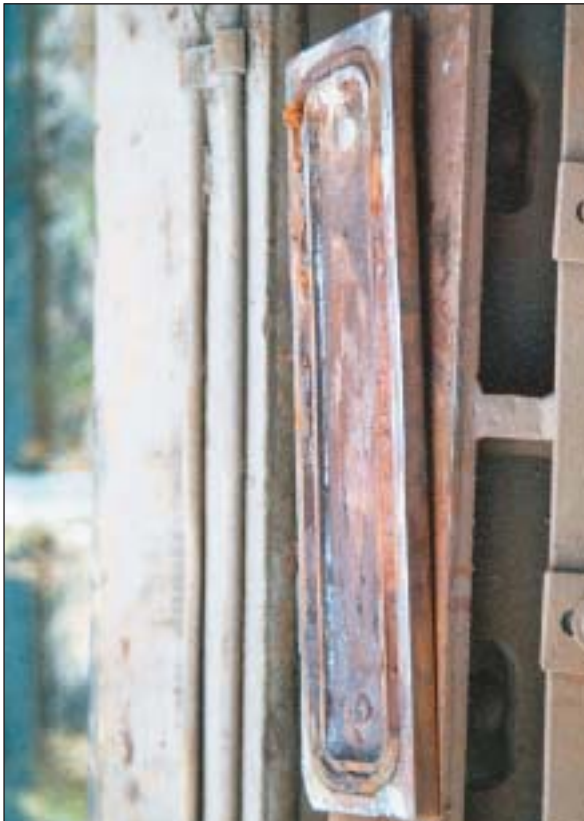
FIGURE 8:

Side bearer plate sitting on locating pin on mounting surface in the position of 'best fit' for deformations on mounting surface, locating pin and side bearer plate

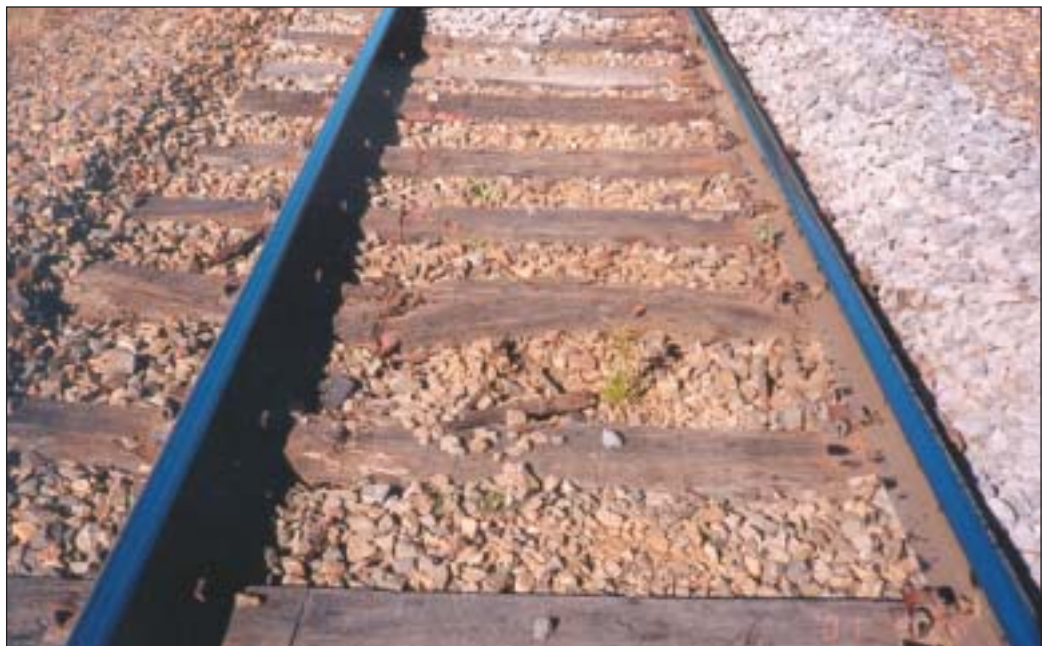
The track and some signalling infrastructure sustained damage between the point of derailment and where the train stopped, a distance of about 950 m. Many sleepers were damaged as a result of being struck by the wheels of the derailed bogie (figure 9). A number of sleepers were replaced to permit restoration of rail services. Some damaged sleepers were not replaced but the damage was sufficient to reduce their remaining service life.

FIGURE 9:
Section of track showing damaged sleepers

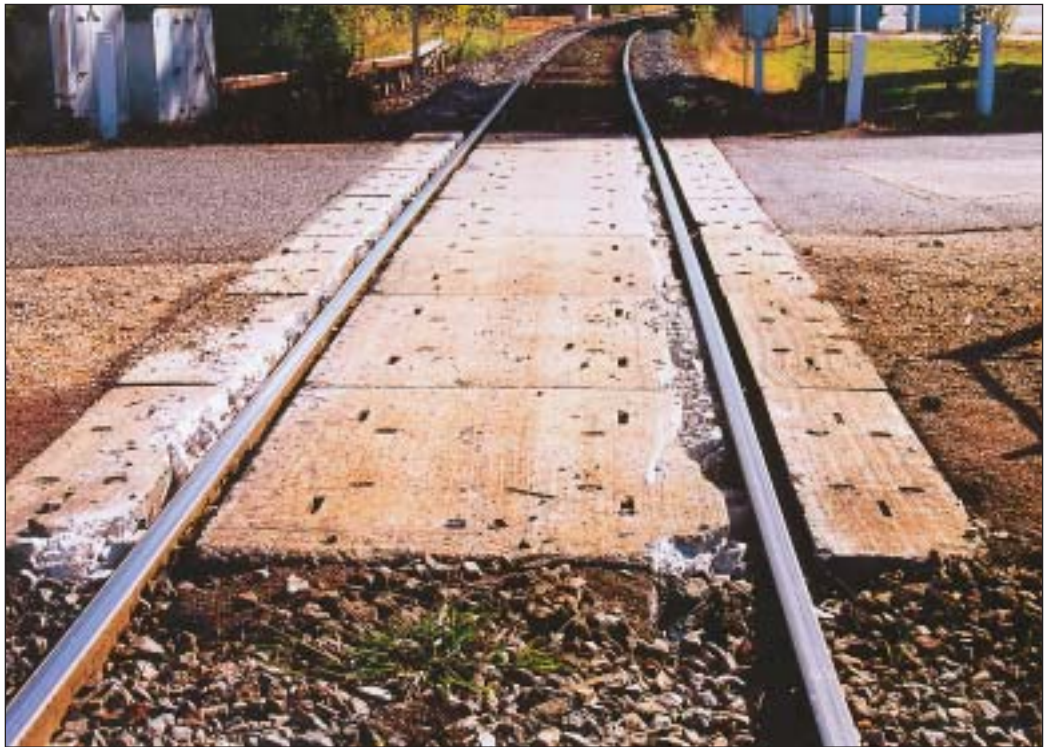
Level crossings at High Street and the station entrance road sustained minor damage to sections of their concrete and bitumen roadway panels (figure 10). This damage was caused by the derailed wheel flanges riding over the roadway as car 'E' passed through the crossings. The concrete footway slab in the four-foot of the station pedestrian crossing was also damaged (figure 11).

FIGURE 10:
Station entry level crossing showing damage to roadway

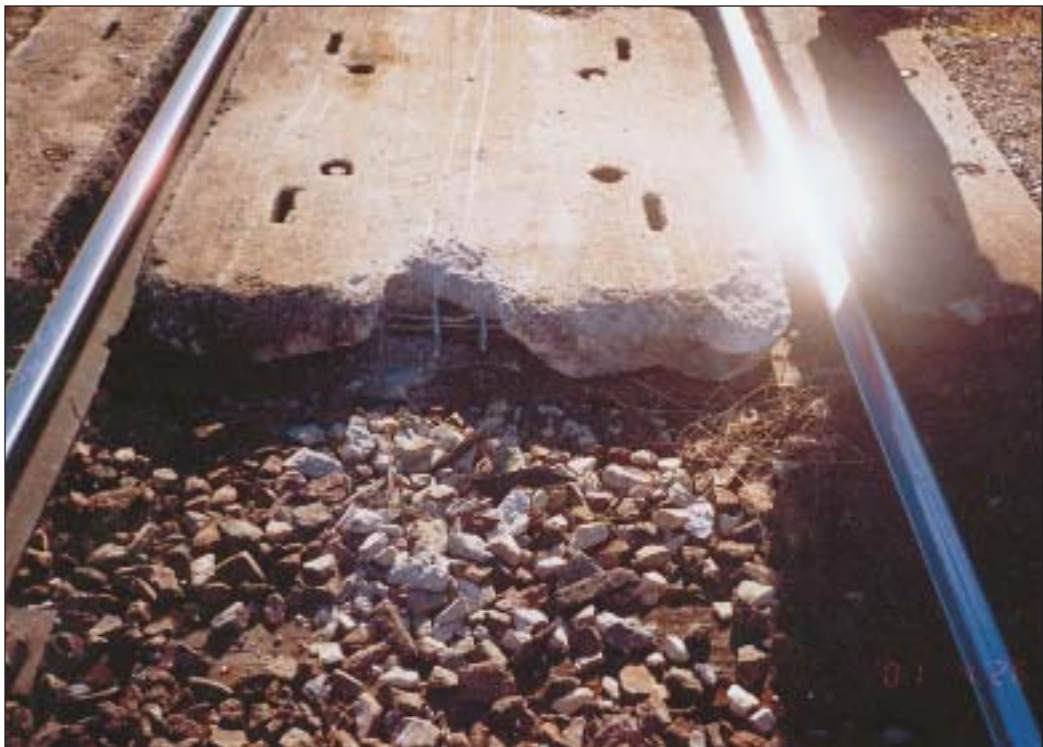
FIGURE 11:
Pedestrian crossing showing impact damage to concrete slab in track four foot

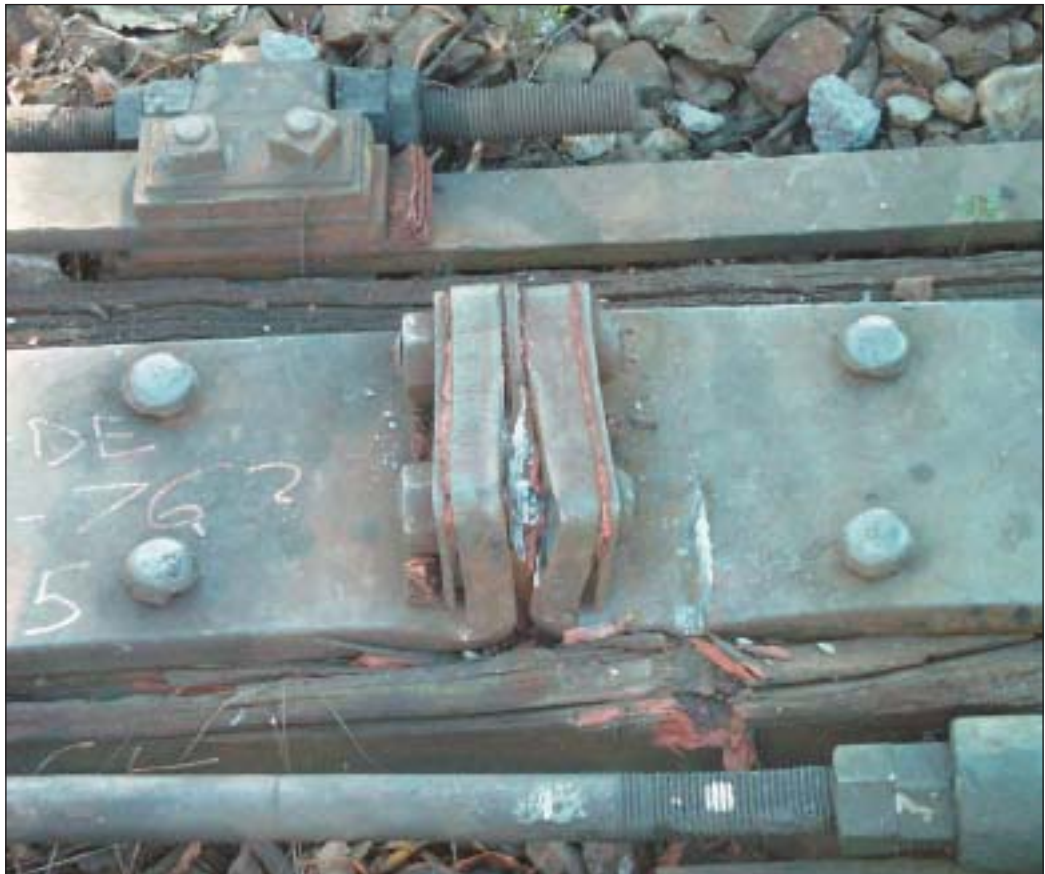
Signalling cables and an insulated joint were damaged at the High Street level crossing, with some damage to relay equipment adjacent to one set of points. Interlocking equipment on three turnouts (300.758 km, 300.605 km and 300.417 km) was damaged as a result of hard contact with the derailed bogie wheels riding in the four-foot (figure 12). These points were subsequently locked out-of-use pending permanent repairs.

FIGURE 12:
Damage to interlocking equipment on a turnout

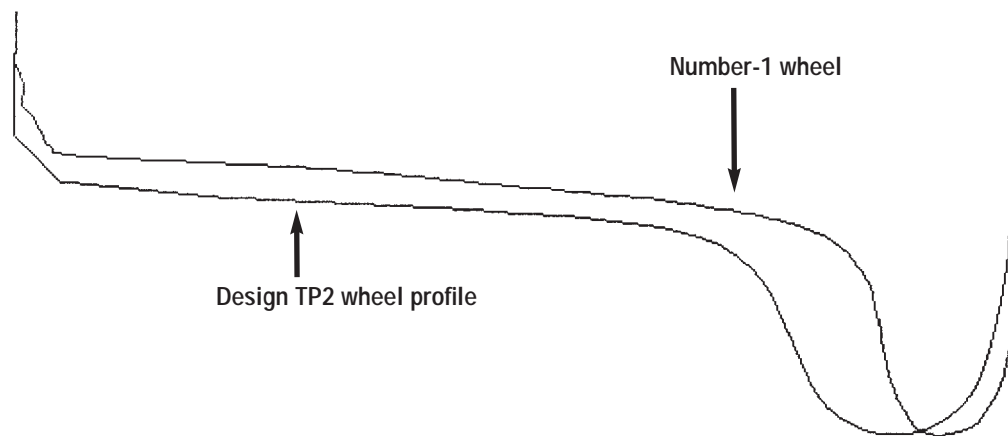
The wheel profiles show that the number-1 wheel flange was below the current State Rail condemning limit⁶ of 19 mm. Figure 16 is the profile of number-1 wheel after the derailment overlaid on the standard TP2 profile. Wheel diameter measurements indicate that number-1 wheel was the smallest on the bogie and 2 mm smaller than number-2 wheel. Current in-service dimensional tolerance for the diameter of wheels on the same axle is 1 mm variation.

FIGURE 16:
Number-1 wheel and TP2 profiles

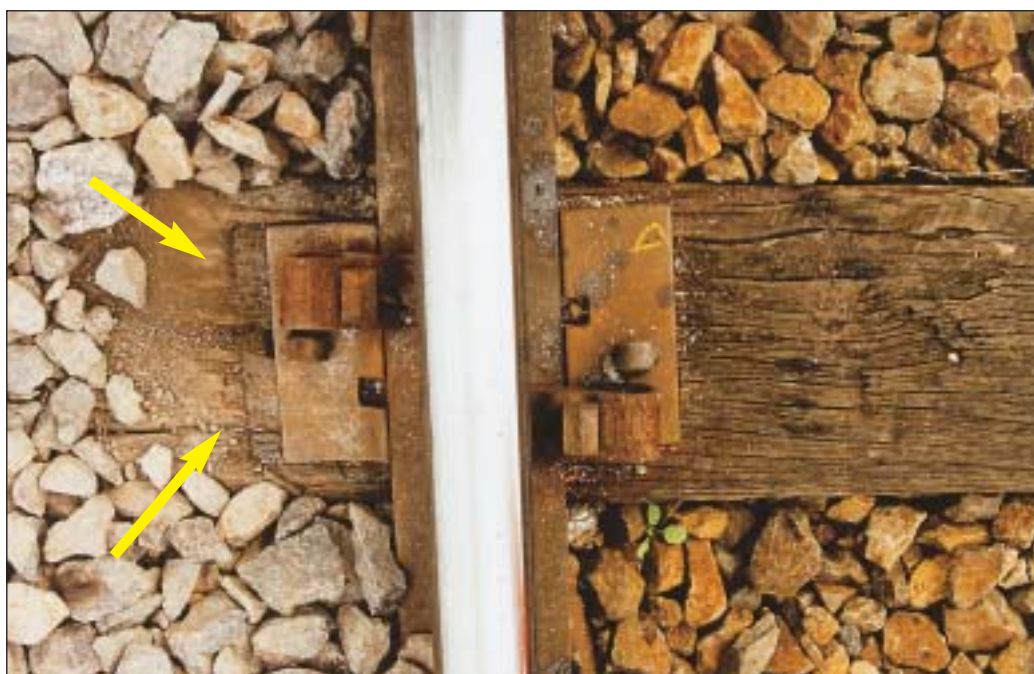
FIGURE 18:
TrakLok fastener on high rail showing sleeper wear as a result of plate movement

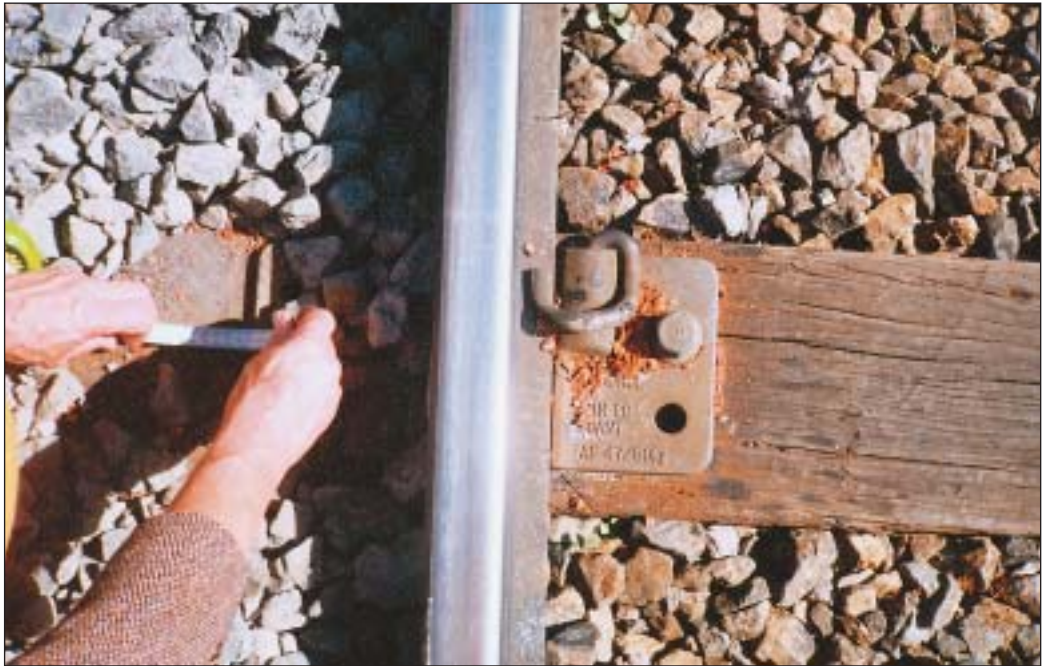
FIGURE 19:
Measuring plate movement on a Pandrol fastening fitted to the high rail the point of derailment

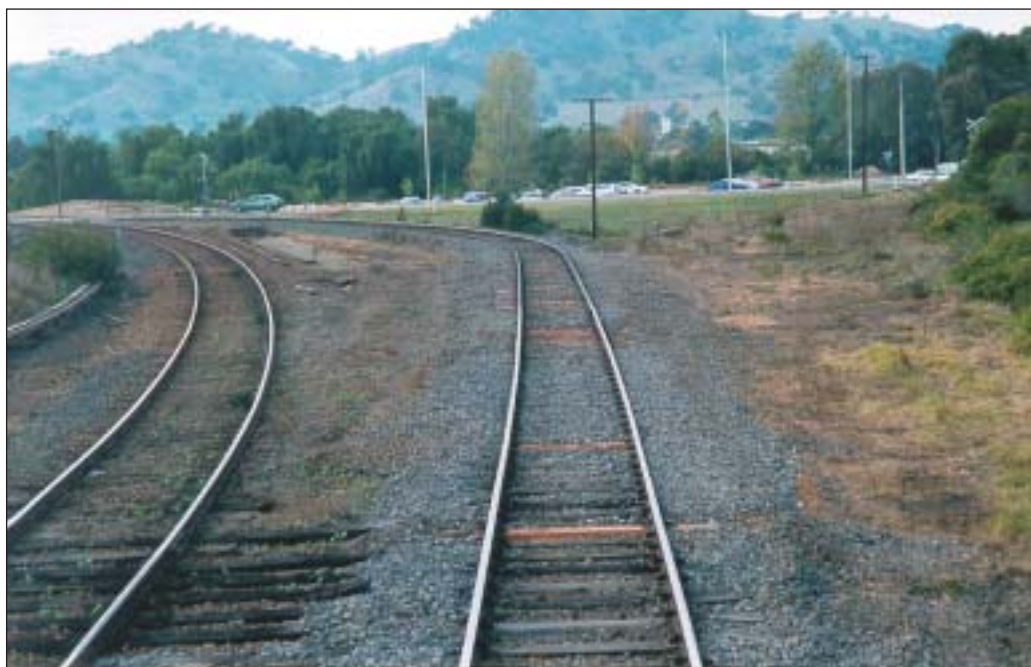
Measurements taken after the derailment showed a curve radius of 200 m then a significant sharpening of the curve in the direction the train travelled to 174 m approaching the point of drop-in. There was no alignment transition from straight track to the 174 m radius section of the curve at its Melbourne end. Figure 20 is a photograph of the curve where the derailment occurred looking towards the Hovell Street crossing, the standard gauge mainline is on the right.

FIGURE 20:
Curve where the derailment occurred

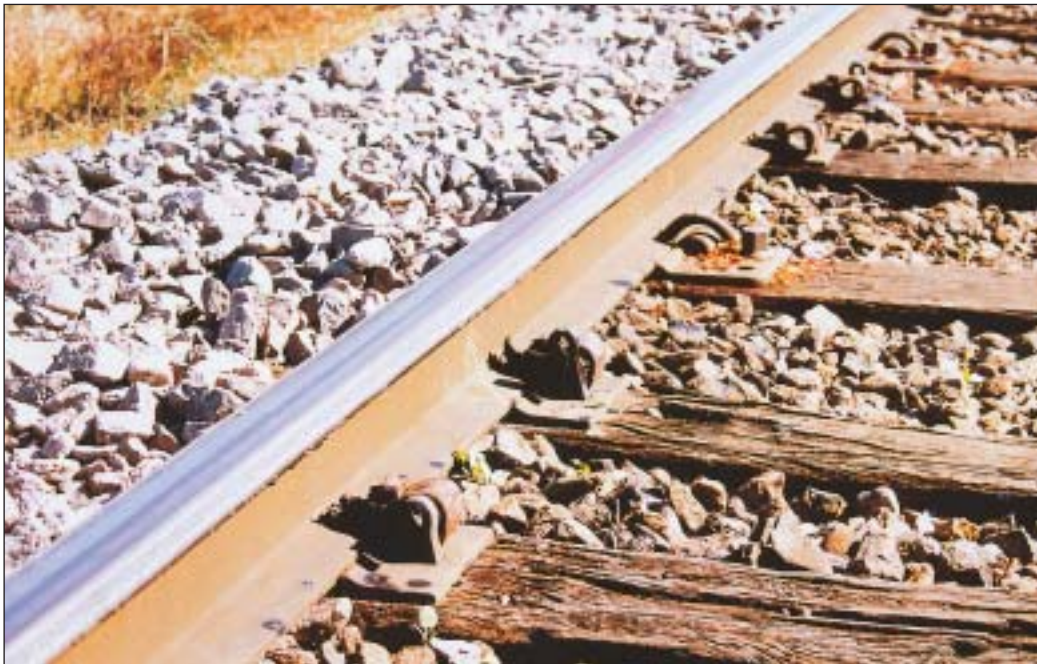
As part of the resilient fastening project in 2000, 22 sleepers were renewed between 301–301.1 km and 1 sleeper was renewed between 301.1–301.2 km in January 2000. These are the only records of sleeper replacement since 1 July 1998 when ARTC took over the lease on the line. Figure 21 shows the condition of some sleepers in the curve where the derailment occurred and the ballast profile on the field side of the high rail.

FIGURE 21:
Sleepers and ballast in the area of the derailment

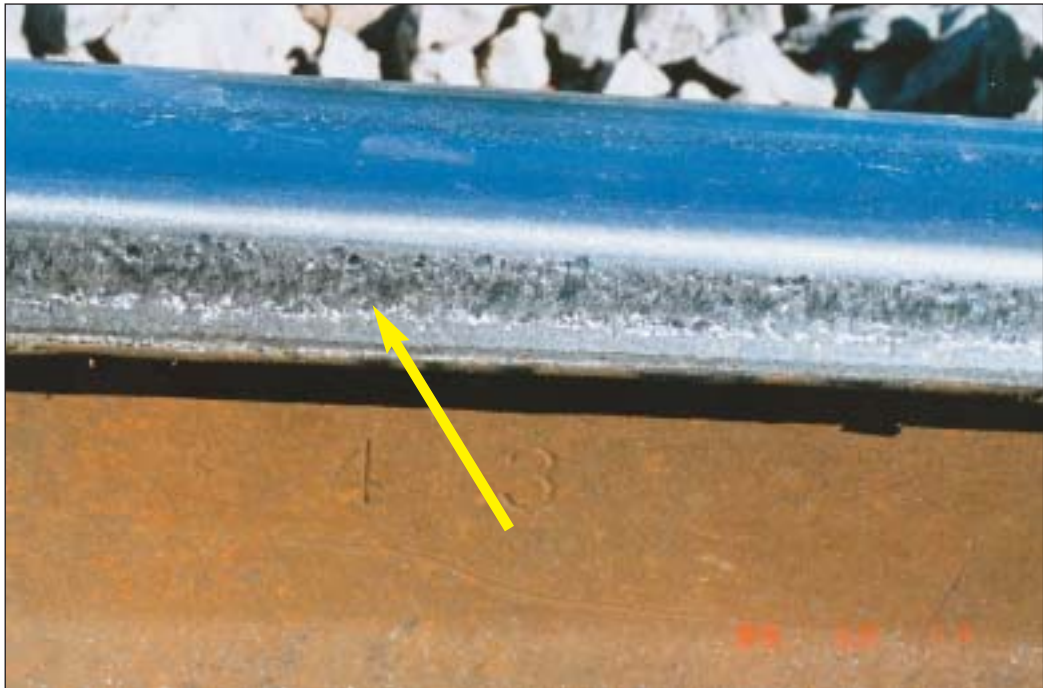
At the time of the derailment a lubricator was fitted to the high rail on the Melbourne end of the curve. The lubricator was fitted to provide grease to the gauge face of the high rail throughout the curve where the derailment occurred. It was apparent on inspection after the derailment, that the lubricator had been inoperative for some time as the gauge face of the high rail exhibited a bright rough surface (figure 22). The plucking and pitting of the gauge face indicated a high rate of local wear consistent with a lack of lubrication. In addition there were fresh metal flakes lying on the inside toe of the rail throughout the 175 m radius section of the curve.

FIGURE 22:
High rail gauge face showing wear from lack of lubrication

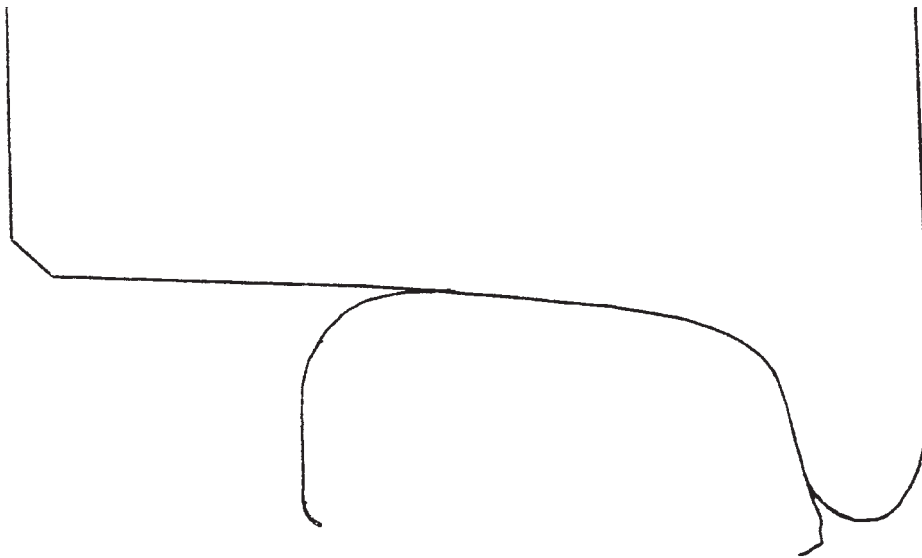
Allowing for the 6 mm chamfer on the wheel rim, the actual contact between the tread of the inner wheel and the rail head could have been as little as 12 mm. Hence there is high risk of derailment caused by the inner wheel tread dropping into the track four-foot. Figure 25 shows that the flange of the leading outer wheel (number-1) fits well into the worn side of the outer rail. By taking account of the 1357 mm back to back dimension and 49 mm dynamic gauge widening the position of the inner wheel on the inner rail may be predicted as shown in figure 26.

FIGURE 25:
Predicted number-1 wheel contact with high rail

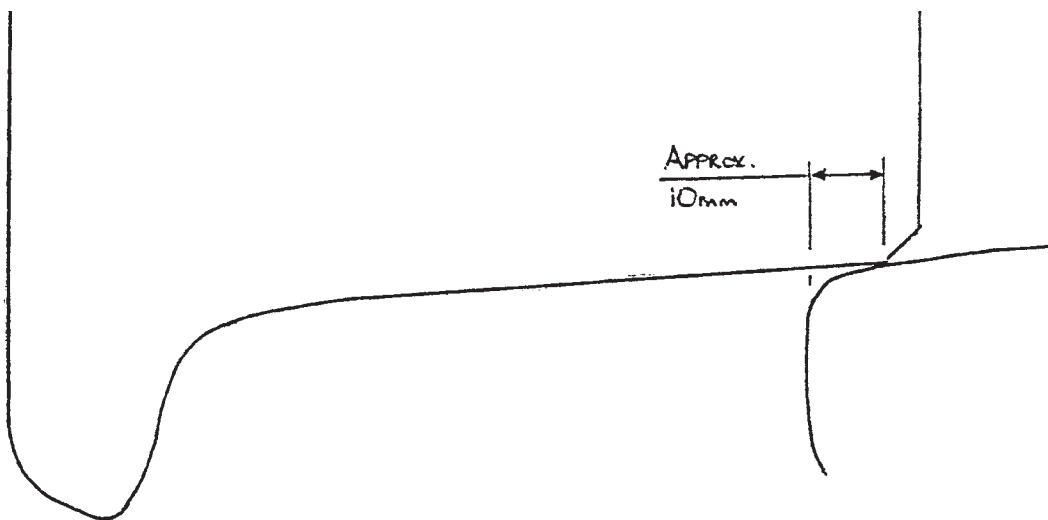
FIGURE 26:
Predicted number-2 wheel contact with low rail

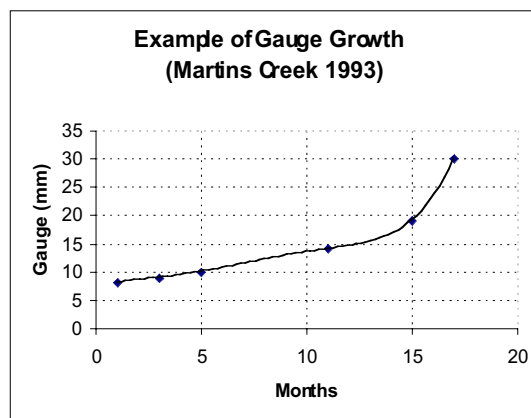
Figure 1

Widening of this magnitude is a serious defect warranting immediate repair once found.

Wide gauge of this order does not appear suddenly but develops over many months. However the growth is likely to become exponential, as the example of a similar case shows.
