AVIATION SAFETY INVESTIGATION REPORT  
200205780

# **In-flight uncontained engine failure and air turn-back, Boeing 767-219ER, ZK-NBC**

8 December 2002

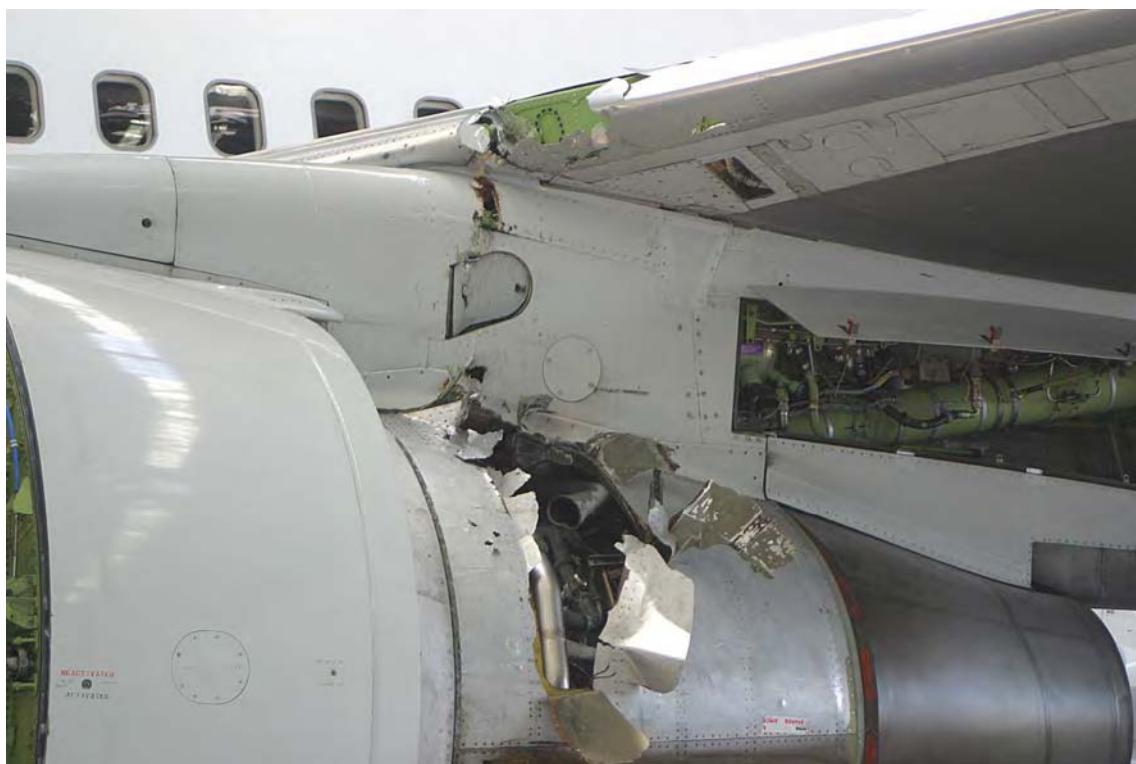
The primary airframe damage was sustained by the engine pylon and the leading edge flap structure immediately outboard of the pylon (figure 1). The left side pylon fairings exhibited a heavy gouge leading vertically upward from the nacelle to the damaged wing leading edge flap (figure 2), the dimensions of the gouge indicating that it was probably produced by the liberated disk segment. The wing leading edge flap skin was extensively torn over a length of approximately 600 mm, with extensive pitting and indentation of the surrounding surfaces from the smaller debris liberated when the disk failed (figure 3). Prominent distortion of the pylon structure was evident externally as buckling and distortion of the adjacent wing underside panels (figure 4). As a result of the discovery of that damage, the operator commissioned a structural condition survey of the pylon and wing structure<sup>1</sup>, which confirmed that the pylon had sustained twisting and buckling damage due to the rapid stopping torque applied during the engine failure. The survey also determined that the damage was confined to the pylon structure, with the adjoining wing box not sustaining any significant damage.

**Fig. 1** Overview of the damage sustained by the left engine and wing leading edge of ZK-NBC

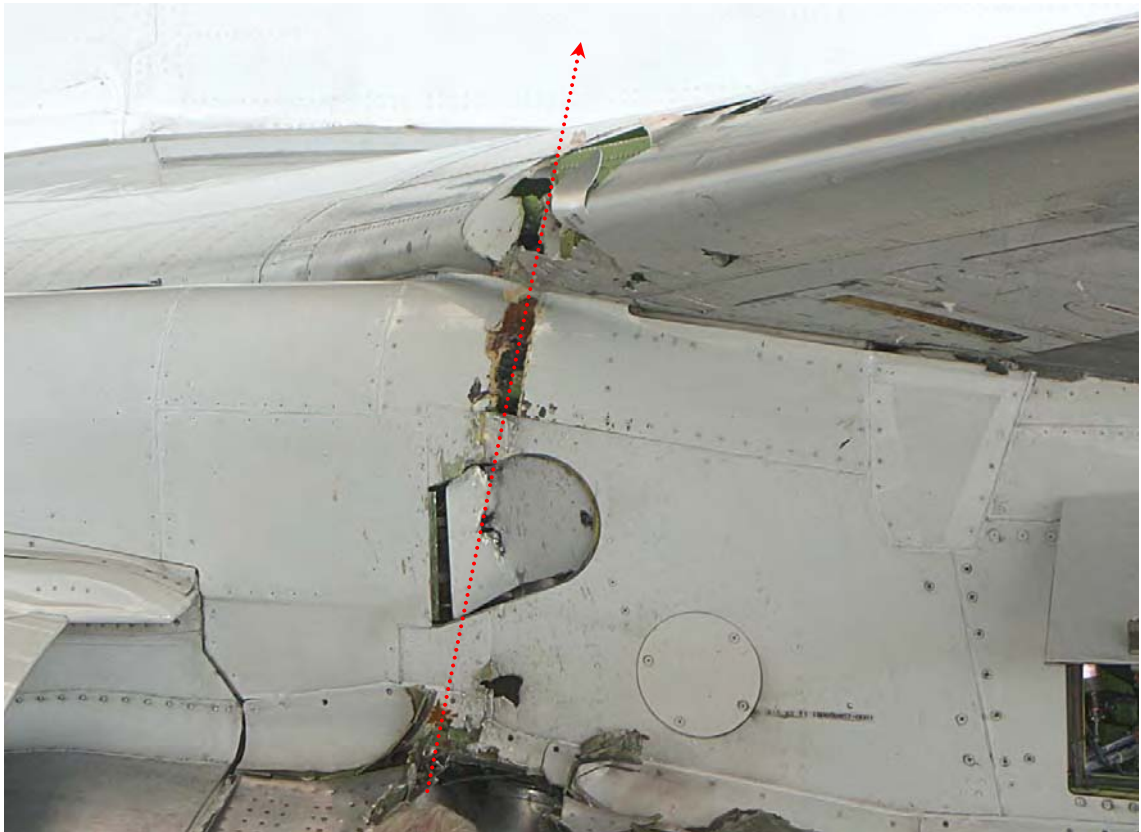
**Fig. 2** Vertical gouge in the engine pylon fairings – likely produced by the liberated segment of high-pressure turbine disk. The dotted line illustrates the likely trajectory of the disk fragment.

An analysis of the trajectory taken by the liberated disk section showed it to have exited the engine core almost vertically, travelling up the outboard side of the pylon and impacting the leading edge flap structure. The resultant damage included heavy gouging of the pylon fairings and the destruction of a 600 mm length of the leading edge flap profile above the engine nacelle<sup>6</sup>. Impact damage from the uncontained failure was otherwise confined to minor impacts on the number-2 trailing edge flap canoe fairing.

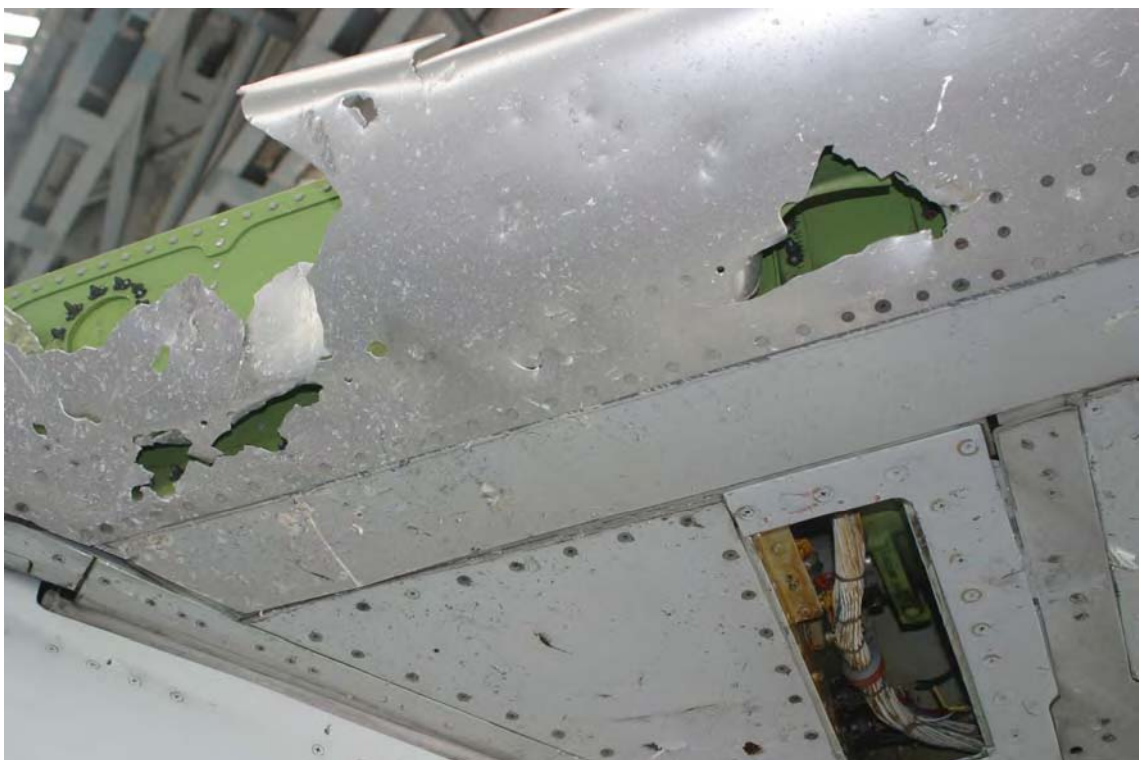
**Fig. 3** Damage to the wing leading edge profile above the engine core rupture.

The damage sustained by the aircraft as a result of the engine failure did not produce immediate aircraft operational problems. The localised damage to the left wing leading edge profile was not sufficient to produce asymmetric handling characteristics and the impact had not damaged the leading edge flap actuation mechanisms. The flight crew's identification of the flap damage and subsequent choice of actions considering the potential effects of the damage on the aircraft's performance minimised the risk of controllability problems arising when the flaps were extended for landing. While the potential existed for more significant airframe damage should the disk section have impacted on the inboard wing or fuselage, the design certification of the aircraft type implied that the hazards to the aeroplane had been minimised in the event of such a failure. Federal Aviation Regulation (FAR) Part 25 (transport category aeroplanes), section 25.903(d) (1) refers. Additionally, certification to FAR section 25.571(e) implied that the aircraft design should have been tolerant of likely structural damage sustained from the uncontained failure of high energy rotating machinery.

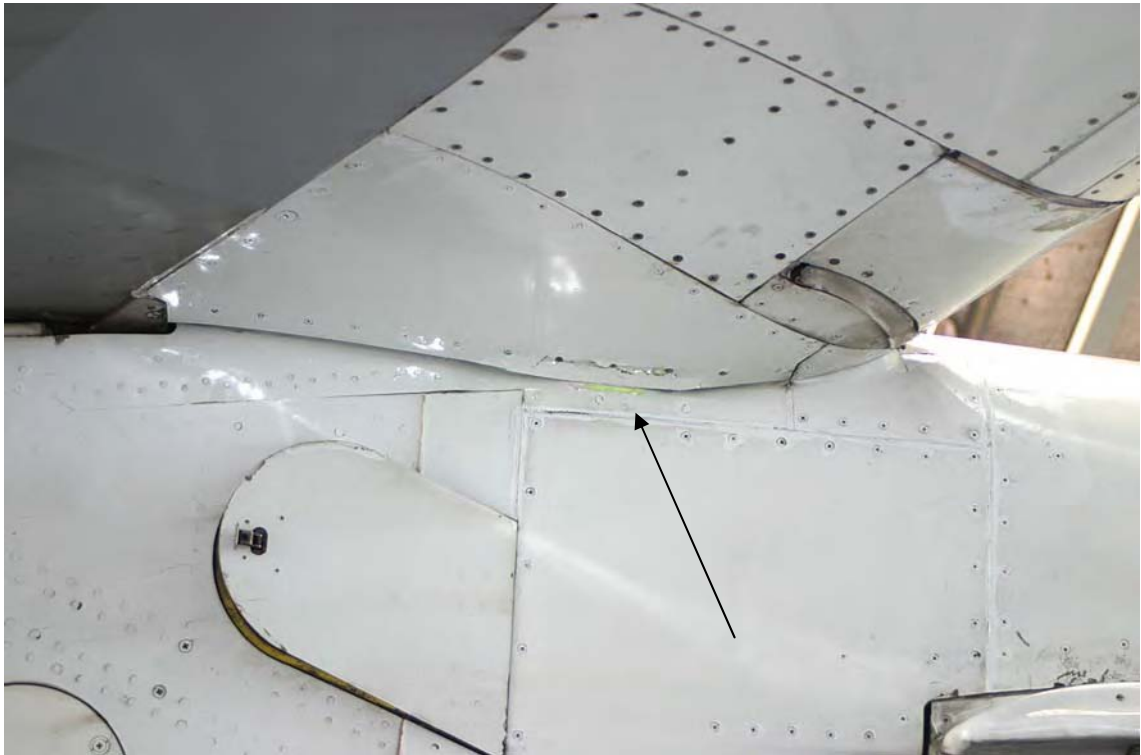
**Fig. 4** Lateral distortion and crushing of the wing and pylon fairings, suggesting mechanical distortion of the pylon structure.

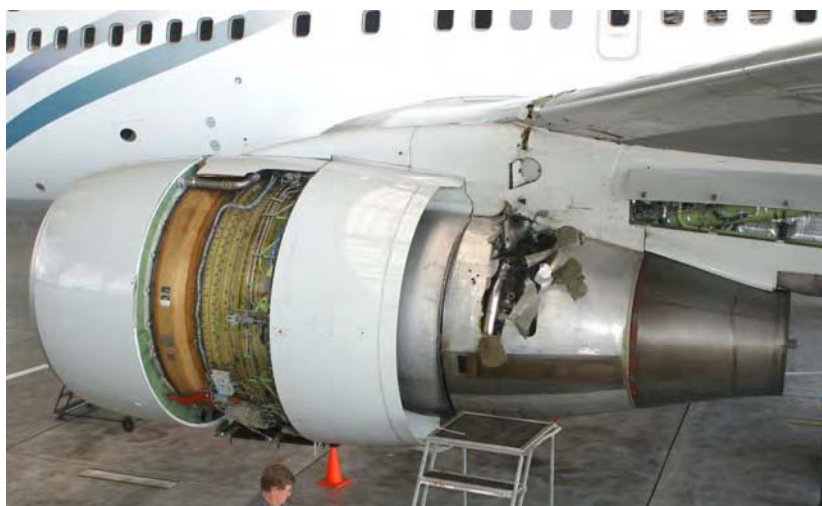
An initial engineering evaluation of the left engine revealed the loss of the outboard fan cowl section and a large rupture of the outboard core cowl, with associated damage to the engine strut and wing leading edge flap above that area (figure 1). The engine core showed the complete circumferential disruption of the high-pressure turbine casing and the loss of a large segment of the first-stage high-pressure turbine disk. The low speed (N1) spool shaft had fractured between the first and second-stage turbine disks.

**Fig. 1** Failed left (No.1) engine from Boeing 767-219 ZK-NBC.

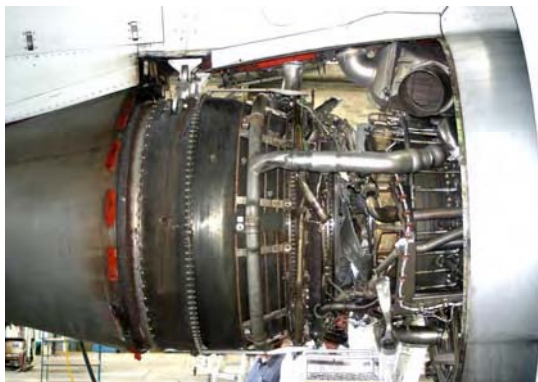
A preliminary examination of the engine after removal of the turbine fairings revealed extensive mechanical damage to the casing, ductwork and wiring around the plane of the first-stage high-pressure turbine rotor (figure 2). The damage had effectively severed the engine at that point, with the fracture of the low-speed (N1) shaft allowing the casing sections to move apart by approximately twenty mm (figure 3). Inside the severed casing, the HPT1 rotor showed extensive damage, with all blades either lost from the disk or fractured at the base of the airfoil section (figure 4). The disk itself had lost a large, crescent-shaped section from the outer rim and web, encompassing approximately fourteen blade slots (figure 5). A characteristic localised area of discoloured fracture surface was noted at the base of the blade slot on the trailing end of the fracture (figure 6). The liberated disk section was not recovered from the internal remnants and was presumed lost from the engine during the initial failure event.

**Fig. 2** Core damage to the engine around the plane of the first-stage high-pressure turbine disk.

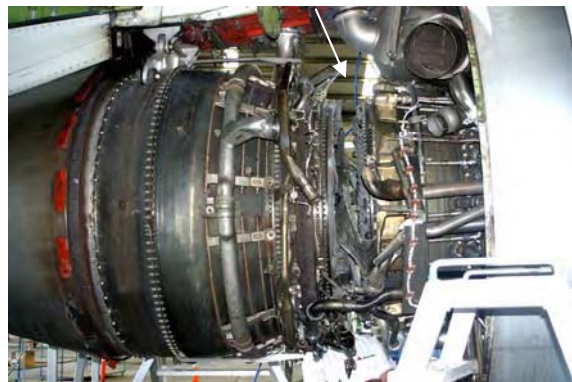
**Fig. 3** Separation of the engine core (arrowed).

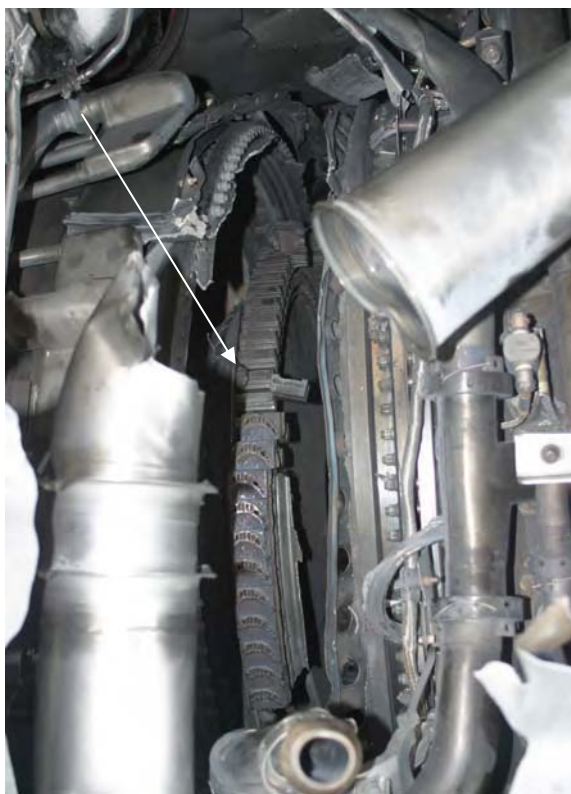
**Fig. 4** View of the stage-1 HPT disk through the severed case. Many blades fractured or lost from the disk.

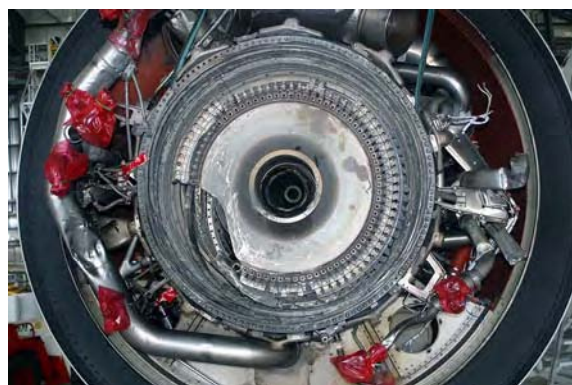
**Fig. 5** Rear face of the stage-1 HPT disk, showing the loss of the rim and web section.

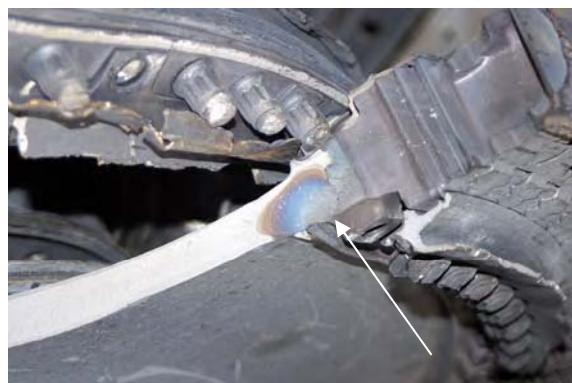
**Fig. 6** Primary disk fracture showing an area of discoloured prior cracking at the base of a blade firtree slot.

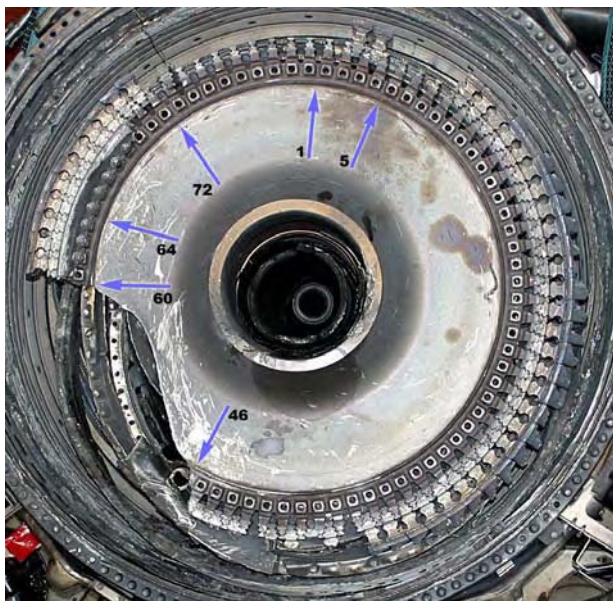
On the basis of the fir tree slot markings, the disk failure had occurred between slots 46 and 60, with the principal fracture origin associated with the discoloured area located at the base of slot 60 (figure 7). Further visual examination identified two other blade slots that were also cracked. Slot 72 presented a full width crack that extended radially along the rear disk face (between the bolt-hole embossments) for approximately twenty-five mm (figure 8). The same crack also ran radially along the forward disk face for around ten mm before turning tangentially and intersecting the rim bolt hole between slots 72 and 73. A smaller slot bottom crack was also found at the base of slot 64 – that feature extended eight mm radially and fourteen mm axially from the rear corner (break-edge) of the blade slot.

**Fig. 7** View of the rear face of the stage-1 HPT disk showing the slot numbering. The primary fracture extended between slots 46 and 60, with additional cracking found at slots 64 and 72.

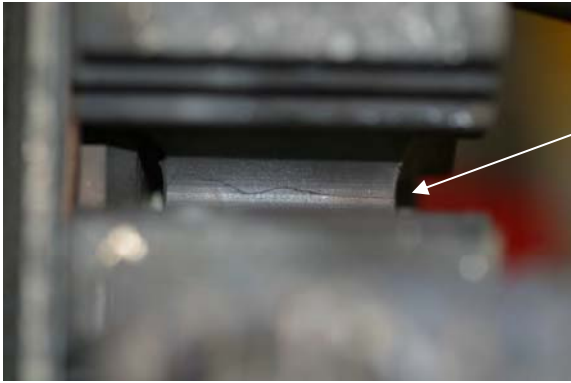
**Fig. 8** Visible cracking found at the base of firtree slot 72.

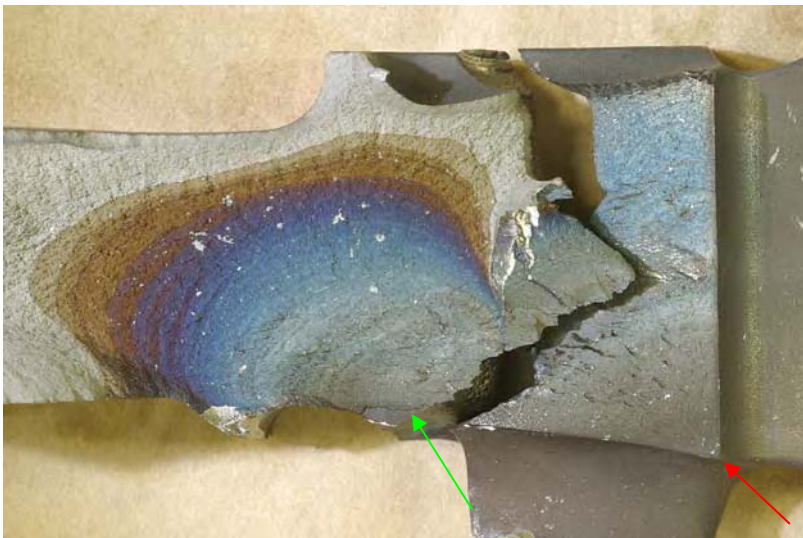
After removal of the slot 60 sample, it was evident that the primary cracking had diverged into the rim bolt hole (as observed in slot 72), forming a triangular shaped area extending from the break-edge corner to the base of the embossment and ten mm along the slot base. Secondary radial cracking had initiated from near the base of the embossment region, resulting in the formation of two separable sections (figures 10, 11).

**Fig. 10** Specimen removed from the disk encompassing the primary fracture initiation region. Fractographic analysis showed primary fatigue crack initiation from the rear slot corner (red arrow), with secondary cracking initiating from the plane of primary cracking towards the base of the rear embossment (green arrow).

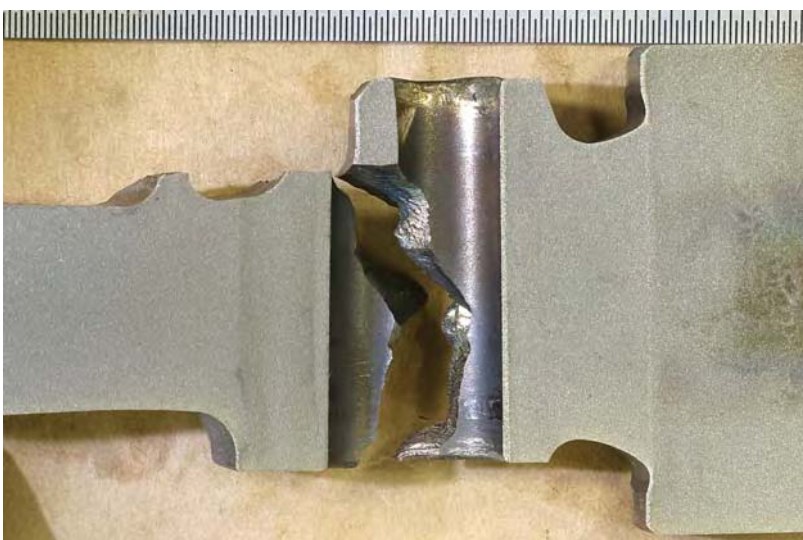
**Fig. 11** Wire-cut surfaces of the specimen above, showing the divergence of the primary fatigue cracking into the rim bolt hole.

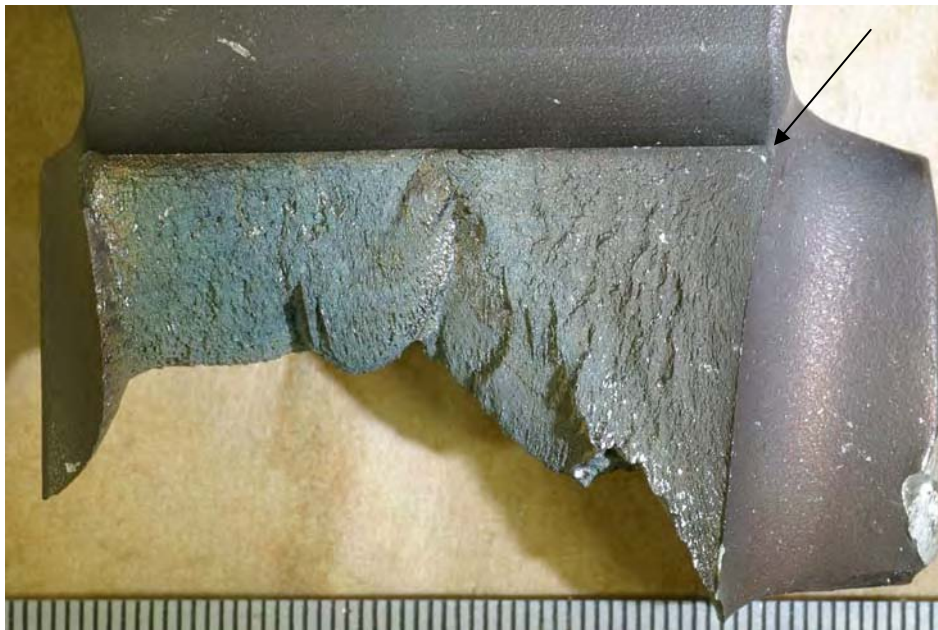
Examination of the primary fracture at low magnification located the origin at the tangency point between the rear break-edge and the base surface of slot 60 (figure 12). Little further detail was available at higher magnification (figure 13), with no evidence of mechanical damage, indentations or other anomalous features observed on the surfaces surrounding the fracture origin. The early fracture surface features suggested the propagation of cracking by intergranular fatigue. The conchoidal, radiating pattern and associated lightening of the oxide colouration shown by the secondary cracking was indicative of a propagating fracture, with the surface morphology consistent with cyclic tensile overload. The clear, widening steps in the oxide patina towards the outer limits of the progressive fracture indicating accelerated crack growth as the defect became larger. The point of final fracture and disk failure was defined at the boundary of the outermost oxidised area (figure 14), where the fracture had adopted a clear morphology of ductile tensile overload. At this point, the fracture had propagated for approximately 39 mm below the firtree slot base and extended longitudinally for almost the full disk thickness in that area.

**Fig. 12** Closer view of the primary fracture origin. Note the absence of characteristic fatigue propagation marks, attributed to crack growth by an intergranular propagation mode.

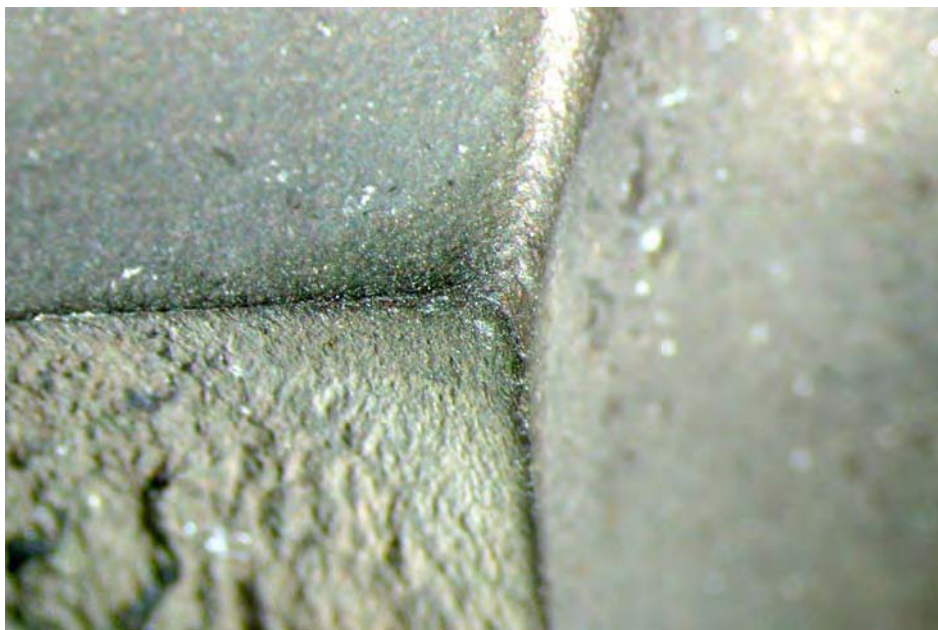
**Fig. 13** Low-power microscopic view of the crack origin. The surrounding slot, corner and rear faces appeared free of damage at that magnification.

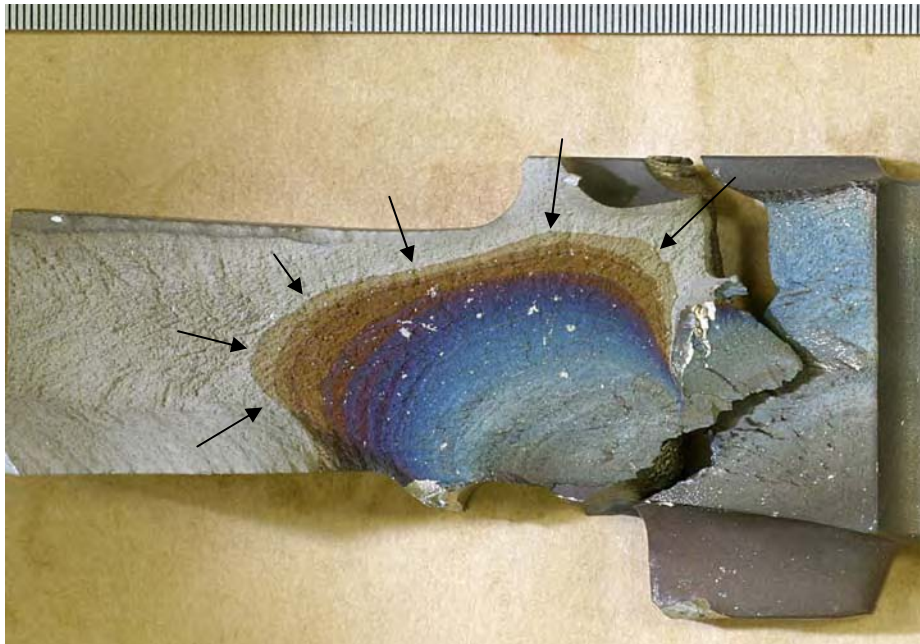
**Fig. 14** General view of the primary fracture showing the limit of progressive crack growth and the transition to final ductile overload failure.

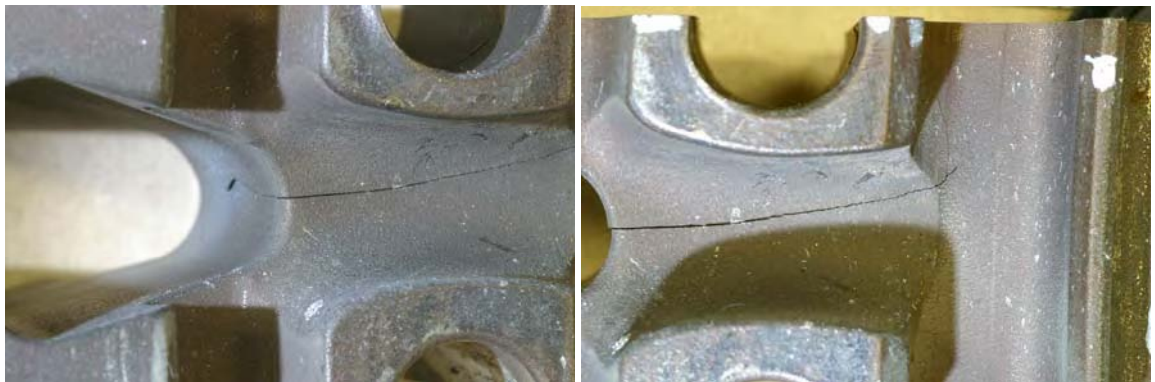
Examination of the slot 72 sample before separation of the crack surfaces showed a slight radial offset in the fracture surfaces at the rear end of the slot (figure 15), with the high point located on the leading side of the fir tree slot. Low-power stereomicroscopic examination of the surfaces surrounding the rear break-edge found no evidence of tooling marks, indentations or other physical abnormalities. The rear disk face cracking extended radially to below the lower embossment edge, before turning circumferentially and propagating inboard of the rim bolt hole (figure 16). On the forward disk face, the slot bottom cracking diverged directly into the bolt hole with only a short radial propagation along the forward face (figure 17). The bore of the rim bolt hole (figure 18) showed the near intersection of the forward and rear crack ends, with only a shallow saw cut required to enable separation of the crack surfaces. On examination, the crack origin was located at the rear break-edge corner, with subsequent radial propagation in a manner very similar to the slot 60 cracking (figure 19). Features associated with a fatigue mechanism were identified extending out from the origin and no gross material abnormalities were observed.

**Figs. 15 & 16** Rear-face view of the cracking found within fir tree slot 72.

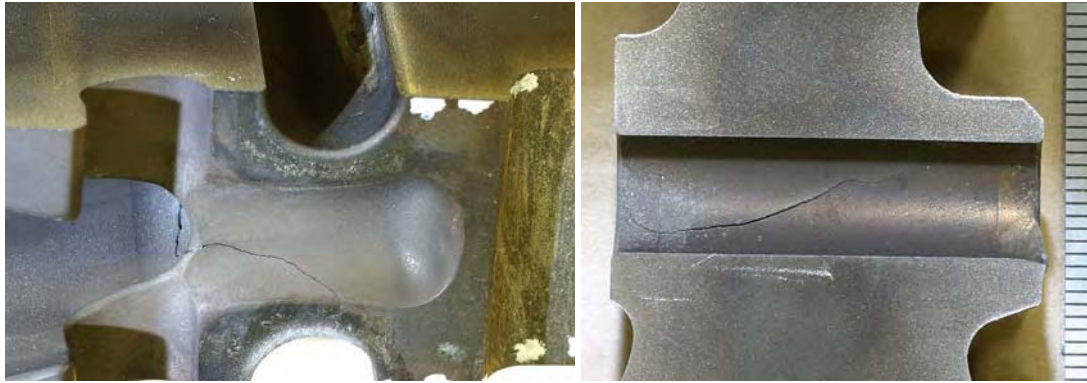
**Figs. 17 & 18** Forward face and internal bolt hole views of the slot 72 cracking.

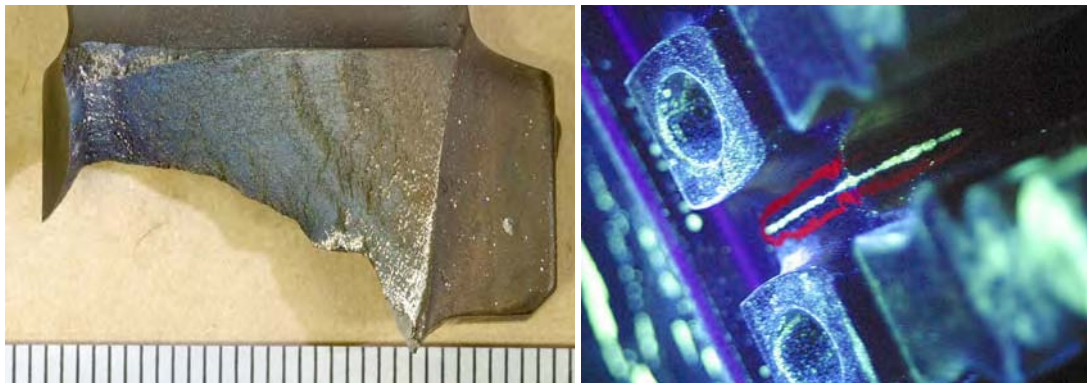
**Fig. 19** Separated surface of the slot 72 cracking. Note the close similarities to the primary cracking in slot 60 that caused the disk failure (figure 12).

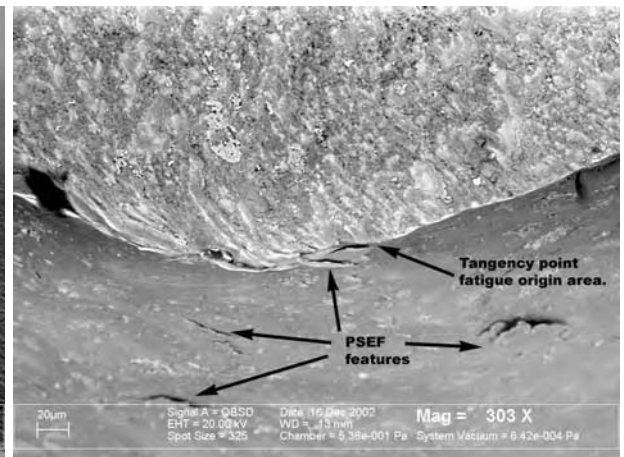
**Fig. 22** SEM view of the primary crack origin, showing the presence of PSEF defects on the external surfaces.

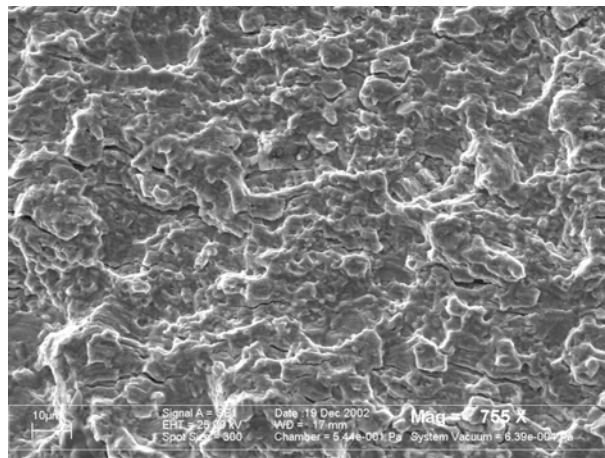
**Fig. 23** SEM view of the fracture morphology adjacent to the origin. Typical of intergranular fatigue.

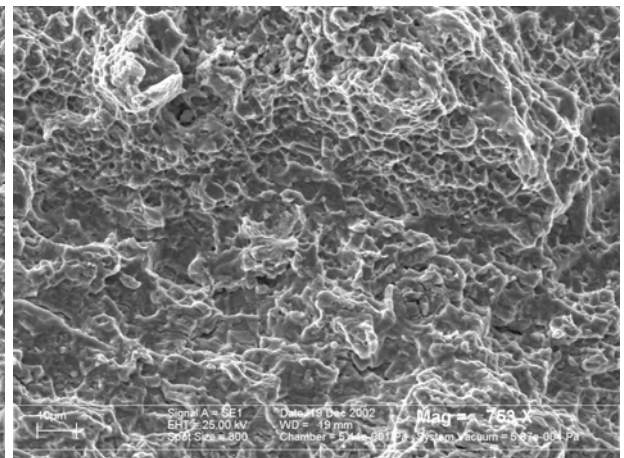
**Fig. 24** SEM view of the fracture morphology at the transition from intergranular fatigue to predominantly cyclic ductile overload.

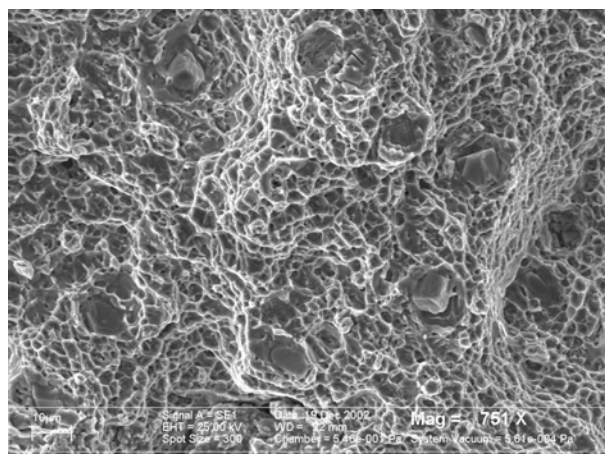
**Fig. 25** SEM view of the fracture towards the edge of the area of prior cracking. Essentially 100% dimpled ductile overload.

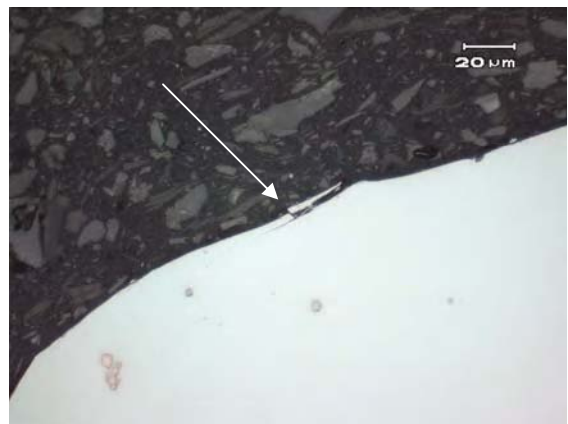
**Fig. 27** Higher magnification unetched view showing a shallow surface fissure associated with a PSEF defect.

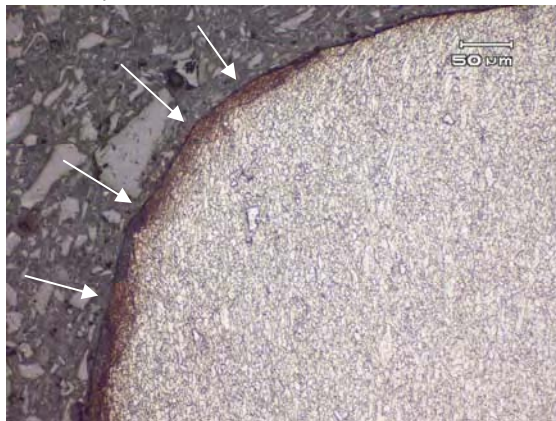
**Fig. 28** Etched view of the section shown in fig. 26 showing a heavily deformed surface layer around the break-edge. Slot base is at top.

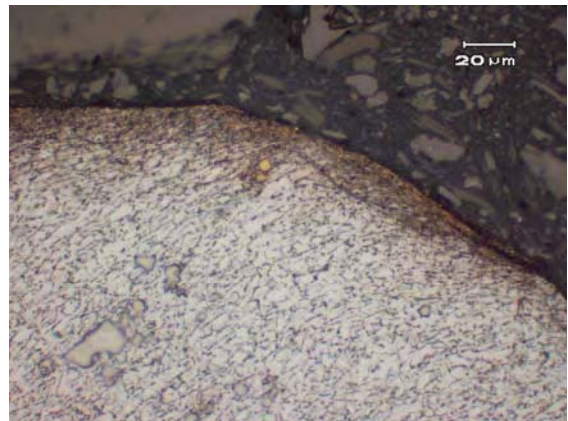
**Fig. 29** Higher magnification view of the etched break-edge, showing another lap-like feature associated with the shot peening.

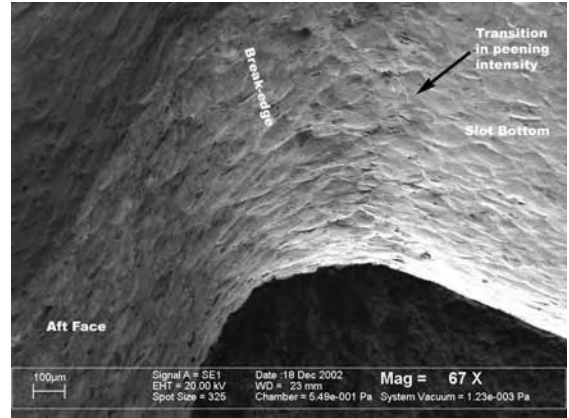
**Fig. 31** SEM view of the rear break-edge showing a clear transition in the effects of peening intensity at the slot break-edge tangency point.

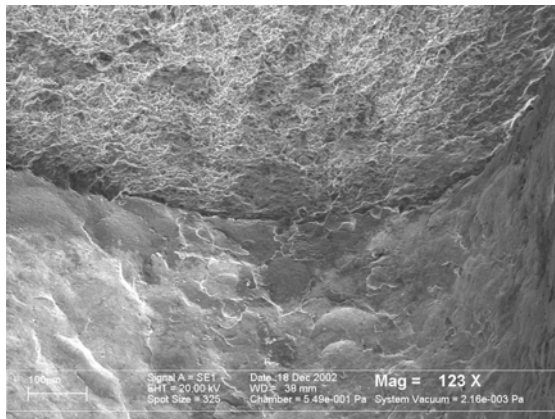
**Fig. 32** Slot 72 rear break-edge showing extensive PSEF features.

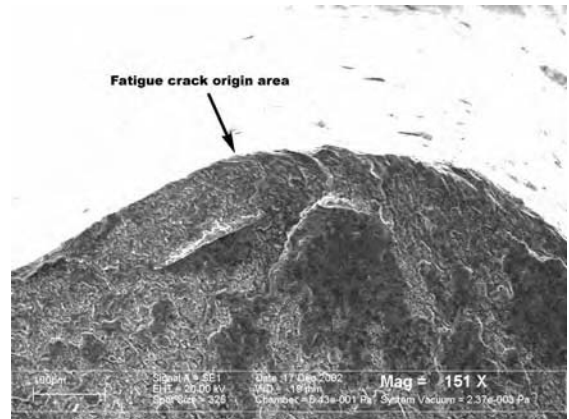
**Fig. 33** Crack origin again identified at the rear break-edge tangency point.

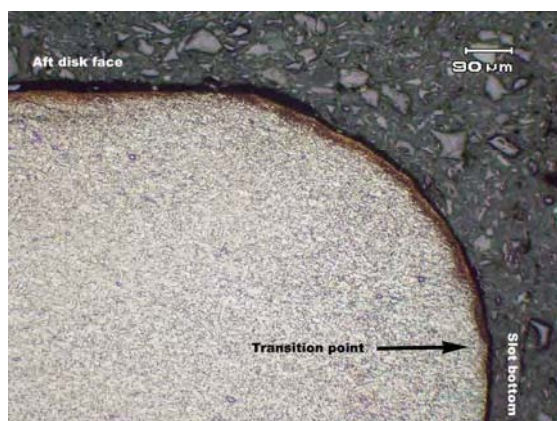
Metallography of the rear break-edge region showed the surface deformation associated with the peening, which again showed a very abrupt transition into the fir tree slot (figure 34). Associated with this transition was a ridge of flowed material that had been raised above the surface by the effects of the shot peening (figure 35). Features such as those are consistent with lower shot incidence angles during peening, where the repeated angular impacts produce a directional shear force within the surface material. The general material microstructure was typical of the disk alloy and consistent with the structures observed in the slot 60 specimen.

**Fig. 34** Etched metallographic view of the slot 72 break-edge profile, showing the abrupt end of the deformed layer at the slot tangency point.

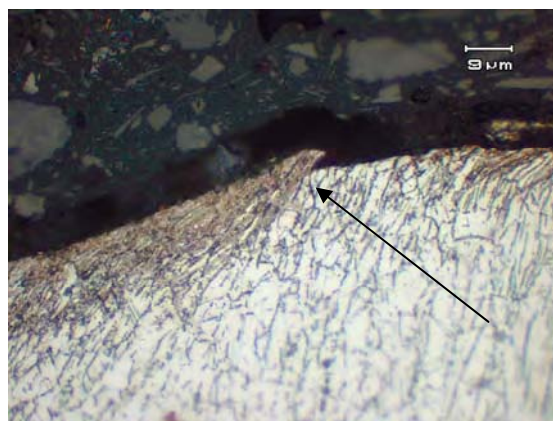
**Fig. 35** High magnification view of the end of the heavily deformed layer shown in figure 34. Note the sharp raised ridge of flowed surface metal.
