**BUREAU OF AIR SAFETY INVESTIGATION
REPORT**

BASI Report B/911/1019

**Bell 206L-1 Helicopter VH-TCH
South Stradbroke Island Qld
3 March 1991**

ACCIDENT INVESTIGATION REPORT

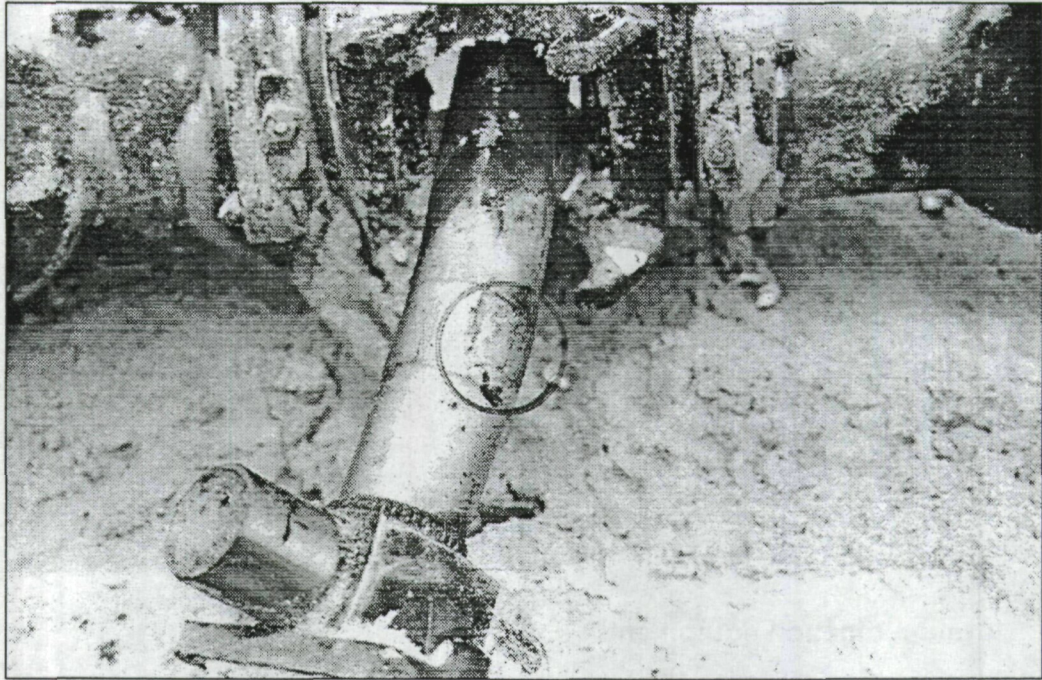
Main rotor head separated from mast. Marks (circled) indicate severe mast bumping.

first impact. The rotor mast was bent in two places due to ground impact and imprints of the blade stops on the mast indicated that severe mast bumping had occurred in flight. Damage to the main rotor blades was extreme, evidence that both blades struck the sand before the cabin impacted. Any remaining integrity of the structure was destroyed by the explosion and subsequent fire.

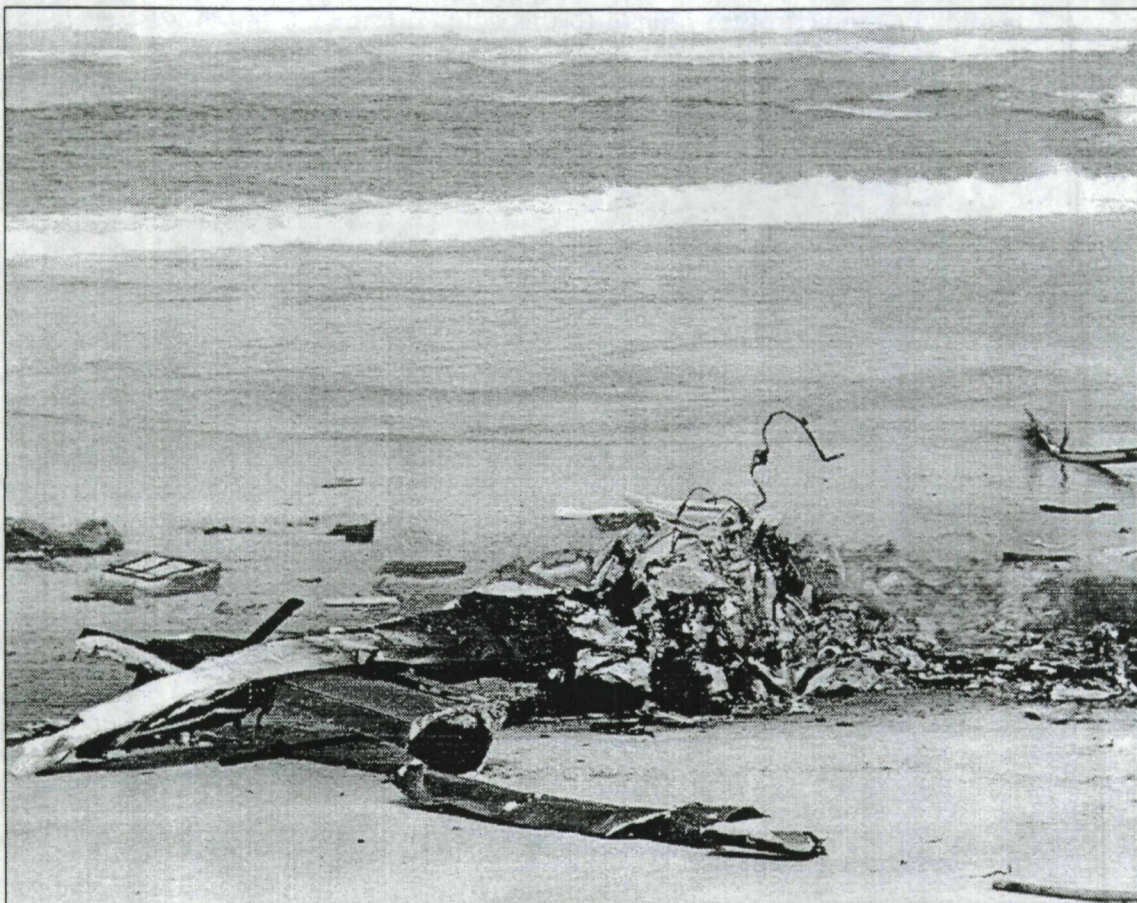
An explosion at first impact was followed by a fierce fuel-fed fire. The intensity of the blaze indicated that a significant quantity of fuel was carried in the helicopter's fuel tank. There were no fire-fighting facilities at the site and the remnants of the cabin were destroyed by the fire.

Remnants of burnt out helicopter.

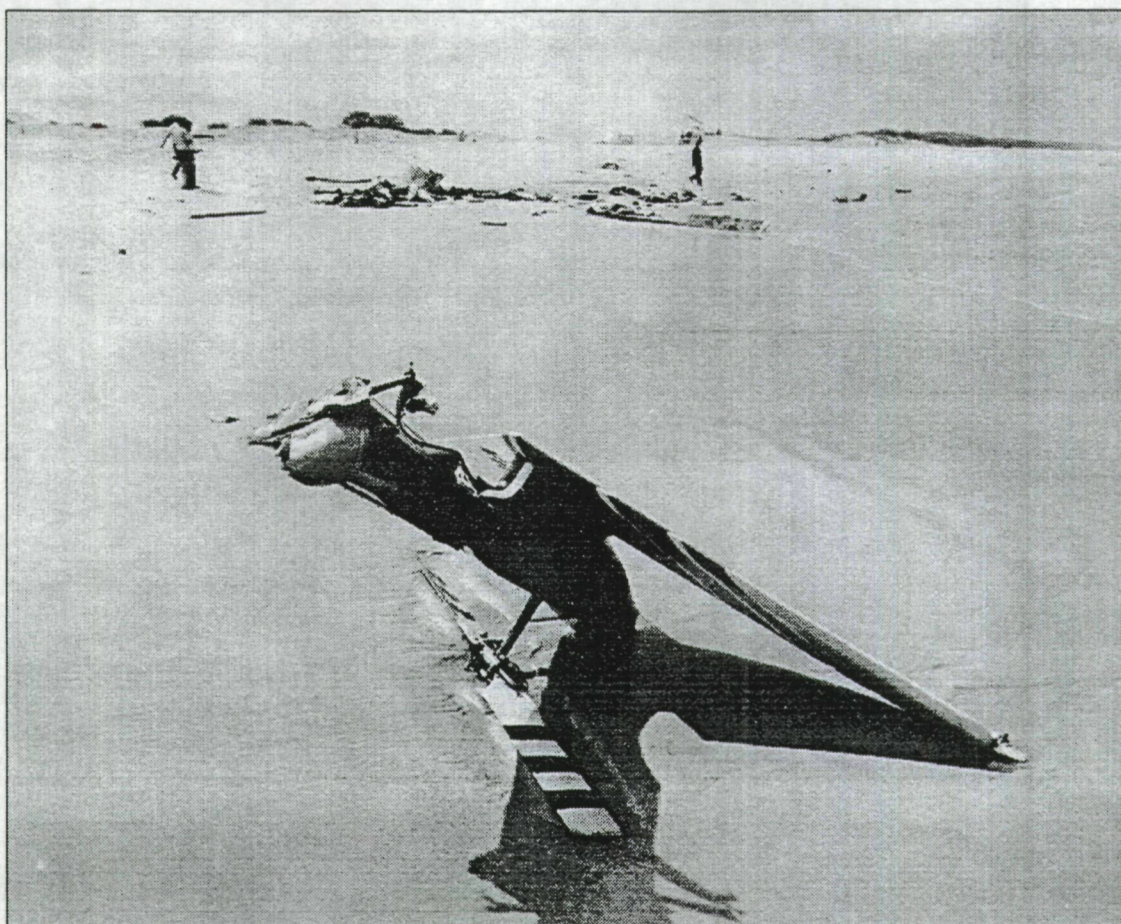
Debris was spread over several hundred metres. The heavier pieces were close to the main wreckage but the lighter material was blown north along the beach by the prevailing wind. The end of the tail boom with an undamaged tail rotor fell clear of the main wreckage, landing in the surf.

Rear section of tail boom complete with rotor. Remainder of wreckage is in the background.
