The New Zealand registered roll on/roll off, gas turbine/electric ship Union Rotorua was about 27 miles south of Sydney Heads, en route for Melbourne, when a fire broke out in the gas turbine house.

It was established that the seat of the fire was in one of the cubicles of the 6.6 kilovolt switchboard, which distributed power from the gas turbine generator to the propulsion motors and auxiliary electrical systems.

The incident was investigated by the Marine Incident Investigation Unit under the provisions of the Navigation (Marine Casualty) Regulations.

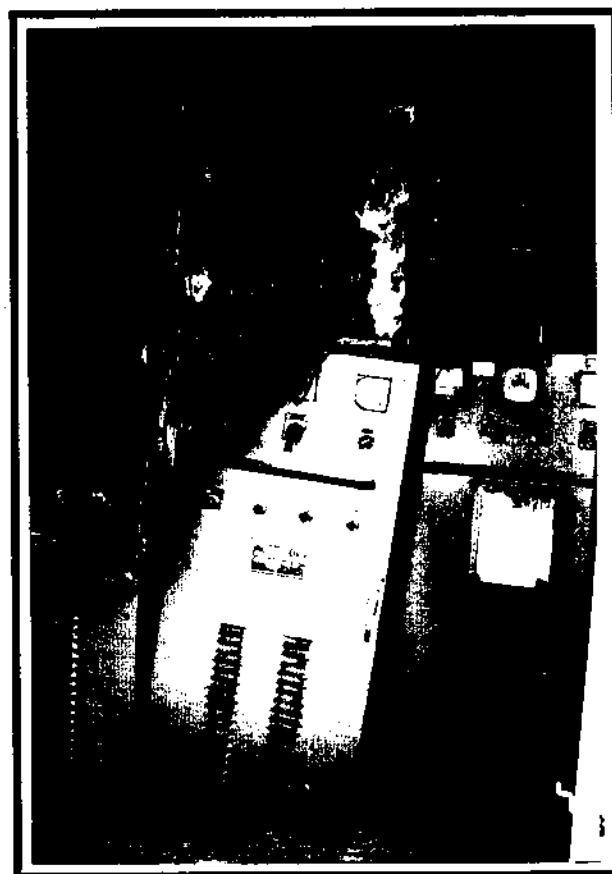
Front view of switchboard cubicals

The aftermost six of the nine cubicles were found to have been damaged by the fire, the forward three suffered some smoke and heat damage.

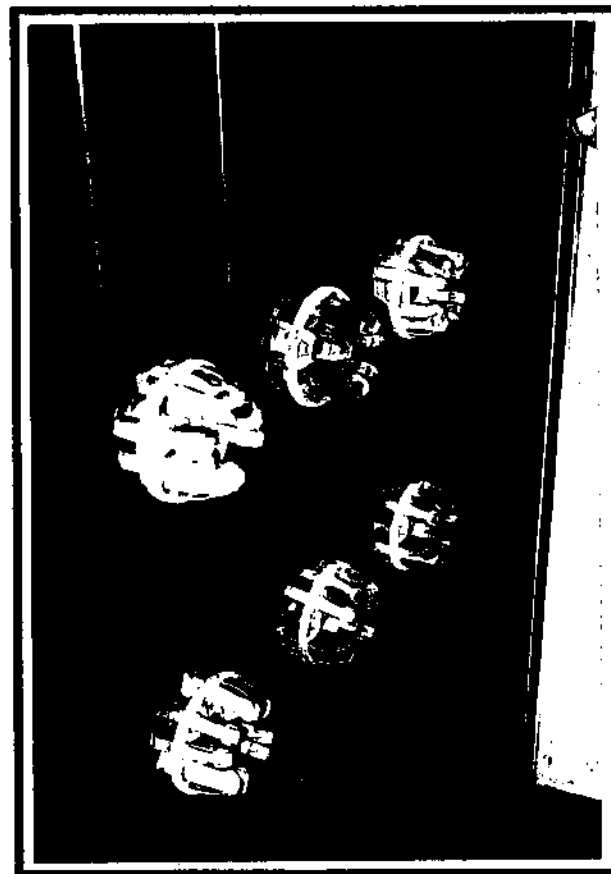
Each circuit breaker was connected to copper pins on the bus-bars by six “tulips” carried on the ends of copper connecting posts. In the case of the main generator breaker, each of the three phases had an incoming connection from the generator and an outgoing connection to the main bus-bars. In the case of all the other breakers, the incoming connection was from the bus-bars and the outgoing connection to the relevant equipment. Each “tulip” consisted of a number of silver-plated “fingers” which, upon racking the circuit breaker into the cubicle, would close around the end of the post on the bus-bars. The “fingers” were spring-loaded to provide the necessary contact pressure.

**View of circuit breaker "tulips" on
the ends of connecting posts.**
