Interim Rail Investigation Report

Derailment of Cairns Tilt Train VCQ5 North of Berajondo, Queensland 15 November 2004

16 February 2005

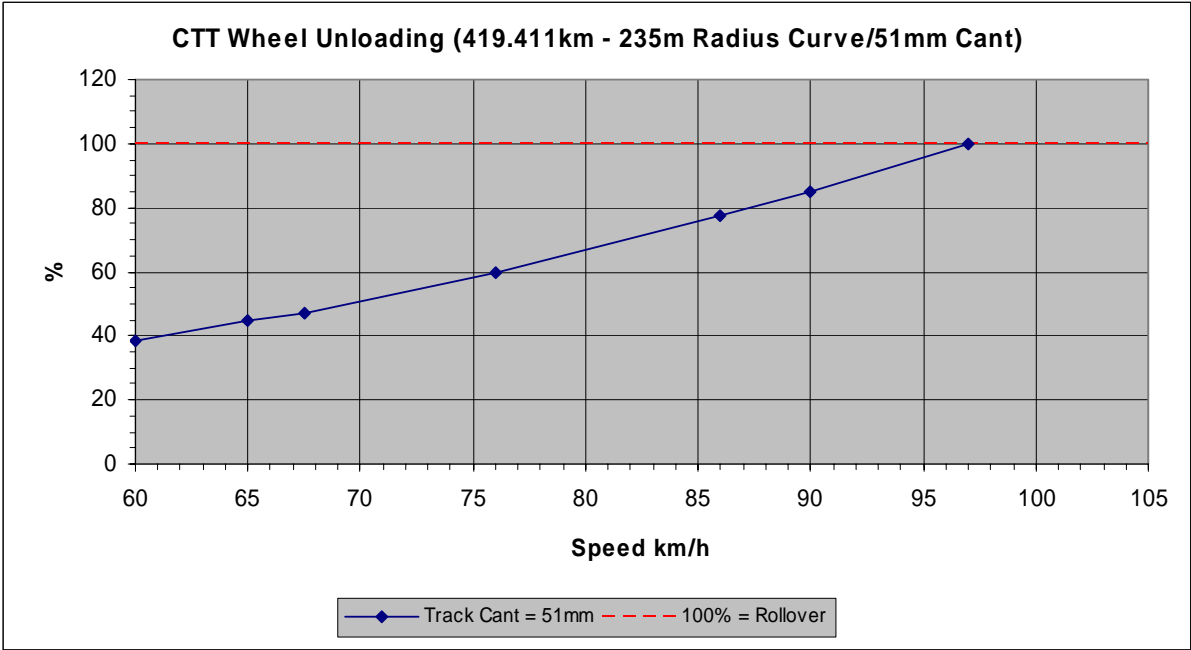
Figure 2. Wheel Unloading vs Speed

In understanding the mechanism of this derailment it is important to recognise that rollover will occur when the centre of gravity of the train acts just beyond the vertical on the outer running rail. Computer modelling undertaken to date, suggests that 100% wheel unloading for the lead power car through the first 60km/h curve would have occurred at 97km/h. The modelling, supported by speed/centre of gravity calculations and field observations indicate that the lead power car probably rolled and then dragged the remaining trailer cars off the track before all units came to rest. While the principal causal factor for the derailment is speed related, the reason for the over speed is the subject of ongoing investigation. Figure 2 below, is a graph of 'Wheel Unloading, (front left)' vs 'Speed' for the CTT on a 235m radius curve with 51mm cant as per the accident site. 100% wheel unloading represents theoretical commencement of rollover. Further work is being conducted to validate the computer modelling.
