INFRA-08415
Released in accordance with
section 25 of the *Transport Safety
Investigation Act 2003*

Engine malfunction: rejected takeoff Mount Isa, Qld 16 December 2006

ABSTRACT

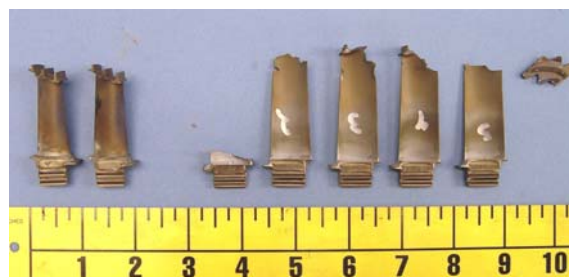
A detailed inspection report³ of the teardown process was provided by the engine manufacturer. The teardown confirmed that a single stage-four PT blade (SN R4PUA) had fractured at the airfoil root. Secondary damage in the form of tip separation had occurred to the four adjacent PT blades due to impact with the liberated PT blade segment (Figure 1).

Figure 1: Separated and damaged stage-four PT blades

Additional secondary engine damage mentioned in the report included; numerous indentations and impact punctures to the exhaust frame, severe circumferential mechanical rubbing of the PT shaft outer surface due to an out-of-balance stage-four PT rotor, and heat discolouration of the stage-three PT blade set and stage-four nozzle guide vanes.

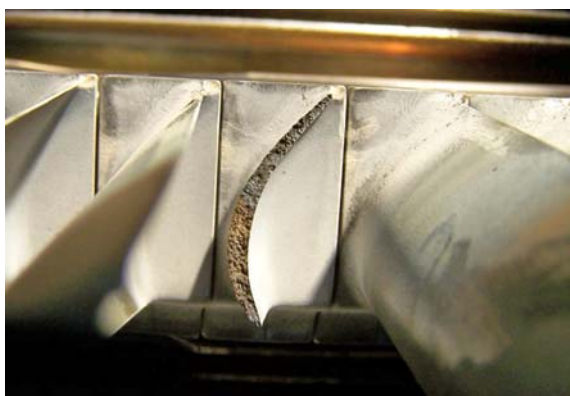
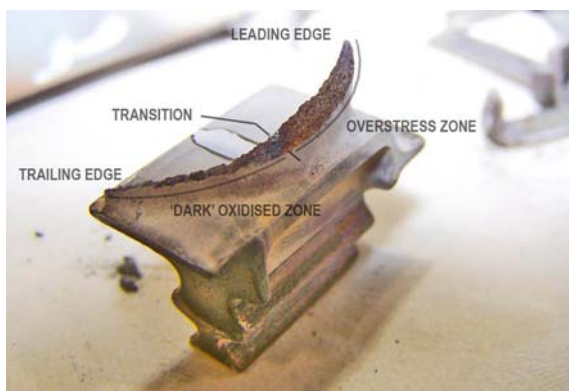
Visual examination of the PT blade revealed that it had fractured close to the blade root (Figures 2 and 3). The fracture surface was divided into either that of tensile overstress, or a 'dark'

oxidised zone. The oxidised zone extended from the trailing edge of the airfoil surface through to about the mid-chord region, while the region of overstress extended forward to the leading edge. Although the oxidation partially concealed the underlying fracture surface, no evidence of fatigue or any other such progressive failure mechanisms were observed.

Figure 2: Fractured stage-four PT blade at the airfoil root

Figure 3: Fractured stage-four PT blade (SN R4PUA)

Examination of the PT blade fracture surface revealed that it had fractured in tensile overstress at the blade root. Half of the fracture surface had been heavily oxidised. The 'zonal' oxide layer indicated that a pre-existing crack had been present in the PT blade for a significant period of time during engine operation. No evidence was found of fatigue cracking. The factors that influenced why the PT blade had partially cracked in the first instance could not be established with absolute certainty. It may be that foreign object impact damage resulted in the formation of an initial first-stage tensile overstress crack (as observed) within the blade root region. Final fracture of the PT blade occurred from tensile overstress, where high power settings were required to achieve the necessary engine performance to accelerate the aircraft for takeoff.

Metallurgical analysis of the fractured power turbine blade revealed that a pre-existing crack had been present at the blade root for a significant period of engine operation prior to the incident malfunction.

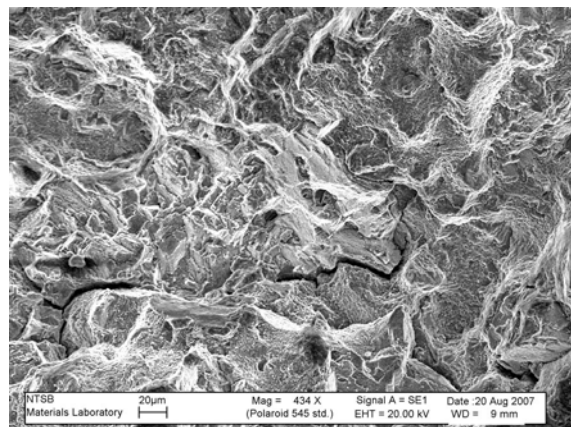
To further confirm the mode of fracture, the finer features of the fractured PT blade surface were examined at high magnification using a scanning electron microscope (SEM). Most detail in the oxidised region was unresolvable. However, tensile dimples and secondary cracks were present in the overstress region (Figure 4).

Metallographic sectioning of the fractured blade did not reveal any evidence of blade creep that might have otherwise suggested exposure to adverse operating temperatures.

Figure 4: SEM image of the fracture surface showing only features of tensile overstress
