Summary

Pierre LD, a bulk carrier of 165,239 tonnes deadweight, registered in French Antarctic Territory, sailed from the Western Australian port of Dampier on 21 November 1992 with a full cargo of iron ore. While transiting the departure channel, the ship suffered a major electrical failure together with a failure of the emergency steering system. The ship

veered out of the departure channel and grounded to the east of East Malus Island.

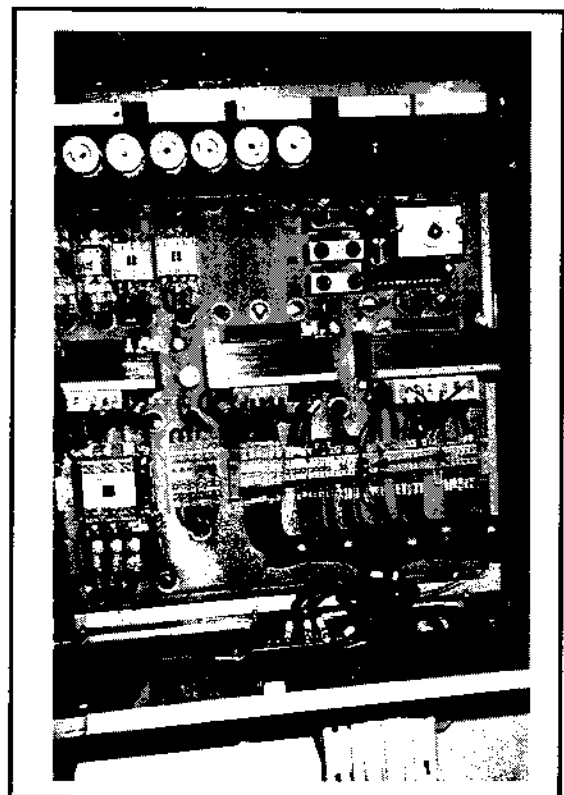
**Emergency steering system
control panel**

The fault in the emergency steering system was eventually traced to a loose electrical cable connection in the emergency steering system control panel, located in the steering gear compartment. This loose connection affected the starboard rudder demand only, and although more port rudder could have been applied, the rudder could not be moved from port 10 to midships or to a starboard position.

★ — Bridging contact inserted at
loose connection

1. Although a sequence of failures occurred, the grounding was the result of the failure of the emergency steering system.
2. The failure of the emergency steering system was due to a faulty electrical connection to the starboard solenoid control valve.
