ATSB TRANSPORT SAFETY REPORT
Aviation Occurrence Investigation AO-2007-065
Final

Midair collision
Latrobe Valley Aerodrome, Victoria
1 December 2007
Cessna 172 VH-EUI & Avid Flyer 28-0929

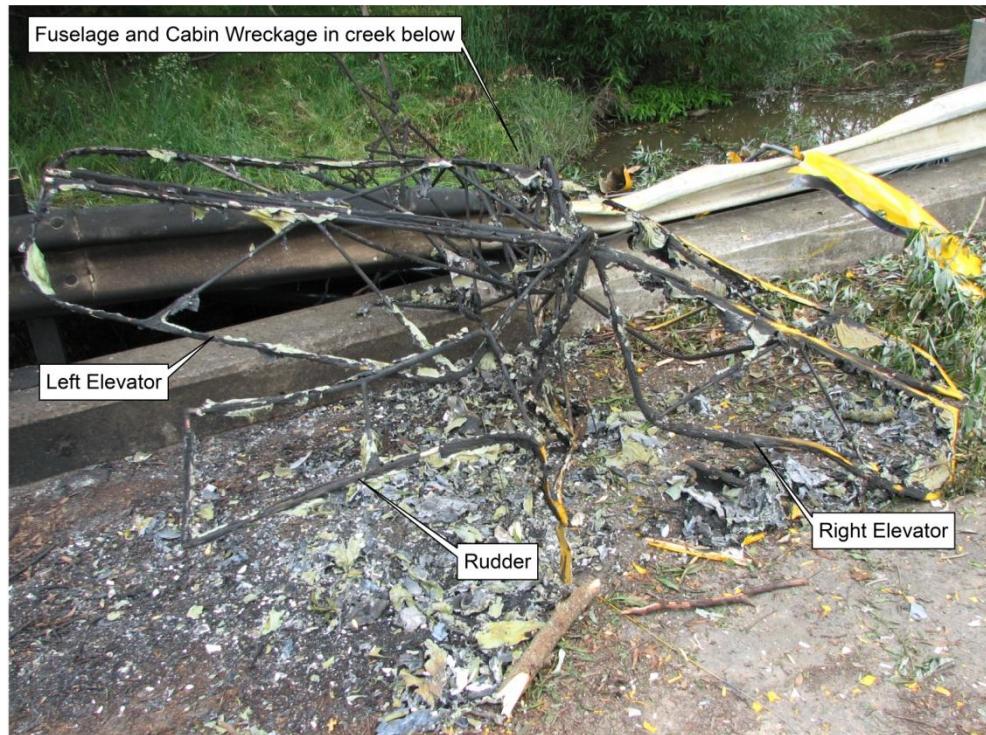
Figure 5: Main wreckage

The aircraft impacted the ground while in a nose-down attitude and travelling from east to west through the trees that surrounded the accident site. All of the aircraft items that were located remote from the main wreckage displayed evidence of gross overload failure consistent with the aircraft's impact with the terrain or trees.

There was no evidence of an in-flight fire, whereas a post-impact, fuel-fed fire resulted in fire damage to most of the aircraft's structures. The extent of the fire damage indicated that a reasonable quantity of fuel was on board the aircraft at ground impact.

Impact damage to the upper surface of the stabiliser spar tube and elevator hinge points was identified that had occurred prior to the fire. The upper part of the vertical fin was not identified with the main wreckage and the remnants of the vertical fin's attachment structure exhibited deformation in a downwards direction. There was no similar downwards bending of the aircraft structure surrounding the fin's attachment point, suggesting that the damage to the vertical fin occurred before ground impact.

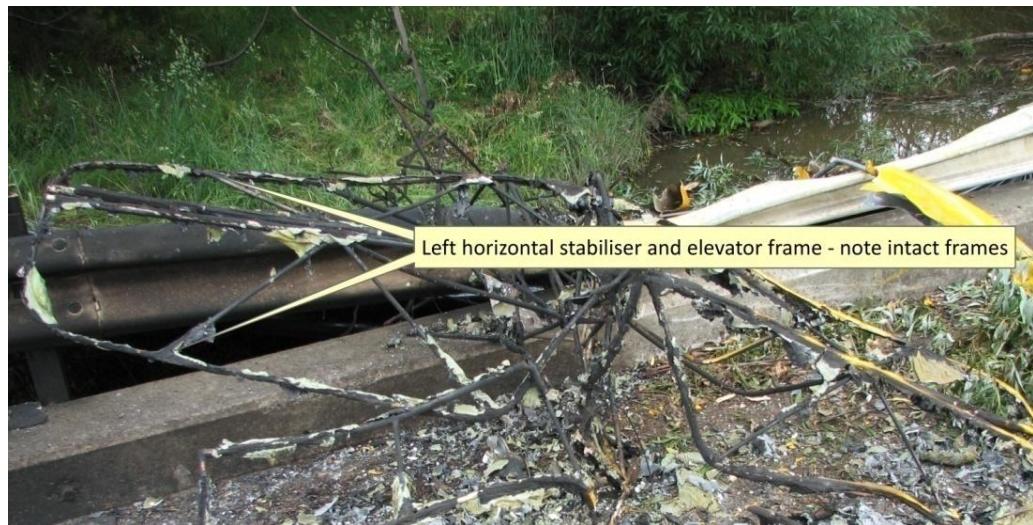
Figure 6: Left horizontal stabiliser and elevator frames

The left horizontal stabiliser and elevator frame and structure showed no evidence of contact with the propeller of the Cessna²³ (Figure 6).

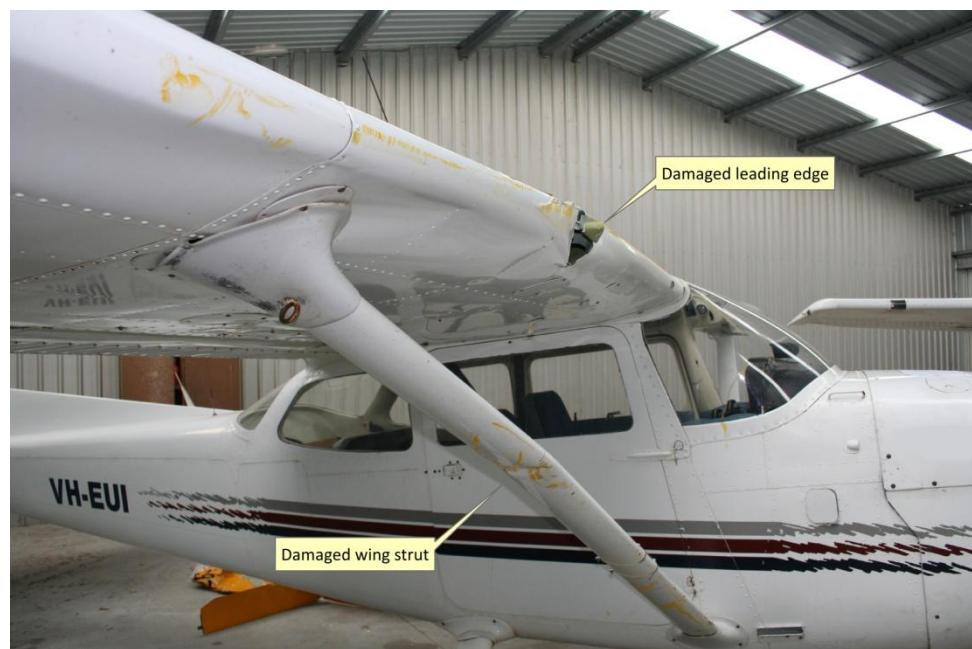
Figure 7: Damage to VH-EUI's right wing and strut

bending of the right wing strut, with additional damage on the lower surface of the strut. There was a hole measuring about 10 cm by 20 cm in the leading edge of the right wing (Figure 7) and damage to the lower surface of the left wing flap. In addition, there was indentation damage and yellow paint transfer to the wing and the aircraft's propeller spinner²⁵.

The damage to the right wing strut was directly below the hole in the leading edge of the right wing. When examined, the bending of the strut and of the wing structure surrounding the hole were found to be the result of a force being applied in an upwards direction.

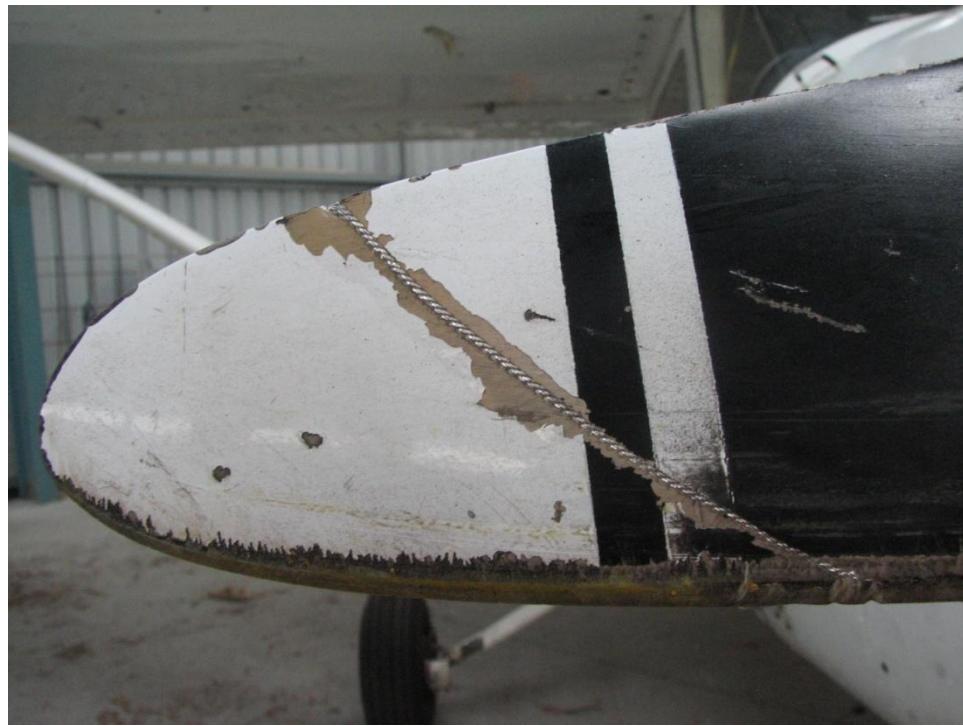
Figure 8: Propeller damage and wire imprint

Damage to the leading edge and face of one of the aircraft's two propeller blades included a witness mark from what appeared to be a wire cable (Figure 8). That mark was later found to be consistent with the internal wire bracing structures of the Avid's left wing. There was also impact damage on the leading edges of both propeller blades consistent with striking a hard object or objects.

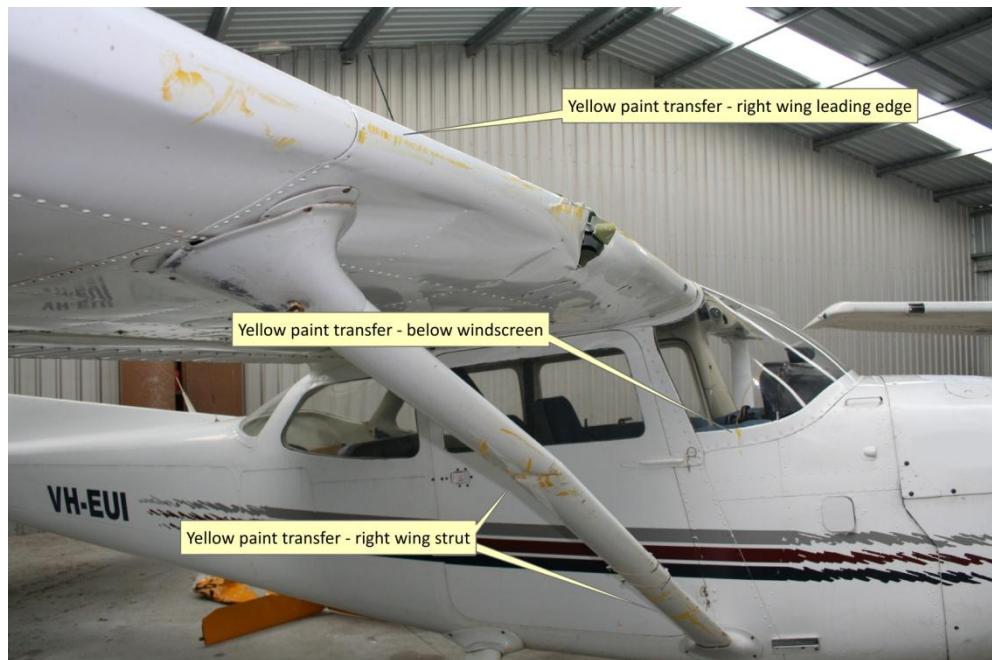
Figure 9: Right side areas of paint transfer

There were multiple yellow paint transfer marks on EUI, including on the leading edge of the right wing and strut, the right horizontal stabiliser, the propeller and spinner, and the left wing root leading edge (Figure 9). There was also yellow paint transfer on the underneath surface of the left flap, and on the upper surface of the leading edge of the left wing, about 2.7 m outboard from the wing root. Finally, there was yellow paint transfer on the right side of the windscreens, and on the fuselage below the windscreens (Figure 10).

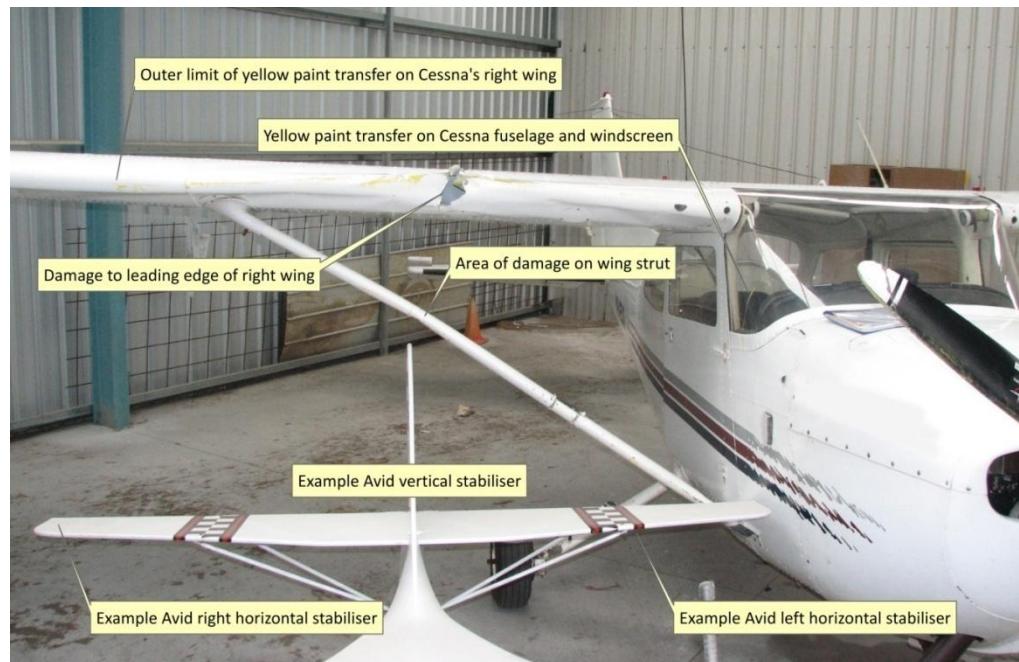
Figure 11: Alignment of an exemplar Avid with the damage to EUI

To further evaluate the collision damage to EUI, an exemplar Avid aircraft,²⁶ was used to reconstruct the positions of both aircraft at the point of collision. Those positions were as reported by witnesses, with both aircraft on a similar heading and the Avid to the right of EUI's centreline (Figure 11).

The reconstruction showed that the impact damage to EUI's wing strut and the hole in the leading edge of the right wing aligned with the Avid's vertical fin. In that relative position, the Avid's left horizontal stabiliser would have contacted the right side of the fuselage and windscreens of EUI, coincident with the yellow paint transfer in that area.

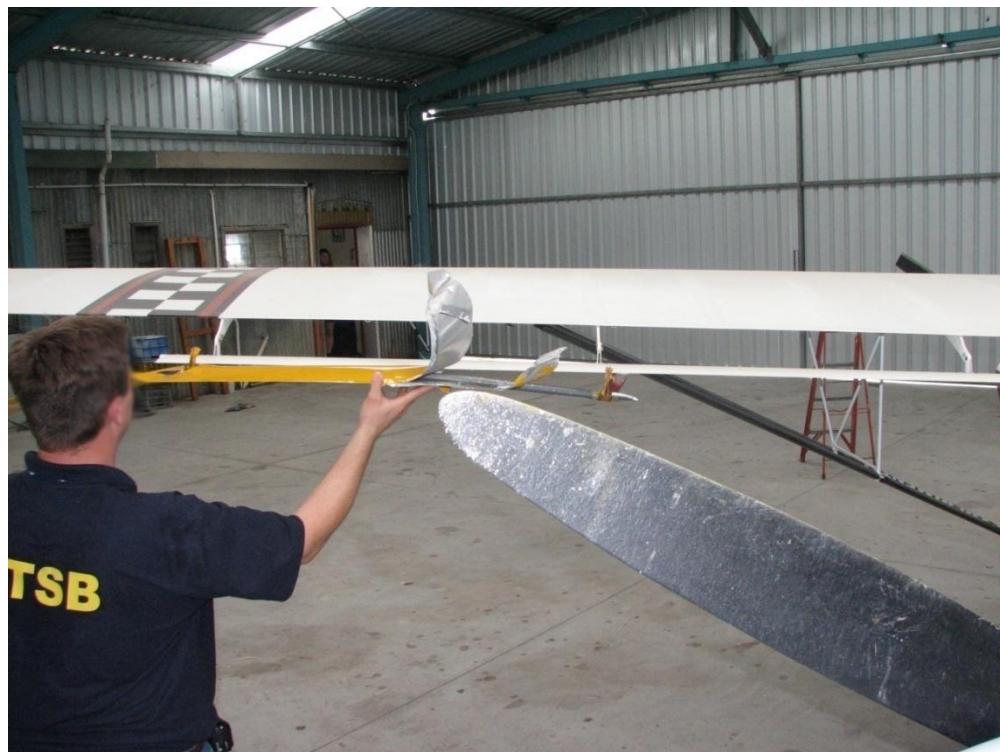
Figure 12: Reconstructed alignment of the Avid's damaged left flaperon and EUI's propeller arc

When the aircraft were in that position, the Avid's left flaperon was still about 1m forward of EUI's propeller. The reconstruction revealed that the damage to the Avid's left flaperon aligned with the arc of EUI's propeller tip, and that the damage to the left underneath surface of EUI's flap was in line with the position of the Avid's left flaperon mass balance weight.

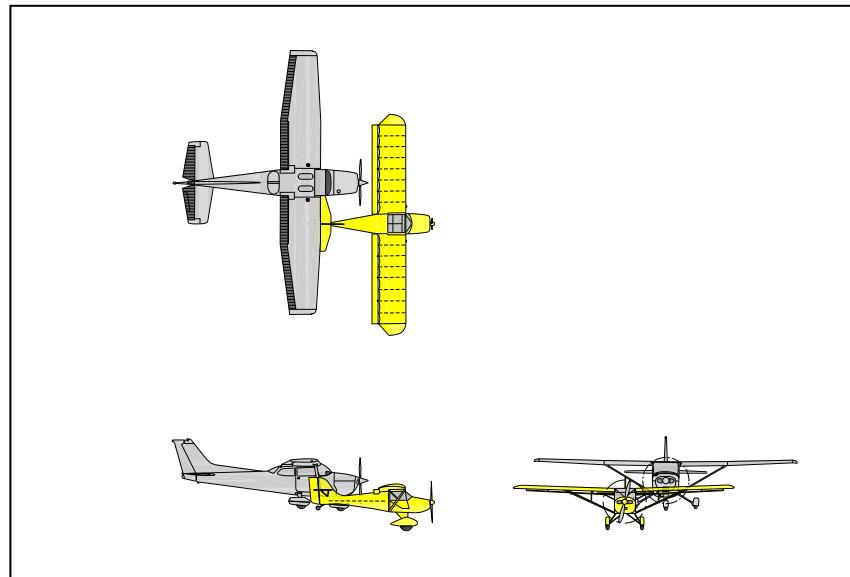
Figure 19: Collision sequence 2

Shortly after, EUI's right wing strut contacted the top of the Avid's fin and rudder (Figure 19). The force of that impact bent the rudder and fin over, probably breaking the Avid's fin from the aircraft.

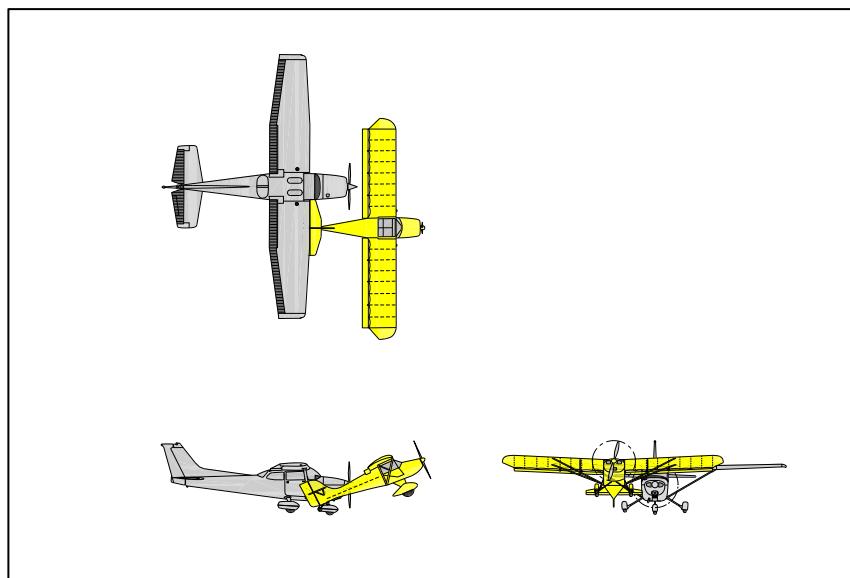
Figure 20: Collision sequence 3

The downward force of EUI on the Avid pitched the nose of the Avid up, and increased the angle of attack on the Avid's horizontal stabiliser, creating a large aerodynamic upward force (Figure 20).

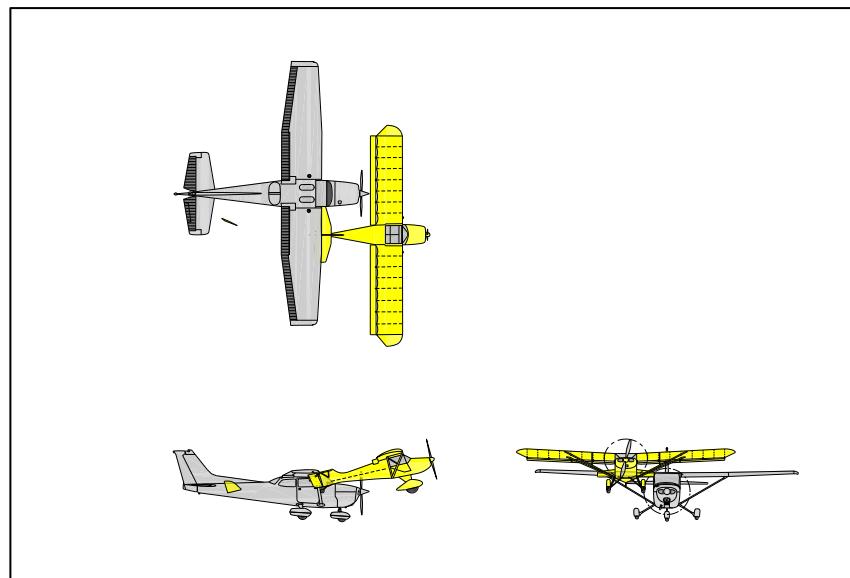
Figure 21: Collision sequence 4

The upward aerodynamic force on the Avid's tailplane became so large that the aircraft's damaged tail section slipped forward and off EUI's wing strut (Figure 21).

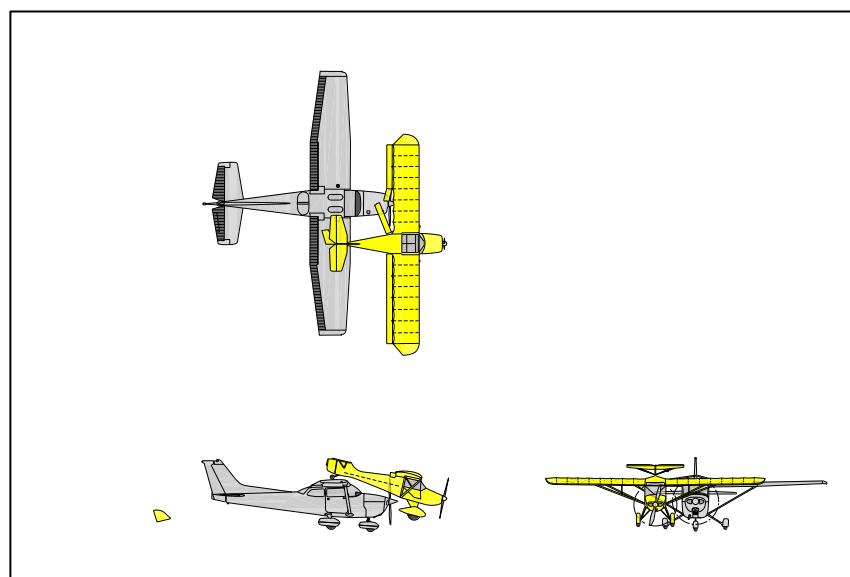
Figure 22: Collision sequence 5

As EUI continued to overtake the Avid, its propeller contacted the left flaperon and trailing edge of the Avid's left wing (Figure 22). The damage to the flaperon resulted in the mass balance weight detaching and moving rearward to strike the flap of EUI. The inboard section of the flaperon was flung upwards by the propeller, directing it towards EUI's left wing root. The flaperon bent around the leading edge of the wing root, where it remained until EUI landed and taxied in.

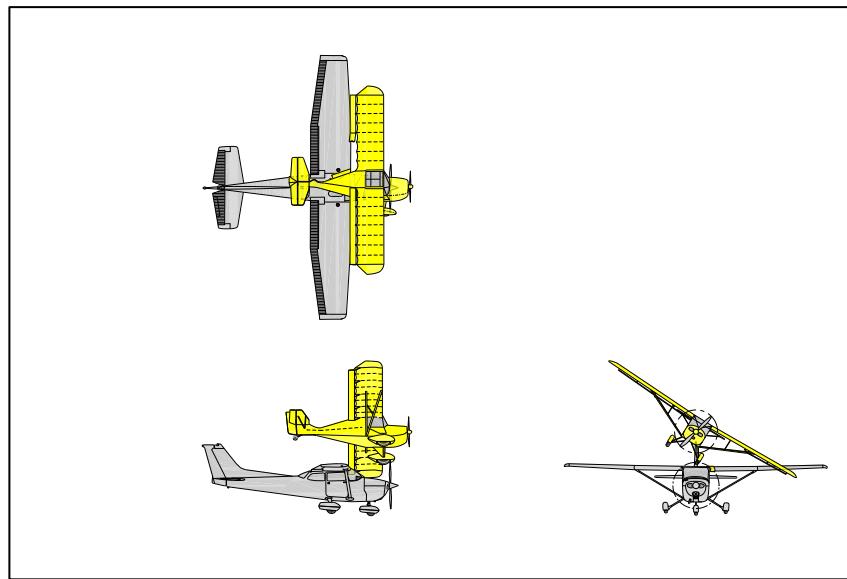
Figure 23: Collision sequence 6

The damage to the Avid's left flaperon and wing resulted in the aircraft rolling to the left (Figure 23). The left wing of the Avid struck the leading edge of the left

wing of EUI, before the Avid spiralled to the ground. EUI remained under control and was safely landed.
