**ATSB TRANSPORT SAFETY INVESTIGATION REPORT**

Aviation Occurrence Report – 200401917

**Powerplant/propulsion event - 40km S Tobermorey, NT  
30 May 2004  
Robinson Helicopter Company R22 Mariner II  
VH-MIB**

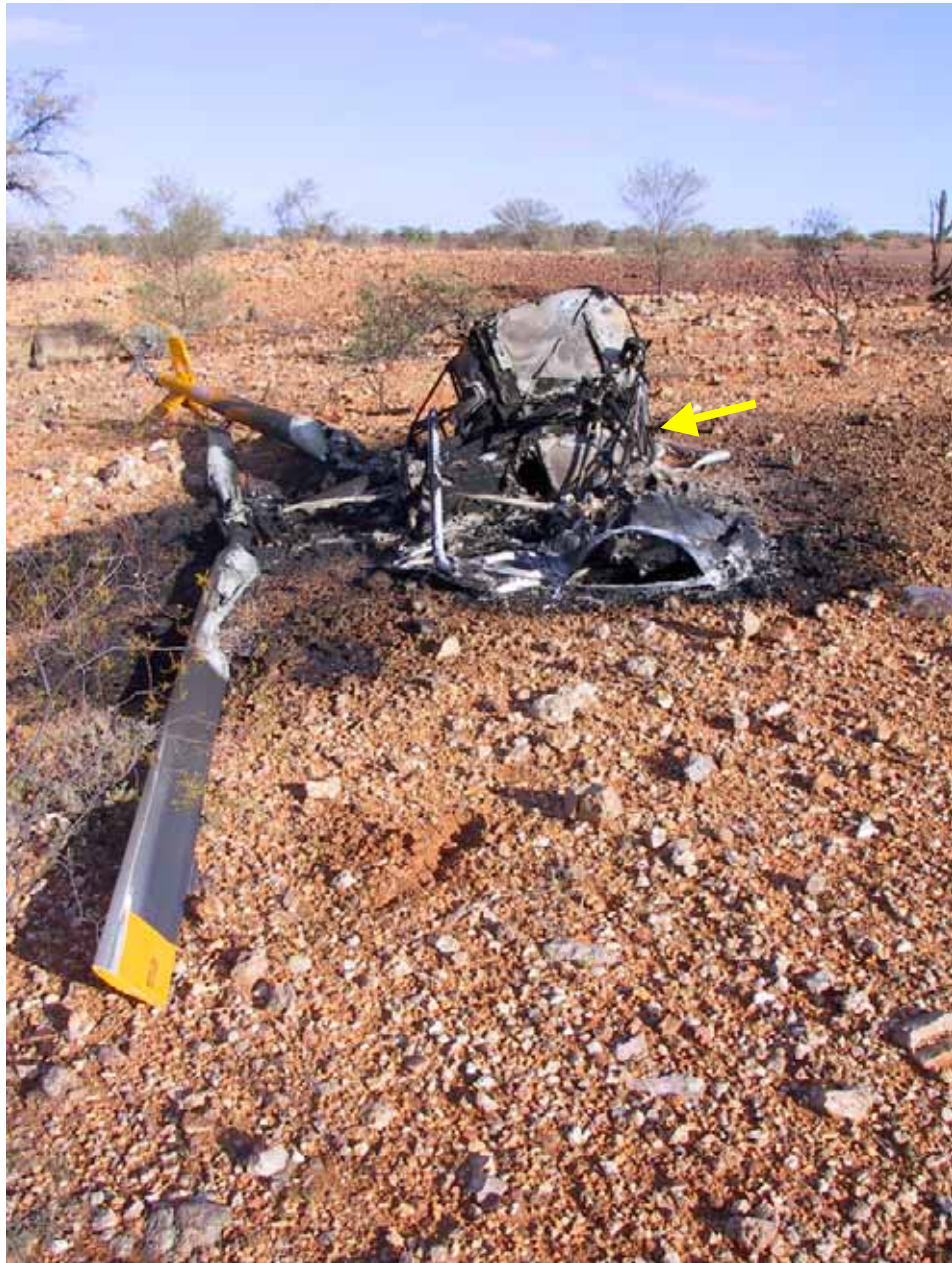
**Figure 1: Helicopter wreckage (arrow indicates bulkhead deformation behind pilot seat position)**

Severe crush damage to the lower cabin bulkhead was evident immediately behind the pilot's seat. (Figure 1).

The crush damage observed to the right side of the cabin structure showed that impact forces were greater on the right side of the helicopter than the left. As a result, the pilot, who occupied the right seat, was subjected to higher impact forces than the passenger in the left seat. The impact forces in this accident were not directly aligned with the helicopters fore-aft and vertical axes. Hence, the level of protection afforded by the seat/harness combination was reduced and probably contributed to the injuries sustained by the pilot. The extent of the post-impact fire precluded any definite conclusions as to what, if any, material may have been carried under the pilot's seat.

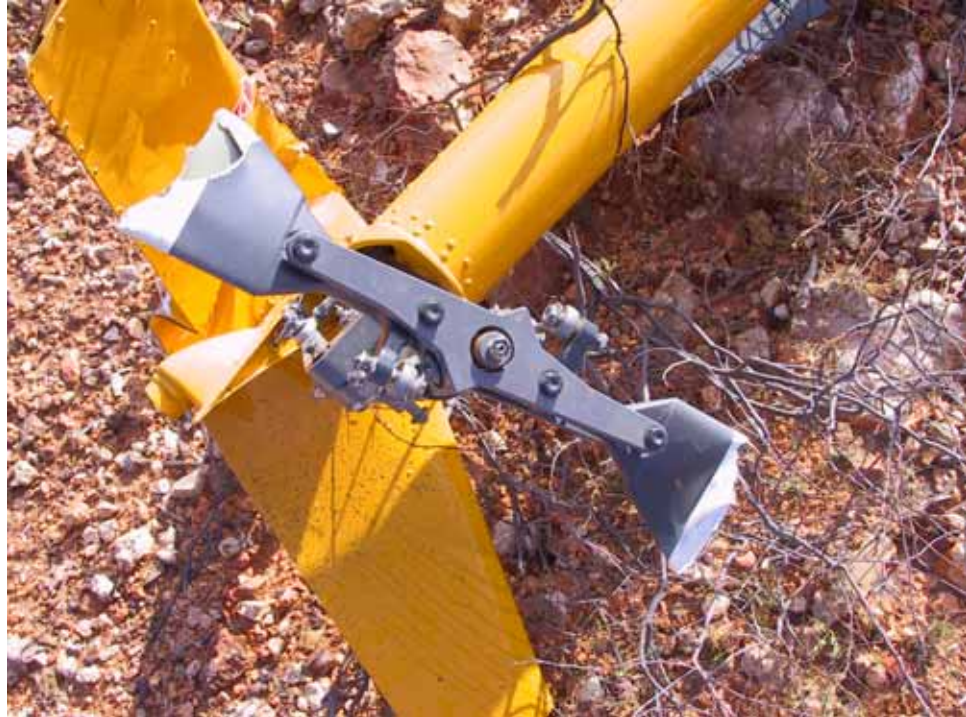
was consistent with impact forces or fire. The main rotor blades exhibited damage consistent with low rotor energy at impact. Both tail rotor blades had fractured approximately 1/4 span outboard of the rotor hub centre drive (Figure 2). The failed section of one blade was found adjacent to the main wreckage. The failed section of the other blade was found subsequently about 70 m from the main wreckage. Both blade sections were taken to the ATSB laboratories for further examination.

**Figure 2: Tail rotor damage**

The metallurgical evidence confirmed that the failure mode of both tail rotor blades was very similar and was the result of contact with the ground during the impact sequence. The rocky material embedded in the blade tips provided clear evidence

that the blades had struck the ground while rotating. The blade that was found about 70 m from the wreckage was thrown that distance as the result of tail rotor rotational energy.

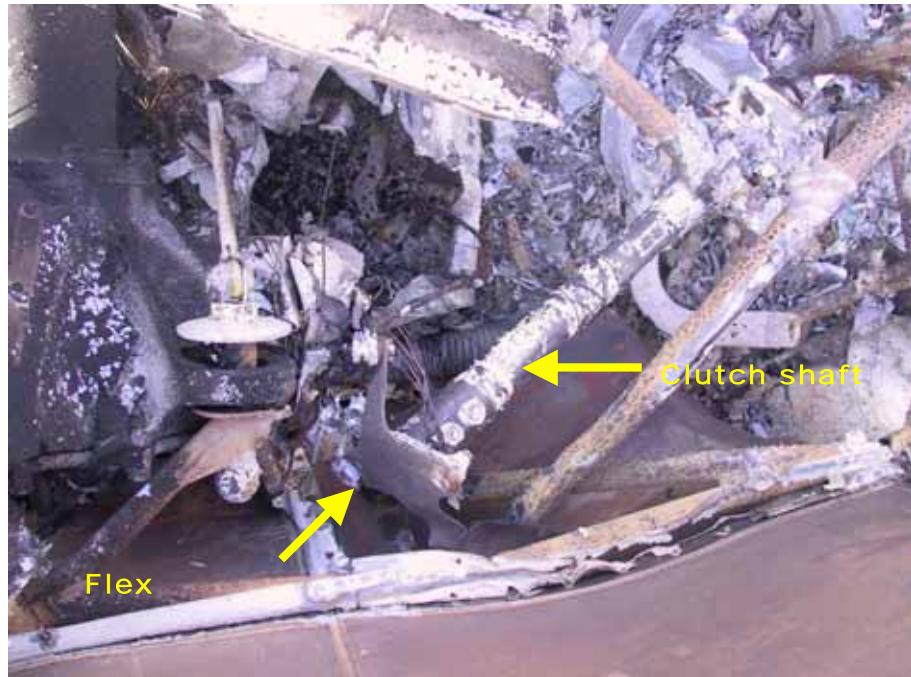
All of the engine drive system components were identified within the wreckage. The flex plate for the forward flexible coupling of the main rotor drive system was fractured at one of the two attachment points to the main rotor gearbox yoke (Figure 3 and 4). The flex plate, including the clutch shaft, were retrieved from the accident site, for further examination. The flex plate for the intermediate flexible coupling was intact and showed evidence of rotational damage consistent with partial drive system power at impact. The rear flex plate and coupling components were also found intact.

**Figure 3: Forward flexible coupling as found in wreckage**

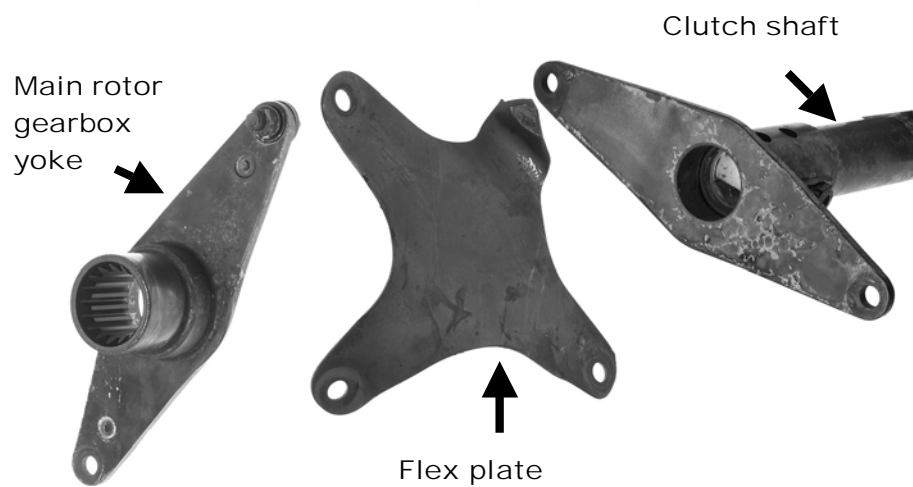
**Figure 4: Components of failed forward flexible coupling**

The specialist examination found that the flex plate in the forward flexible coupling fractured as a result of the propagation of a fatigue crack at one of the bolted connections between the plate and main rotor gearbox yoke. Final fracture of the flex plate occurred during operation and not as a result of the collision with the ground. No crack growth or wear damage was observed at the three remaining boltholes. Examination of the bolt installed at the failure location revealed that extensive fretting wear had occurred around the entire circumference of the bolt, in the region adjacent to the flex plate and the regions adjacent to the reinforcing plates. Fretting wear was also evident on the washer surface adjacent to the bolt head.

The bolted joint at the flex plate failure location was found to have a single thin washer under the bolt head and nut, and no spacer washer between the yoke and flex plate. This spacer and washer combination was different from that specified by the manufacturer for use with a NAS6605-6 bolt.

One of the bolted joints in the forward flexible coupling had been assembled incorrectly, resulting in a lack of clamping force and subsequent fatigue failure of the flex plate in the forward flexible coupling and loss of drive to the main rotor gearbox.

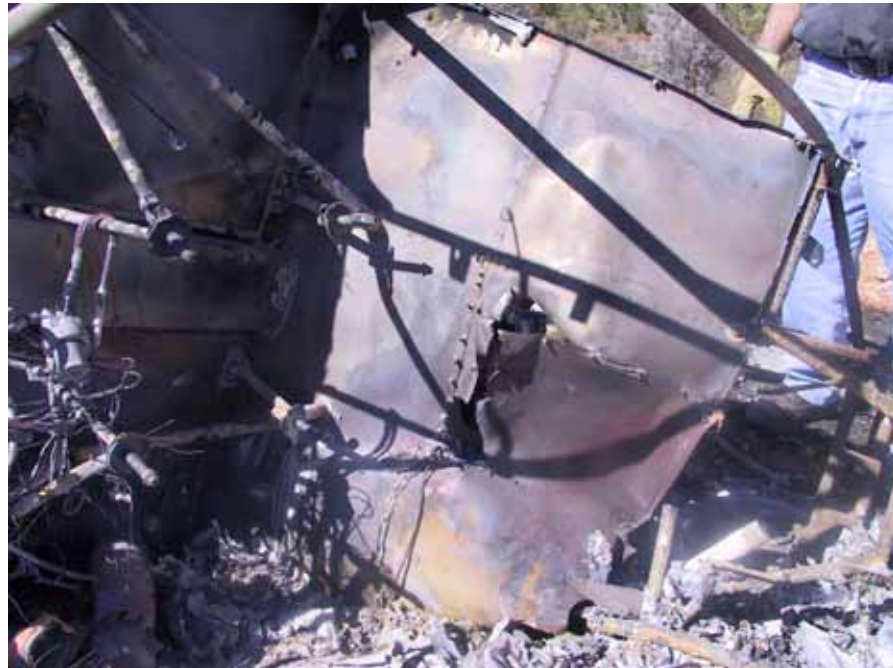
The fuel system and engine ancillaries were destroyed by the fire. There were vertical cuts puncturing the inside wall of the right fuel tank and the horizontal stainless steel firewall above the engine. The cuts in the right tank and the firewall aligned with the forward flex plate plane of rotation (Figure 5). The left fuel tank was destroyed by fire.

**Figure 5: Flex plate puncture of stainless steel firewall above engine.**

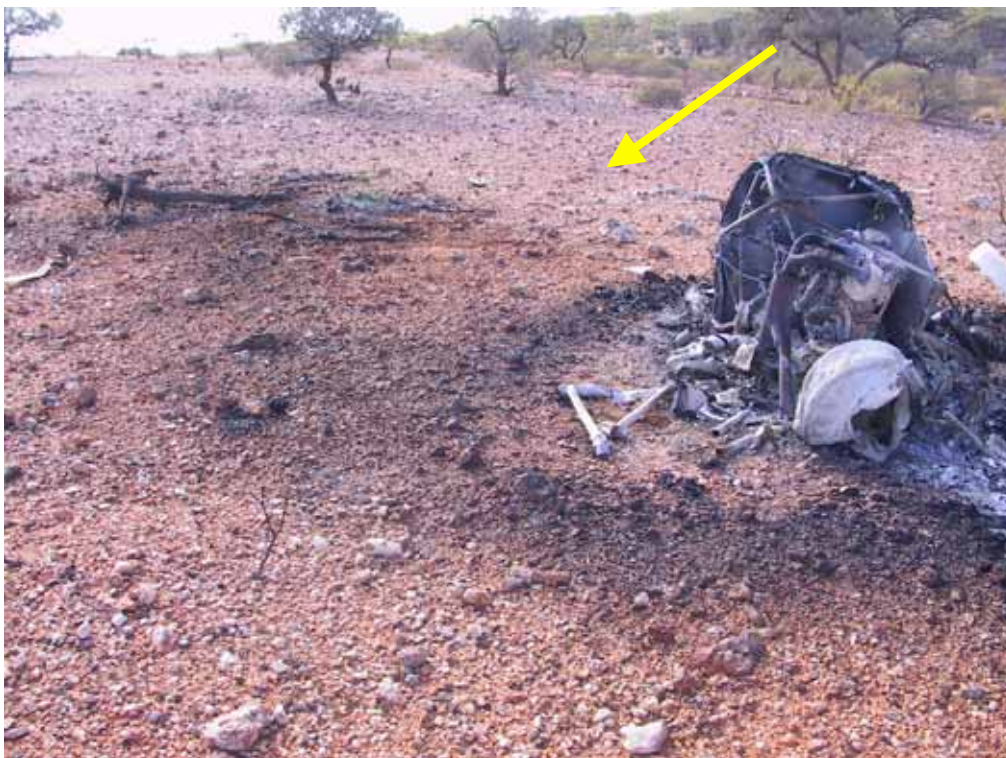
There was a fire affected area (sooting) on the ground that extended up-slope from the wreckage (Figure 6). The sooting formed a swirl pattern of decreasing radius in the direction the helicopter was yawing when it contacted the ground.

**Figure 6: Sooting pattern adjacent to wreckage (arrow indicates approximate direction of flight at impact)**
